2nd UGCT seminar
10 September 2015

Use of X-ray radiography and tomography to evaluate self-healing concrete

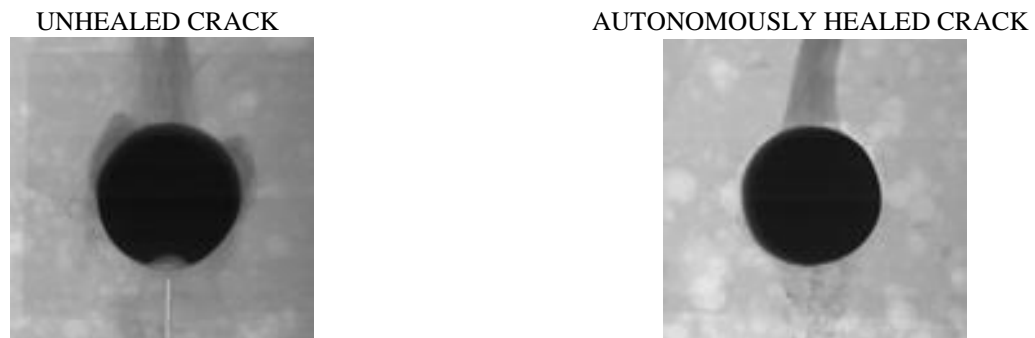
Figure 2: Prevention against pitting corrosion, by self-healing of the crack through release of encapsulated polyurethane, after 30 hours exposure to an acceleration corrosion test

the crack was prevented. Recently, X-ray radiography has also been used to demonstrate that due to the reduced ingress of water and aggressive agents into the crack, corrosion of reinforcement steel can be prevented. While for the unhealed reference samples pitting corrosion of the embedded steel was clearly visible on the radiographs, for samples with autonomously healed cracks corrosion initiation was clearly prevented (Figure 2).
