Tesfaalem G. Asfaha, Frankl, A., Mitiku Haile, Nyssen, J., 2014. Catchment rehabilitation and hydro-geomorphic characteristics of mountain streams in the western Rift Valley escarpment of Northern Ethiopia. *Land Degradation and Development*, online early view. DOI: 10.1002/ldr.2267

## CATCHMENT REHABILITATION AND HYDRO-GEOMORPHIC CHARACTERISTICS OF MOUNTAIN STREAMS IN THE WESTERN RIFT VALLEY ESCARPMENT OF NORTHERN ETHIOPIA

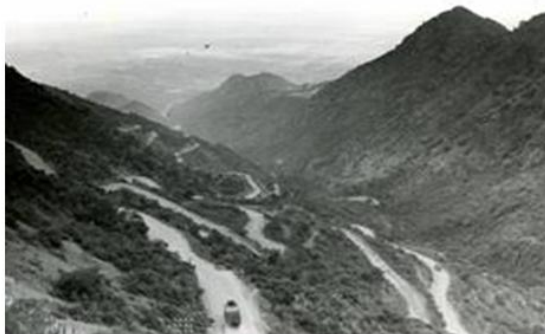
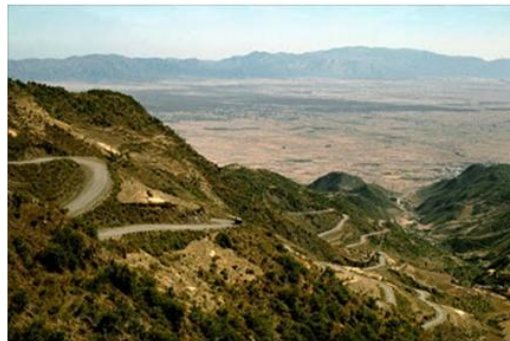
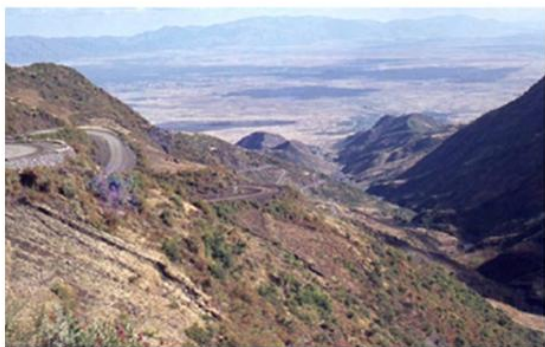
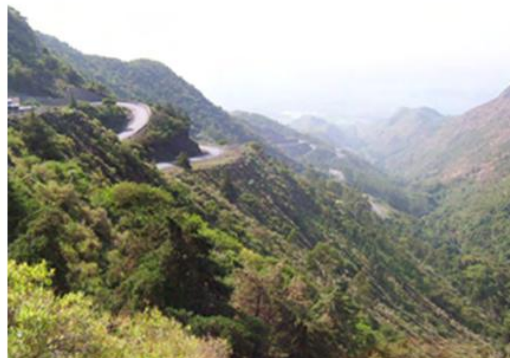
Figure 3

1937 photo ©IAO

1970 Photo © Larry Workman

1975 Photo © Neil Munro

2006 Photo © Jan Nyssen

The incidental repeat photographs of Gira-Kahsu catchment (Figure 3 - catchment 2 in Table 1) show a gradual reduction in vegetation cover up to 1975 and a strong increase in 2006. The farmlands on sloping areas of the catchment observed in the 1975 photo were totally covered by shrubs in the 2006 photo. This was also verified in the field. On the other hand, in the Wera'-Hara catchment (catchment 3, Table 1), where farmlands, grazing lands and settlement dominate the upper part of the catchment, less vegetation cover and the largest noticeable scars are observed in the sloping parts of the catchment (Figure 4).

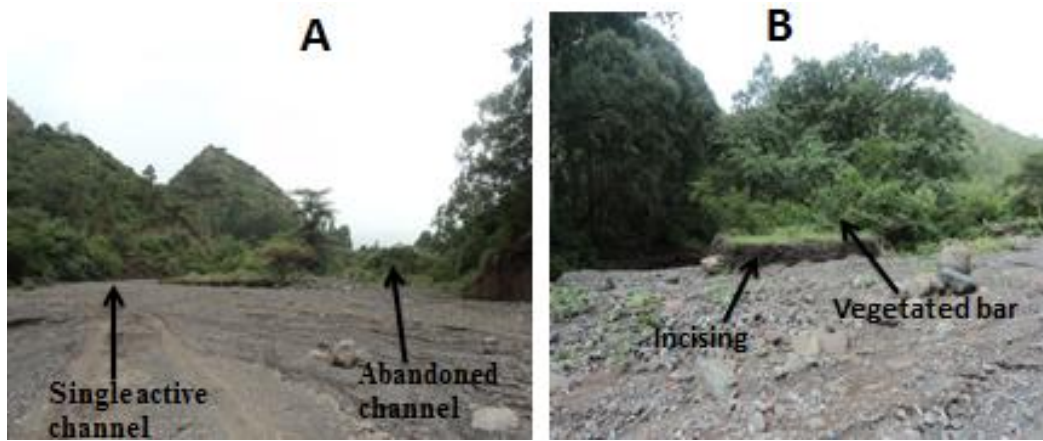
Figure 8

**Figure 8.** Abandoned channels. The river now flows in one of the preexisting channels and deepens it (B).

catchments and its subsequent effect on reduction of discharge and sediment flow (Figure 8 and Figure 9).

in which, the + or - signs indicate an increase or decrease in discharge (Q) and sediment load ( $Q_s$ ) of the streams, and their impact on the width (w), depth (d) and width/depth ratio (w/d) of the channels. The four equations conceptualize the general response of stream channels to runoff and sediment load alterations related to changes in catchment vegetation cover. Generally, eq. (3) corresponds to the situation of degraded catchments where high discharge and sediment supply to the streams results in widening of the channels. With high sediment supply, oversaturated flows cause the channels to aggrade (eq. 5). This situation was commonly observed in the most of the degraded catchments and in the catchments which comprise different land use/cover classes. For example, the big boulders shown in Figure 6A, were deposited in 2010 in the Wera'\_Hara catchment owing to the existence of very large farmlands, grazing lands, settlement and rock out crops in its upper catchment. Reversely, eqs. (4) and (6) explain the status of the channels after reforestation where decreased discharge and sediment supply have resulted in incision and less aggradation and thereby reducing the width of the active part of the channels. This corresponds to the situation of the catchments like the Gira-Kahsu catchment where reduced discharge and sediment supply led to narrowing of the active channels (Figure 6B) and incision (Figures 6B, 7A, 7B, 8B).

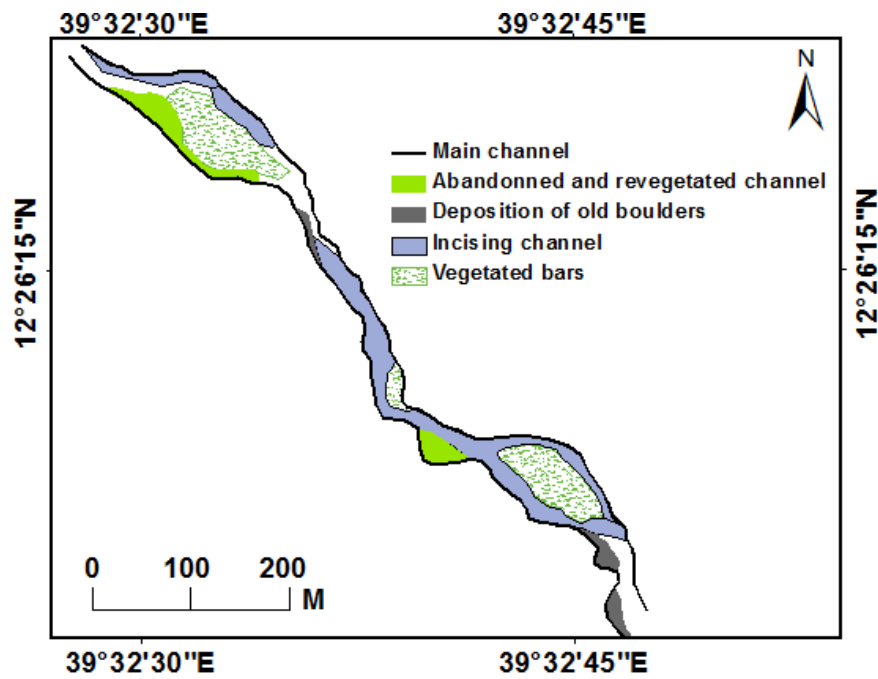
Figure 9

**Figure 9.** Stream channel adjustments in the lower reach of the Gira-Kahsu catchment
