## 8. Long-term gully and river channel dynamics in Tigray

(Based on Frankl et al., 2011)

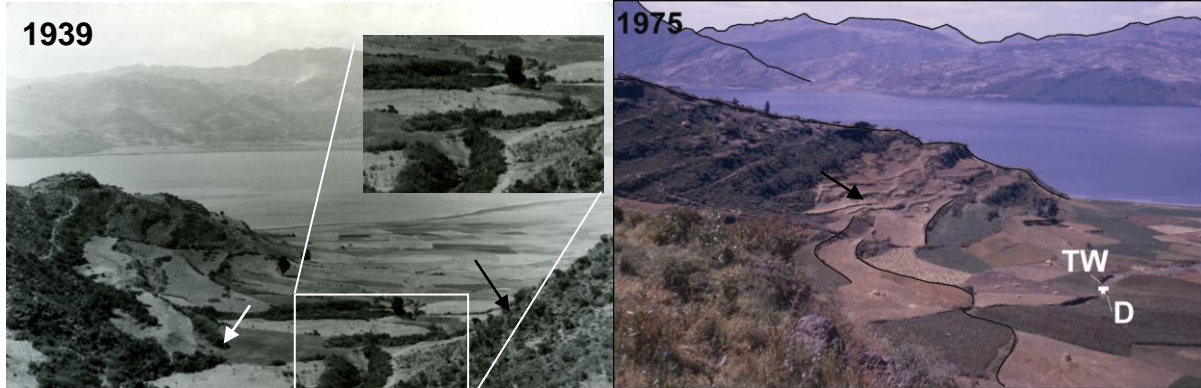
**Fig. 1.** *Left:* This photograph was taken in 1939 by A. Maugini (© Istituto Agronomico per l'Oltremare, Firenze, I) at Lake Ashenge, shortly after the construction of the road towards Addis Ababa. It shows that wood harvesting and agricultural exploitation severely affected the environment, but that shrub cover on the land (white arrow) and on the surrounding hills (black arrow) remained relatively high. The gully draining the valley is dormant and has been partially converted to cropland (enlargement). By 2009, the gully had extended downstream by 294 m (Frankl et al., 2011). It is now freshly incised and remains active despite the recent soil and water conservation efforts. **Right:** While surveying soil erosion in North Ethiopia in 1975, Neil Munro (Tigray Rural Development Study) incidentally photographed the same valley and gully previously recorded in 1939. The gully in 1975 appears freshly incised. Agricultural expansion was ongoing and is evidenced by recent terracing on the hillside (arrow). Cross-section properties could be calculated using repeat photography (Frankl et al., 2011) and were in 1975: Top Width (TW)= 5.00 m, Depth (D)= 1.73 m. In 2009 TW increased to 11.60 m and D to 3.80 m.

**Stop 1.** Development of a gully in a small catchment draining to Lake Ashenge (p. 40).

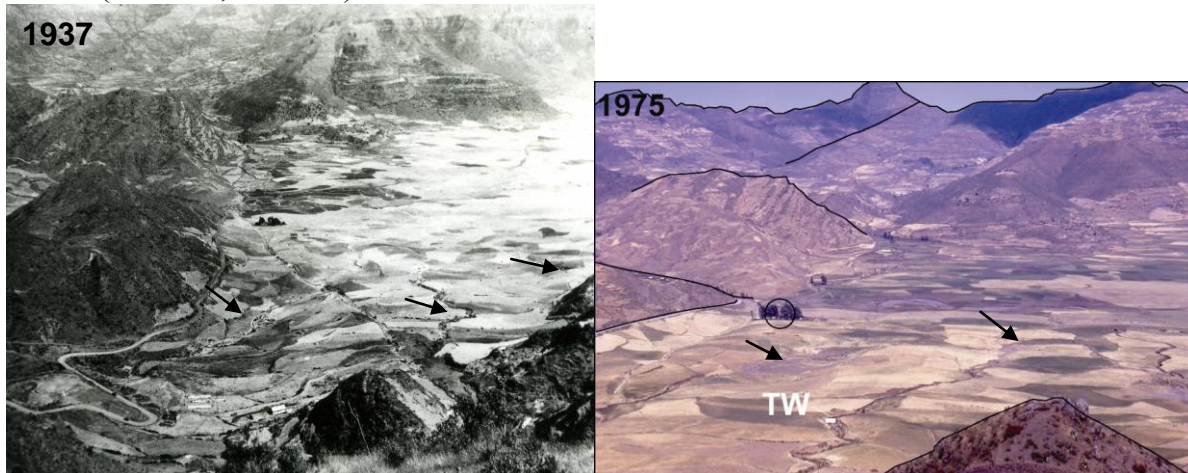
**Fig. 2.** *Left:* First pictured in 1937 by A. Maugini (© Istituto Agronomico per l'Oltremare, Firenze, I), the Atsela catchment was poorly managed and bore the signs of intensive agricultural exploitation. Farmland extended beyond its 2009 area to the lower steep mountain slopes, where terracing was absent. The three gullies (arrows) that nowadays cut through the valley

floor were already present in the early 20<sup>th</sup> century. However, their lower ends were located higher in the valley bottom at approximately 2490 m a.s.l. **Right:** This photograph taken by Neil Munro in 1975 shows that the overuse of the land continued and that the erosive activity of the gullies strongly increased. The channels appear re-incised and prolonged downstream by a total length of 1663 m, ending in large debris cones (arrows). At present, some of the stabilizing gully sections were converted into cropland because risk of flooding is decreased. The Top Width (TW) of the central gully could be calculated (Frankl et al., 2011) and was 6.35 m in 1975. At present the gully TW is 8.20 m (Frankl et al., 2011).

**Stop 2.** Panoramic view of the Atsela valley bottom, with Amba Alaje at the back. Here the gully network expanded throughout the 20<sup>th</sup> century and is now shrinking (p. 40).

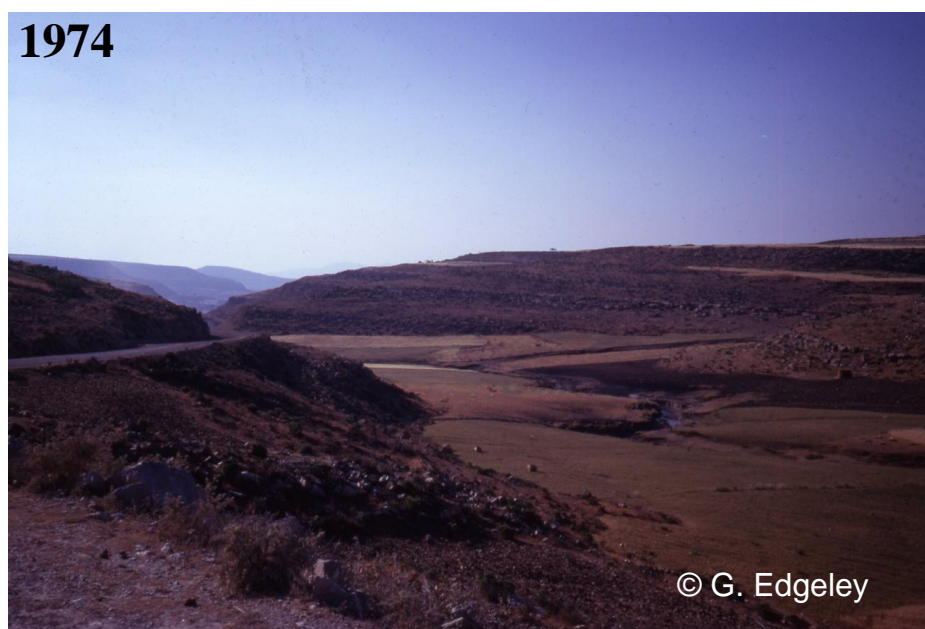
**Fig. 3.** The gully west of the town of May Mekdan drains an area of ca. 50 km<sup>2</sup>.

Gullying in the Vertisols around May Mekdan is not recent as old citizens can remember the presence of a gully which could be crossed fairly easy by foot some 50 years ago. Photographs of 1974-1975 (**Fig. 3**), indicate that the gullies in the catchment of May Mekdan were active, having steep walls and carrying coarse bed load. The gully section west of May Mekdan was then some 9.27 m wide and 4.08 m deep (Frankl et al., 2011). Between 1974-1975 and 2009 the gully width and maximum depth doubled. Most of the cross-section change was already accomplished by 1994 (**Fig. 4**), after which the gully incised by a mean of 1.32 m. Despite the implementation of soil and water conservation measures on the hillsides that started in 1995, gullying remains very active (**Fig. 5**), as important flash floods still occur and gully networks expand through piping (**Fig. 6**). First order streams which have a strong link to the surrounding hillsides are de-activating (**Fig. 7**).

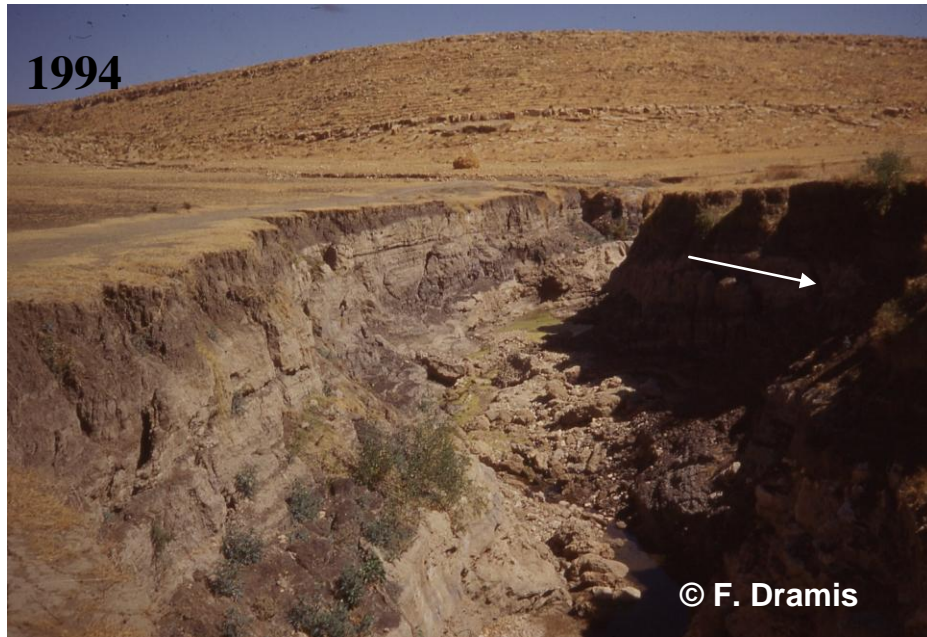
**Fig. 4.** The gap in the gully bank in 1994 indicates the occurrence of large slab failures (arrow). Note the increase in shrub cover after 1994 on the slope in the background.

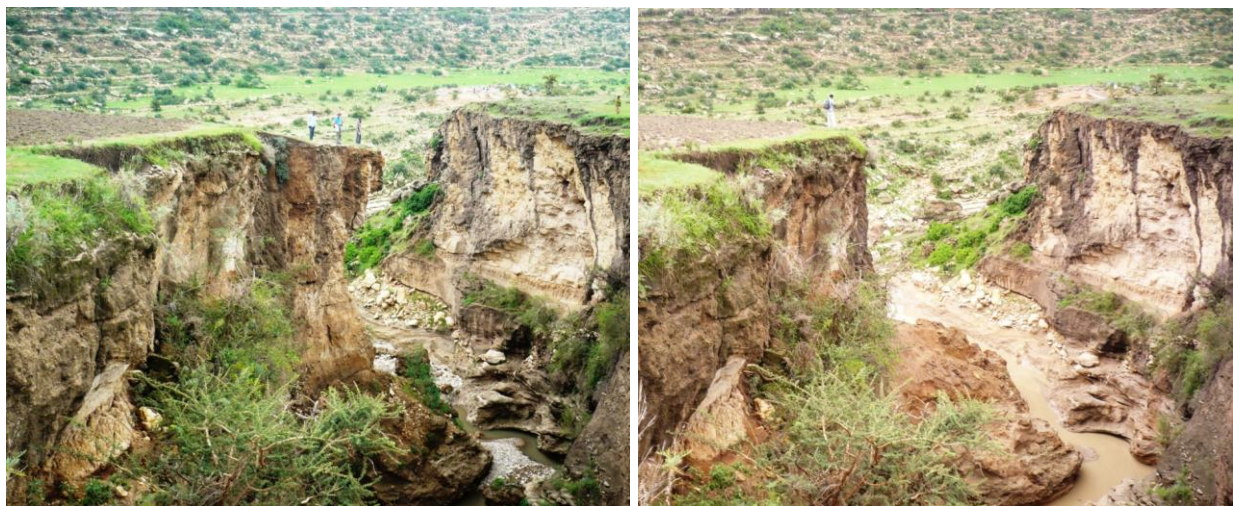
**Fig. 5.** Gully sidewall erosion by a large slab failure was caused by undercutting and the development of tension cracks parallel to the gully wall. Photographs by A. Frankl before (left) and after (right) an important rainfall event in the summer of 2010, when flood marks rose up to 3.5 m in the main gully (Fig. 6).

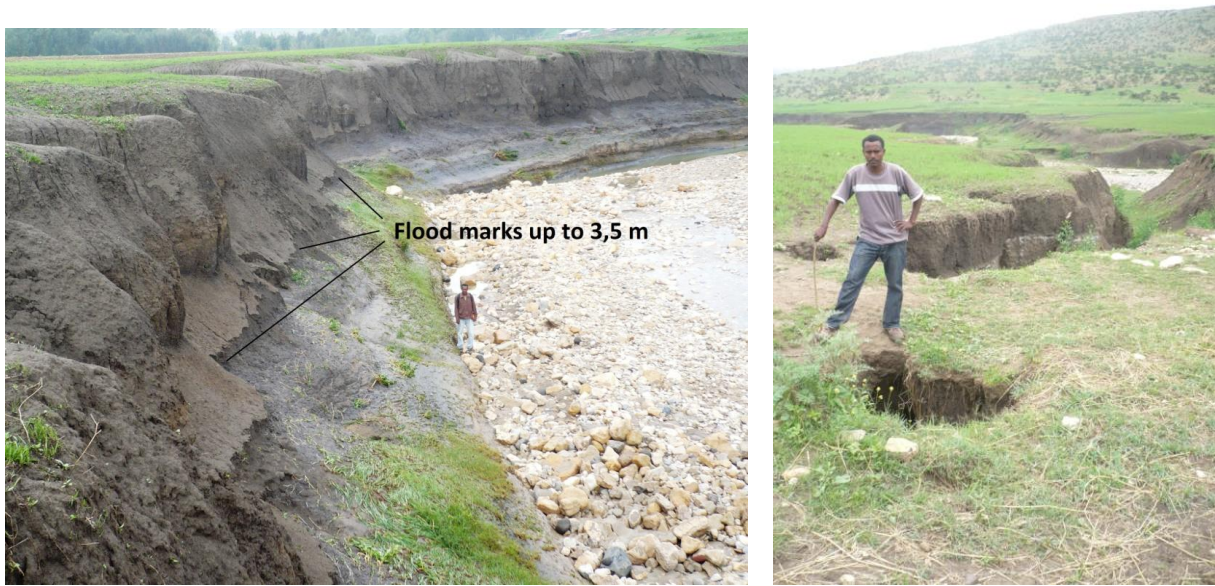
**Fig. 6.** *Left:* Flood marks were recorded up to a height of 3.5 m in the gully draining the May Mekdan valley, after three successive rainstorms stroke the area in 2010. **Right:** Bank gullies linked to piping in the Vertisols are frequent.

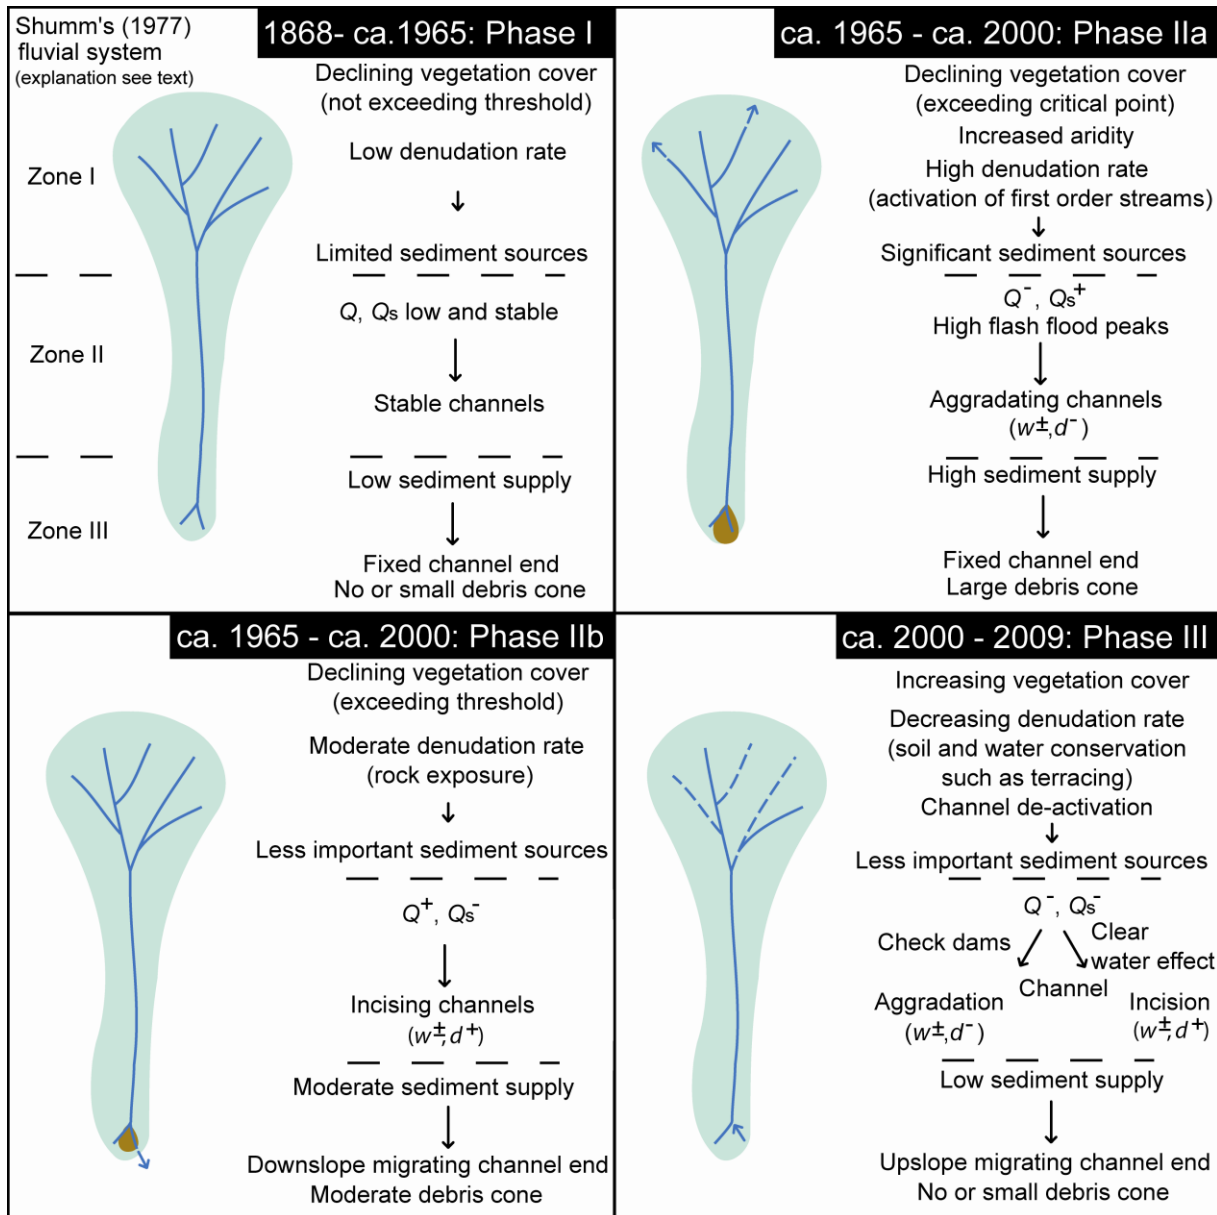
**Fig. 8.** Conceptual model of changes in the hydrogeomorphology of the Northern Ethiopian highlands based on Schumm's (1977) fluvial system. The threshold refers to a critical reduction in vegetation cover resulting in runoff conditions triggering gully incision or network expansion (After Frankl et al., 2011).

A conceptual hydrogeomorphic model was devised for these catchments and validated for the Northern Ethiopian Highlands (**Fig. 8**). Three major phases can be distinguished in the hydrological regime of the catchments. In the first phase, between 1868 (or earlier) and ca. 1965, the relatively stable channels showed an oversized morphology inherited from a previous period when external forcing in environmental conditions had caused the channels to shape. In the second phase (ca. 1965 – ca. 2000), increased aridity and continued vegetation clearance accelerated the channel dynamics of the gully and river system. The third phase (ca. 2000 – present) started after the large-scale implementation of soil and water conservation measures. In 2009, 23% of the gully and river sections were stabilizing. This paper validates previous research indicating severe land degradation in the second half of the 20<sup>th</sup> century. Additionally, it demonstrates that the recent erosive cycle started around 1965 and, that at the present time, improved land management stabilizes headwater streams.
