In: Sánchez Espinosa, E. & Garcimartin, M.A. (eds.). Proceedings of the Vth International Symposium on Concrete for a Sustainable Agriculture. Agro-, Aqua- and Community Applications. San Lorenzo de El Escorial, Spain, 5-8 June 2005, 239-247. ISBN 84-7401-190-6.

CONTACT PRESSURES AND DEFORMATION OF CATTLE CLAWS IN CONTACT WITH A CONCRETE FLOOR

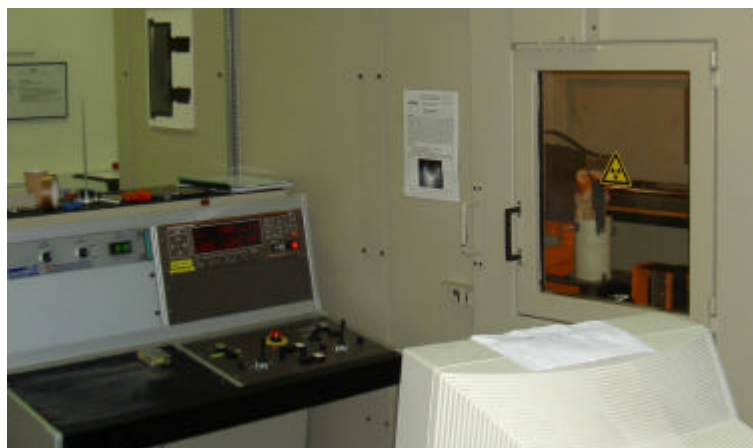
Figure 4. CT scanner with claw placed on turntable behind window

For assessing the deformation of a claw under load, different claws of calves were used. The claws had to be somewhat smaller because they needed to fit within the angle of view of the CT scanner, which is shown in Figure 4. The CT scanner is an AEA Tomohawk system with a Philips HOMX 161 X-ray source and an Adimec MX12P CCD (Charge-Coupled Device) camera. The X-ray source remains stationary but the subject (i.e. the claw) turns around by means of stepping motors. The claw was rotated over 187° and for each 0.5° , an image was taken. All these scans were then used as input for a 3D reconstruction consisting of approximately 350 slices along the height of the claw (Z-axis). The reconstruction was done with dedicated Tomohawk software. The voxel (i.e. volume pixel) size as well as the distance between the slices was around 0.25 mm. This number was not the same for all scans made and depends on the distance between X-ray source and subject and X-ray source and CCD camera plate; these distances were not exactly the same for the different scans. The Tomohawk scanning system is shown in Figure 5.

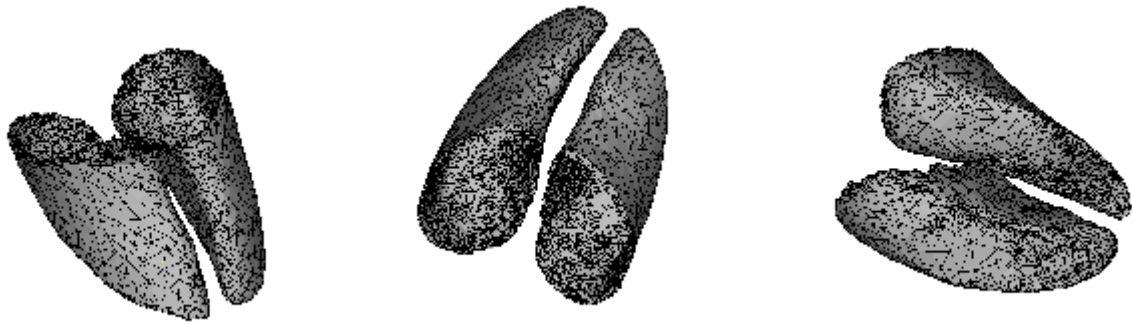
Figure 12. Different views of the horn shoe

Figure 12 shows the horn shoe of the unloaded claw in different views. This result was achieved with Mimics by subtracting different threshold masks, by manually editing the slices and by using the 3D FEA toolbox. The triangles on the surface of the horn shoe are automatically generated surface meshes. Before meshing smoothing operations were carried out on the surface and afterwards the amount of triangles was reduced. These 3D images can be exported to FEA packages (e.g. Abaqus); the triangles then will serve as a basis for creating 3D tetraeders.

An example of a CT slice is shown in Figure 9. This slice was made by importing the Tomohawk data file of a slice in Matlab and then exporting the file to bitmap format. Figure 10 shows the same slice, but the grey values above 152 (= threshold) were converted to white while the lower grey values were converted to black. This operation was done with Matlab in order to be able to distinguish the bone structure and the claw wall more easily. Mimics works in the same way, but operations are much more automated. In Figure 10 there is still some “noise” (isolated white specks between bone and claw wall) which can not be removed by purely changing the threshold value (it could be removed by manually editing the bitmap slice images). This noise occurs due to the very low contrast between the tissue surrounding the bone and the claw wall horn. Mimics offers tools for refurbishing the images, e.g. masks with different thresholds can be subtracted from or added to each other and small cavities in the structures can be filled. These tools were used for making the pure horn shoe structure shown in Figure 12.
