XIX ANIDIS Conference, Seismic Engineering in Italy

# Securing the church of Madonna del Sole during the emergency phase of 2016 earthquake: interoperability of different actors as an instrument for reducing seismic risk of damaged built heritage

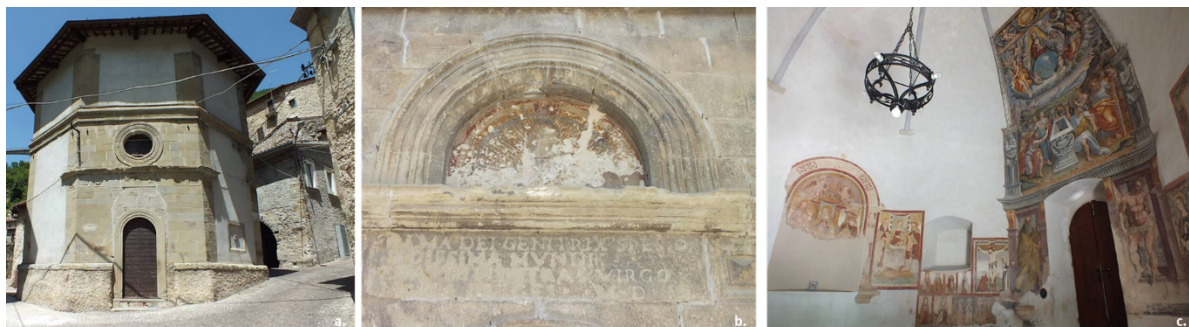
**Fig. 3.** (a) Church of 'Madonna del Sole'; (b) The painting showing Maria in the sunrays; (c) Some of the frescoes inside the church.

The church is a small building with a central octagonal plan, whose origin is traced around the first decades of the XVI cent. Its external walls are covered with sandstone blocks and plaster, with a sculpted basement and a moulded string course all along them. Some frescoes representing Christ and the Saints are painted inside, probably by Cola dell’Amatrice or by some of his disciples. In a niche above the entrance a painting shows Maria surrounded by sunrays, while other decorations and an inscription dated back to 1550 are sculpted near the doors of the church (Fabiani 1952). The church had been recognized of great historic and artistic interest already in 1918, after the promulgation of the Italian law n. 364/1909, one of the first national laws for the conservation of cultural heritage (ICCD 2022, ViR 2021).

Fig.3 – Image prepared by authors. The original photos were taken by the Diocese of Ascoli Piceno. They are available on the website: <https://www.iluoghidelsilenzio.it/oratorio-della-madonna-del-sole-arquata-del-tronto-ap/nggallery/page/1> (accessed: January 2021);

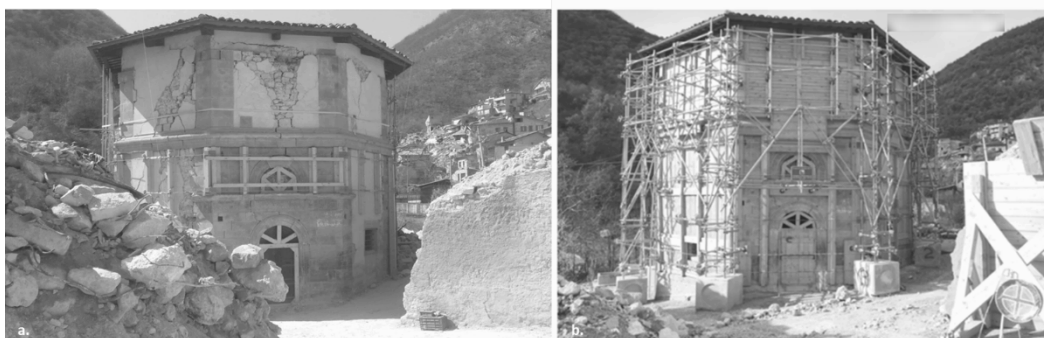
**Fig. 5.** (a) The church of ‘Madonna del Sole’ after the earthquakes of October 2016; (b) The church in November 2017.

The realized contermesures effectively increased the residual strength of the structure, minimizing the occurrence of further collapses to the already damaged parts. On the contrary, some collapses occurred where the contermesures were not still installed, such as it happened for the bell tower of the church, that collapsed on the sacristy, also damaging part of the roof of the church

After the earthquakes of 26<sup>th</sup> and 30<sup>th</sup> October 2016, the church was subjected to a further securing intervention, as the existing countermeasures had been seriously damaged, being thus no more able to protect the building. This second intervention was designed in November and it was approved by the MiC at the beginning of December 2016. Nevertheless, it was possible to realize it only during the spring, as the collapse of most of the surrounding buildings made the access to the site very difficult. Furthermore, the big amount of the debris caused some problems for the recognition of the ones belonging to the church, that needed to be stored in a safe place for their restoration, as it was established by the MiC (MiBACT 2016). At the present, the church is still under restoration.
