GEOMATICS SUPPORTING KNOWLEDGE OF CULTURAL HERITAGE AIMED AT RECOVERY AND RESTORATION

G. Vacca ^{1*}, A. Dessi ¹

The paper presents the potential and the accuracy of the two techniques and their integration in the process of study, planning and execution of the restoration of the San Giovanni Battista church in Fonni (Sardinia, Italy), founded in the 16th century. The building, due to structural problems and humidity infiltrations, is currently subject to a serious intervention for consolidation and conservative restoration.

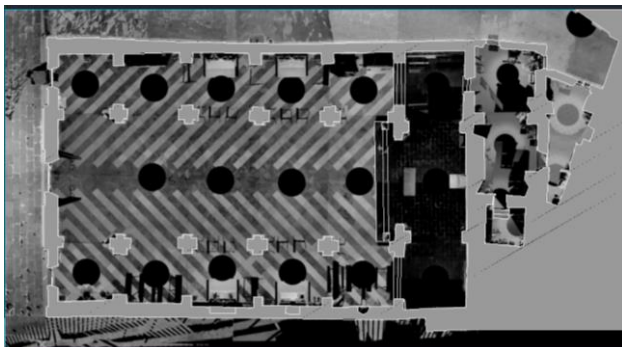
Figure 1. Map of the Church of San Giovanni

The church of San Giovanni Battista is located in Fonni, a town in central Sardinia (Italy). It is a historical building that was subject to several interventions, expansions and modifications through the centuries, of which no documentation remains. Currently, the church occupies a surface area of about 550 m² and is composed of three naves divided into six spans, one of which is the presbytery. A square bell tower is built next to the sacristy. Figure 1 shows the map of the church in its current state.

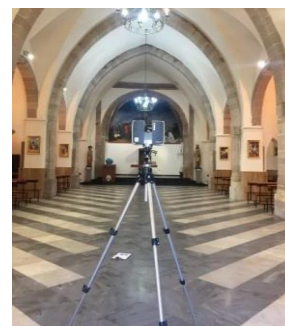
Figure 2. Faro Focus 3D

It was therefore decided to perform a Terrestrial Laser Scanner (TLS) survey that would allow to obtain a complete 3D model from which to extract all the graphic outputs of the church. For the choice of the instrument and for the design of the scans, we started by thinking about the geometry of the church, the architectural details and the state of cracks and deterioration present to be detected. From these considerations we decided to use the Faro Focus 3D (Figure 2) Terrestrial Laser Scanner. It is a compact scanner characterized by an operative range that varies between 0.6 and 120 m, with a ranging error of ± 2 mm for scanner-object distances between 10 and 25 m.

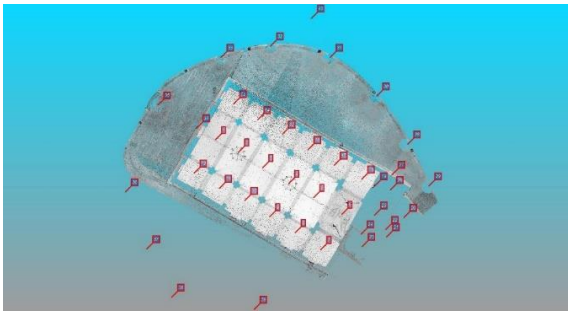
Figure 3. Points of TLS survey

The scans were performed at a resolution of 1/4, quality 3x (resolution of 7 mm / 10 m) and an overlap between the scans of at least 30%. A total of 40 scans were performed with these parameters, of which 28 internal and 12 external scans (see Figure 3). The survey was carried out on 19 October 2017.

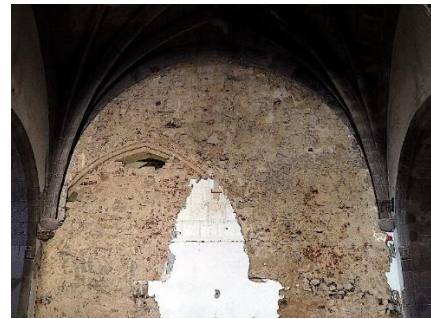
Figure 6. Presbytery post removal with opening

Figures 5 and 6 give a clear example. On the wall of the presbytery was brought to light an opening certainly dating back to the implant of the church and subsequently closed. Other openings, niches and paintings were found in the walls of other chapels.

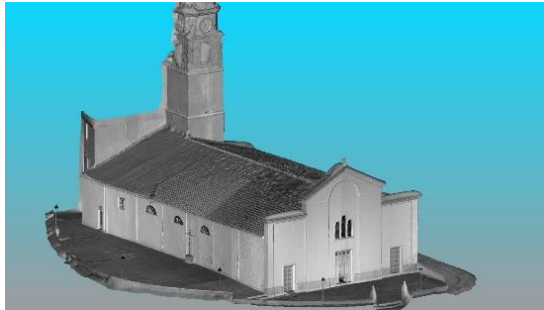
Figure 4. Church 3D Model

The complete point cloud of the church was, subsequently, georeferenced in the ETRF2000 reference system, through 20 Ground Control Points (GCP) placed outside the Church and surveyed through a GNSS survey in RTK mode, using differential corrections coming from the network of permanent stations of Sardinia SARNET [<http://www.geodesia.biz/sarnet/>]. After processing the 40 point clouds, the mesh and then the 3D model (Figure 4) was generated with the JRC 3D Reconstructor software. From this the following graphic output have been extracted:

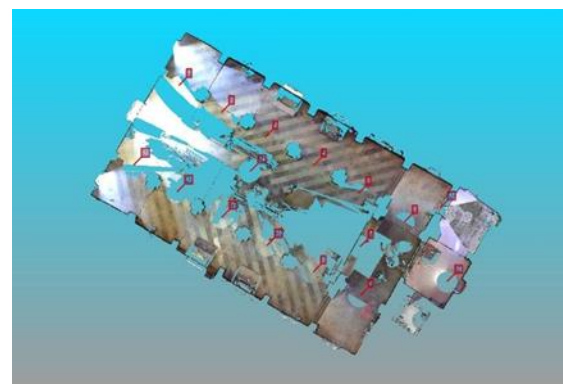
Figure 7. Points of TLS survey – Phase II

As for the TLS survey also in this case the Faro Focus 3D Terrestrial Laser Scanner and the JRC Reconstructor software v. 3.1.0 by Gexcel Ltd were used. The scans were carried out at a resolution of 1/4, 3x quality (resolution of 7 mm/10 m) and an overlap between the scans of at least 30%. A total of 18 internal scans were performed with these parameters (see Figure 7). The survey was carried out on May 7, 2021.
