Strengthening Historic Covered Bridges To Carry Modern Traffic

May 2007

U.S. Department
of Transportation
**Federal Highway
Administration**

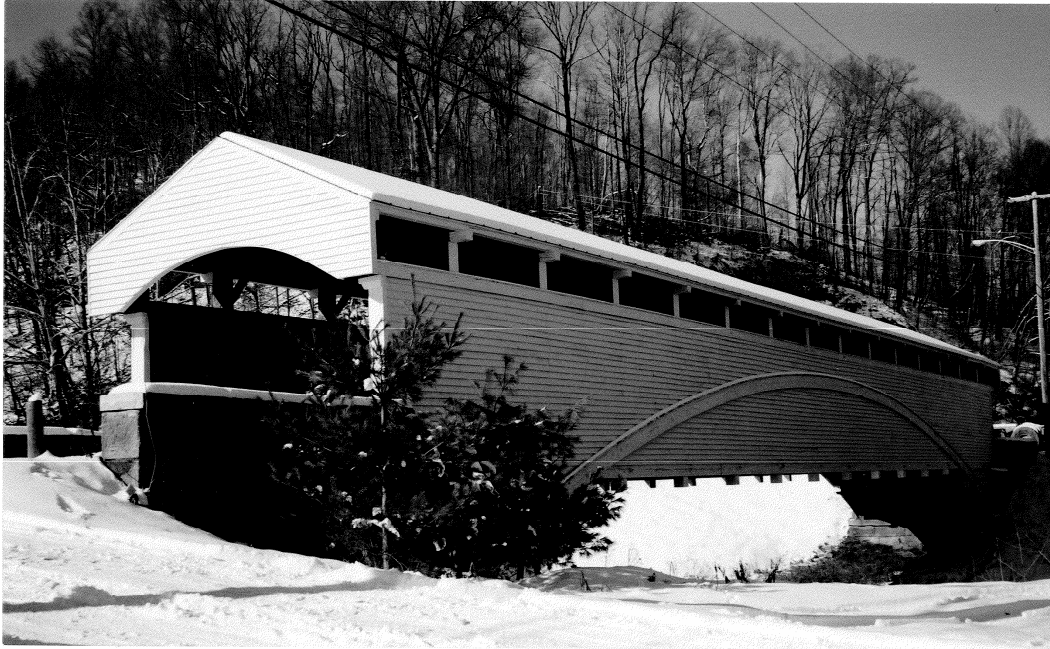
Figure 1. Photo. Barrackville Covered Bridge, Barrackville, WV.

The application of the ultrasonic NDT method has also been used widely and successfully to test historic structures. For example, CFC of WVU has developed state-of-the-art portable field instrumentation to conduct ultrasonic testing of historic bridges. CFC tested the Barrackville, WV, Covered Bridge (figures 1 and 2 of chapter 1) and the Salt Creek Covered Bridge located in Muskingum County, OH. The Salt Creek Covered Bridge, built in 1876 using white oak, is a warren truss that spans 31.7 m (104 feet). This makes it as one of the longest clear-span timber bridges in the State of Ohio (figure 5).

Another covered bridge structure restored by CFC/IHTIA is the bridge at Barrackville, WV, on the Fairmont and Wheeling Turnpike (figures 1 and 2). The bridge spans 39.9 m (131 ft) clear from spring line to spring line of abutments. The trusses are multiple kingposts sandwiched between pairs of arches framed into the trusses to create an indeterminate, composite timber structure. Because of deterioration that prevented it from carrying automated traffic, the Barrackville Bridge was being used as for pedestrians prior to restoration.

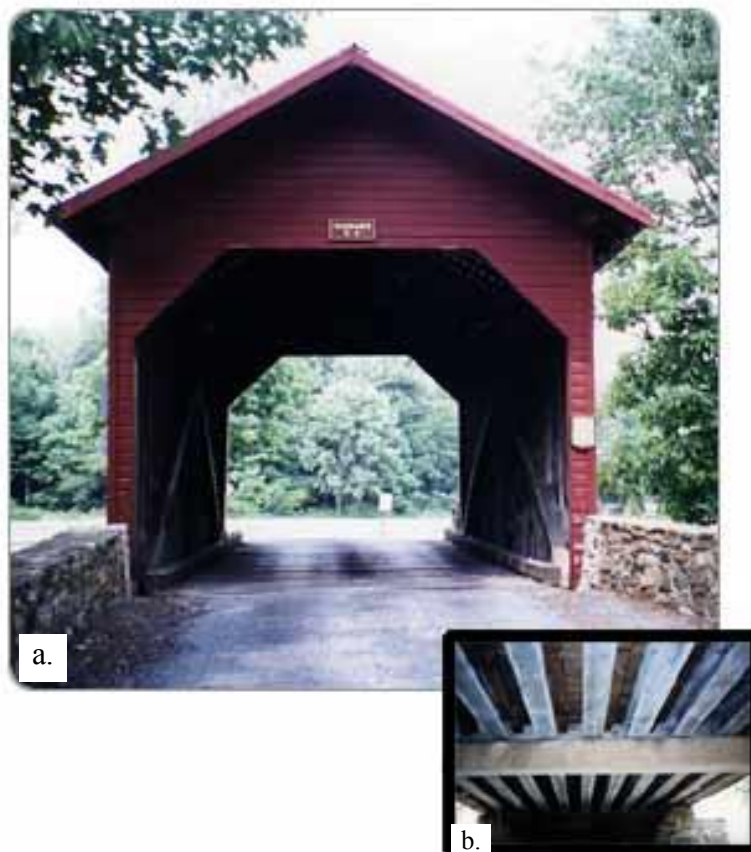
Figure 3. Photos. Roddy Road Covered Bridge (a) rehabilitated with steel I-beams (b), Frederick County, MD.

The Roddy Covered Bridge is a kingpost design originally constructed in 1856. The structure possesses a 12.2-meter (m) (40-foot (ft)) span, 4.9-m (16-ft) width, and 3.7-m (12-ft) clearance. The timber deck stringers were replaced with steel in 1964–65 to strengthen the structure and increase load capacity. These steel stringers were replaced again in 1979–80 because they had completely corroded and once again by galvanized steel stringers and diaphragms in 1995.

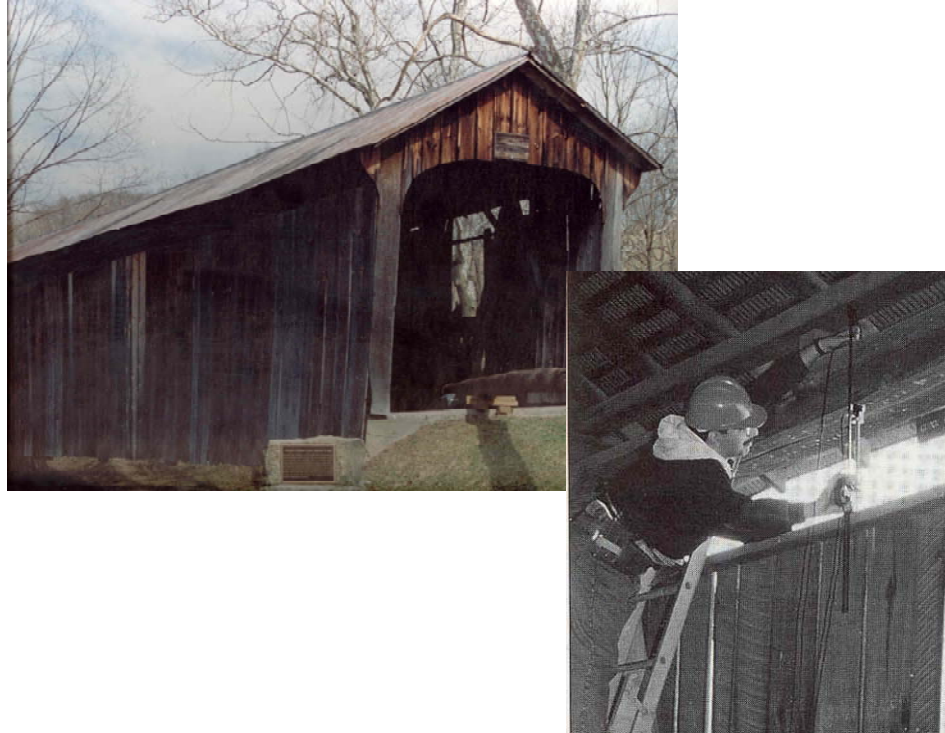
Figure 5. Photos. Salt Creek Covered Bridge, Muskingum County, OH.

The Salt Creek ultrasonic field testing assessed the integrity of the upper truss chords for repair and renovation. Figure 5 also shows the sensor positions for the ultrasonic through-transmission mode and the spring-loaded quick grip clamp. The results of the field testing indicated that 17 members in the bridge had defects needing immediate rehabilitation. CFC also developed an NDT manual for bridge superstructures for the West Virginia Department of Transportation (WVDOT).

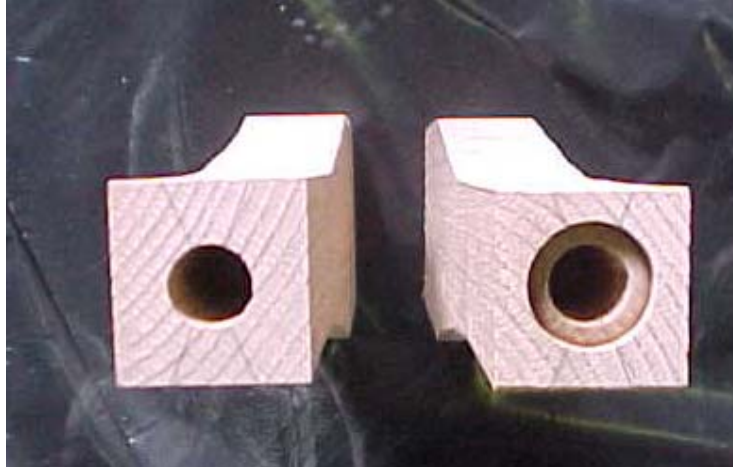
Figure 8. Photo. Tension specimens.

Two 0.556-cm (0.219-inch) holes were drilled on the sides a and b (figure 8) to pressure-inject the PLIOGRIP adhesive. The specimens were left for another 48 hours to cure before testing (figure 9).

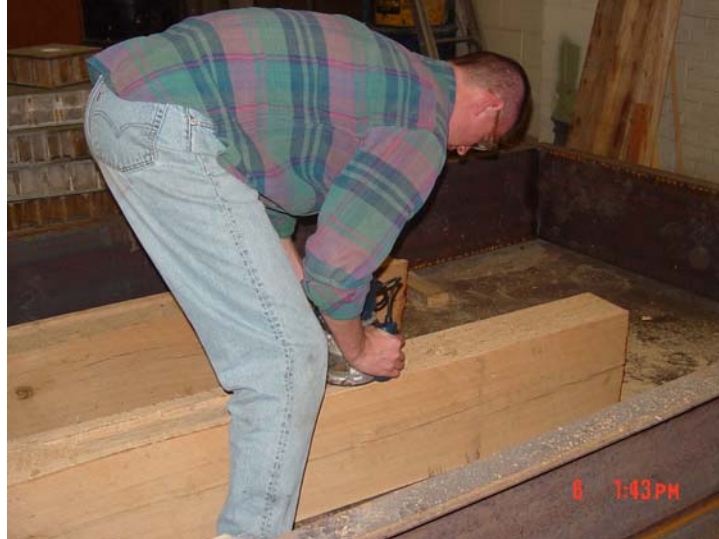
Figure 17. Photo. Routing of test specimen.

Typical rehabilitation of wooden beams with polymer composites uses a GFRP plate bonded directly to the tension face of the member. However, to hide the reinforcement to comply with the Secretary's guidelines, the GFRP plate had to be recessed into the member. This was accomplished by routing a 10.16- by 0.952- or 1.27-cm (4- by 0.375- or 0.5-inch) section, depending on the thickness of the GFRP plate used. The specimens were routed the entire length of the member, as shown in figure 17.

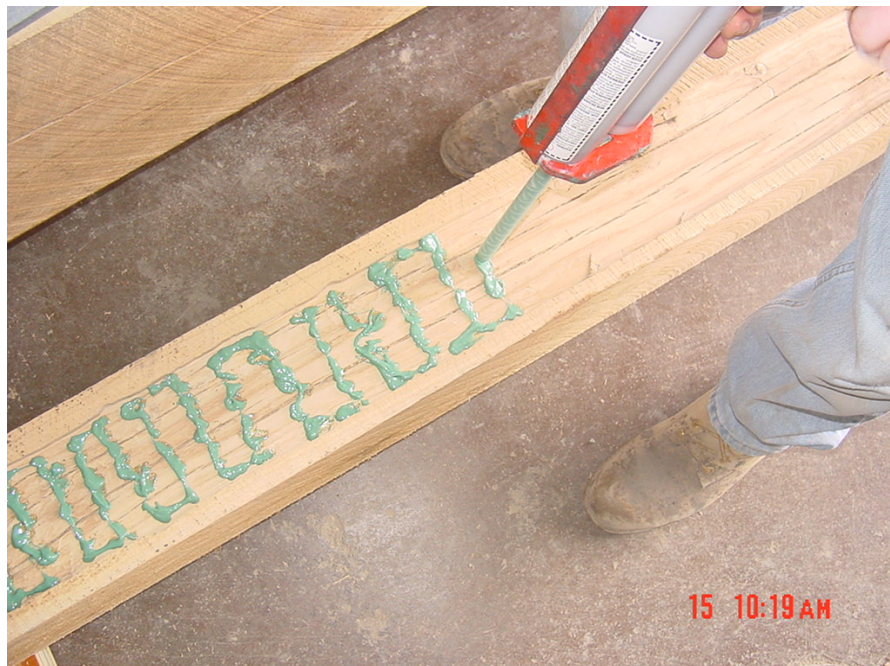
Figure 18. Photo. Applying adhesive on test member.

Once the routing was completed, to provide an adequate bonding surface, the protective coating was sanded from the side which was to be applied to the member. The adhesive used was the urethane-based PLIOGRIP, manufactured by Ashland Inc. After the plate was sanded, the adhesive was applied directly to the member, as shown in figure 18.

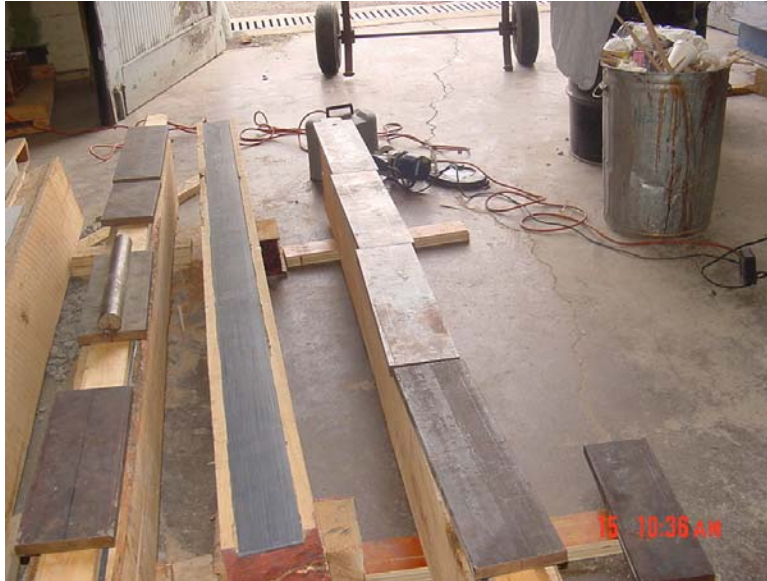
Figure 19. Photo. Steel plates used as weights on test specimen.

The plate was then placed in the recessed area and was put under pressure to ensure proper bond between the plate and wooden member (see figure 19).

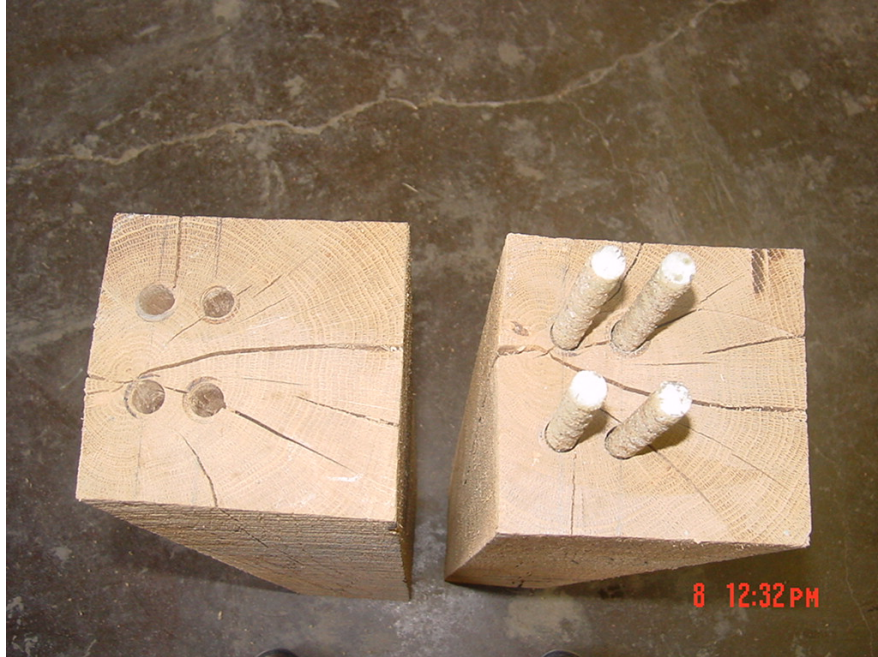
Figure 26. Photo. End view, BB-2.

After the specimens were cut transversely into two halves, 1.59-cm- (0.625-inch-) diameter holes were drilled into the ends of the specimens. The holes were drilled in accordance with the design requirements of the *National Design Specification® (NDS®) for Wood Construction*²⁴, section 8.5. Two specimens were prepared and tested, BB-2 and BB-3 (see figures 21–25). BB-2 was reinforced with two GFRP reinforcing bars and BB-3, with four (see figures 21–27). After the holes were drilled to accommodate the reinforcing bars, a 0.556-cm (0.219-inch) hole was drilled into the side of the members to allow for the injection of adhesive. PLIOGRIP was used for these members. An injection process was used because, in earlier experiments conducted to determine the best method to achieve the desired bond, injection proved the best method to get to as close to perfect bond as possible. The 1.429-cm- (0.562-inch-) diameter, sand-coated GFRP bars were placed into the holes and the two pieces were joined together. Bar clamps secured the two halves in place while the adhesive was injected (see figure 28). The bar clamps were also used to provide pressure on the specimens while the adhesive had time to cure properly. The specimens were clamped for approximately 48 hours. It should be noted that BB-2 was put together with improper alignment of the holes. To avoid problems while testing, the holes on one side of the specimen were enlarged to 2.222-cm (0.875-inch) diameter. The GFRP reinforcing bars were then wrapped with a GFRP fabric that had been soaked in PLIOGRIP. The bars were then placed into the specimen in the same manner as BB-3.

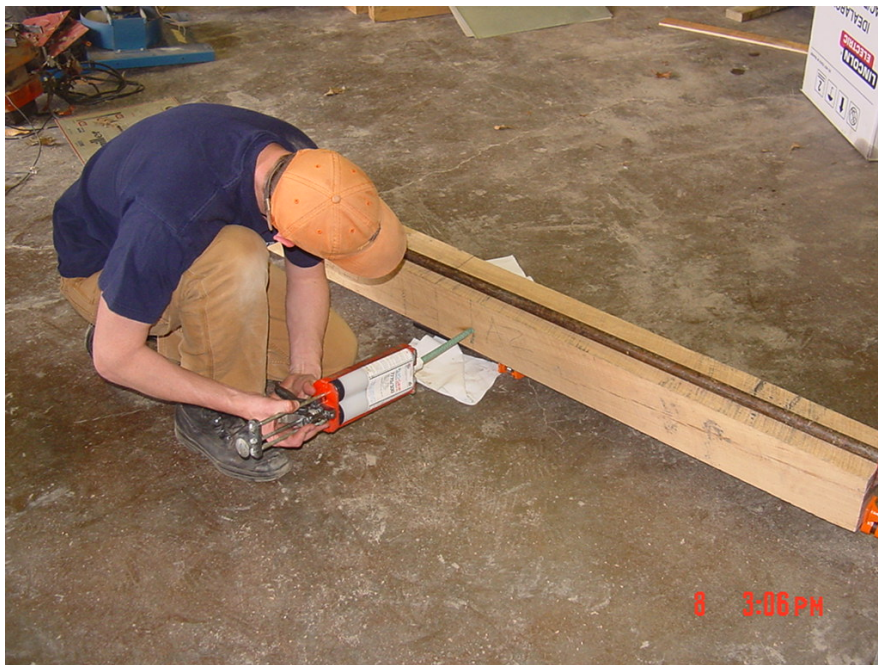
Figure 27. Photo. Injection of adhesive.

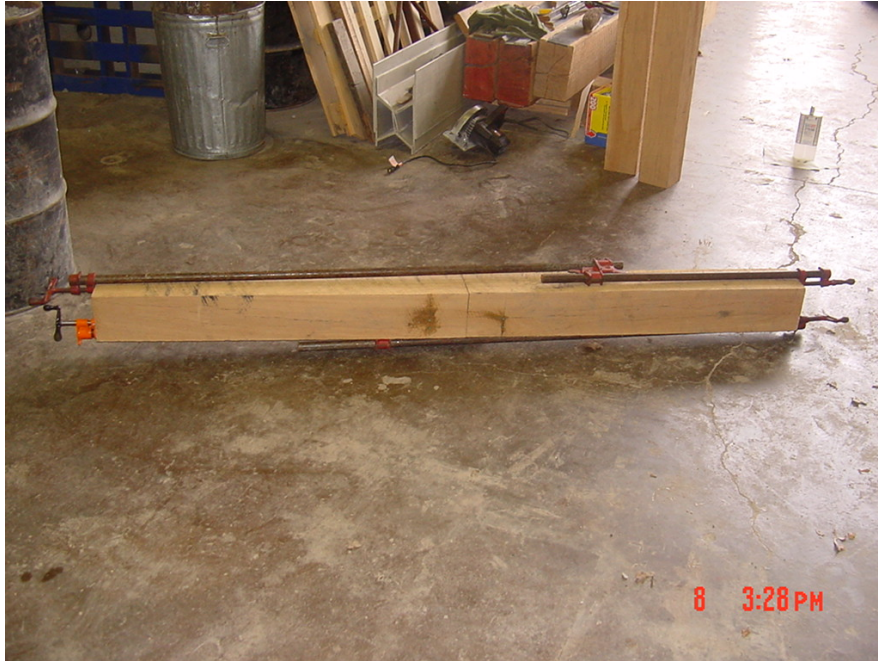
Figure 28. Photo. Clamping of specimens.

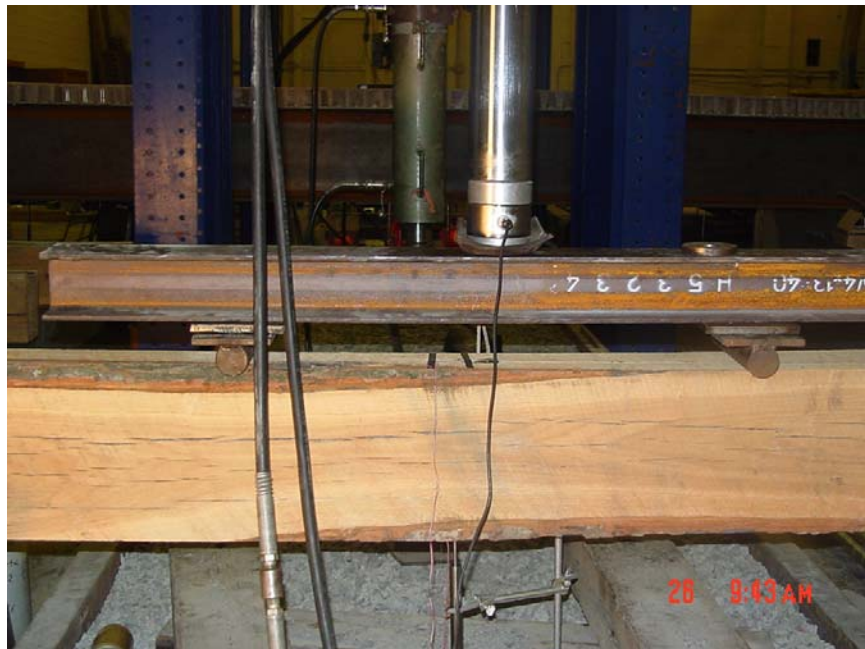
Figure 38. Photo. Side view of reinforced specimen.

During these set of experiments, two different methods of concealing the reinforcement and preserving the historic integrity of the member were investigated. Both methods take advantage of routing the member in order to place the reinforcement inside of it and not on its bottom. From the top and side, the GFRP plates cannot be seen (figure 38).

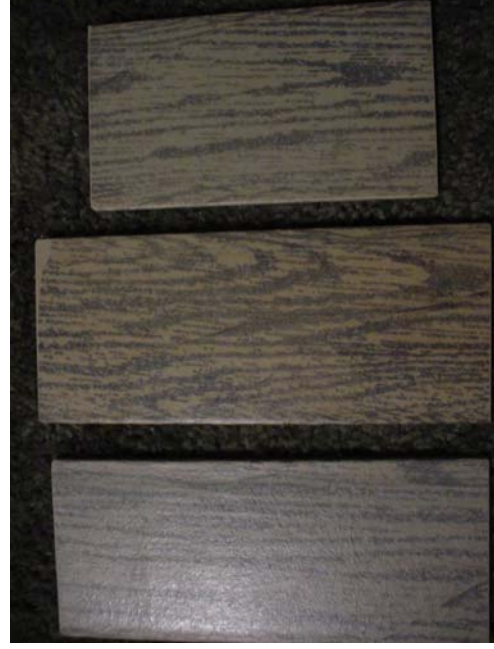
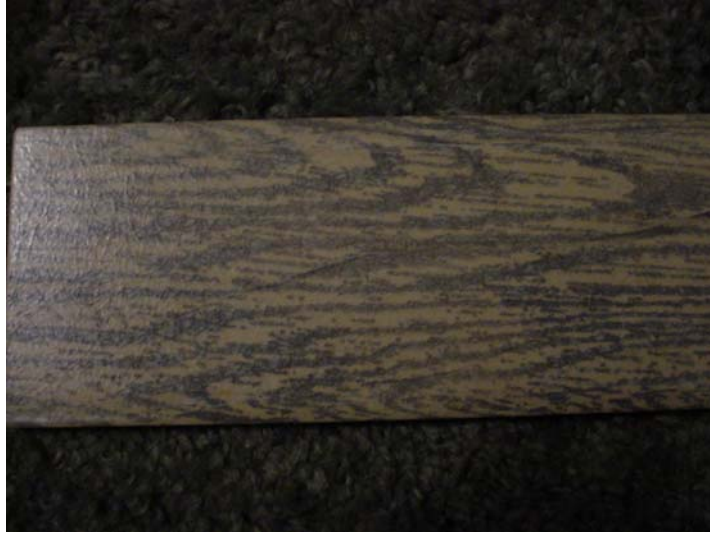
Figure 40. Photo. GFRP with veil.

The next method investigated to conceal reinforcement was that of making GFRP look like wood. The idea was not to add to the GFRP a layer or ply that could degrade with time and peel off. Instead, a veil integrated at the pultrusion process was added to the GFRP plate to match existing wood or grain. A polymer composite manufacturer with whom CFC has an excellent working relationship was given a sample of a 100+-year-old wood, and using a computer-generated image, they created a veil to match the existing aged wood grain and color. Samples of the GFRP with wood grain veils are shown in the figures 40 and 41.

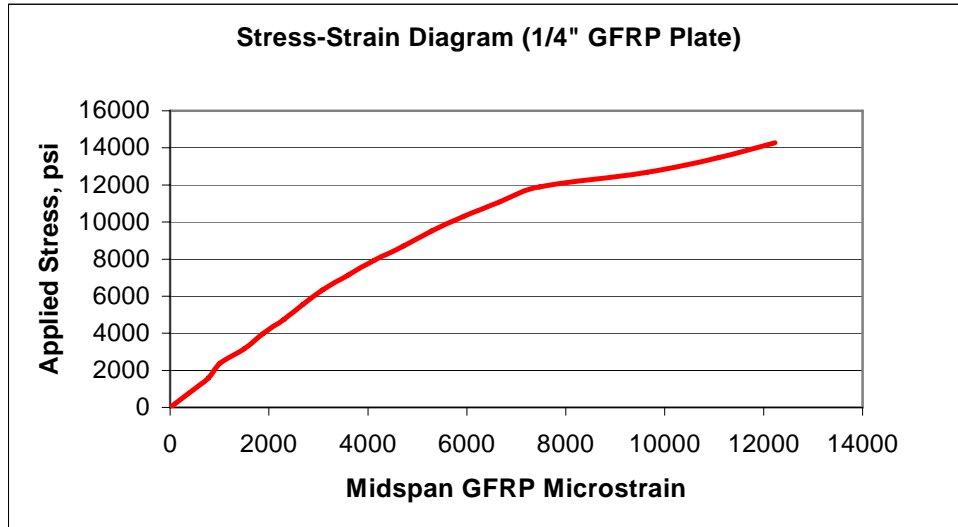
To demonstrate the effectiveness of GFRP reinforcement, specimen B-2 was reinforced using a 0.64-cm- (0.25-inch-) thick GFRP plate with vinylester matrix and tested to failure. This specimen was stiffer than the unreinforced specimen and had a bilinear behavior, as clearly shown in the stress/strain curves in figure 44.

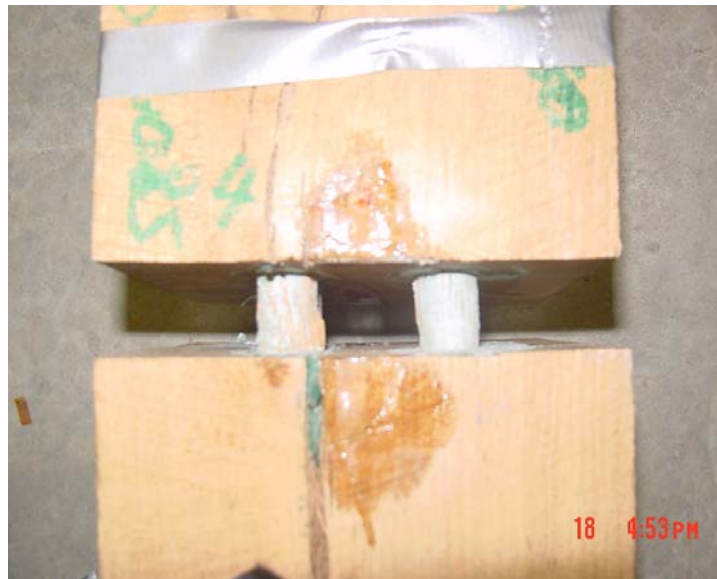
Figure 55. Photo. Specimen after testing.

Both specimens were tested to failure under four-point bending. The load versus deflection and load versus strain behavior were similar to that of earlier tension test specimens. No sounds or checking could be heard throughout the duration of the test. There was no yielding or increase in strain or deflection at constant loading (i.e., no ductility). The members did not immediately fail once the ultimate load was reached; they continued to deflect as the loading continued, but the member could not resist any more additional load (see figure 55). The ultimate mode of failure was bond failure between the PLIOGRIP and wood. The bond between the adhesive and GFRP was still intact (see figure 56). The a/d ratio for these tests was 3.2. For a bending test, this ratio should be above 5 if bending failure is desired and below 5 for shear. This ratio was irrelevant for these tests. The placement of the GFRP reinforcing bars in the specimens inhibited failure induced by horizontal shear failure.

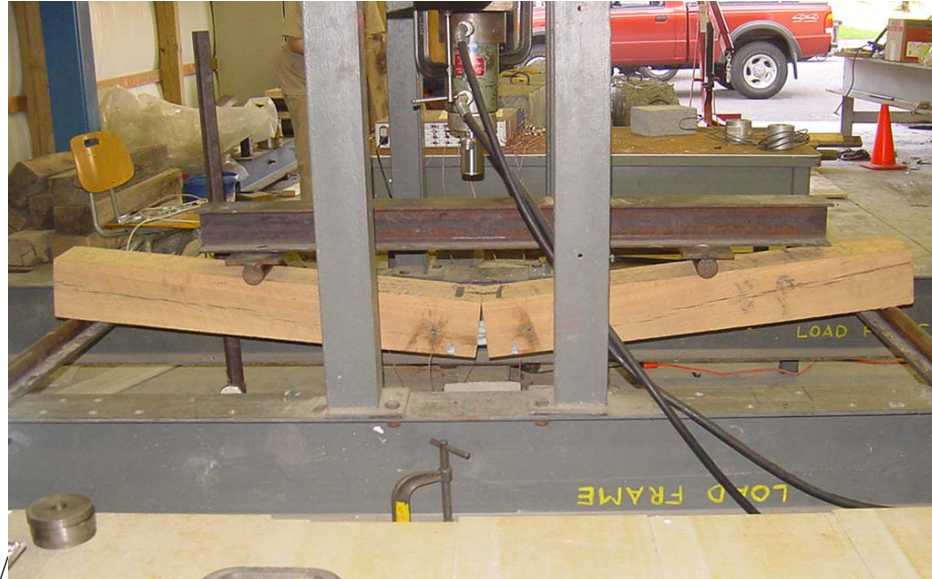
Figure 56. Photo. Specimen after testing.

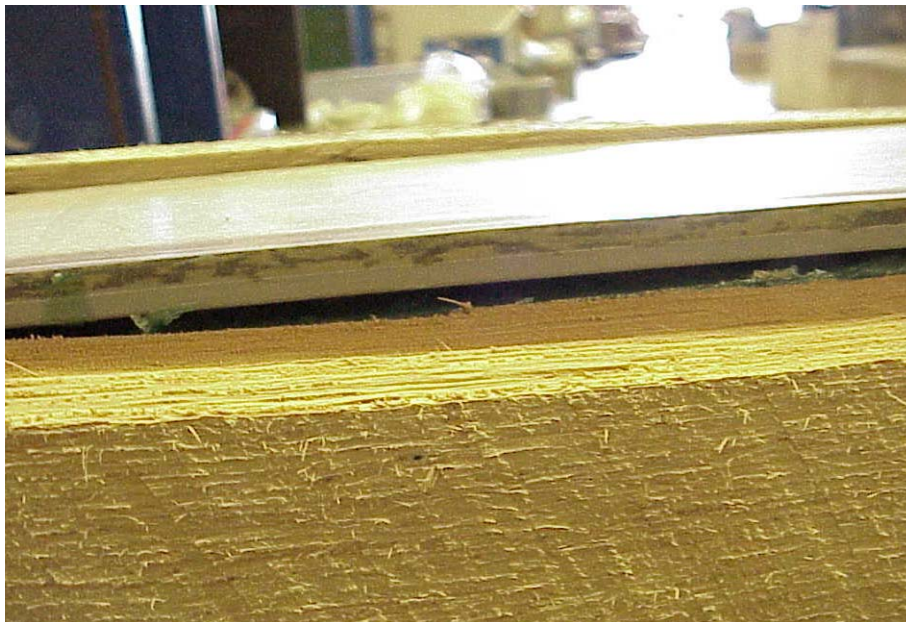
The primary mode of failure for LB-8 was dominated by horizontal shear failure of the wood and failure in the bondline, causing a peeling action of the GFRP plate. The full capacity of the plate was not reached in these members. The failure of the wood member in horizontal shear and the failure of the bondline occurred before the capacity of the plate could be fully used. LB-8 results demonstrate the necessity of full bond (see figure 62). A short work time adhesive (20 minutes, as suggested by the manufacturer) was used. This short work time adhesive resulted in partial bond between the plate and wood because the adhesive started to set up before the plate could be placed in the member. As seen in figure 63, there are no signs of failure in the GFRP plate in this specimen. Also, shown in figure 64, the separation of the plate was because of partial bond in the GFRP/wood.

Figure 62. Photo. Bond failure of LB-8.
