## Heavy Truck and Bus Traversability at Highway-Rail Grade Crossings

University Transportation Center for Railway Safety (UTCRS)

MwRSF Research Report No. TRP-03-392-18

June 29, 2018

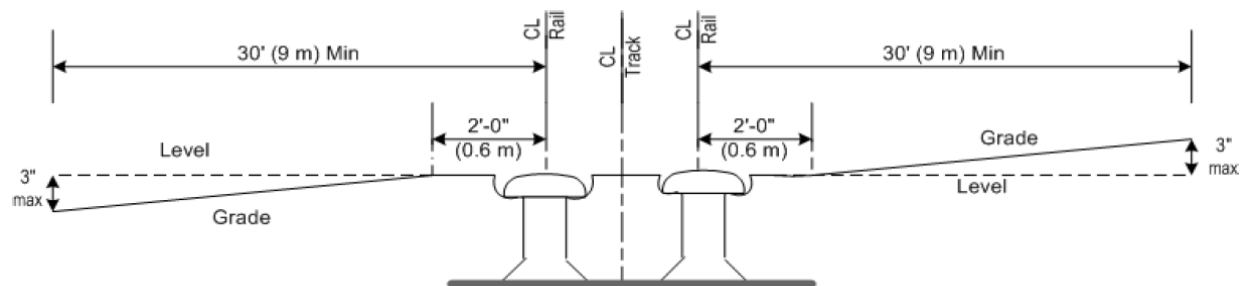
*A Policy on Geometric Design of Highways and Streets* [8], published by the American Association of State Highway and Transportation Officials (AASHTO), contains guidelines for highway and street design. Concerning highway-rail grade crossings, dimensions are specifically recommended for approach grades, which are illustrated in Figure 4. At grade crossings, the crossing surface should be level with the top of the rails extending 2 ft (0.6 m) from the center of each track. The road surface should not be more than 3 in. (76 mm) higher or lower than the top of the rail for 30 ft (9.1 m) adjacent to each rail.

Figure 4. Railroad-Highway Grade Crossing [8]

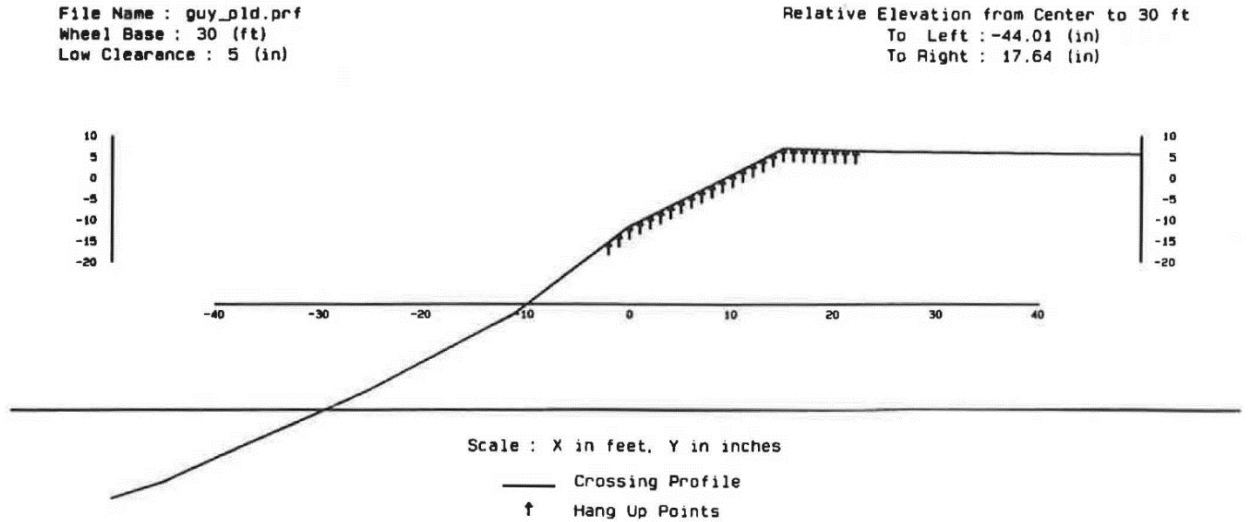
A computer program, HANGUP, was developed to simulate low-clearance vehicles traversing grade crossings. The program can run in either manual or automatic mode. Manual mode can be utilized when specific wheelbase and ground clearance values need to be evaluated at a crossing. The output of a manual-mode simulation is shown in Figure 18. The arrows indicate points where a vehicle would become high-centered. To determine which combination of wheelbase and ground clearance values will cause high-centering over a crossing, automatic mode can be used. It will test wheelbases from 10 to 40 ft (3.0 to 12.2 m) in 1 ft (0.3 m) increments and ground clearances from 1 to 10 in. (25 to 254 mm) in 1 in. (25 mm) increments. The output of an automatic-mode simulation is shown in Figure 19. Results are given in binary code, where a high-centering incident is signified by a 1 and a safe crossing is signified by a 0.

The HANGUP program has many limitations. It is a 2D modeling program that does not take vehicles' dynamic factors into consideration. In addition, the program only accepts integer values. For ground clearance, rounding to the nearest whole inch could give an incorrect result.

Figure 18. HANGUP Manual Mode Output [4]

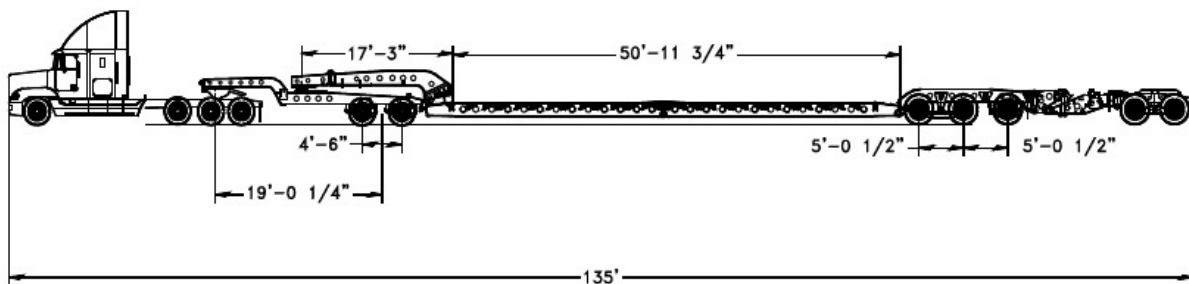
On January 28, 2000 a tractor-trailer combination vehicle transporting an oil refinery condenser unit was impacted by a Metrolink commuter train in Glendale, California [19]. The tractor was a 1997 Peterbilt model. The trailer was a 1992 Aspen semi-trailer with two 2-axle boosters and a 3-axle lowboy semi-trailer equipped with a hydraulic lift, as shown in Figure 21. The tractor-trailer unit was 135 ft (41.1 m) long, had a ground clearance of 6 in. (152 mm), and had a gross weight of 226,000 lb (102,512 kg). The oil refinery condenser was valued at \$1.5 million and its transportation required permits from four states.

Figure 21. 1997 Peterbilt Tractor and 1992 Aspen Semi-trailer Combination Unit [19]

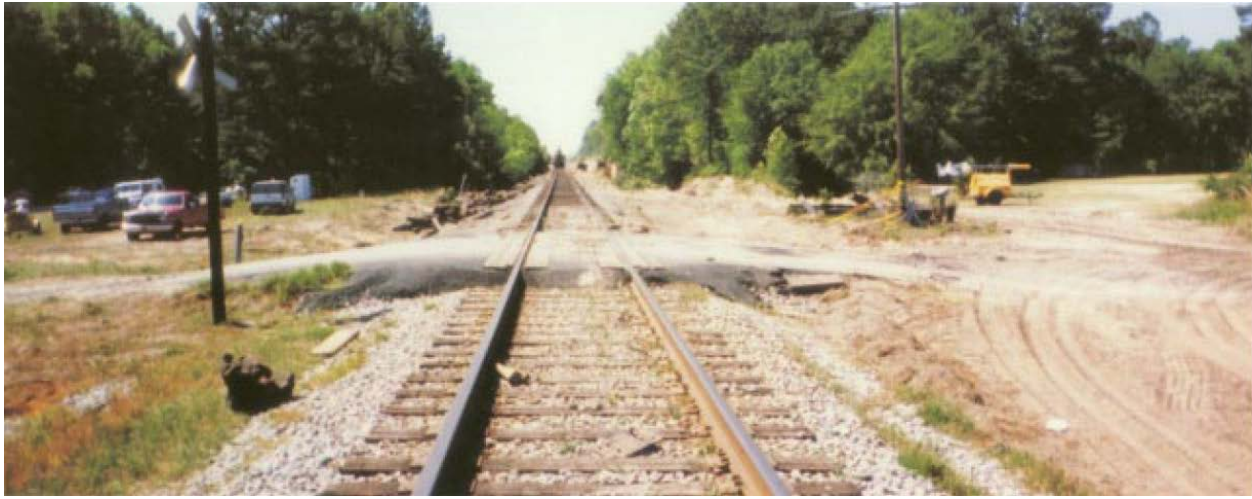
To return home after a delivery, the driver had to traverse a hump railroad crossing located on an unpaved road known to locals as Boogaloo Road. The crossing had 5.28 percent and 9.97 percent grades on either side, has USDOT grade crossing number 634810U, and is shown in Figure 24. No hump crossing warning signs were posted. The truck driver had traversed this crossing before, but never with a trailer as low as the one involved in the crash.

Figure 24. Boogaloo Crossing [5]

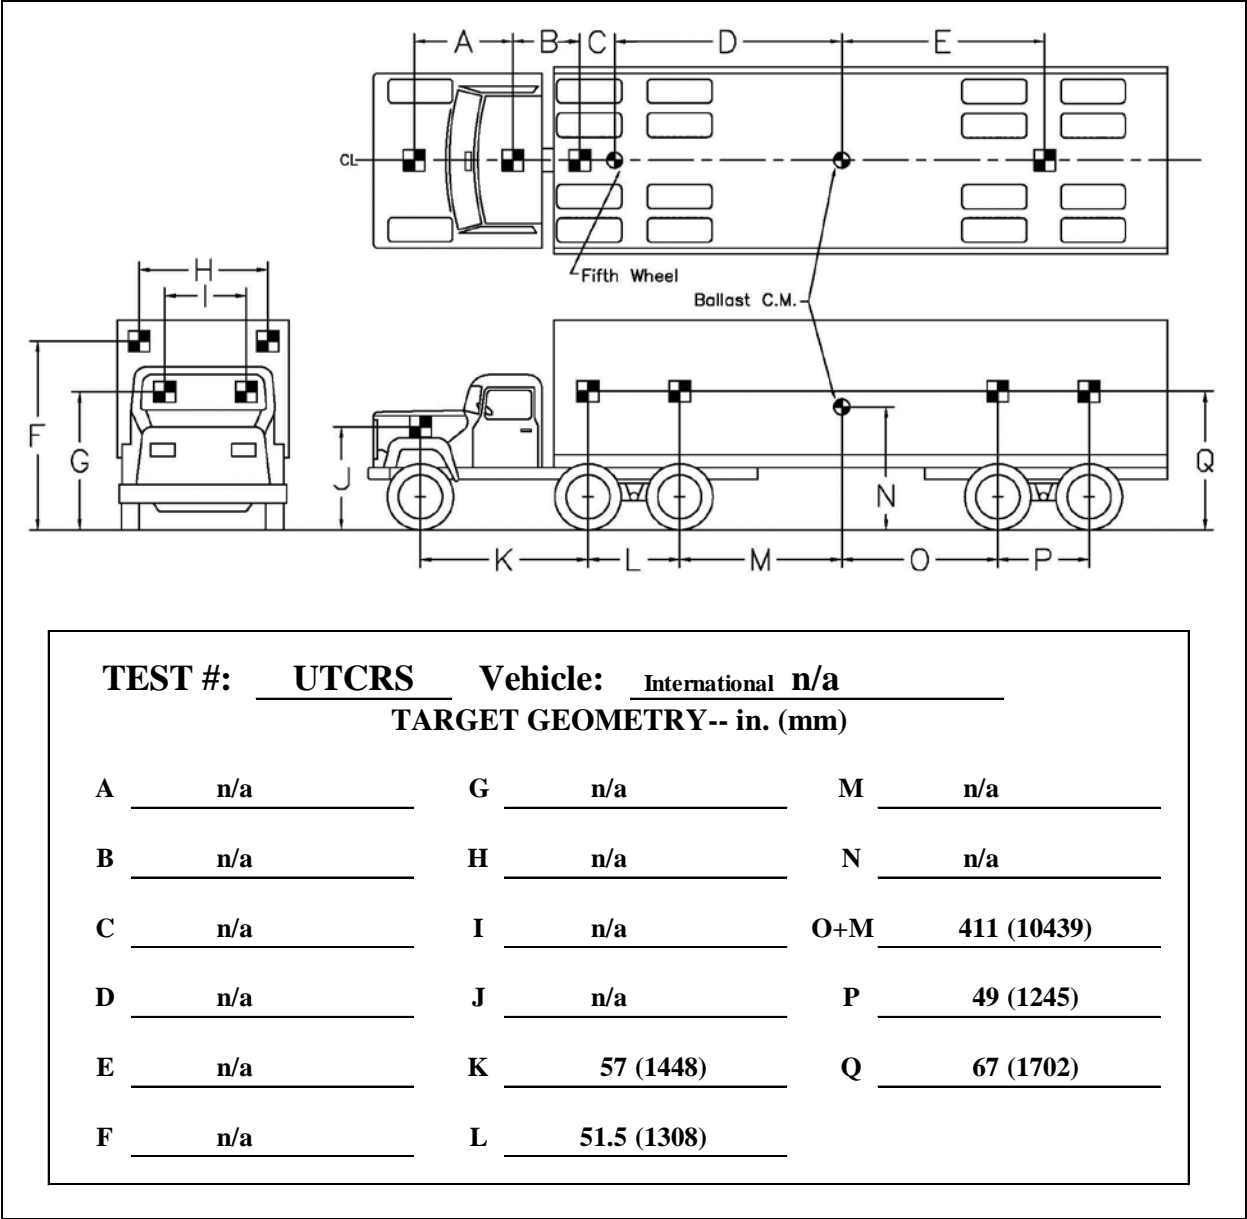
Targets were placed on the tractor-trailer to measure vertical displacements of the vehicle with video analysis software. The target locations and names are shown in Figures 55 and 56, respectively. Dimensions which were not collected were denoted with “n/a,” as shown in Figure 55.

Figure 55. Target Locations for Test Nos. UTCRS-1 through UTCRS-4

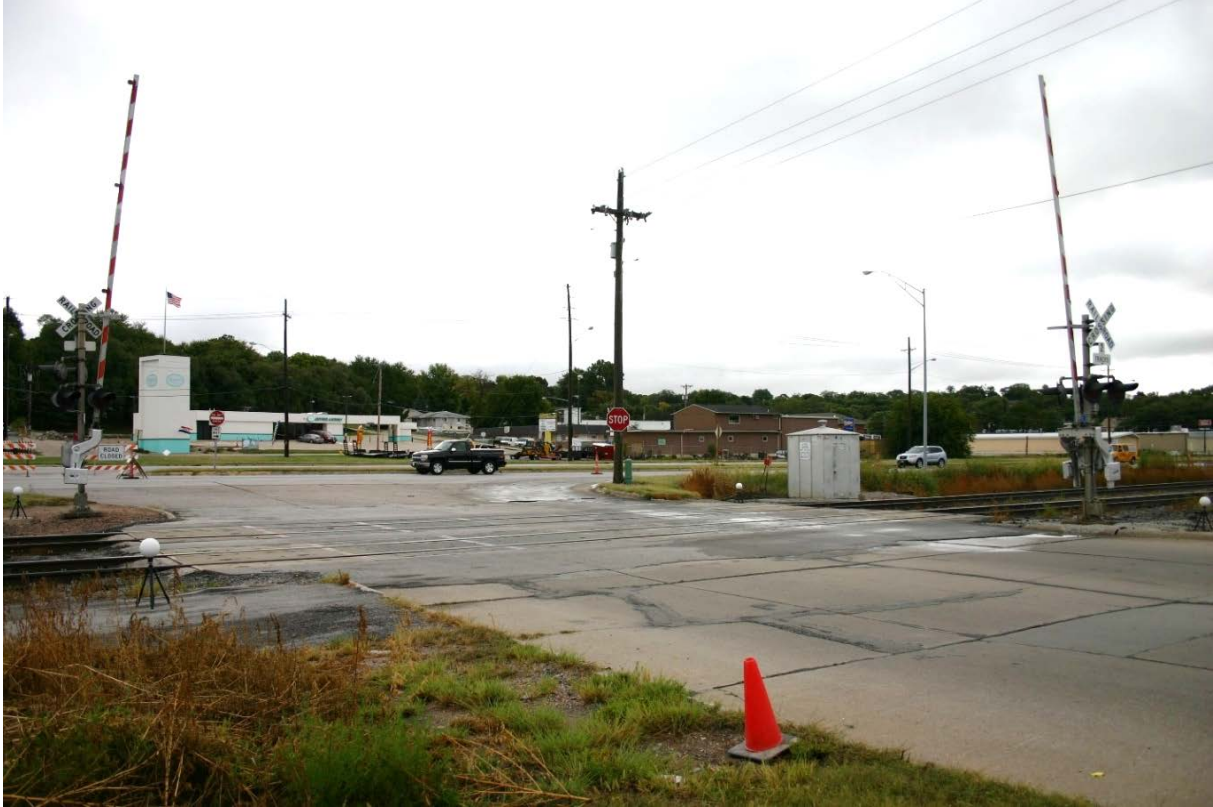
Crossing 817404F, located on Kasper Street, was the first crossing scanned on September 26, 2017 and is shown in Figures 90 through 92. This crossing appeared flat and did not have any scrape marks on the asphalt. While scanning the crossing, a semi-truck and trailer traversed the crossing. The truck stopped at the stop sign before turning onto Fort Crook Road, and while stopped the trailer was parked over the railroad tracks. This problem of inadequate space for trucks at crossings is not the focus of this research, but is an important issue.

Figure 90. Crossing 817404F

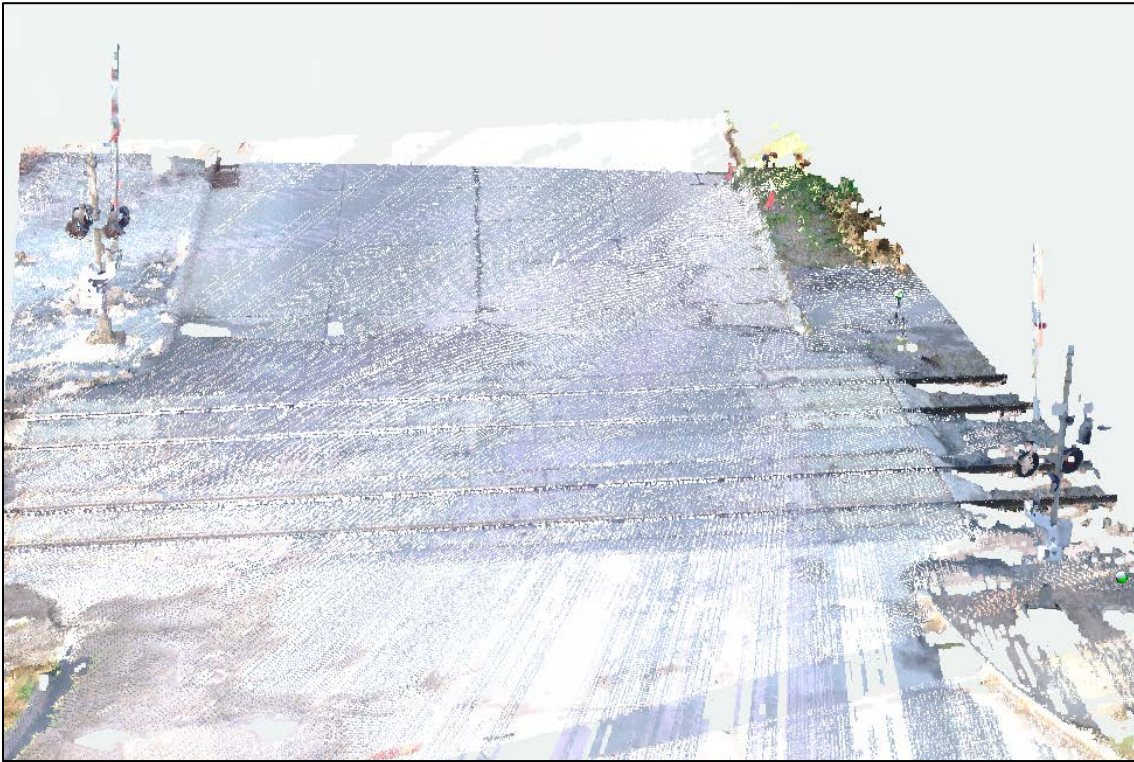
mm). Based on the results of the slope and height analysis, crossing 817404F is not within the recommended AASHTO/AREMA (2015) grade crossing guidelines.

Figure 104. Crossing 817404F FARO Scan Front View

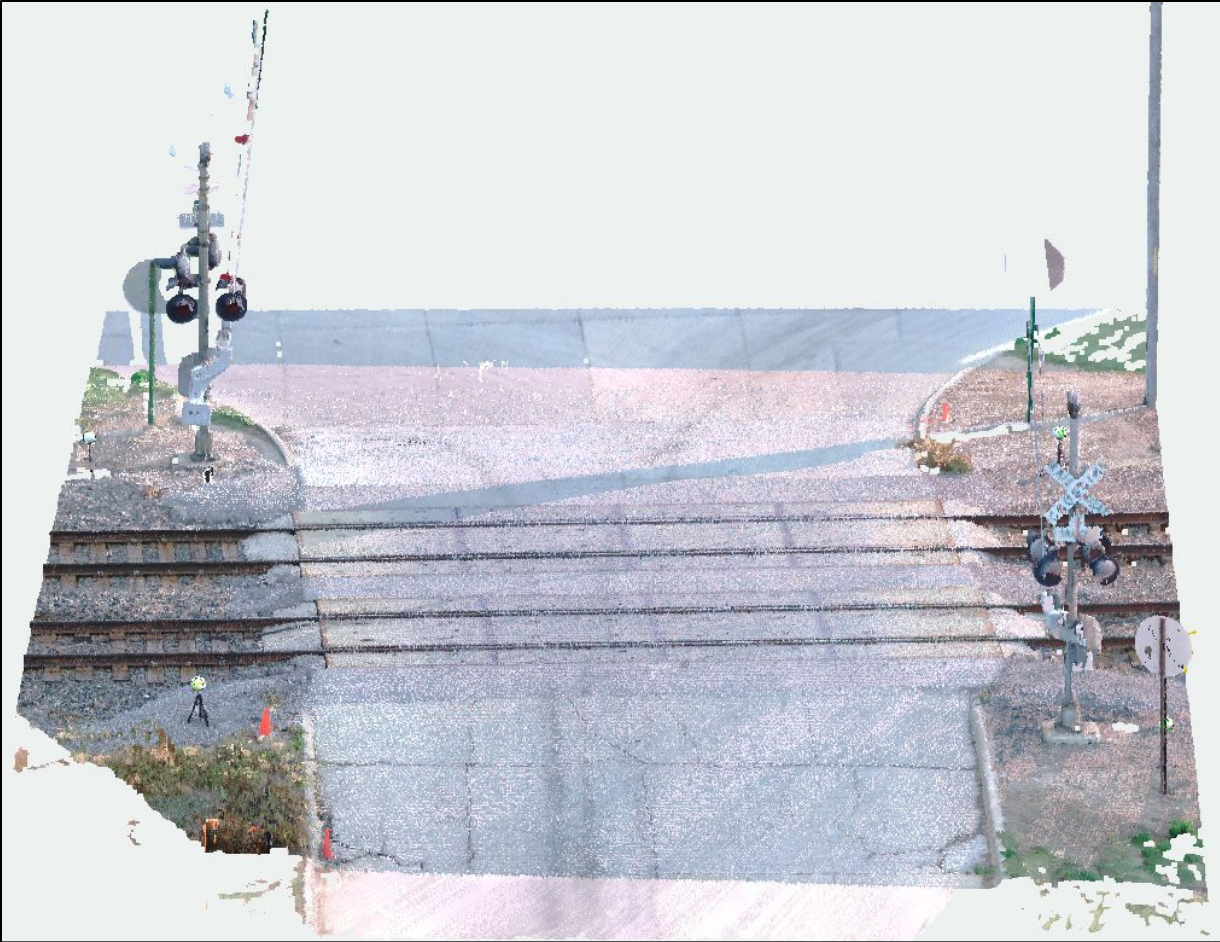
The results of the 3D scans are shown in Figures 112 through 114. Slope and elevations of the track determined using results of the 3D scan data was compared with ASHTO/AREMA (2015) guidelines, as shown in Figure 115. The approach slope has a grade of 2.88 percent and a track elevation of 8.70 in. (221 mm). The departure slope has a grade of 1.32 percent and a track elevation of 3.96 in. (101 mm). Based on slope and elevation measurements, crossing no. 816134F is not within the recommended guidelines provided by AASHTO/AREMA (2015).

Figure 112. Crossing 816134F FARO Scan Front View

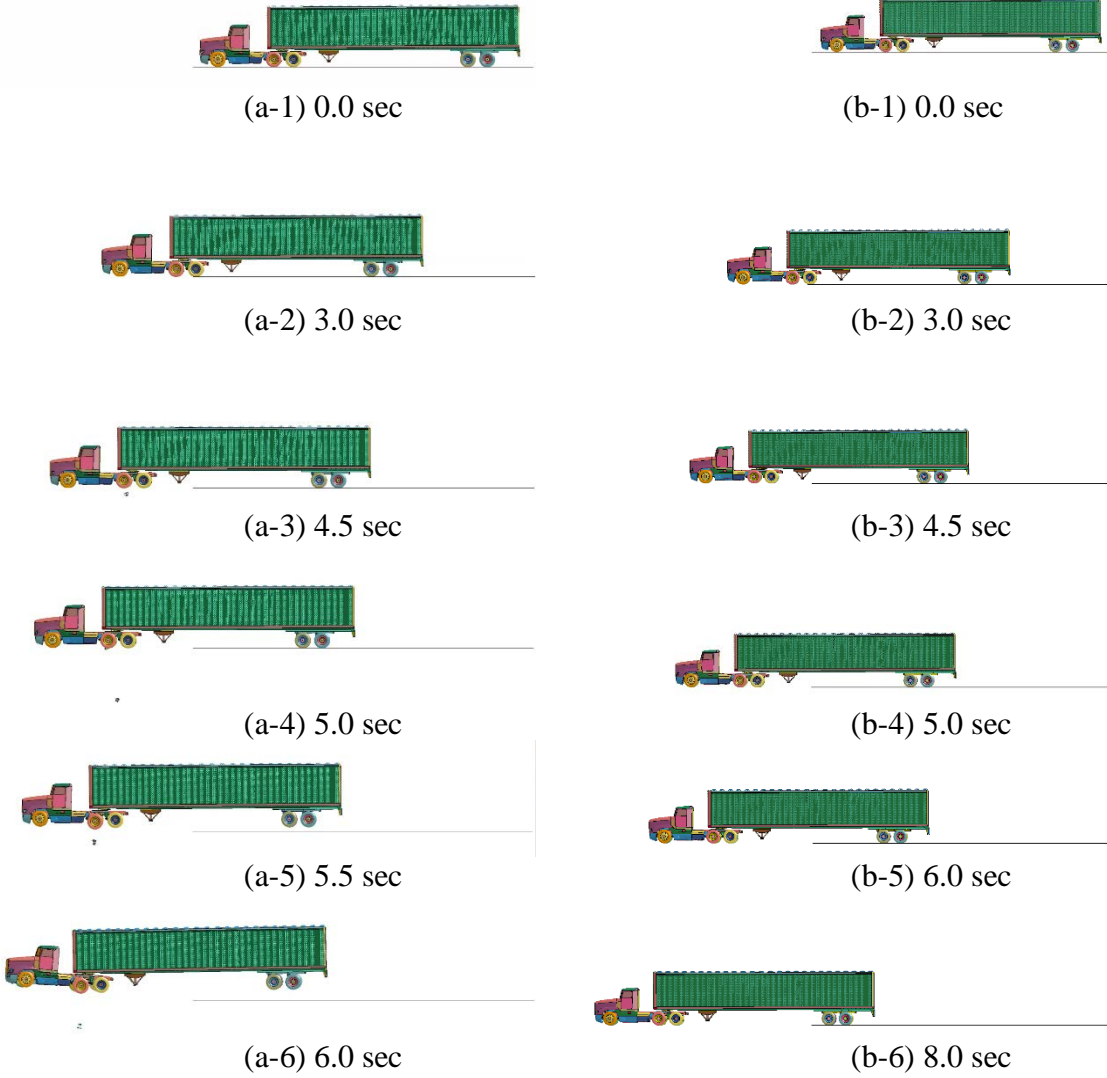
Figure 122. Side Sequential View, (a) Model Developed by Plaxico and Reid and (b) Updated Model

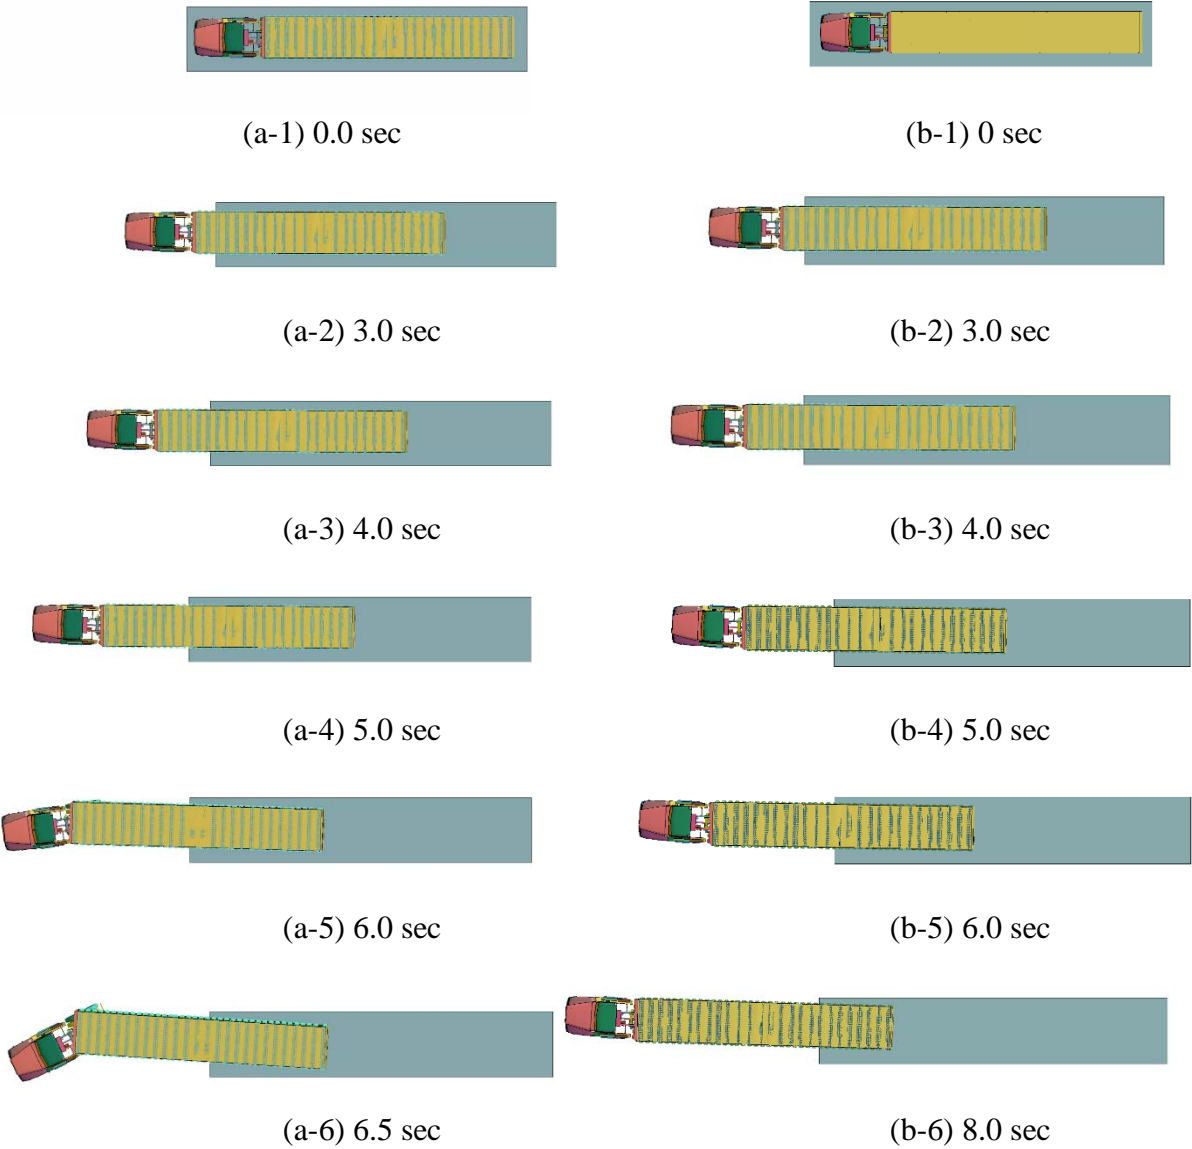
Figure 123. Overhead Sequential View, (a) Model Developed by Plaxico and Reid and (b) Updated Model

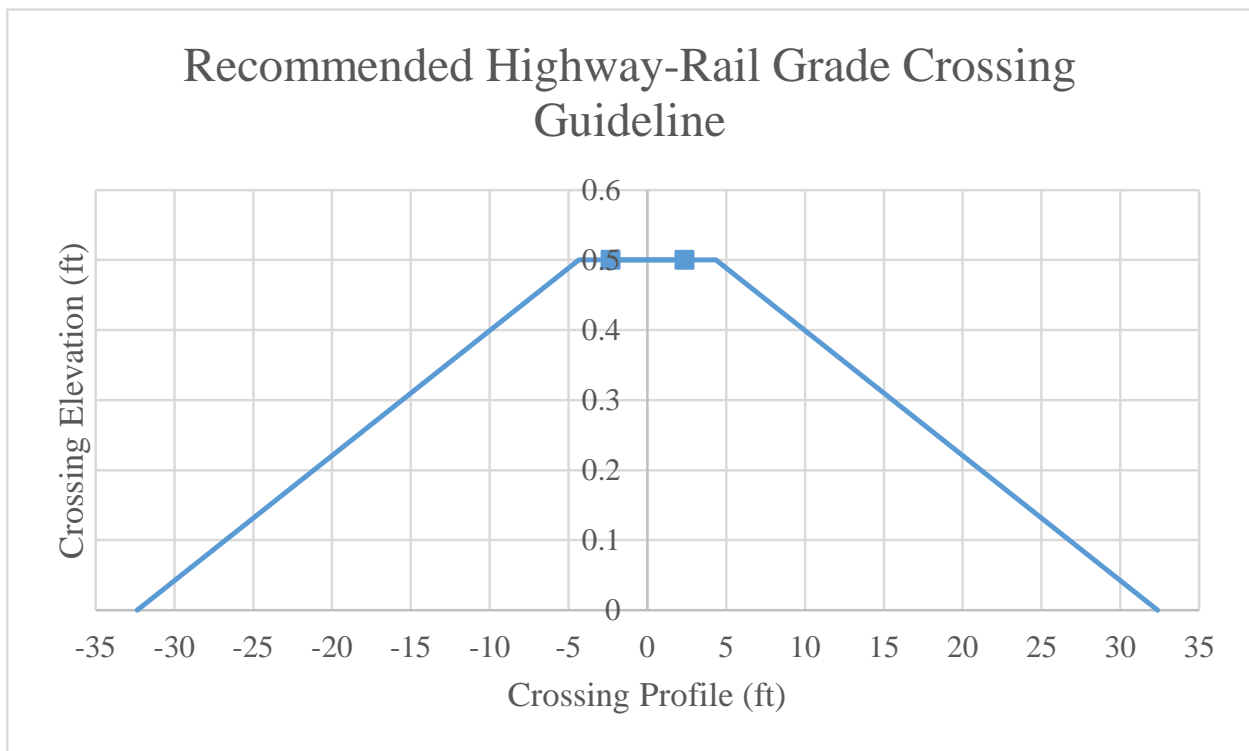
Based on the simulation results, a maximum highway-rail grade crossing guideline is recommended and illustrated in Figure 162. The crossing surface should be level with the top of the rails for 2 ft (0.6 m) outside of the rails. For 30 ft (9.1 m) outside of each rail, the surface should not be more than 6 in. (152 mm) lower than the top of the rail. This recommendation corresponds to the AASHTO/AREMA (2015) guideline with 3 in. (76 mm) elevation and the AREMA (1990) guideline with 0 in. elevation.

Figure 162. Recommended Highway-Rail Grade Crossing Guideline

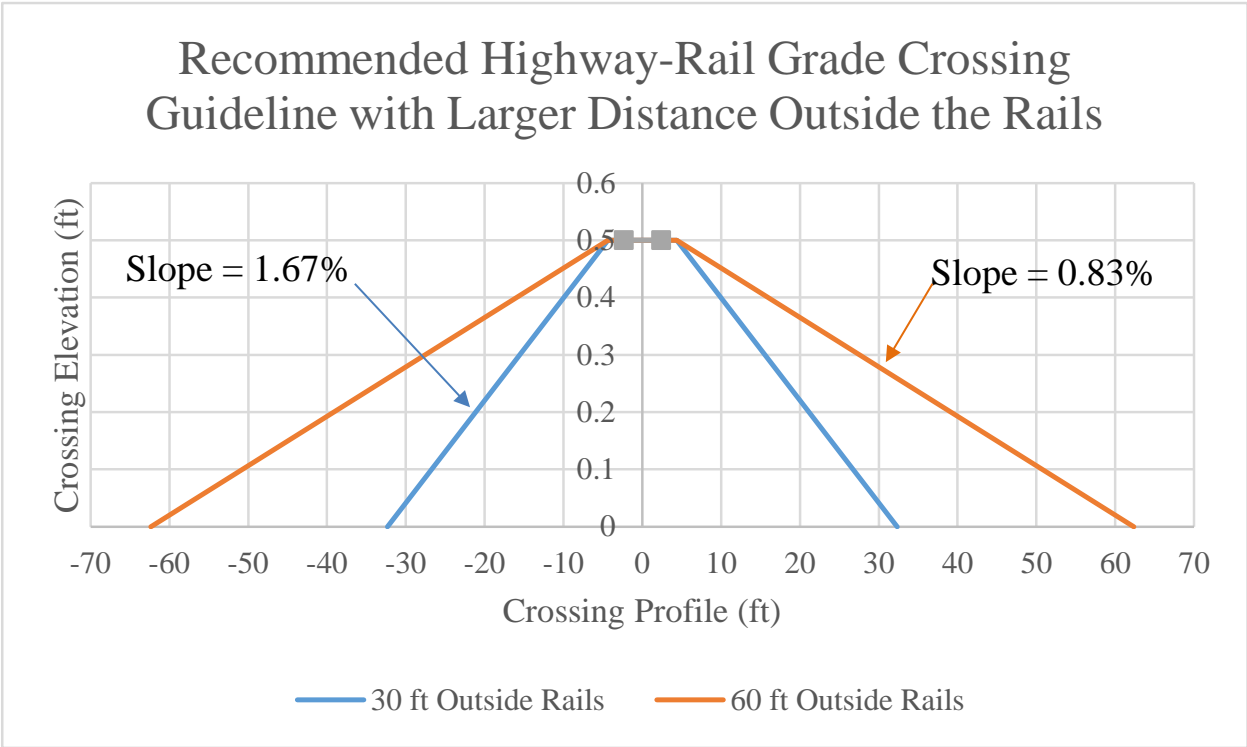
This recommendation could be amended to state that for a *minimum* of 30 ft (9.1 m) outside of each rail, the surface should not be more than 6 in. (152 mm) lower than the top of the rail. Any length greater than 30 ft (9.1 m) would result in a less steep approach grade, shown in Figure 163.

Figure 163. Recommended Highway-Rail Grade Crossing Guideline with Larger Distance Outside of the Rails

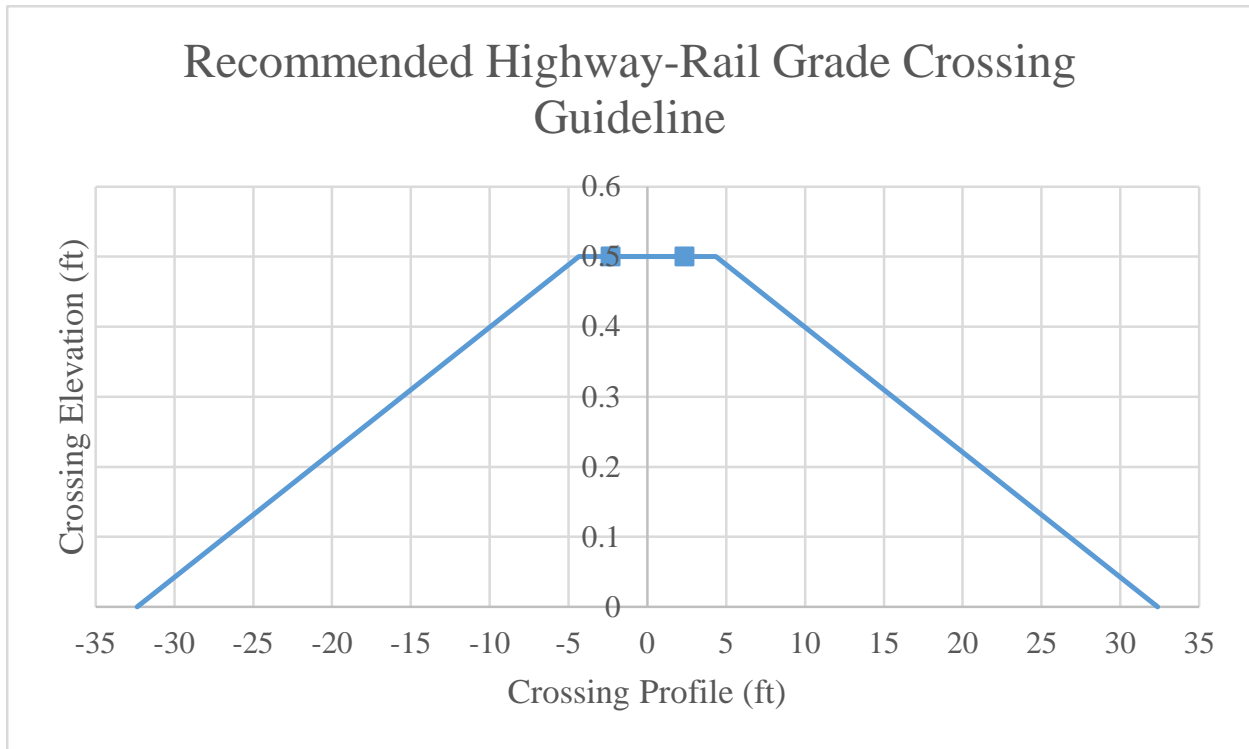
A maximum crossing profile guideline was recommended in Section 8.6 and is shown in Figure 164. The guideline states, “The crossing surface should be level with the top of the rails for 2 ft (0.6 m) outside of the rails. For a minimum of 30 ft (9.1 m) outside of each rail, the surface should not be more than 6 in. (152 mm) lower than the top of the rail.”

Figure 164. Recommended Highway-Rail Grade Crossing Guideline

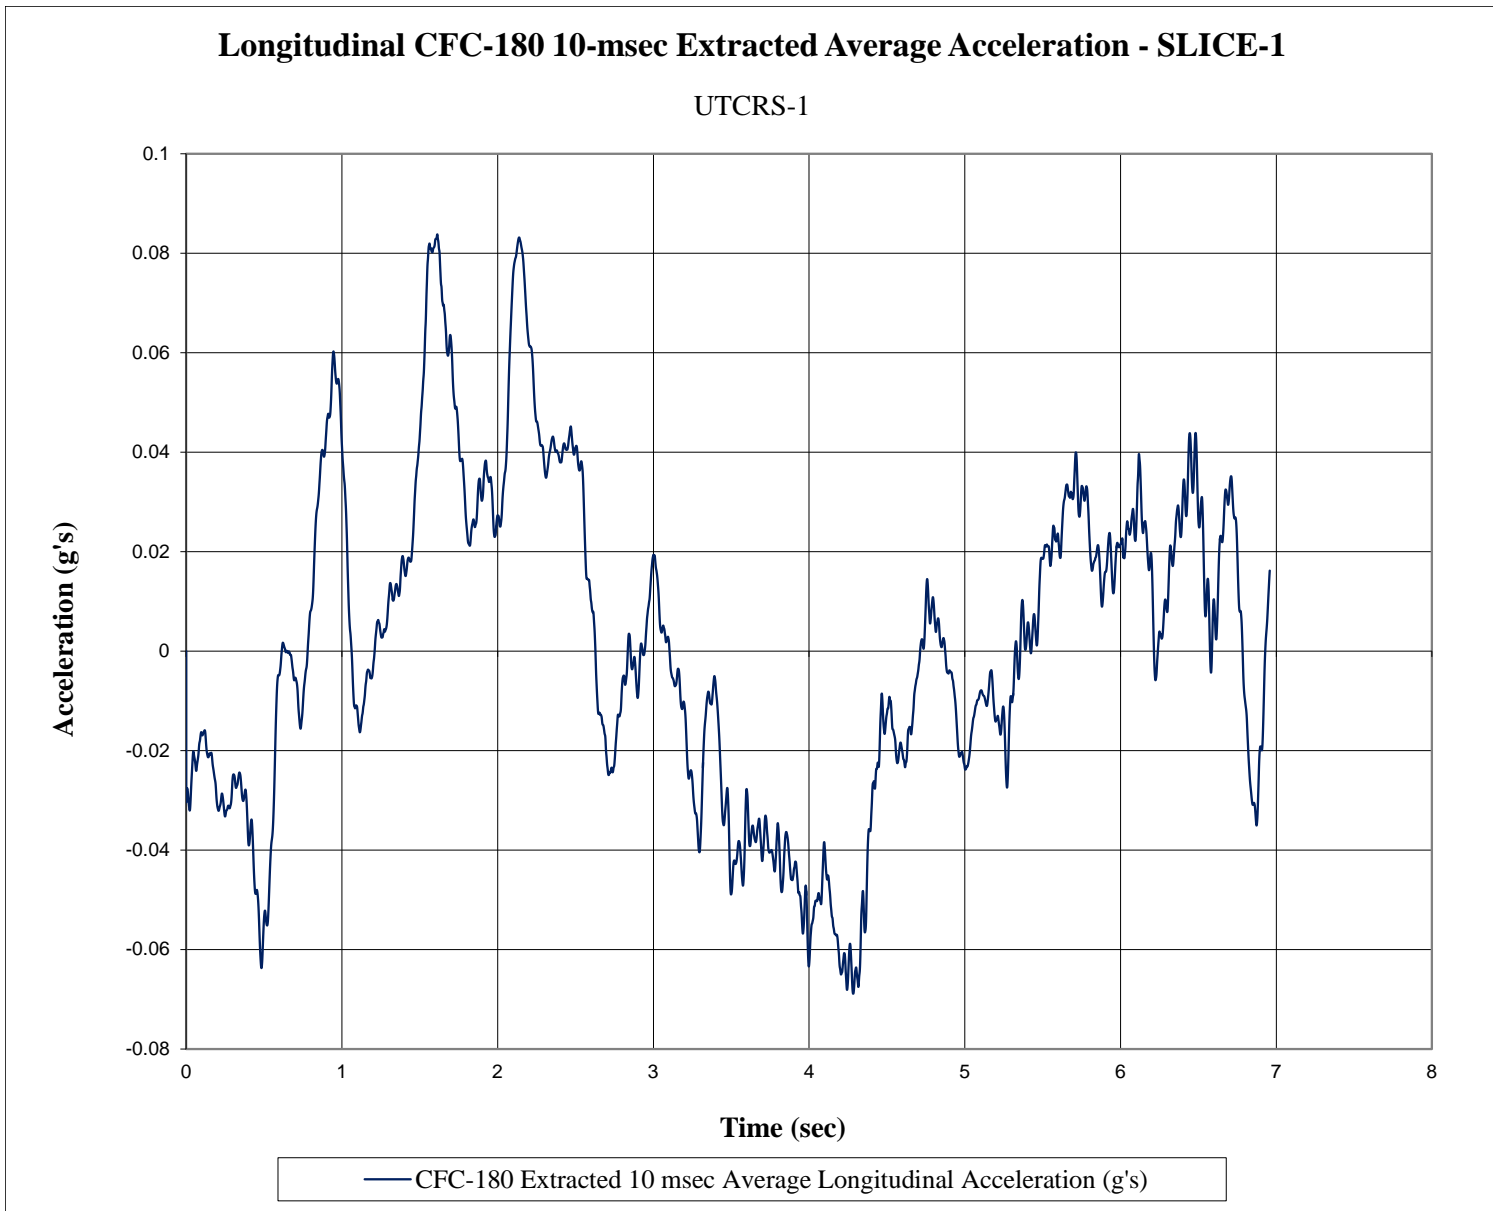
Figure C-1. 10-ms Average Longitudinal Acceleration (SLICE-1), Test No. UTCRS-1

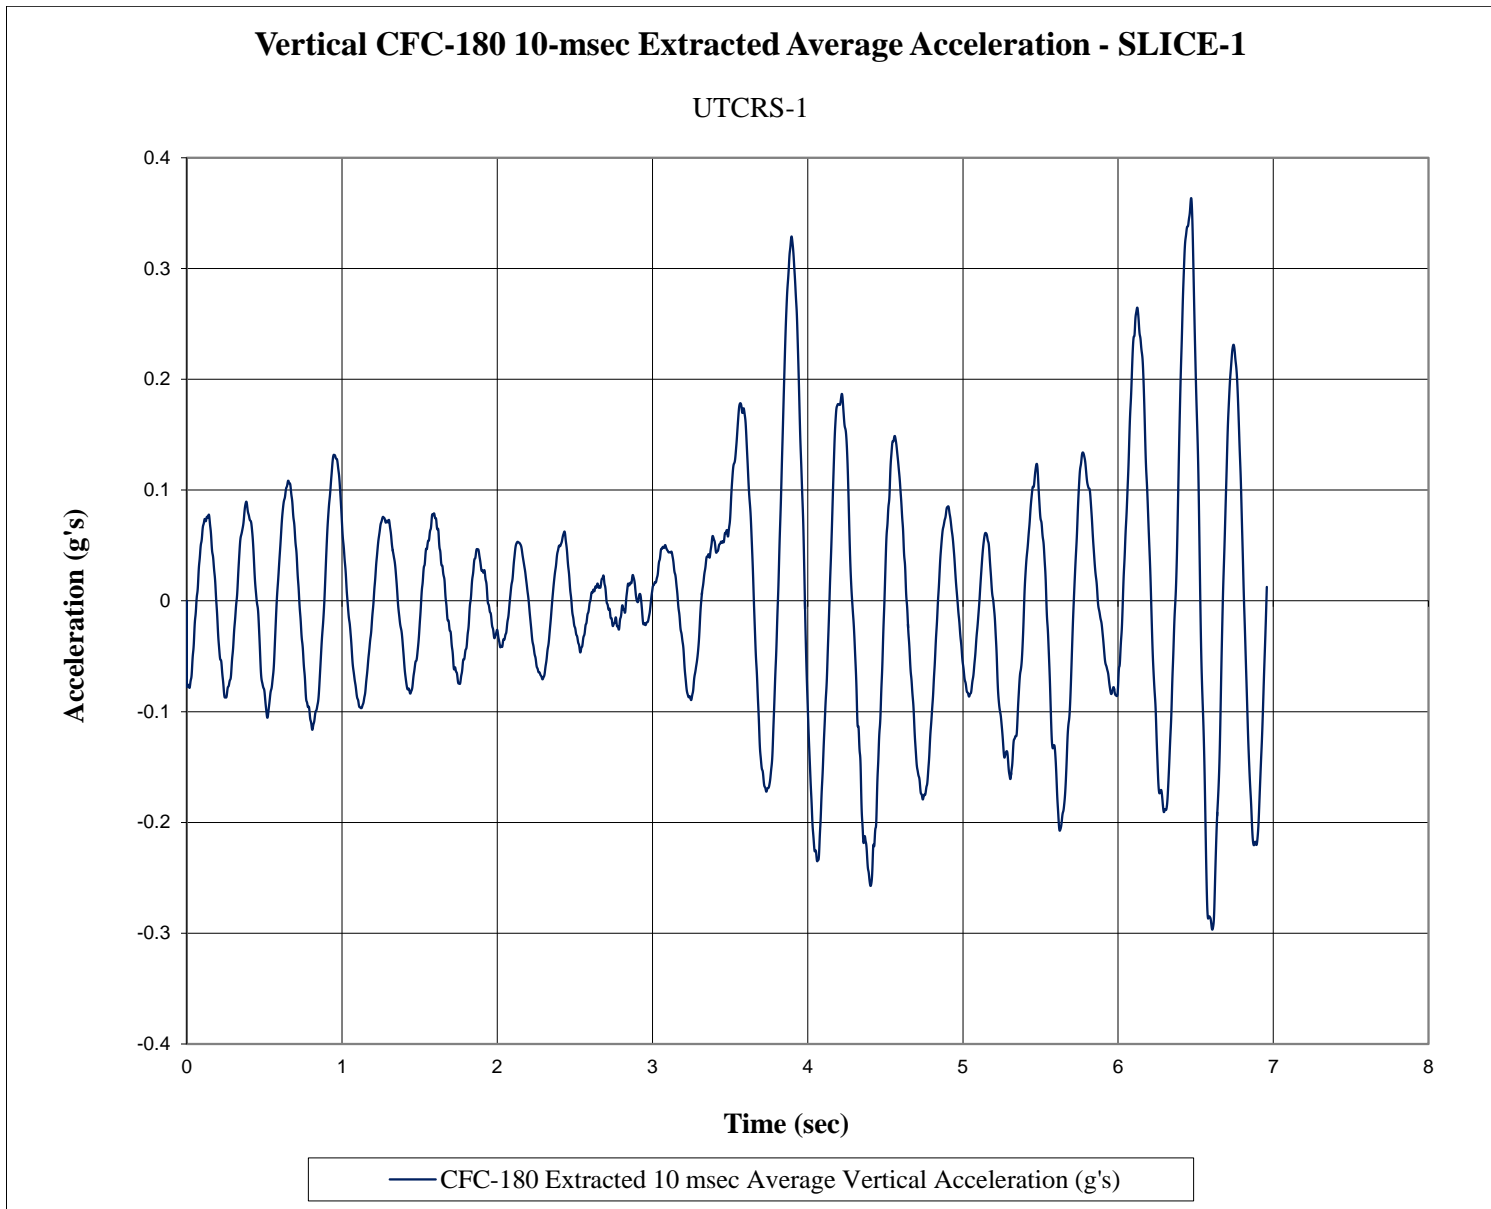
Figure C-7. 10-ms Average Vertical Acceleration (SLICE-1), Test No. UTCRS-1
