## 22. The sediment budget of May Zeg-zeg catchment and its components

Jan Nyssen<sup>1</sup>, Wim Clymans<sup>2</sup>, Jozef Naudts<sup>2</sup>, Jean Poesen<sup>2</sup>, Ine Vandecasteele<sup>3</sup>, Nigussie Haregeweyn<sup>4</sup>, Jan Moeyersons<sup>5</sup>, Jozef Deckers<sup>2</sup>, Mitiku Haile<sup>4</sup>

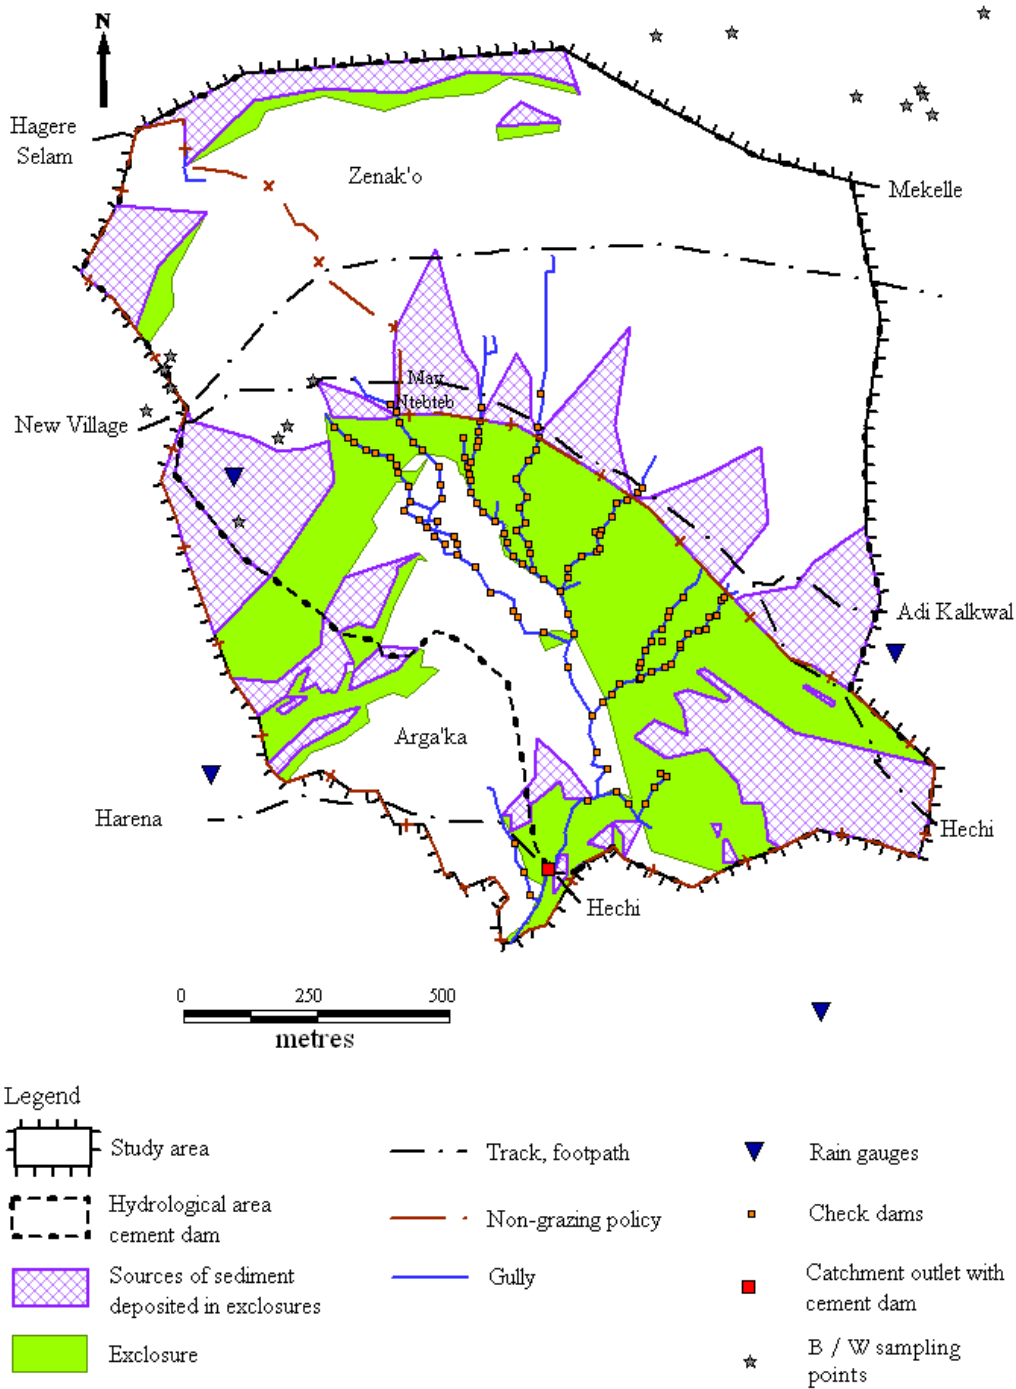
Figure 1. May Zeg-zeg catchment with location of SWC techniques (in 2006) as well as research instrumentation. BW stands for above-ground biomass.

An overall approach to assess the effectiveness of soil conservation measures at catchment scale is the comparison of sediment budgets before and after implementation of a catchment management programme. In the May Zeg-zeg catchment (187 ha – Fig. 1) in Tigray, north Ethiopia, integrated catchment management has been implemented since 2004: **stone bunds** were built in the whole catchment (Fig. 2), vegetation was allowed to regrow on steep slopes and other marginal land (**exclosures**), stubble grazing abandoned, and **check dams** built in gullies (Fig. 3; Fig. 4). Land use and management were mapped and analysed for the situation before (2000) and after catchment management (2006) (Fig. 5; Fig 6), whereby attention was also given to the quantification of changes in soil loss due to the abandonment of stubble grazing (Table 1). Sediment yield was also **measured at the catchment's outlet**. A combination of decreased soil loss (from 14.3 t ha<sup>-1</sup> y<sup>-1</sup> in 2000 to 9.0 t ha<sup>-1</sup> y<sup>-1</sup> in 2006) and increased sediment deposition (from 5.8 to 7.1 t ha<sup>-1</sup> y<sup>-1</sup>) has led to strongly decreased sediment yield (from 8.5 to 1.9 t ha<sup>-1</sup> y<sup>-1</sup>) and sediment delivery ratio (from 0.6 to 0.21). This diachronic comparison of sediment budgets (Fig. 7; Fig. 8) revealed that integrated catchment management is most effective and efficient and is the advisable and desirable way to combat land degradation in Tigray and other tropical mountains.

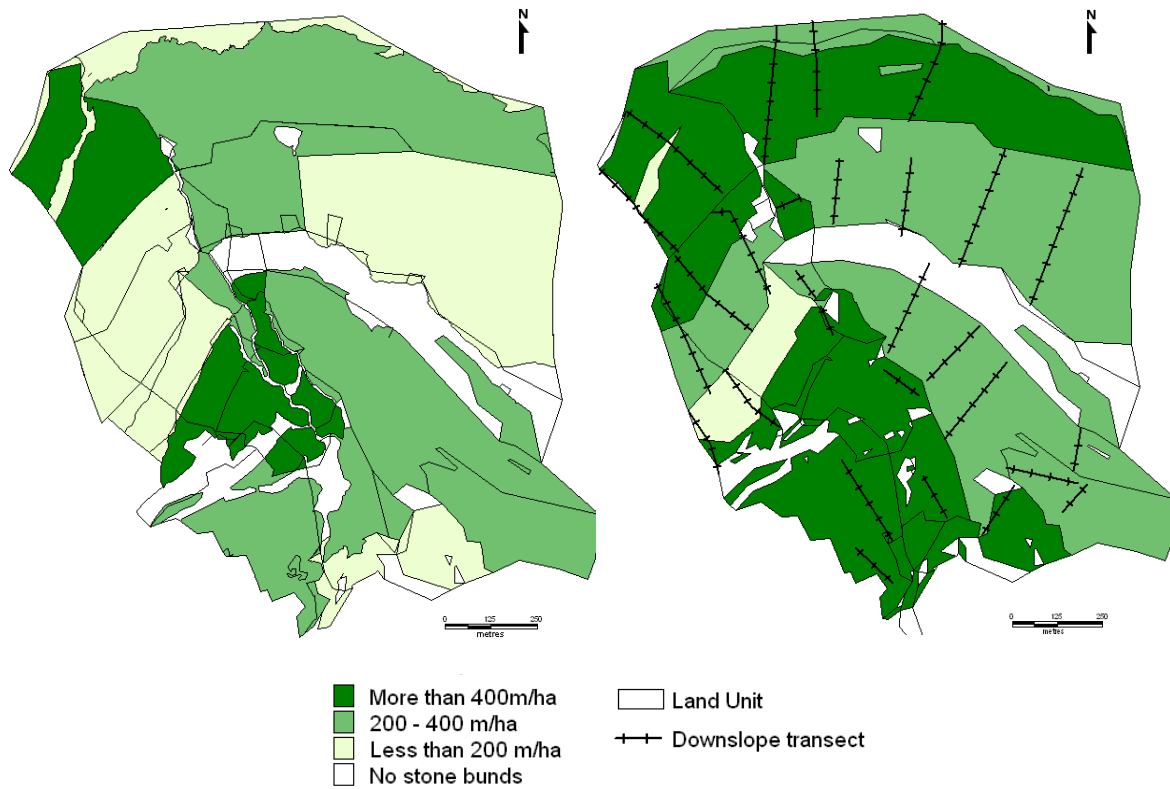
Figure 2. Stone bund densities in 2000 (left) and 2006 (right). Position of the 2006 downslope transects for measurement of stone bund density is indicated.

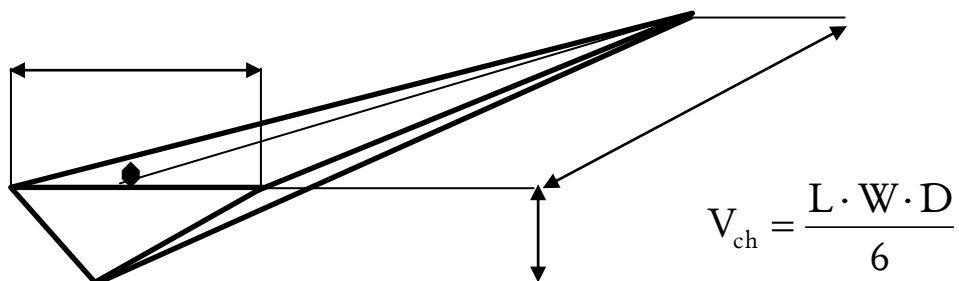
Figure 3. Schematic representation (perspective) of the most common shape of sediment deposition behind check dams in a gully: black dot represents the deepest point, depth (D, m), length (L, m) and width (W, m)

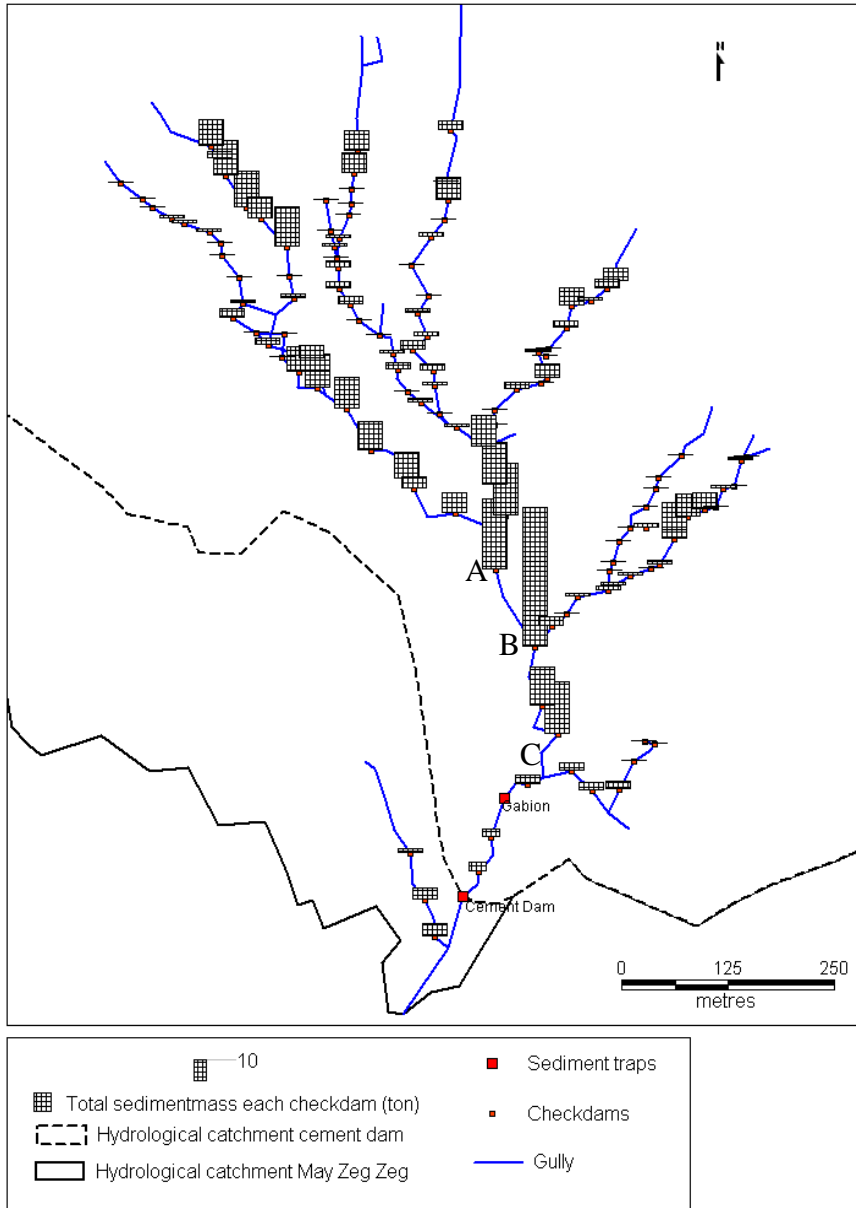
Figure 4. Measured sediment deposition (t) behind check dams in May Zeg-zeg; A, B and C are junctions in the gully system. See Figure 1 for location in the catchment of the gully system with check dams.

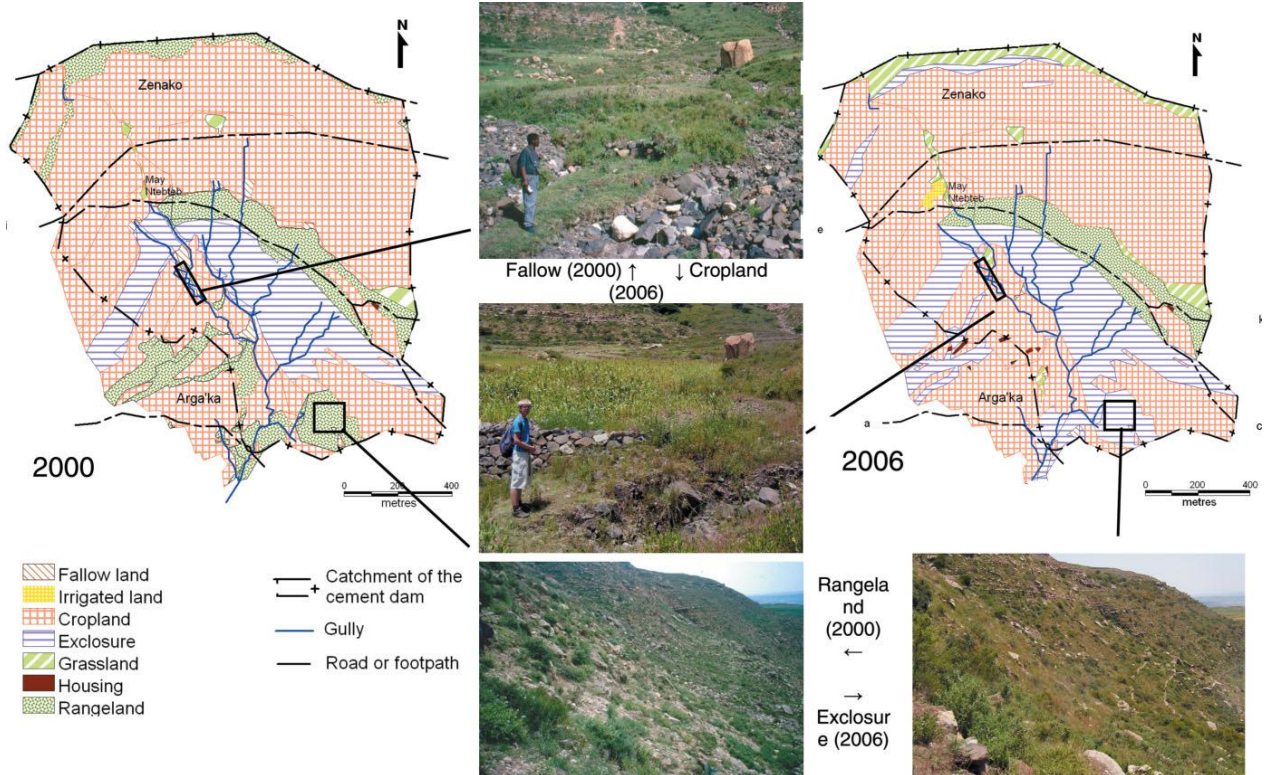
Figure 5. Land use maps of MZZ catchment in 2000 and 2006 with photographs of typical land uses in both years.

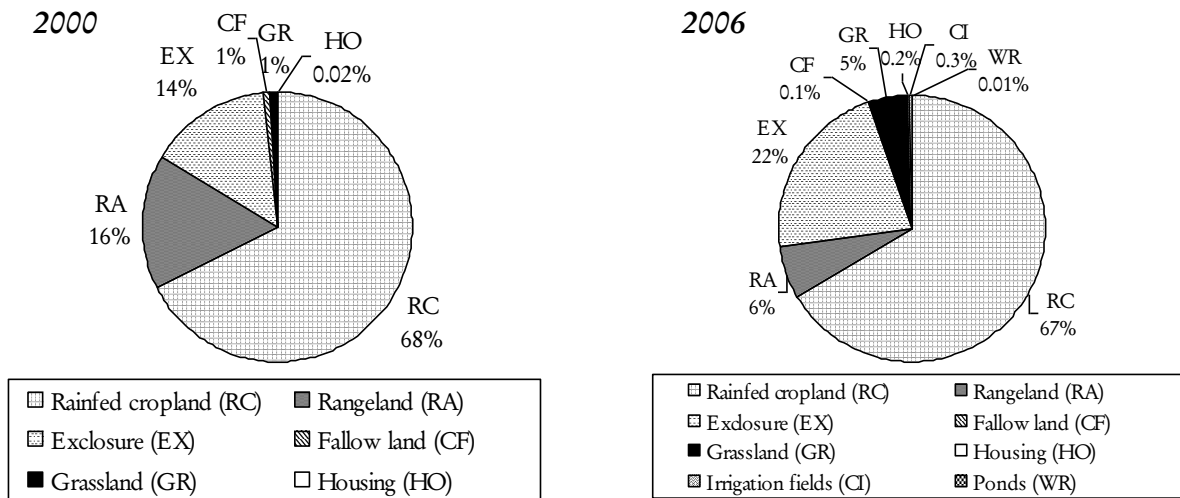
Figure 6. Relative areas of land use types in 2000 and 2006.

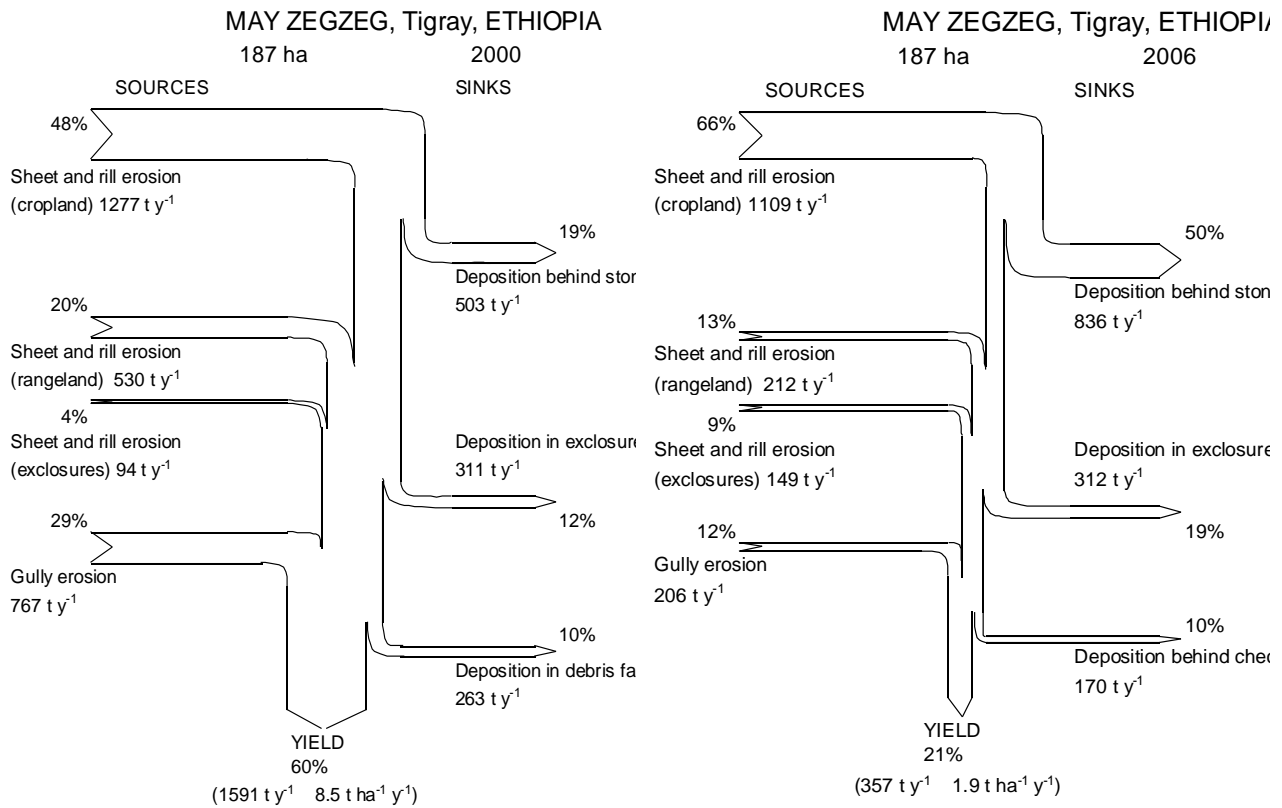
Figure 7. Sediment budgets for MZZ catchment in 2000 (left) and 2006 (right) with computation of sediment sources and sinks. Width of arrows is proportional to sediment masses involved.

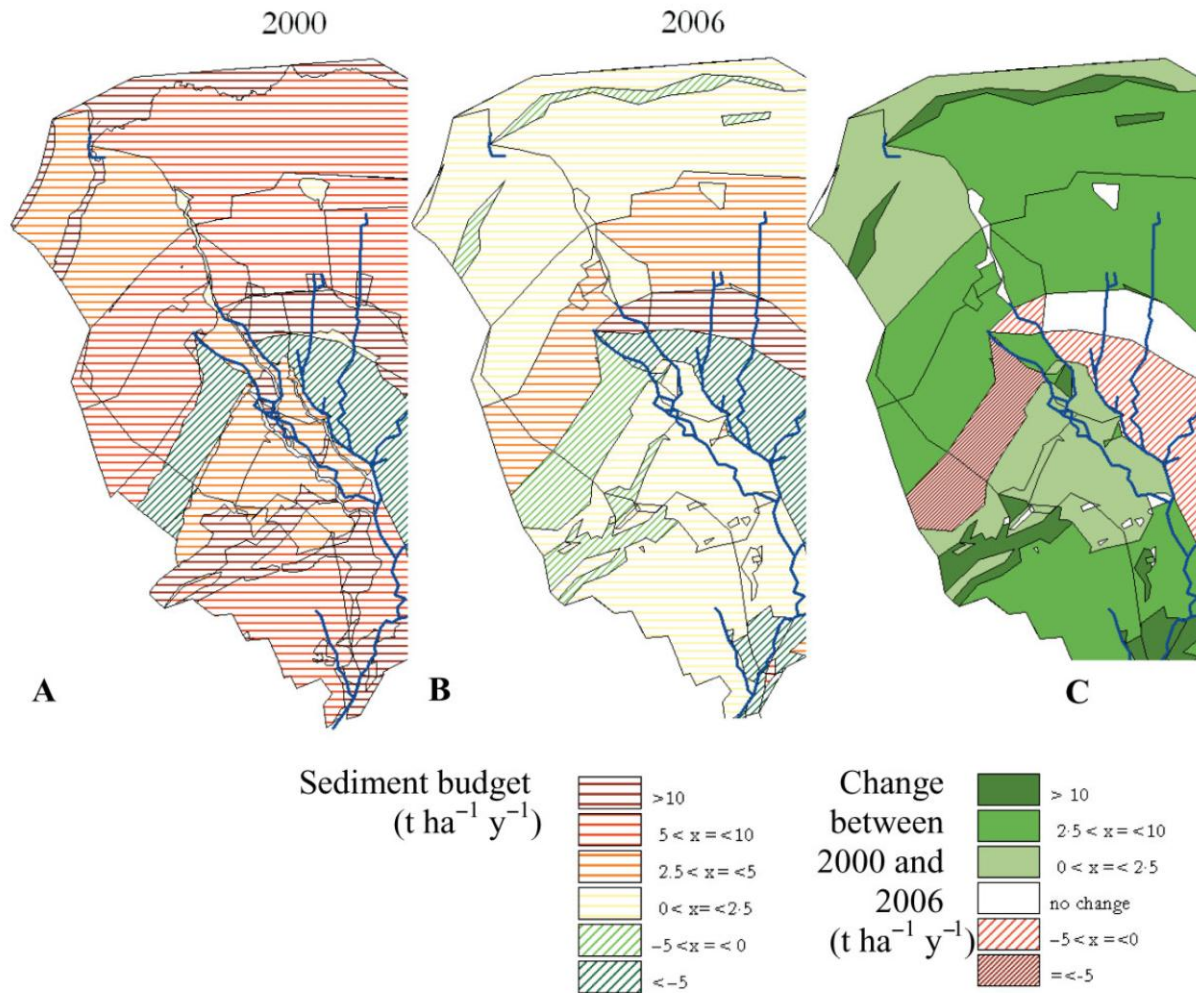
Figure 8. Sediment budget (sediment production minus sediment deposition = sediment yield) (t ha<sup>-1</sup> y<sup>-1</sup>) for each land unit in 2000 (A) and 2006 (B). Sediment delivery areas (sources) are positive (red) and sediment deposition areas (sinks) are negative (green). (C): changes between 2000 and 2006 with improvements (green) and declines (red), related to decreased sediment input. Gully erosion and deposition behind check dams are not represented.
