Energy Efficiency Analysis in Korça Regional Hospital

In this research work, we have analysed some of the key challenges associated with energy efficiency (EE) in hospital buildings. As the building sector is one of the most important energy users in Albania, our focus will be on hospitals as a complex building typology. A general overview and analysis of the building envelope where energy consumption in hospitals will be given. Afterward the focus will be on energy audit as a process that will facilitate the improvement of energy efficiency in this building typology. In order to prioritise energy efficiency measures some economic indicators will be introduced. The aim is to present an alternative model for energy auditors and energy managers. All these analyses and procedures will be carried out at Korça Regional Hospital. This analysis will assist decision makers in selecting the most appropriate EE measures from among many influential parameters.

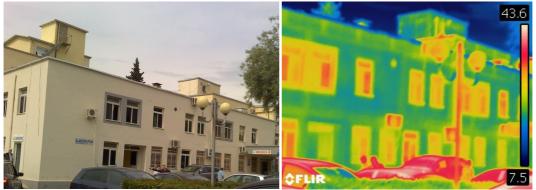
This analysis also revealed insufficient thermal insulation for the buildings, as most of the heat loss comes from the walls. For this, the image from the thermal camera can help us to have a clear idea (see Figure 6).

Figure 6. Image of façades from thermal camera

The highest energy savings potential is identified by investments in energy savings for space heating through thermal insulation of the external walls, thermal insulation of the roof, efficient windows and the introduction of an efficient diesel heating system. Financial analysis will help us to have a good idea of which energy efficiency measures are the most feasible and which ones should be implemented. Implementing and upgrading the building management system is also an important measure.
