Experimental Study of Sidewall Rupture of Cylindrical Lithium-Ion Batteries under Radial Nail Penetration

To understand the relationship of the sidewall rupture at different states of charge (SOCs) of cylindrical cells with high specific energy, this work presents the results of radial nail penetration tests of 21700-format cylindrical cells at different SOC. The thermal runaway and sidewall rupture behaviours were characterised by key performance indicators such as temperature, mass, fire behaviour, and voltage change. In addition, released gases from a subset of tests were measured using the Fourier transform infrared spectroscopy. The change in the internal structure of another subset of cells after the test was observed by X-ray computed tomography. The results show that the sidewall rupture still exists for tests at low SOC (< 30% SOC), but the outcome of thermal runaway and sidewall rupture is milder than those at high SOC ($\geq 50\%$ SOC). The average mass loss of cells increases with the increment of SOC. The cell casing thickness is reduced by $12.7\% \pm 0.3\%$ of the fresh cell, which in combination with the reduction in the strength of the casing material at high temp

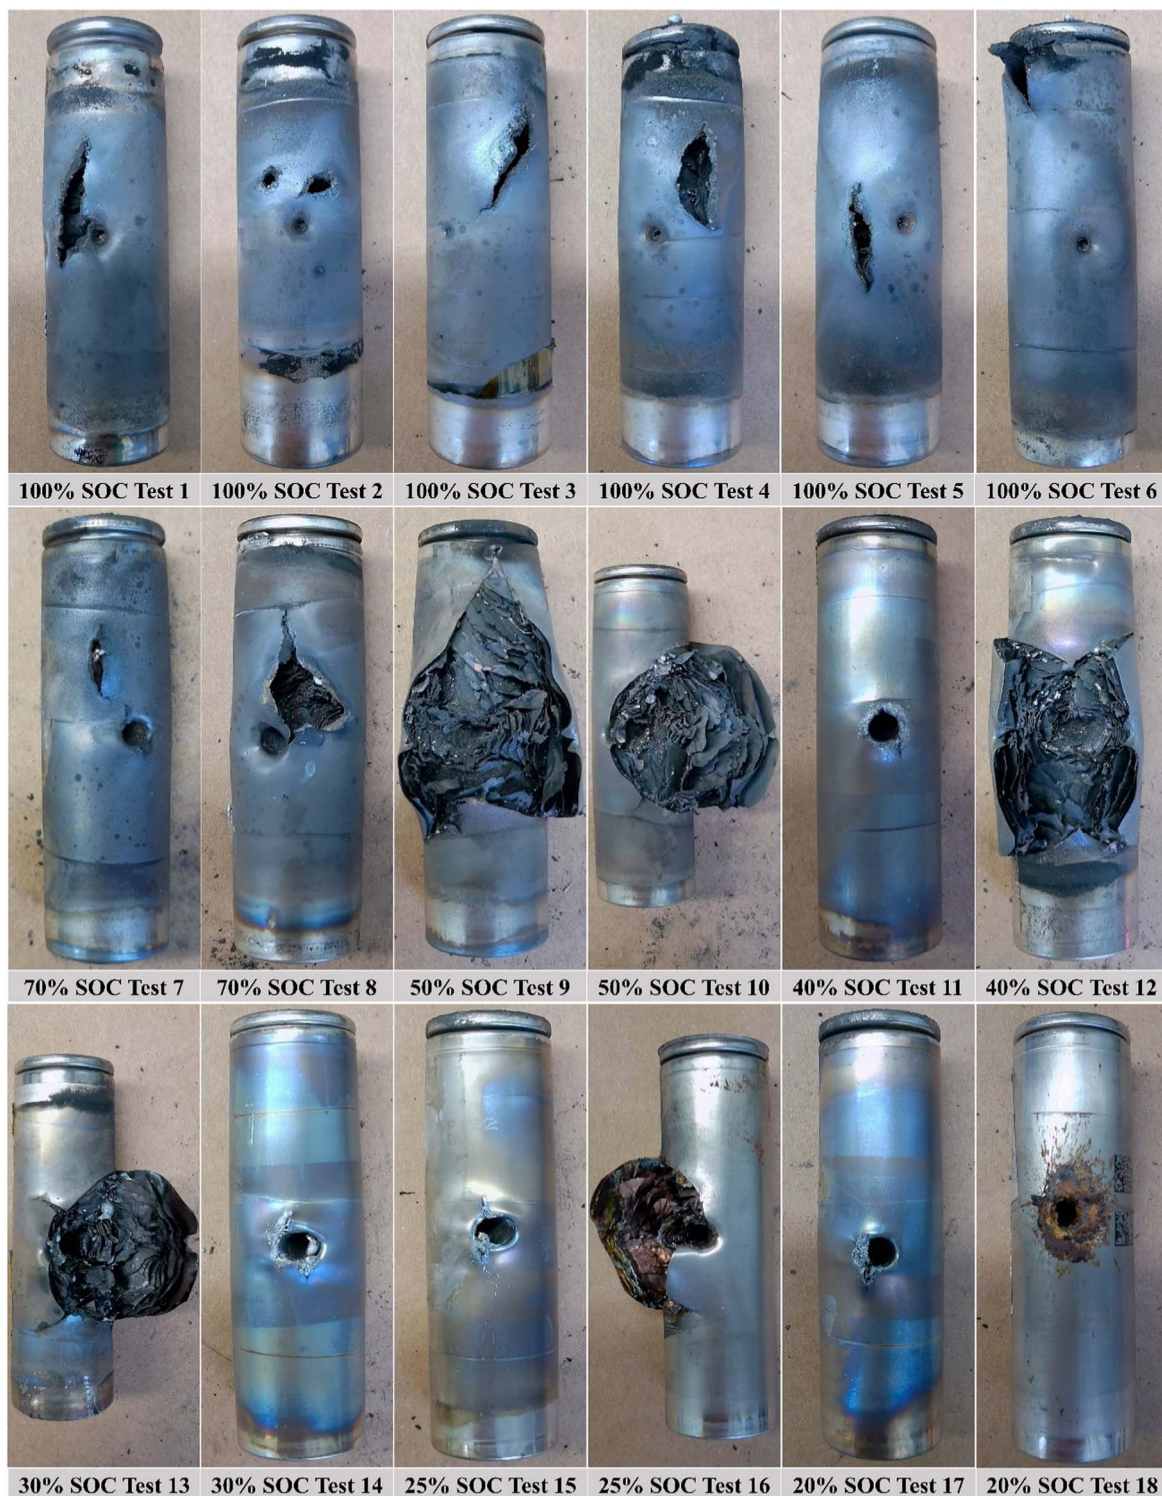
As shown in Table II and Fig. 2, sidewall rupture is with TR in most of them but only one test at 25% SOC without TR. For cells at 50% SOC or higher, sidewall rupture was observed in all tests including one with 100% SOC showing holes created by melting the metallic casing. Sidewall rupture was also found in tests less than 50% SOC. One of two tests at SOC from 25% to 40% happened sidewall rupture. As expected, sidewall rupture was not observed in tests when the cell SOC was further reduced. The rupture behaviour of tests at 70% SOC was similar to that at 100% SOC with a relatively small opening. The vent disk was believed to activate before sidewall rupture because the sparks or fire were observed ejecting from venting holes ahead of that from the cell side. Some catastrophic explosion cases were observed in tests less than 70% SOC and their ruptures propagated through the penetrating location maybe because the vent disk was completely or partially blocked, and the strength of the casing around the penetrating hole was less than the original strength due to a deep insertion for lower SOC, therefore the penetrating location became the weak point of the casing. The opening of the penetrating location looked bigger than the nail diameter for tests less than 100% SOC with TR because sparks were also ejected from the penetrating location in these tests and therefore increased the opening area. Note that the penetrating depths of tests at 100% SOC were shallower than those with low

Figure 2. Photos of tests 1–18 after the test.

SOC because the tests were stopped with the observation of sparks and the tests at 100% SOC were easier triggered to TR than those at low SOC. The occurrence of catastrophic explosion for tests at low SOC suggests that insertion depth is also a contributing factor to sidewall rupture and the deep insertion may facilitate the violent sidewall rupture. The present results show that the increase of SOC greatly increases the likelihood of sidewall rupture. The main reason is that the internal pressure generated by gases released during TR is very high and the strength of the battery casing greatly degrades at high temperatures.⁸ In addition, the structural integrity of the cell may be damaged by the impulse force generated by the nail during penetration, see test 16 with 25% SOC and without TR. Further analysis of sidewall rupture will be done by comparing mass after test, gas released, and CT scan in the following sections.

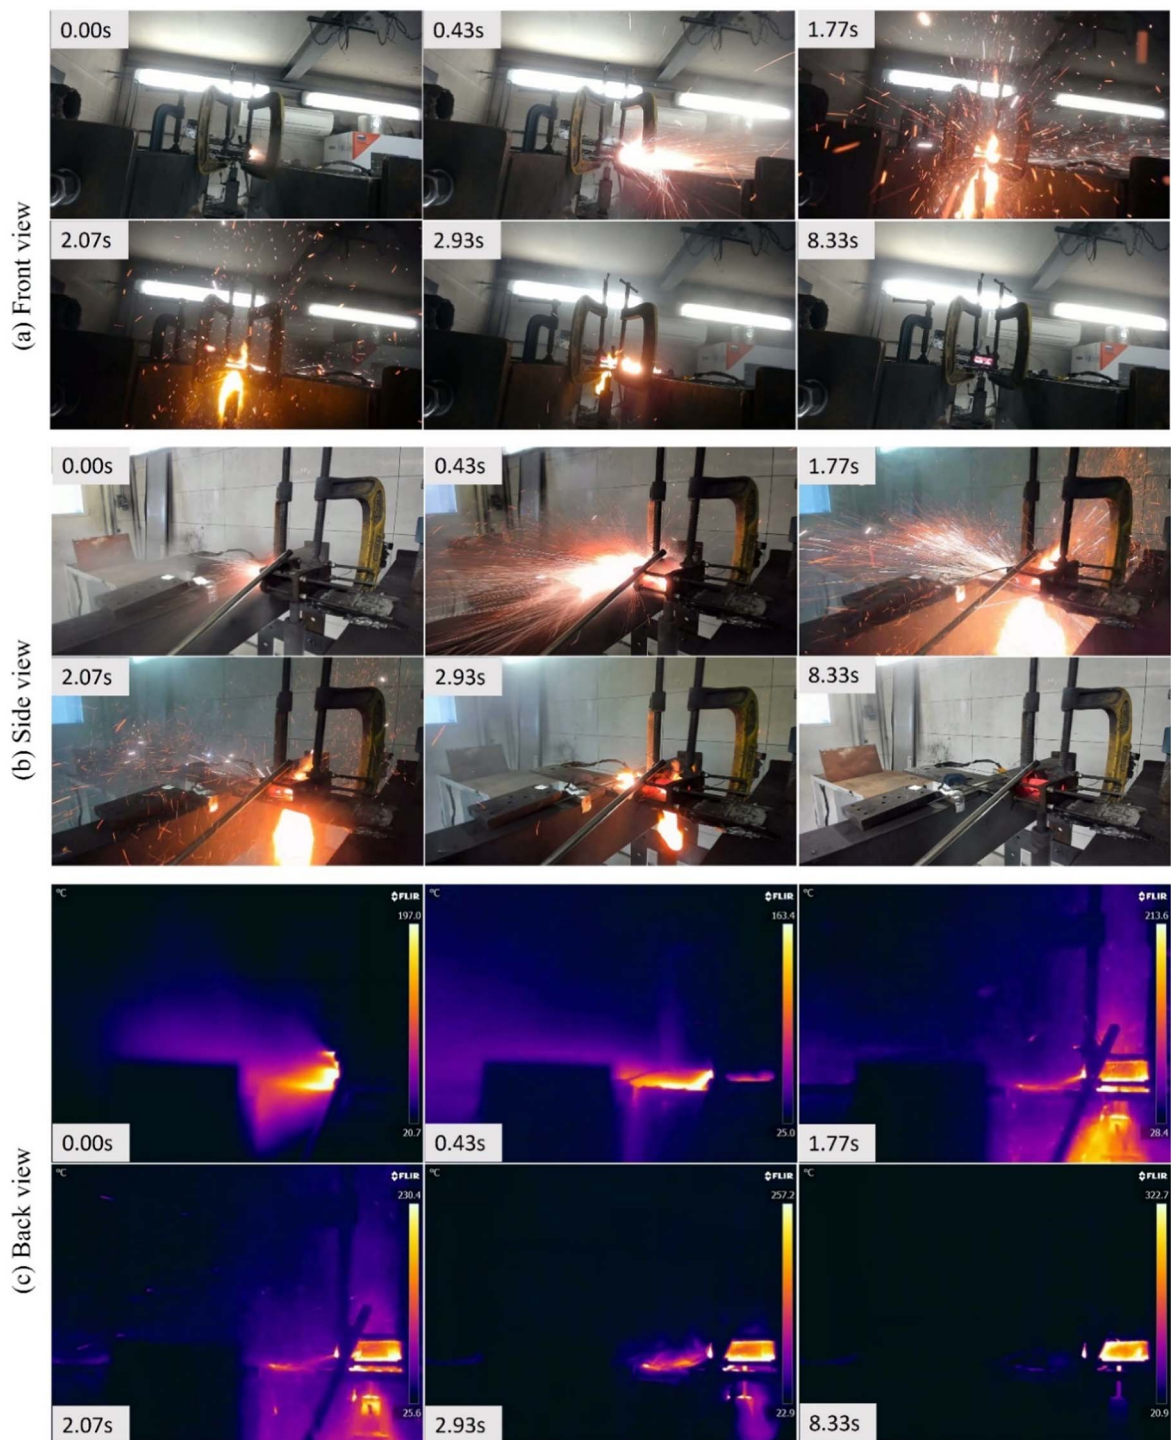
Fire behaviour.—As shown in Fig. 5, some key images from test 1, as a representative example, are extracted to present the fire

characteristic of tests at 100% SOC. Here the time is set to be zero when sparks were observed in tests. Smoke and sparks ejected together from venting holes at the initial stage of TR, followed by a burst of sparks and flames from venting holes, and then flames burst from the side of the cell, next, the fire was extinguished after consumption of all combustible gases and finally, the cell cooled down. There was no great difference between different tests at 100% SOC. The whole process could be mainly divided into three stages: spark, flame and cooling. In the stage of spark, a large number of

sparks with smoke ejected firstly from venting holes, and then also from the opening of the cell side (sidewall rupture) within 1 s. Many bursts of sparks from venting holes and the opening of the cell side were observed in this stage, while a very weak ejection of sparks was from the penetrating location. It suggests that the pressure valve works when the internal pressure exceeds its critical value. Sidewall rupture occurring at this stage also suggests that the internal pressure is extremely high, and the opening area of the valve is not large enough to release pressure in such a short time. The smoke here

Figure 5. Evolution of fire behaviour of test 1 at 100% SOC. (a) Front view, (b) side view, and (c) back view from the IR camera.

mainly consisted of electrolyte vapours, carbon dioxide and water vapour because the concentration of these gases increased quickly at this stage, see more results about gases analysis in the following section. The concentration of these gases should be beyond the flammability limits of the gas mixture because these gases were not ignited by sparks.³² In the stage of flame, jet fire ejected from both venting holes and the opening of the cell side until the fire extinguished for exhausting all combustible gases, and many fragments ejected before forming the steady jet fire. There was an overlap between the stages of sparks and flame. The sparks were dominated in the stage of spark and the jet fire was dominated in the stage of flame accordingly. The transition from sparks to jet fire had been discussed in detail in our previous study of cylindrical cells with external heating using a high-speed camera.³² The cell cooled down gradually to room temperature in the stage of cooling. According to the definition, the first two images in Figs. 5a–5b are in the stage of sparks, the third image and the fourth image are in the stage of transition and the fifth image is in the stage of flame, and the last one is in the stage of cooling. The temperature distribution of the whole cell and the TR characteristics were also captured by the IR camera as shown in Fig. 5c.

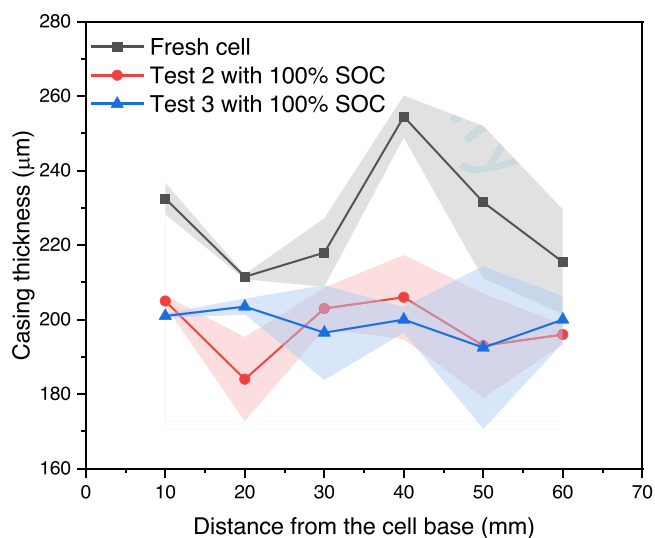
Figure 11. Comparison of battery casing thickness before and after the test. The shadowed area is the error bar of casing thickness.

Figure 11 shows a direct comparison of battery casing thickness with different distances from the cell base before and after the test. The error bar with fill area of casing thickness is plotted in Fig. 11. The thickness value in Fig. 11 is the mean value of two measurements at the same height but in different SOC locations via a CT scan with

a resolution of 31 μm . The thickness of the cell at different locations after nail penetration test was less than that of the fresh cell, in other words, the thickness became thinner than the fresh cell. The average thicknesses of the fresh cell, test 2 and test 3 at different locations were $227 \pm 16 \mu\text{m}$, $198 \pm 9 \mu\text{m}$, and $199 \pm 4 \mu\text{m}$, respectively. It means that the battery casing thickness has been reduced by $12.7\% \pm 0.3\%$ of the fresh cell. It may be caused by melt of the battery casing under high temperature. The cylindrical cell can be considered as a cylindrical pressure vessel. According to the stress analysis of the pressure vessels,⁴² the hoop stress subjected to the cell thickness of the tested cell is 1.15 times that of the fresh cell. It suggests that the strength of the battery casing becomes weaker than that of the fresh cell due to thinner casing thickness. It may conduce to the occurrence of sidewall rupture.
