# The Monitoring of Environmental Conditions within Corporate Collections at Keyworth and Murchison House: 2004

Internal Report IR/05/039

INTERNAL REPORT IR/05/039

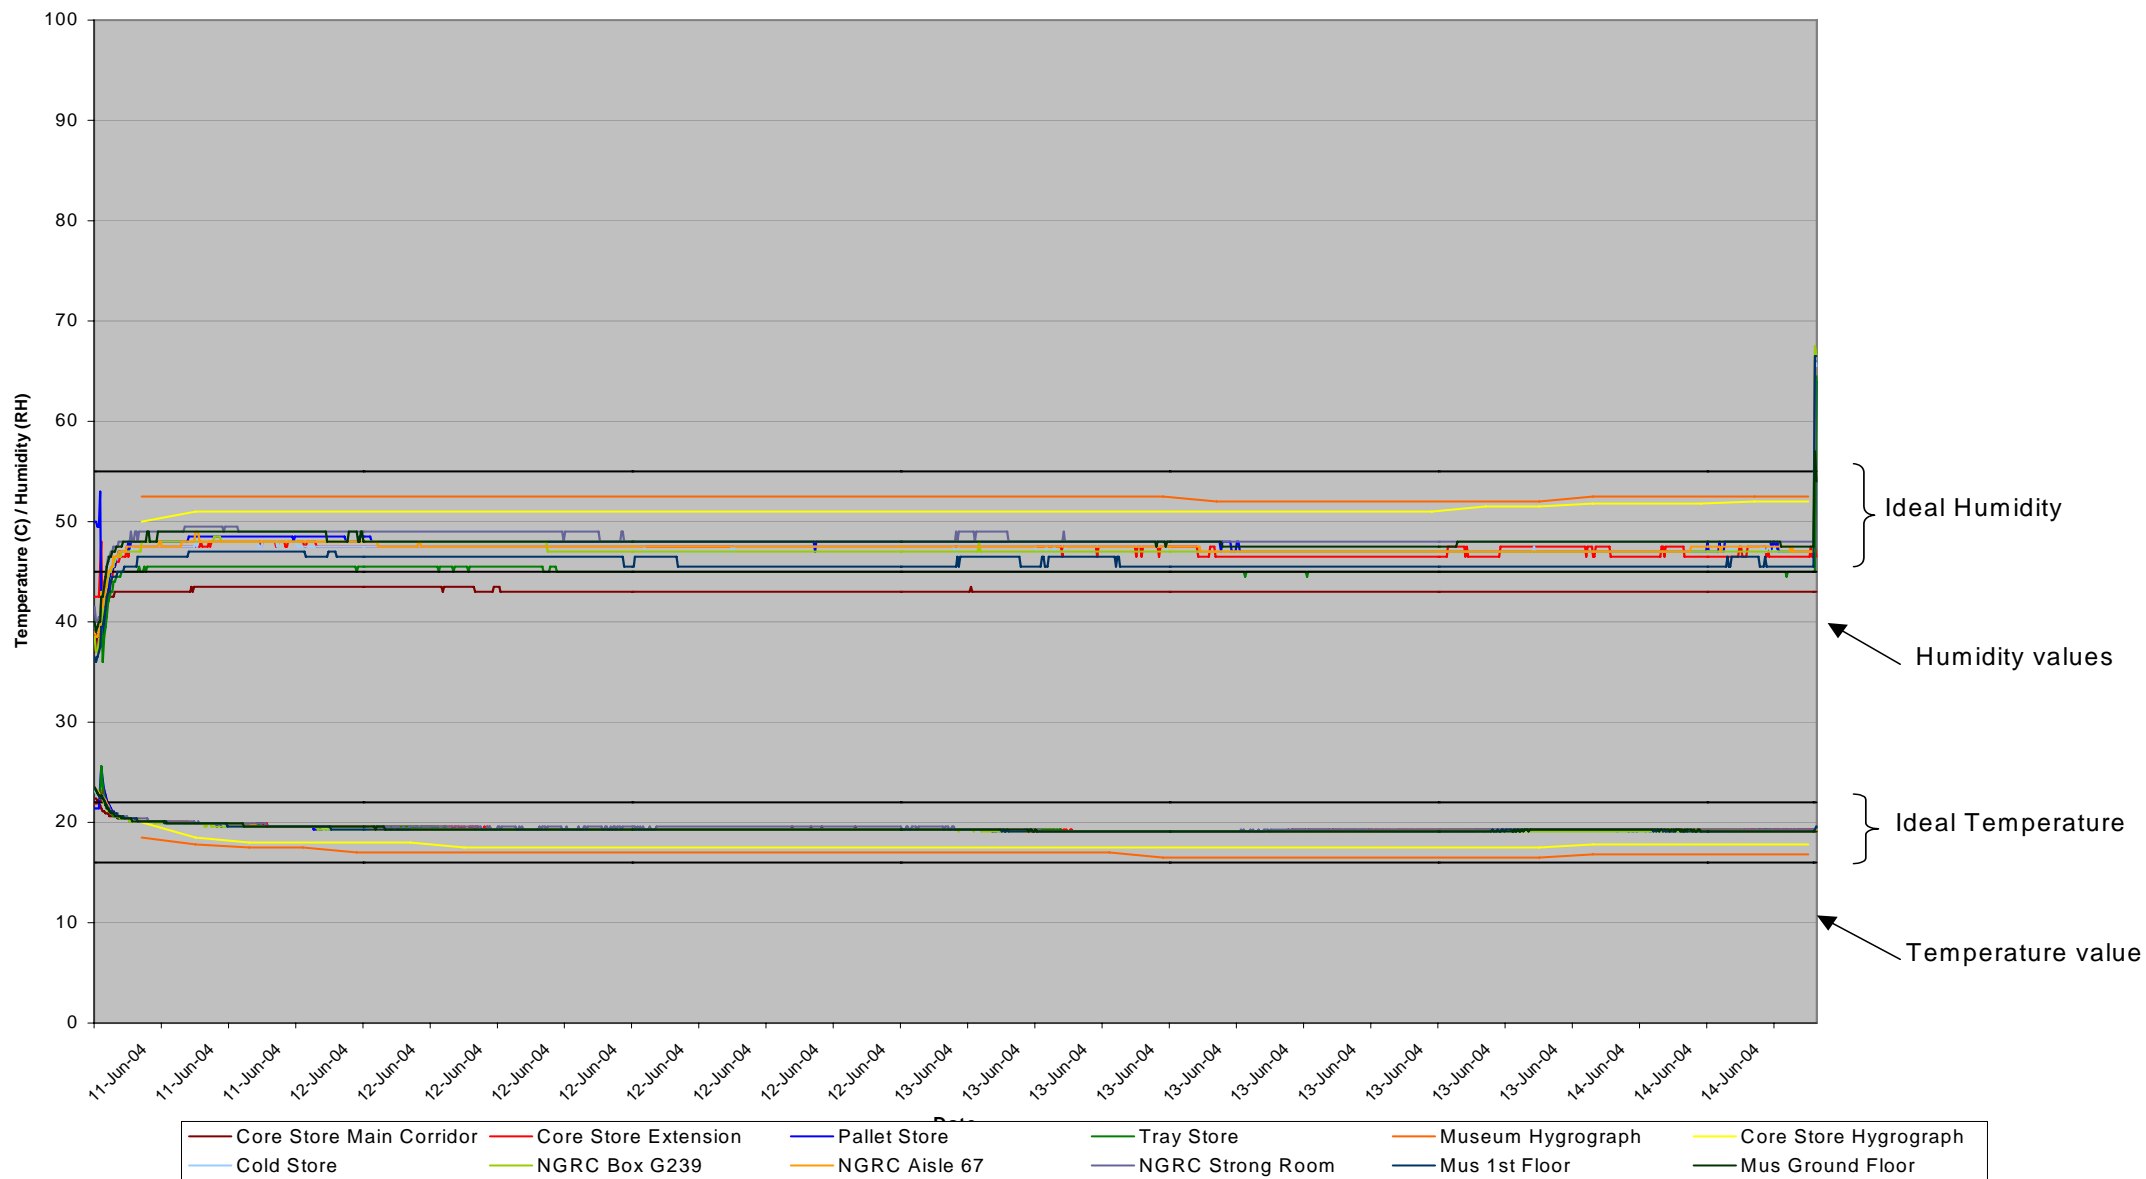
**Figure 1: All Loggers prior to Calibration Period - Keyworth 2004**

### All Loggers prior to Calibration - Keyworth 2004

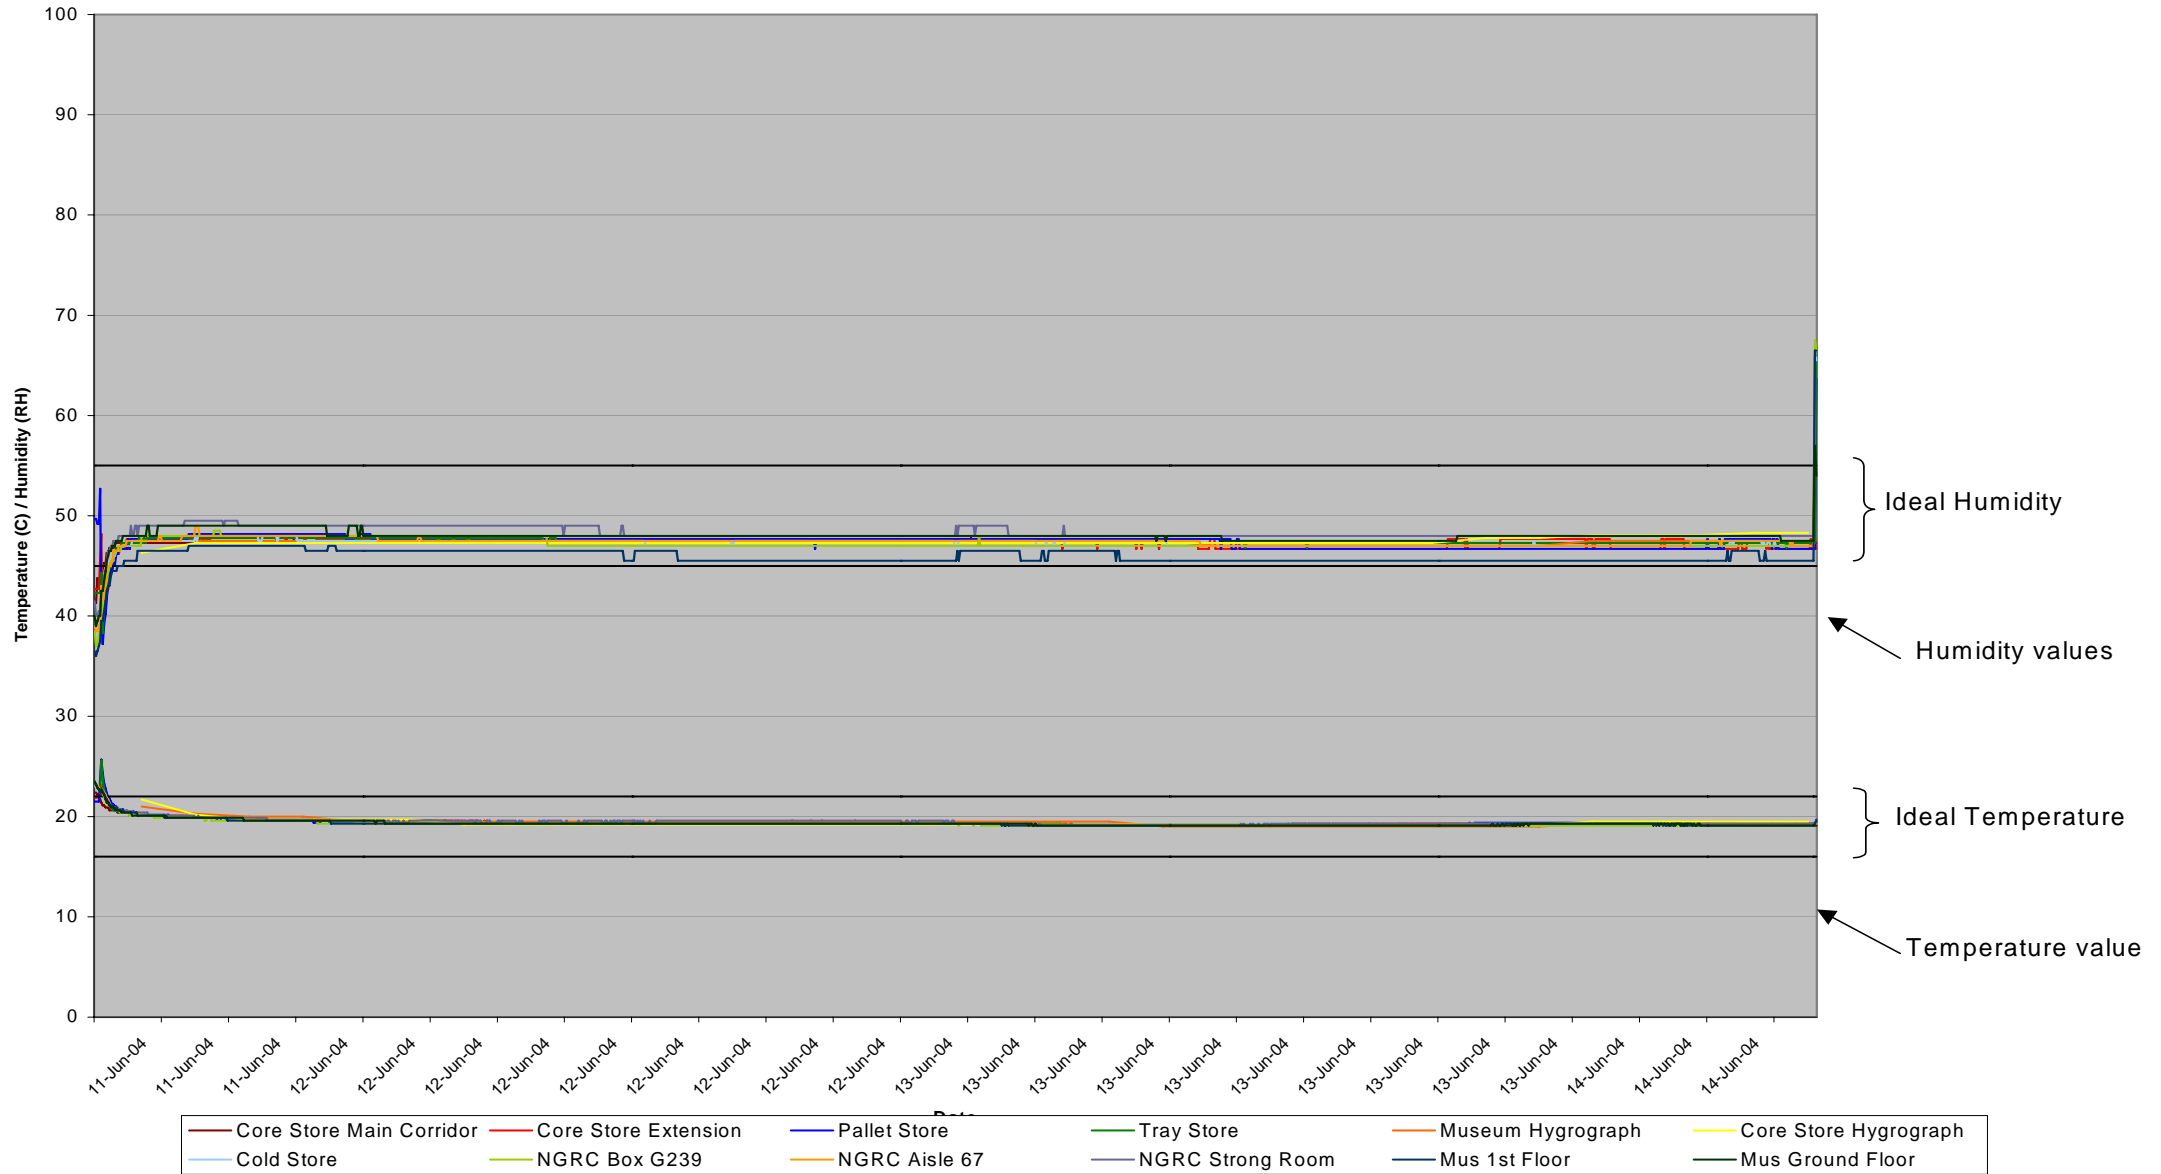
**Figure 2: All Loggers after Calibration Period - Keyworth 2004**

### All Loggers after Calibration - Keyworth 2004

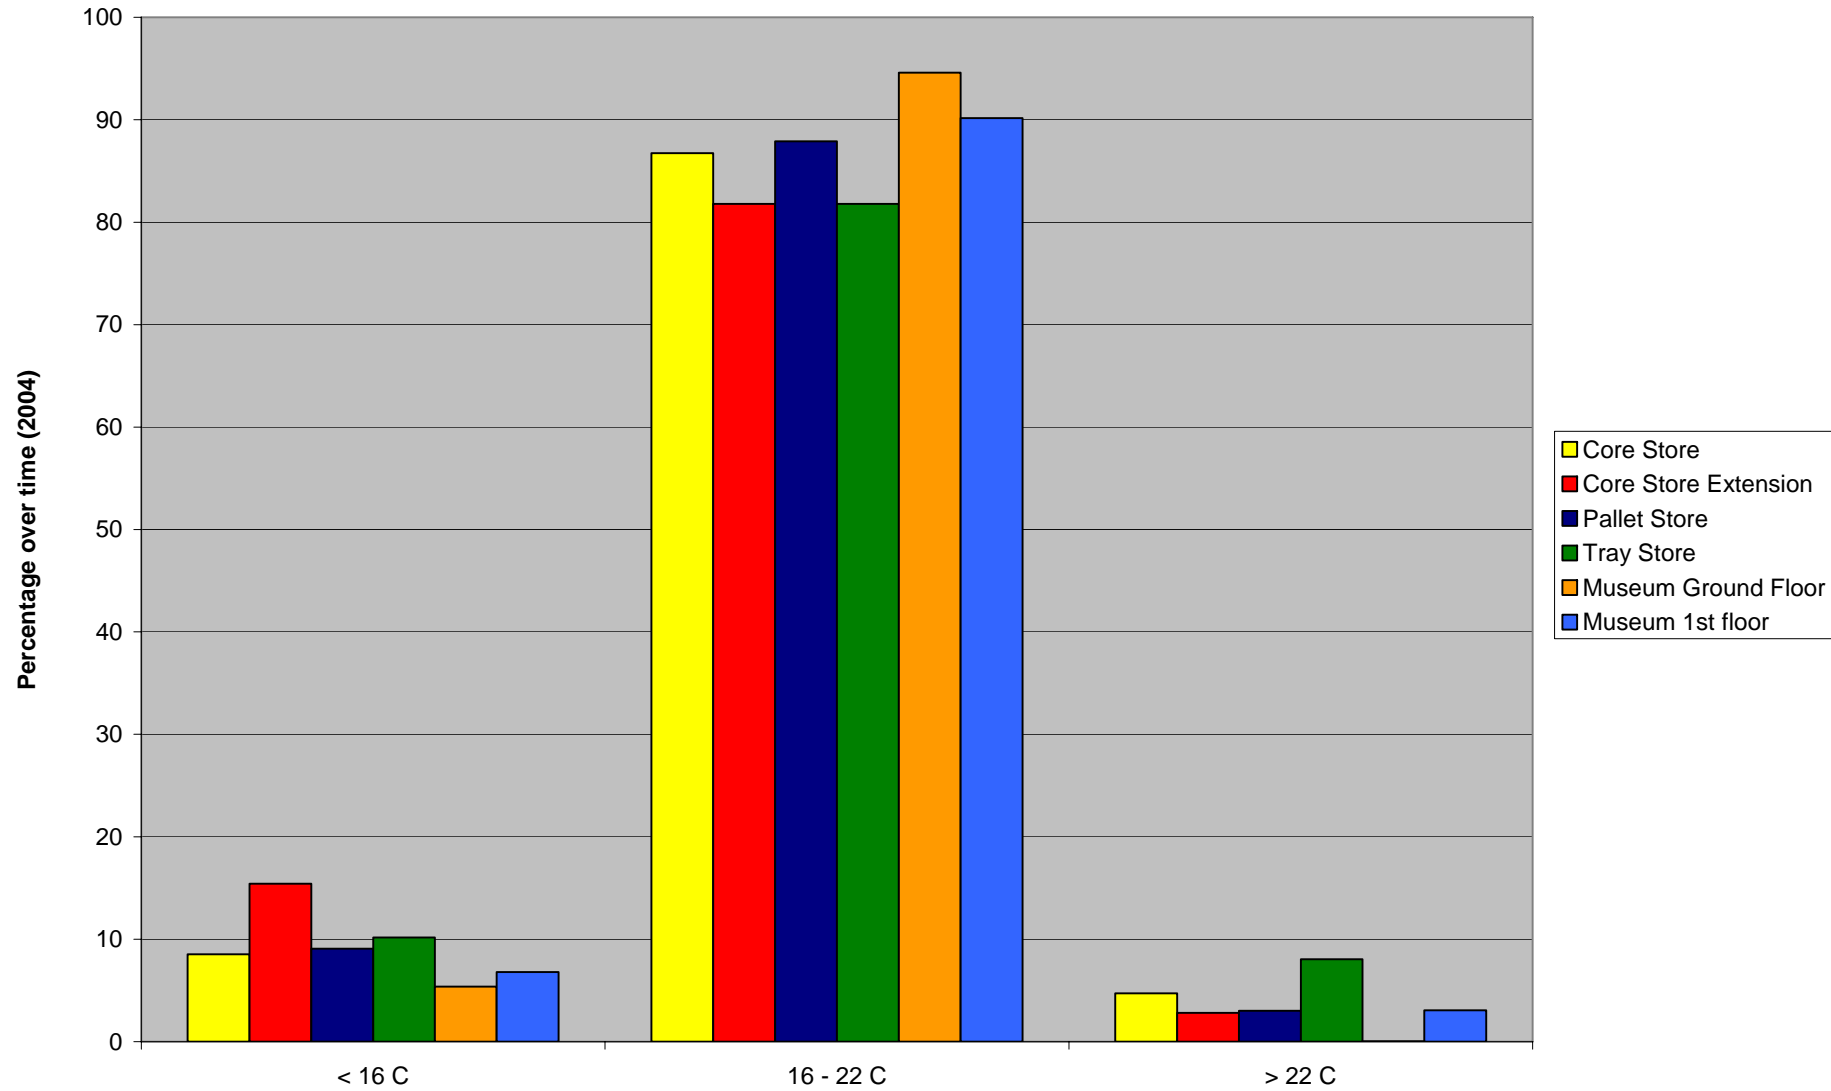
Figure 7: Histogram: Temperature ranges for all existing monitors – Keyworth 2004

Temperature Ranges for existing Environmental Monitors - Keyworth 2004

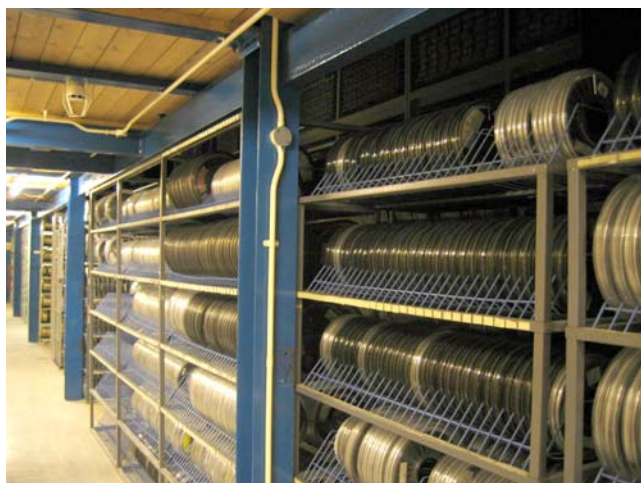
These magnetic tapes, are currently being stored on the second floor of the tray store, are in addition to the other types of material being stored within the tray store. They were stored there by SNS (System Network Support) and contain important data from the Coal Authority. Each tape is placed within a sealed plastic case, in open planned racking, on a specially built mezzanine floor on the second floor of the tray store. Some 12,000 of these tapes have already been sent away to be transferred onto CD. However the rest remain here until funding is available to complete this transfer process.

**Plate 1: Magnetic Tapes within Core Store**

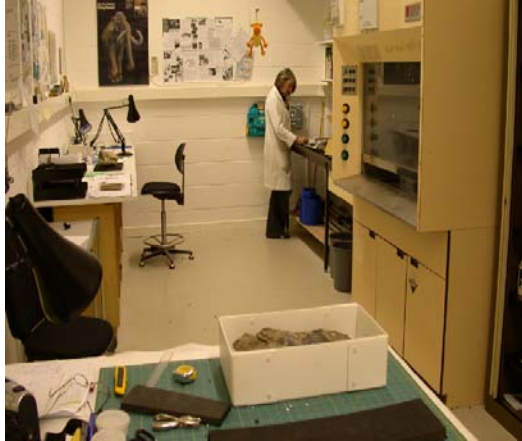
**Plate 2: Conservation Laboratory**

The Conservation Laboratory contains a variety of specimens whilst the Conservator carries out the preservation work. Depending on the size of the specimen and the remedial conservation work required, it could be some time before the specimens are returned to its usual storage location. That is why it is important to monitor the temperature and humidity within this area.

Monitoring for the Conservation Laboratory commenced on the 9<sup>th</sup> November 2004, this is one of our newest monitors purchased in November, and thus was not included during the calibration period. As this monitor was recently supplied from the manufacture, it already should be accurately calibrated and thus should be giving similar readings to those monitors calibrated in house.

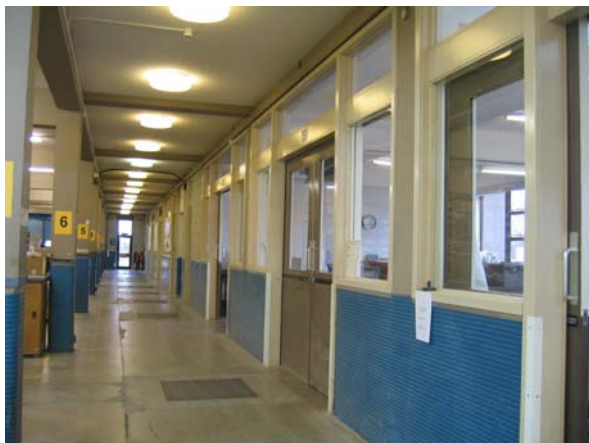
**Plate 3: Core Store Main Corridor**

Additionally, just outside the Conservation Laboratory is the main corridor of the core store. This is where for the majority of the time the three core store technician's work. Adjacent to this area are examination bays where material is put out for examination for staff and visitors. Within this area, boxes of core and other material are stored whilst waiting for the material to be sorted and curated. Member of staff use this corridor to get to the main core store, the pallet store and the core store extension. Forklift trucks use this corridor to transport material from the loading bay doors to the rear of the core store.

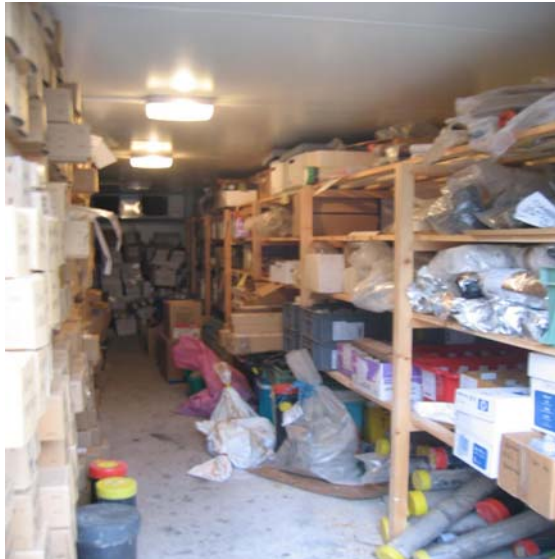
**Plate 4: Cold Store No. 2**

The stores are kept at a temperature of 4°C (+/- 2°C) this is to inhibit the growth of bacteria within the samples. The cold stores temperature is regulated by a thermostat system, and is driven by large fans to the rear of the stores. Air is drawn in from the outside, but is first cooled, and then is distributed throughout the cold stores by additional fans.

Monitoring for cold store (No. 2) commenced on the 14<sup>th</sup> June, after the in-house calibration period.

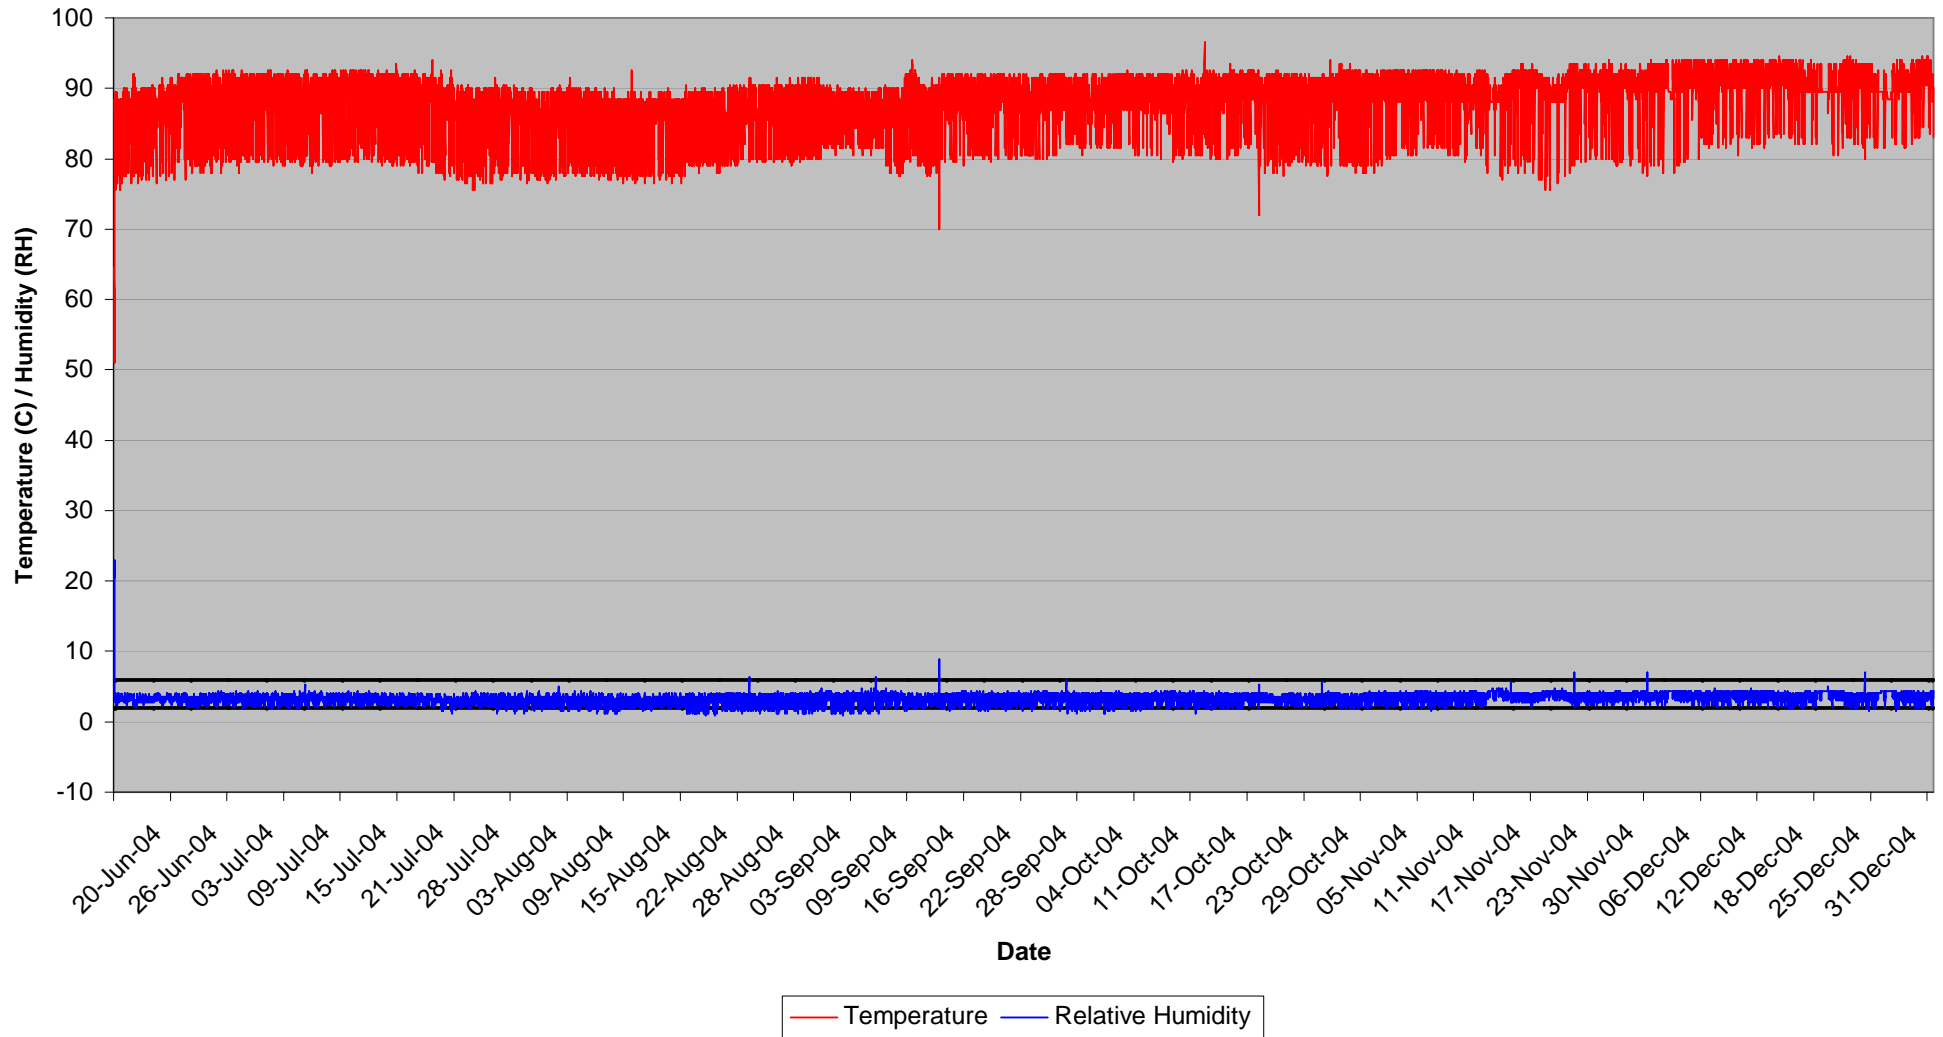
Figure 17: Temperature and humidity readings within Cold Store No. 2

### Environmental Monitor within Cold Store Number 2 - Keyworth 2004

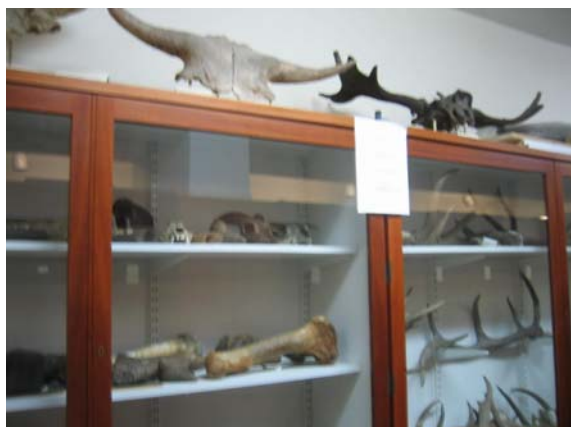
**Plate 5: Museum display sub-fossil Bone**

As discussed in last years report *Shepherd & Tulloch, 2004*, most of the museums fossils are stored within Mahogany cabinets, or glass wall cabinets. There is a collection of large sub-fossil bone specimens that are housed on top of the wall cabinets on the ground floor of the museum. These are currently not stored in cases, but are open to the environmental conditions of the museum. It was decided to monitor this part of the museum and thus see if the specimens were being suitable stored.

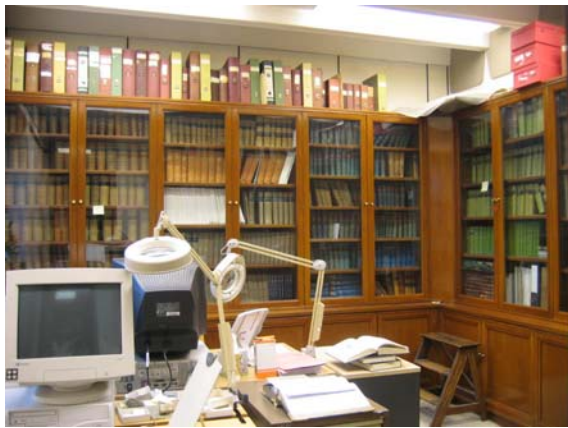
The temperature readings from the top shelf of the museum library have increased slightly by 5°C, compared to those readings taken in the glass bookcase for the period before. Still, both sets of temperature readings are above the maximum recommended temperature for this type of material. On the other hand, both library localities are significantly below the recommended minimum humidity range of 55%. There are a 'few' occasions where the humidity levels increase sufficiently to become acceptable. One of the main factors could be due to windows and doors being opened to make working conditions for staff, more comfortable in the museum library. With doors and windows open, hot humid air can penetrate into the building and allow humidity levels to rise.

### **Plate 6: Museum Library**

It can be seen that the humidity readings outside the bookcase are closer to the 55%, compared to 40% within bookcase. Readings within the cabinet are more acceptable as these are constant, and thus provide a more stable environment.

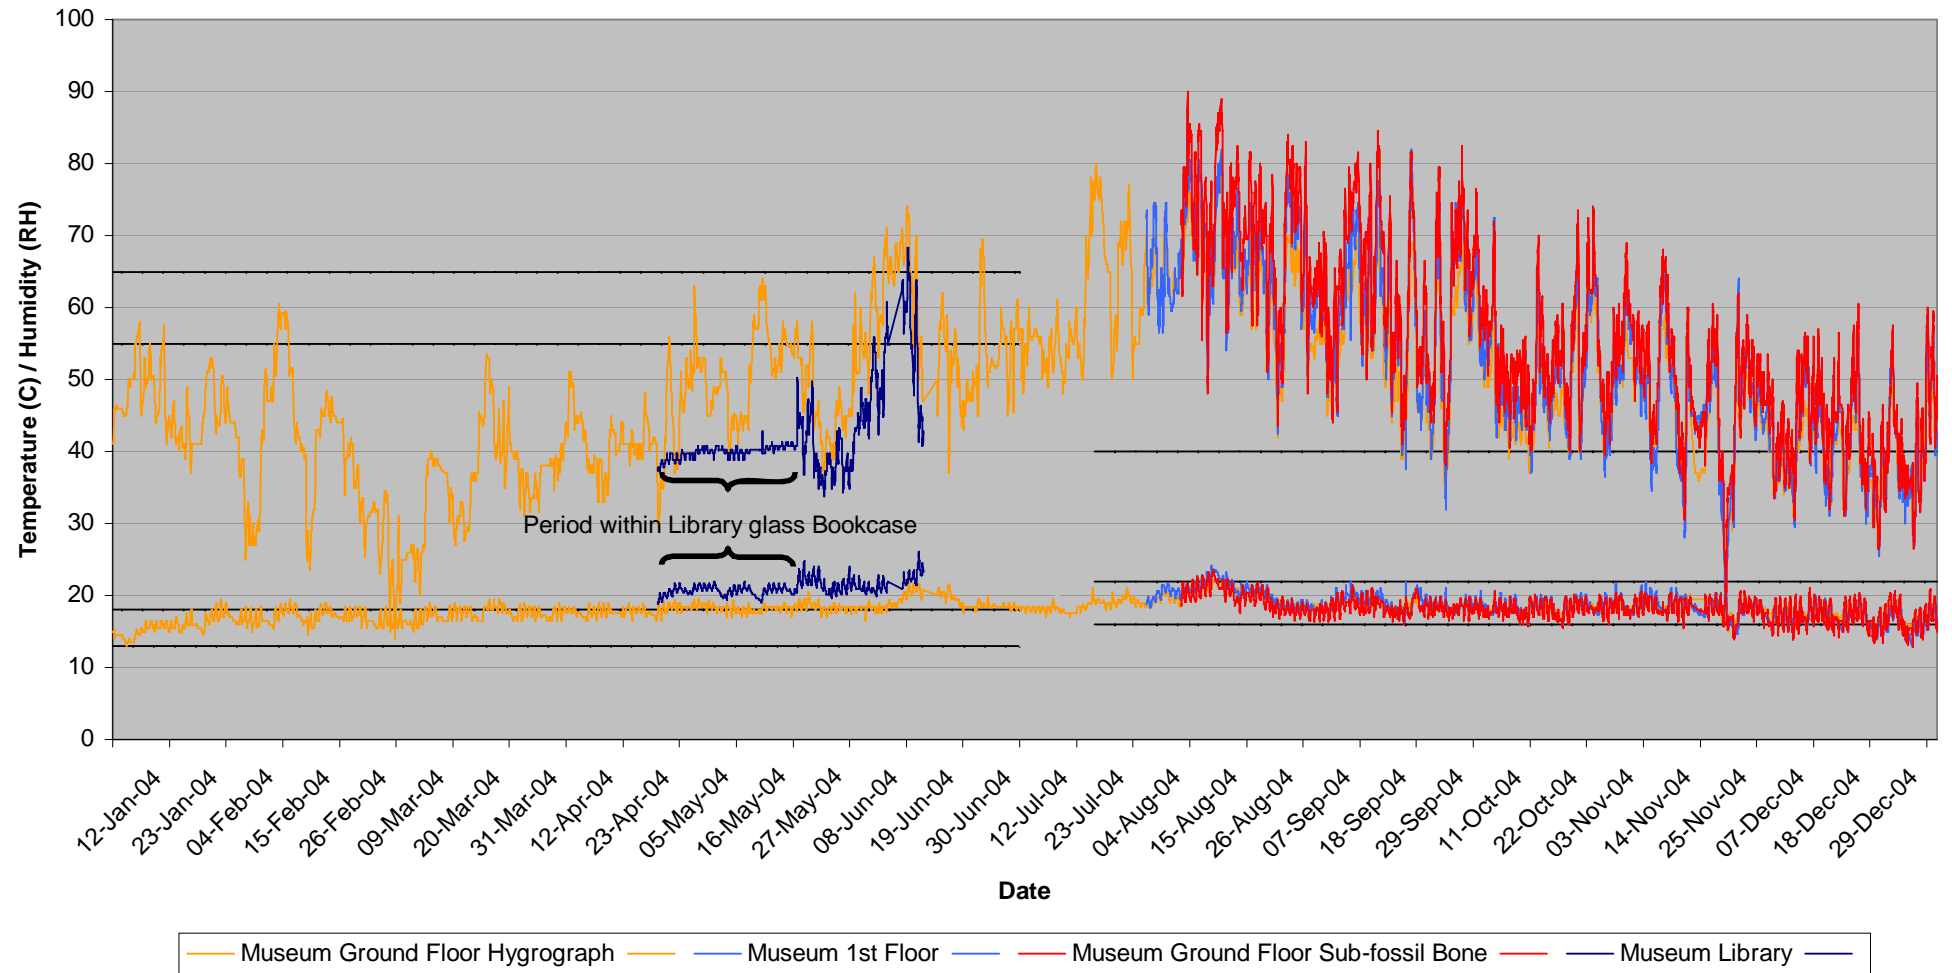
Figure 20: Temperature and humidity readings Museum Sub-fossil bone and Museum Library

### Monitors near Sub-fossil Bone, Museum Library & on both floors of Museum - Keyworth 2004

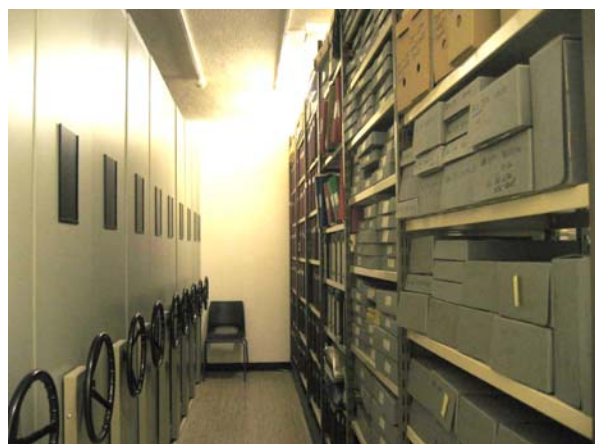
**Plate 7: NGRC Strong Room**

From the 2003 report, it was recommended that the monitoring within the NGRC strong room should continue. Funding became available to purchase three additional monitors for the NGRC Records Room, rather than using a spare 'mobile' logger from previous years. This would then enable continuous monitoring throughout the year, compared to the fragmented data collected during 2003. Monitoring for the NGRC commenced after the in-house calibration period of 14<sup>th</sup> June. During this time a monitor was placed in the NGRC Strong Room in the same position as 2003 mini-project.

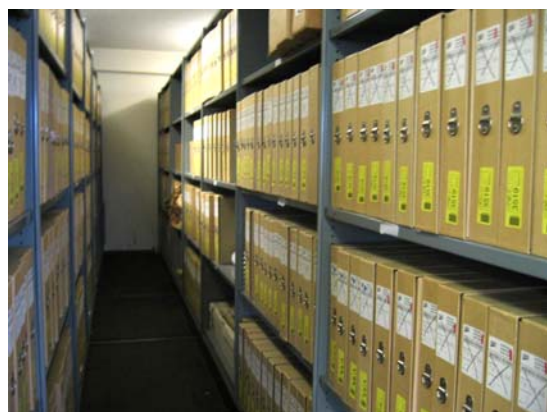
**Plate 8: NGRC Records Room Aisle 17**

The other areas under investigation were within the NGRC Records Room. This houses the main part of the NGRC collection, containing reports, notebook interpretations, plans and other geological or related data. Like the strong room, this too has an automated fire suppression system. Two additional monitors were positioned at either ends of the NGRC Records Room, on shelving in rolling racking within aisles 17 and 67. After a period of four months, a decision was made to move the monitor in aisle 17, to aisle 67, into one of the cardboard boxes containing geological paper records. Any variations in temperature and humidity inside and outside of the record boxes could then be shown.

The ideal conditions in which to store historical records on paper should be between 13-18°C and 55-65 % RH, as stated in the *Standards in the Museum Care of Geological Collections 1993*. The humidity may be as low as 50% if parchment or vellum is not present, as stated in *Guidelines for the Curation of Geological Materials 1985*.

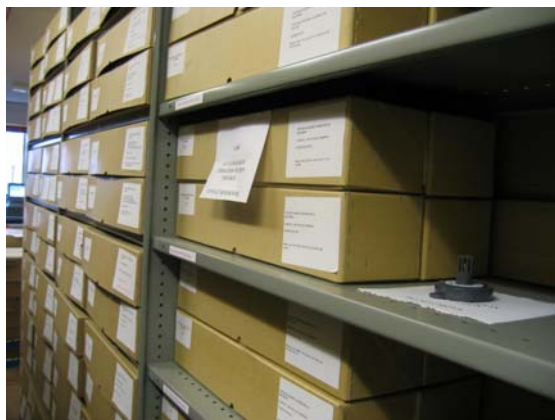
From the 4<sup>th</sup> October, the monitor from aisle 17 was placed into a cardboard box (G239) on aisle 67. The temperature comparisons with the monitor on the shelving of the same aisle were very surprising. It is difficult to see from the graph, but the temperature fluctuations from both monitors are identical. During this period, there is a noticeable pattern that occurs on a weekly basis, with slight but elevated temperatures being recorded during the working week, whilst over the weekends readings fall by about 3°C, before they return to higher levels as work commences in the area again. Readings from both monitors in aisle 67 are showing values greater than the recommended maximum 18°C, with values more suited to general storage conditions of 16-22°C.

**Plate 9: NGRC Records Room Aisle 67**

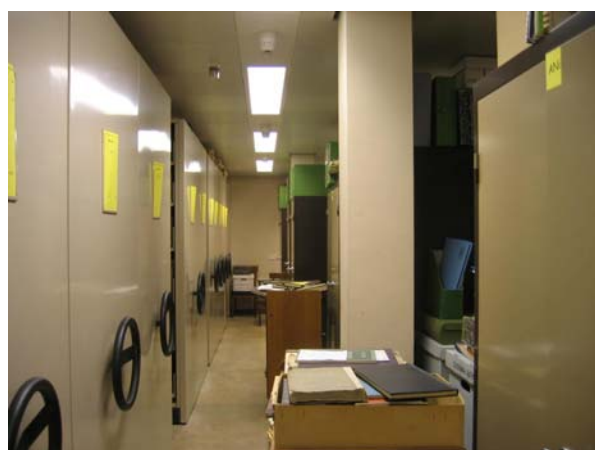
**Plate 10: Library Strong Room**

1. The Archives of the administrative history of the British Geological Survey, and associated material. These comprise correspondence, letterbooks, papers, registered files, photographs, drawings etc., dating from c1800 to the present. There are also a few artefacts such as microscopes, cameras, and items presented to former staff, such as a pair of ceremonial swords presented to Sir Roderick Murchison. There are collections of material associated with former staff.

2. Items held on deposit with BGS, such as the geological photograph collection of the British Association for the Advancement of Science.
3. The Library pre-1900 Rare Book and Rare Map collection, including many valuable items e.g. a copy of the 1815 William Smith map 'A delineation of the strata of England and Wales with part of Scotland'. Archive copies of each printed BGS map held by the Library are also held in this store.

Monitoring commenced on the 9<sup>th</sup> November 2004, with a new monitor purchased. This was not included during the calibration period. As this monitor was recently supplied from the manufacture, and should be accurate.

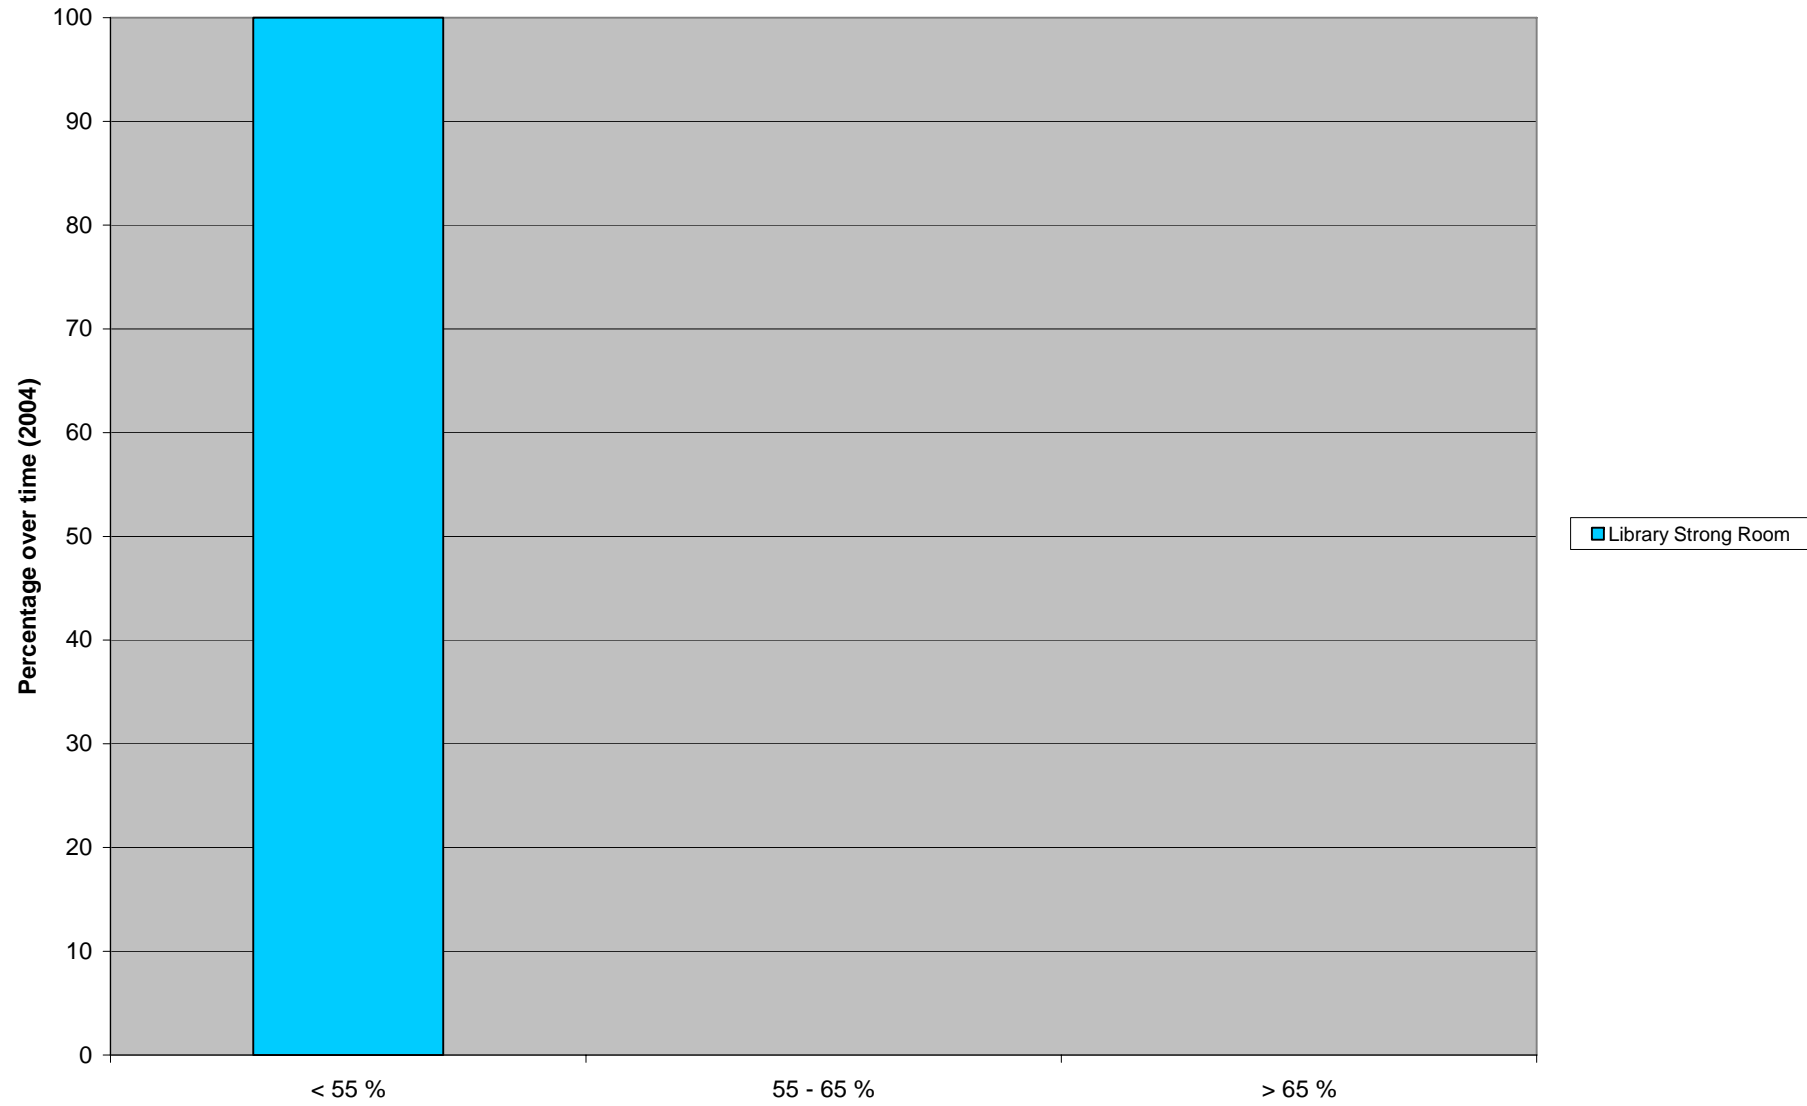
**Figure 32: Histogram: Humidity ranges within the library strong room**

### Humidity Ranges within the Library Strong Room - Keyworth 2004

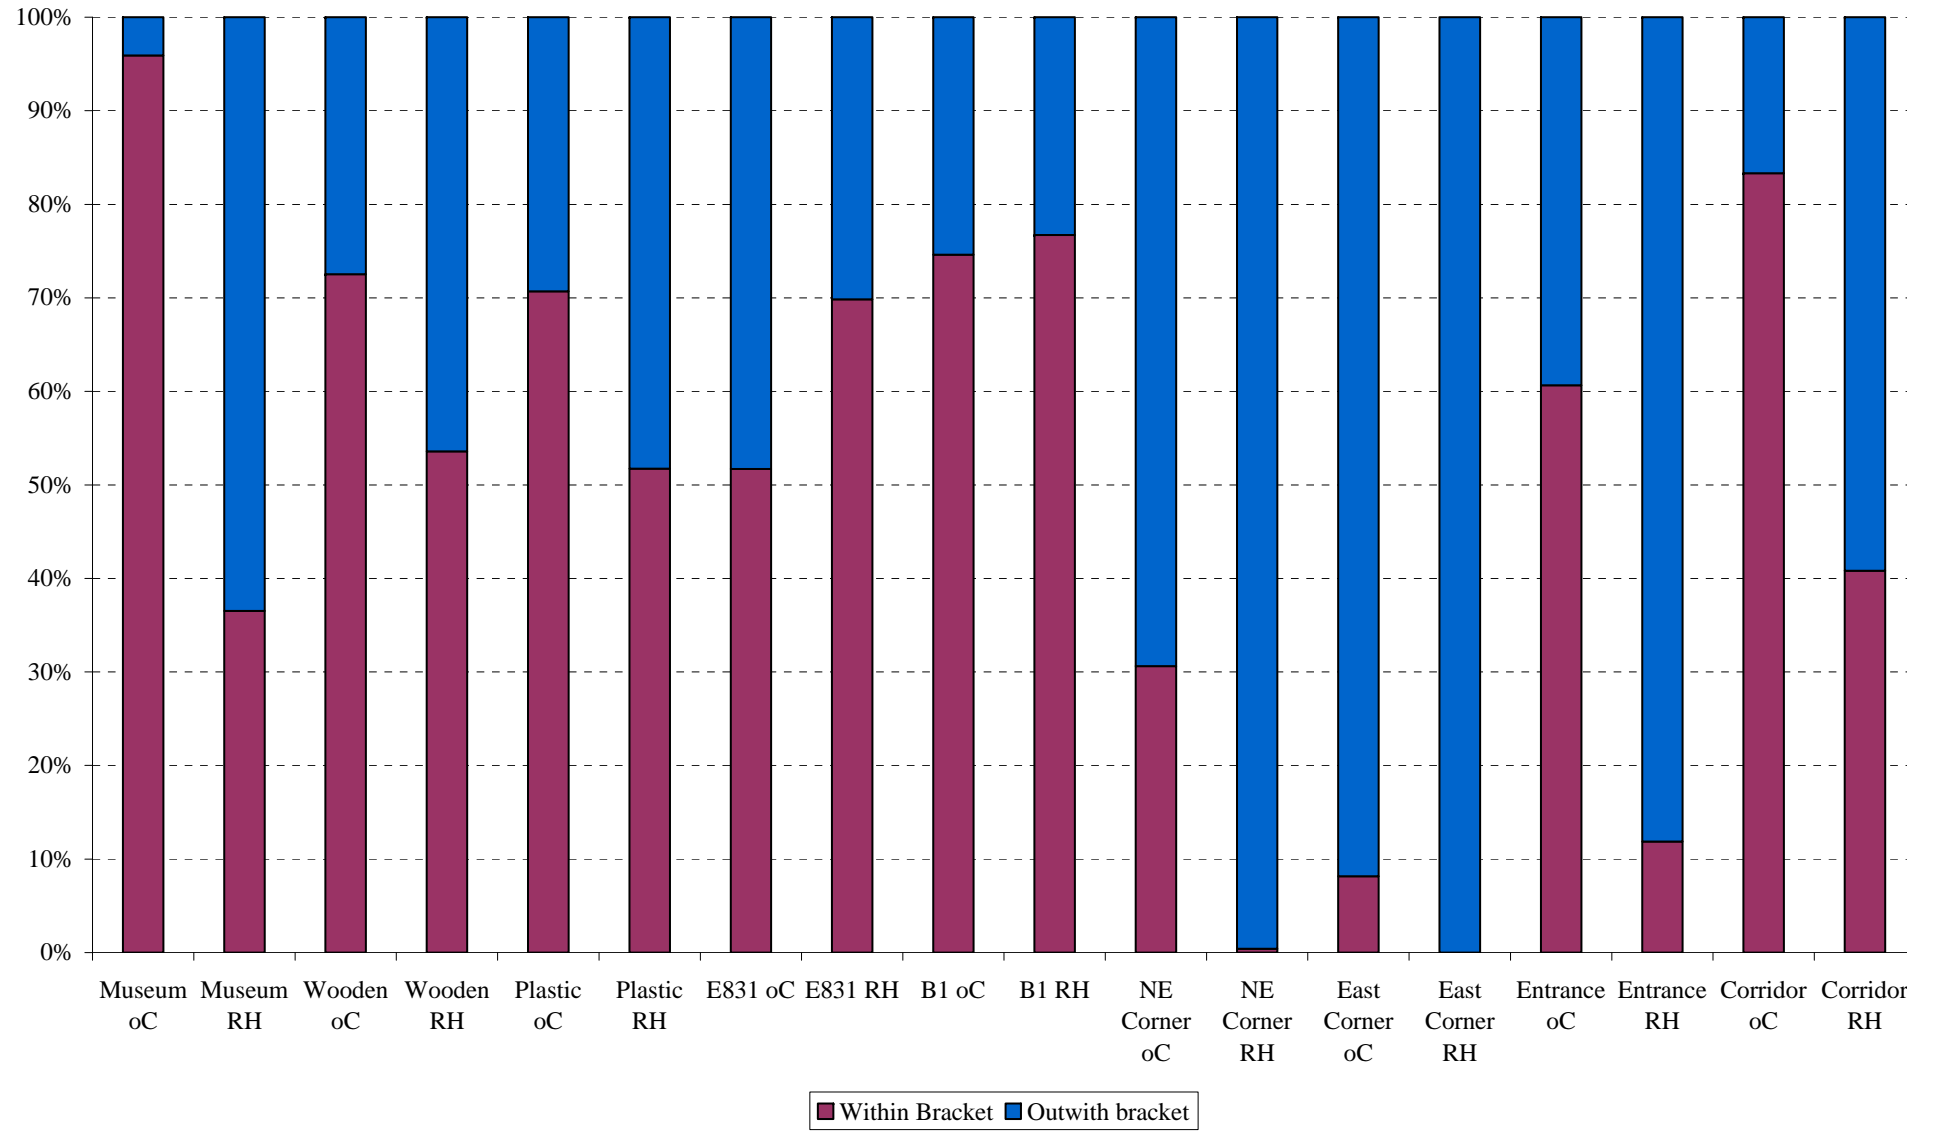
Figure 49: 2004 Temperature/Humidity target success breakdown, Murchison House

### Temperature/Humidity within guidelines 2004
