The aftermath of the Emilia 2012 earthquake damages and the safeguard of the rural anthropized landscape

Manlio Montuori

Department of Architecture, University of Ferrara, Ferrara, Italy.

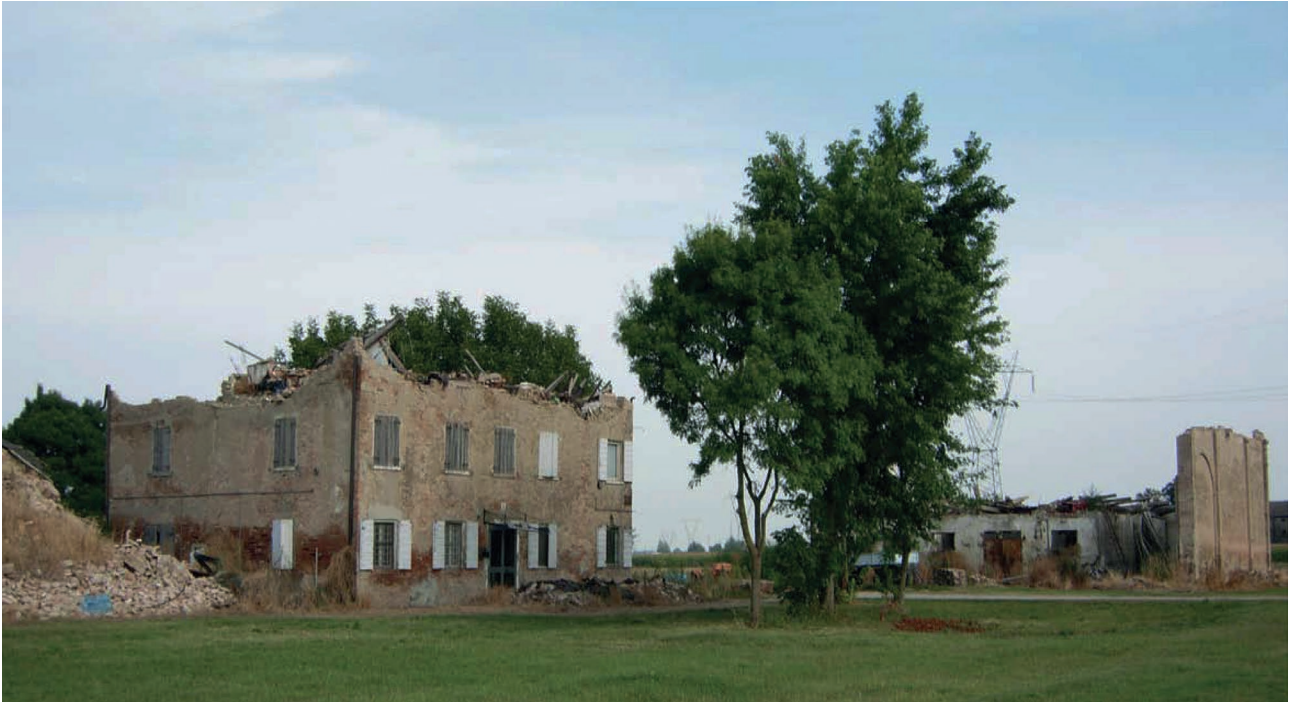
Figure 1 | San Giacomo Roncole in the district of Mirandola, Modena. In the historic courtyard, the stable-barn and the dwelling collapsed due to wall-roof interaction.

The images that, in the aftermath of the recent seismic events that struck Italy, most remain imprinted in the collective memory – e.g., the devastation of Amatrice and forms of Parmigiano-Reggiano damaged due to the collapse of scalere in Emilia-Romagna (Agenzia di informazione..., 2013) – perhaps more than any other thought give the idea of how every earthquake is a unique event in its kind, addressed by many variables: the energy released, the extension of the involved area, the natural, social and economic characteristics of the territories. All of this results in significant variability of damage that the seismic event produces, in the impact of the short and long period on the territory, in emergencies, and in the way, the return back to normality is faced (Fig. 1).

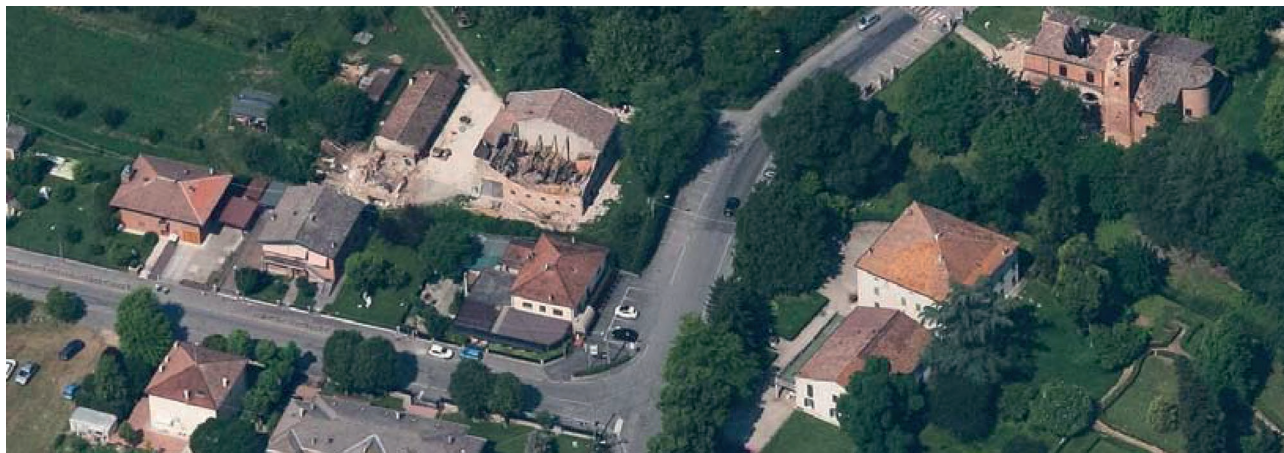
Figure 2 | Medolla, Modena. The roof, resting on long span walls, collapsed and directly contributed with its thrust to the out-of-plane overturning of the walls.

significant horizontal actions. Actually, this overall positive behaviour failed due to various factors, not surprising for a spontaneous construction, directly linked to the construction techniques (e.g., lack of connection between orthogonal walls, concentrated action of the beams either on the floors or the roofs, different load amount on orthogonal walls, the lintel thrusts above the openings) that lead to the overturning mechanism of the facade wall detached from the orthogonal ones and the separation of the same walls in autonomous vertical bands. Thus, the so-formed separate portions of the masonry rotated outwards due to the eccentricity of the thrusting as a consequence of the perimeter walls shape, whose offsets are all arranged from the inner side. The stables and the barns showed the most considerable damage, in many cases triggering the collapse, due to the critical relationship between the height and the thickness of the walls, accentuated by the length/thickness ratio of the long walls, especially in the barns and the *barchesse* that, in addition, have highly irregular configurations, both in plan and elevation. The very slender infill walls are frequently out-of-plane collapsed, mainly when laid in a stretching bond, and if pillars are present, the connection between the pillars and the infill wall proved to be ineffective. The out-of-plane failure mechanisms also involved thicker perimeter walls, especially in the absence of transverse walls. In these cases, the roof, resting on long-span walls, collapsed and directly contributed with its thrust to the out-of-plane overturning of the walls.
