Investigation of Welded Joints of Long-Term Operated Gas Pipeline Controllable Rolled X70 Steel

The complex properties (mechanical, microstructure, and electrochemical) of controllable rolling X70 steel pipes of the main gas pipeline with a diameter of 1420 mm after an operation for 20 years and emergency reserve pipe after a similar period of storage were studied. Taking into account specified heterogeneity caused by the technological effect on X70 steel of controllable rolling, it is difficult to draw unequivocal conclusions about the effect of operational work on changes in the condition of welded joints of investigated pipes. It was established that operating loads did not significantly affect the characteristics of base metal and welded joints. Electrochemical properties (corrosion potential, hydrogen recovery potential, anodic curves slopes) of long-term operated pipes of different manufacturers (Ukraine, France) and stock pipes in NS4 solution are similar. Due to the high reserve of impact viscosity at standard temperature conditions, investigated pipes are characterized by satisfactory resistance against breaking.

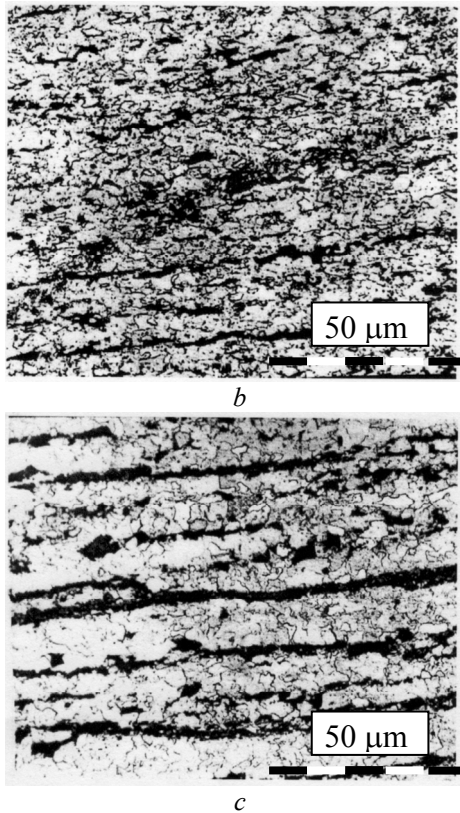
Figure 1. Microstructure of base metal of pipes:

a – after 20 years of operation, steel manufacturer France, pipes manufacturer Ukraine; **b** – after 20 years of operation, steel and pipe manufacturer Japan;

c – after 20 years of storage, the steel producer is not established; pipes manufacturer Ukraine

It should be noted that at less general contamination by non-metallic inclusions of Japanese-made pipe, most of them (up to 96%) is finely dispersed, and their size not exceeds 1.5 microns. The volume part of non-metallic inclusions in the metal seams of Ukrainian pipe is 2-3 times greater (Table 2), while up to 15% of non-metallic inclusions exceed the size 3 microns, and the size of some of them reaches 7 microns.

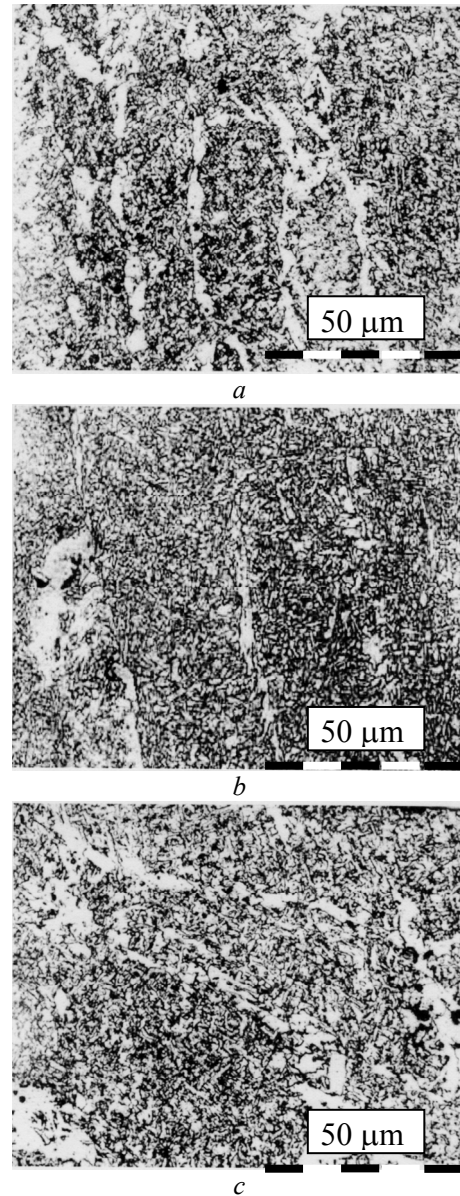
Figure 2. Microstructure of outer weld metal of pipes:

a – after 20 years of operation, steel manufacturer France, pipes manufacturer Ukraine; **b** – after 20 years of operation, steel and pipe manufacturer Japan;

c – after 20 years of storage, the steel producer is not established, pipes manufacturer Ukraine.

Revealed differences in non-metallic phase in the metal of domestic and foreign-made pipe seams are due to the use of different fluxes during their welding. The microstructure of the external seams metal of investigated pipes is fine-grained and relatively uniform across the cross-section of welds. It is a mixture of ferrite formations of various morphologies and dispersed phases of martensite-austenite crystallization.

Acicular ferrite and polyhedral ferrite grains were found in the weld metal, pre-eutectoid ferrite in the form of continuous layers or individual polygonal grains with different shape ratios, and individual areas of lateral lamellar ferrite were located along the secondary boundaries (Figure 2). The peculiarity of the microstructure of the metal welds of pipes produced in Ukraine (both emergency stock and after operation), in comparison with foreign pipes, is a larger proportion of pre-eutectoid ferrite and the presence of single areas of pearlite approximately twice. No developed polygonization boundaries were found in the metal of all investigated seams. The martensite-austenite crystallization phase in

metals welds structure is fairly evenly distributed and represents dispersed allocations of different shapes (polyhedral, acute-angled, elongated) and etching (light in the middle and darkly colored along the contour – martensite islands, and evenly darkly colored – bainite allocations). The saturation of weld metal by the martensite-austenite crystallization phase of the operated Japanese pipe is less than that of the weld metal of the pipes produced in Ukraine (emergency stock and after operation). The integral hardness of the base metal of the outer seams of investigated pipes is within 223-237 HV₅.

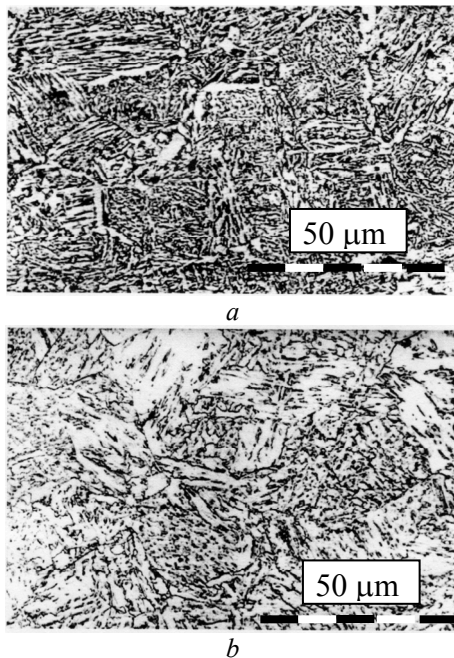
Figure 3. Microstructure of heat-affected metal in the coarse grain area of operated pipes, made in Ukraine (France) (a), in Japan (b).

The microstructure of the metal in the area of a coarse grain of the heat-affected zone (HAZ) of all welded joints mainly consists of upper bainite, that is, ferrite with an ordered carbide phase (Figure 3).

The microstructure of metal in the coarse grain area of HAZ and its dimensional parameters differ depending on the pipe manufacturer due to the features of the steel chemical composition and applied welding technology (Table 3).

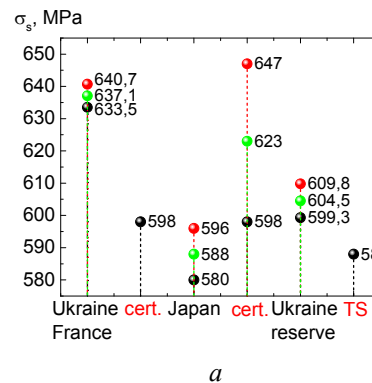
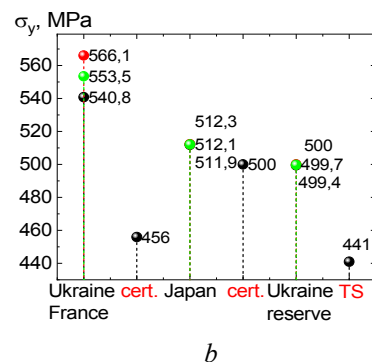
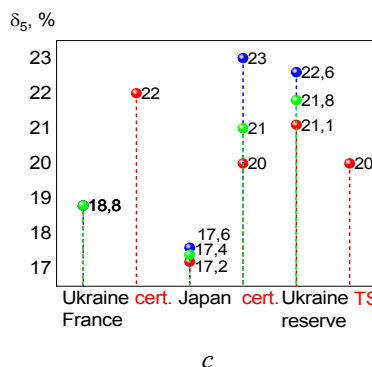
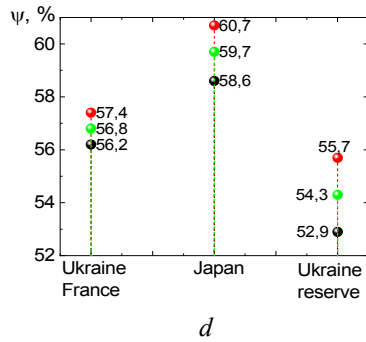
Figure 4. Mechanical properties of the base metal of investigated pipes: a – tensile strength limit; b – yield strength; c – relative elongation; d – relative narrowing.

The yield strength of operated pipes and emergency reserve pipes exceeds the normalized TS 14-3-995 value (not less than 441 MPa): pipes manufactured in Ukraine (metal made in France) – by 22%, manufactured in Japan – by 16%, emergency reserve pipes – by 13%, Figure 4, a.

The tensile stress of the operated pipe produced in Ukraine to the emergency reserve pipe exceeds the standardized TS value (not less than 588 MPa) by 6% and 3%, produced in Japan – which is at the minimum value level according to TS 14-3-995 requirements (598 MPa), Figure 4, b.

Indicators of relative elongation (δ_5) of base metal of the pipes after operation do not answer the established requirements (at least 20%), Figure 4, c: for the pipe manufactured in Ukraine, $\delta_5 = 18.8\%$, for Japanese-made pipe, $\delta_5 = 17.4\%$, which is lower than the standard value by 6% and 13%, respectively.

Normative documents do not regulate the indicator of relative narrowing. For stock pipes, this indicator has the lowest average value, 54.7%, while for operated pipes, it is slightly higher, 56.8 and 59.7% for pipes manufactured in Ukraine (France) and Japan (Figure 4, d).

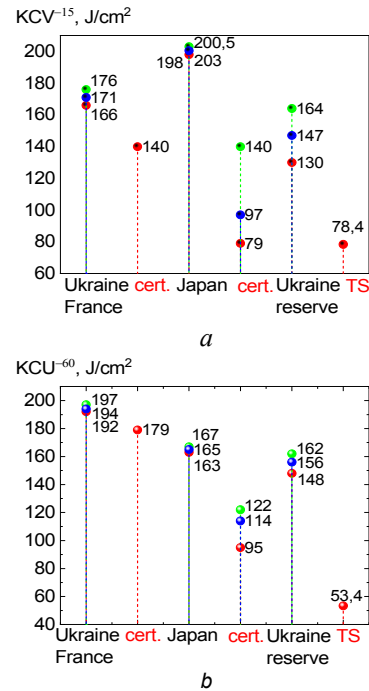
Figure 5. Impact viscosity of the base metal of tested pipes at different temperatures KCV^{-15} (a) and KCU^{-60} (b).

Impact viscosity according to KCV^{-15} (Figure 5, a) and KCU^{-60} (Figure 5, b) indicators for all tested pipes is higher than the values standardized by certificates, respectively.

The base metal of emergency supply pipes meets the requirements of regulatory documentation according to all standardized parameters (σ_y , σ_s , σ_y/σ_s , KCV^{-15} , KCU^{-60} , δ_5). At the same time, it should be noted that the strain stress limit of the base metal of all pipes, when testing flat full-thickness samples, exceeds the normative level, Figure 5.

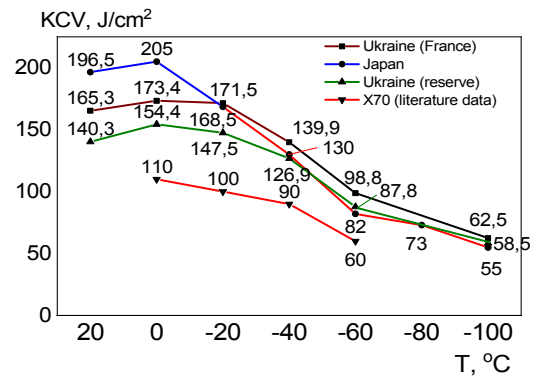
Figure 6. Temperature dependence of the impact viscosity of the base metal of investigated pipes.

Test results of impact bending (KCV) of base metal samples in the temperature range from plus 20 to minus 100°C are shown in Figure 6.

The impact viscosity of the base metal of pipes after operation in the temperature range from plus 20 to minus 40 °C is high; the value of this indicator for all pipes is close. At the temperature of 0 °C, the KCV value for investigated pipes is several times higher than the value standardized by technical conditions (at least 78.4 J/cm²).

Viscous-layered fracture with splits formed during the breaking of controllable rolling steel is observed when testing impact samples in the entire temperature range: from plus 20 to minus 100 °C. Completely brittle failure occurs at the test temperature minus 100 °C. Similar results regarding impact toughness were obtained on the base metal of the emergency stock pipe.

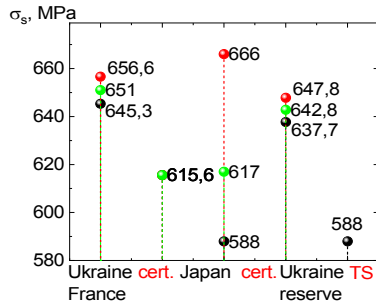
Figure 7. Strength limit of welded joints of the pipes under investigation and stock pipe

Mechanical properties of welded joints. Welded joints of pipes after operation and stock according to the indicator of strain stress correspond to regulatory documentation, Figure 7. During that tests, sample rupture occurred at a distance of 37–40 mm from the fusion line of the seam with the base metal.

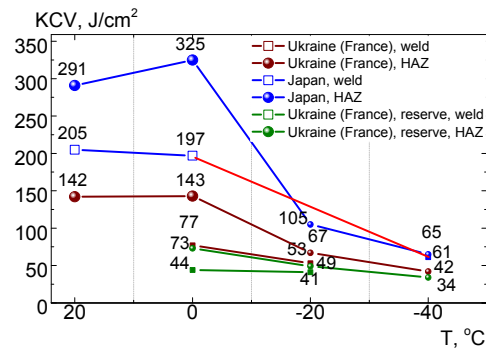
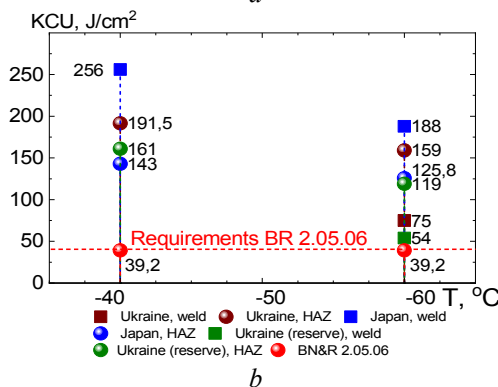
Figure 8. Temperature dependence (a) of impact toughness KCV and impact toughness KCU of the welded joint (b).

Results of impact bending testing of welded joint samples are presented in Figure 8, a (cut along the seam and along heat affected zone at the distance 2 mm from the

intersection point of fusion lines of internal and external seams) in the temperature range from +20 to -40°C.

The value of the impact strength of the seam and heat-affected zone of welded joints of pipes after the operation, as well as emergency storage pipe with sufficient reserve, exceed the indicators established in BR 2.05.06 (KCU^{-40} , Figure 8, a) and technical conditions (KCU^{-60} , Figure 8, b). When testing samples with a sharp cut, the impact strength (KCV) of weld and HAZ, except for emergency reserve pipe, is at the level (or higher) of the values established for the base metal BR 2.05.06 (at least 78.4 J/cm²), Figure 8, a. Weld metal of the emergency stock pipe has the lowest values of impact viscosity: $KCV^0 = 44$ J/cm² and $KCU^{-60} = 54$ J/cm².

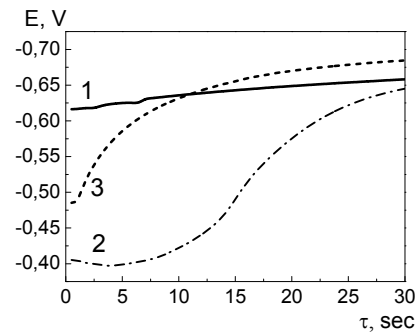
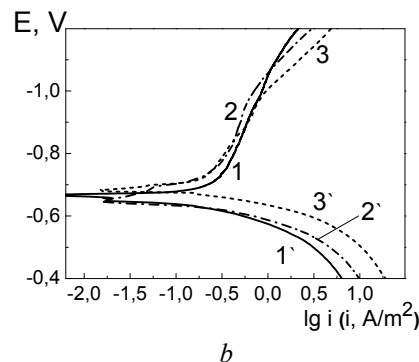
Figure 9. Changing of corrosion potentials in time (a) and polarization curves (b) in NS4 solution of base metal of studied samples of X70 steel: a – after 20 years of operation, steel manufacturer France, pipe manufacturer Ukraine; b – after 20 years of operation, steel and pipe manufacturer Japan; c – after 20 years of storage, the steel producer is not established, pipes manufacturer Ukraine.

Changing corrosion potential of base metal X70 steel of the pipes mentioned above is given in Figure 9, a.

As can be seen from the curves in Figure 2, a, at beginning of measurements, corrosion potentials differ by approximately 200 mV, but after 30 s their values stabilize. For pipe steel after the operation, corrosion potentials equal -0.658 V for the Ukrainian (France) pipe and -0.645 V for the pipe made in Japan. For the metal of stock pipe, corrosion potentials are slightly more negative, -0.684 V.

From the polarization curves presented in Figure 9, b, it can be seen that the nature of anodic and cathodic curves is the same. The limiting diffusion current on the base metal of all the pipes has close values: 0.402 A/m² (Japanese pipe), 0.480 A/m² (Ukraine/France pipe), and 0.378 A/m² (storage pipe), Table 4.

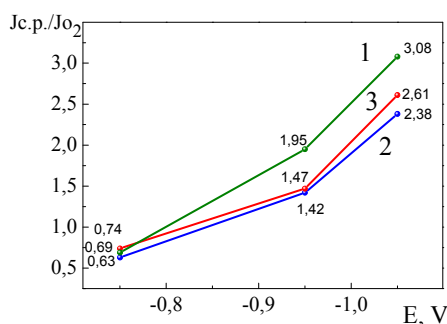
Figure 10. Change in the ratio $j_{c.p.} / j_{O_2}$ defined for X70 pipe steel: 1 – after 20 years of operation, steel manufacturer France, pipe manufacturer Ukraine; 2 – after 20 years of operation, steel and pipe manufacturer Japan; 3 – after 20 years of storage, the steel producer is not established, pipe manufacturer in Ukraine.

Previously, we conducted complex studies concerning the influence of corrosion factors on this indicator [23,24]. While analyzing the effect of protective potential on the corrosion state of pipe surface under protective coating, some authors suggest determining the current density of the cathodic protection and comparing it with the density of the limit current of oxygen reduction. From cathodic polarization curves, the ratio of currents $j_{c.p.} / j_{O_2}$ for operated and storage pipes of X70 steel in NS4 soil electrolyte was calculated, and its analysis was performed (Table 2). In potentials range from -0.75 V to -1.05 V, the ratio for base metal of investigated pipes increases with approximately the same trend; only numerical values differ (Figure 10).

- after 20 years of operation, Ukrainian (France) pipe – from 0.69 up to 2.61;
- after 20 years of operation, Japan pipe – from 0.63 up to 2.38;
- after 20 years of storage, Ukrainian pipe – from 0.74 up to 3.08.
