Title of Dissertation: CREEP CORROSION OVER PLASTIC  
ENCAPSULATED MICROCIRCUIT  
PACKAGES WITH NOBLE METAL PRE-  
PLATED LEADFRAMES

Ping Zhao, Doctor of Philosophy, 2005

Dissertation submitted to the Faculty of the Graduate School of the  
University of Maryland, College Park, in partial fulfillment  
of the requirements for the degree of  
Doctor of Philosophy  
2005

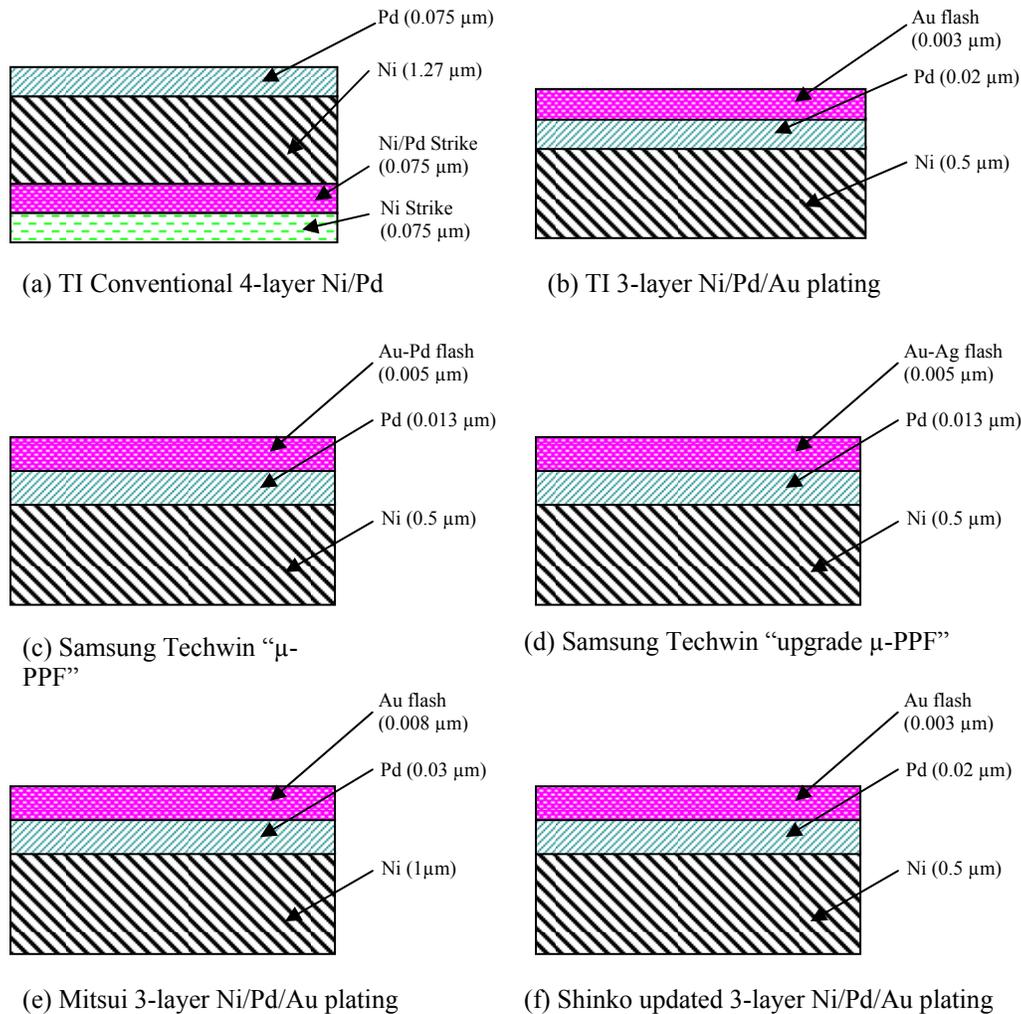
Figure 1.5 Plating structures and nominal thickness values for pre-plated leadframes

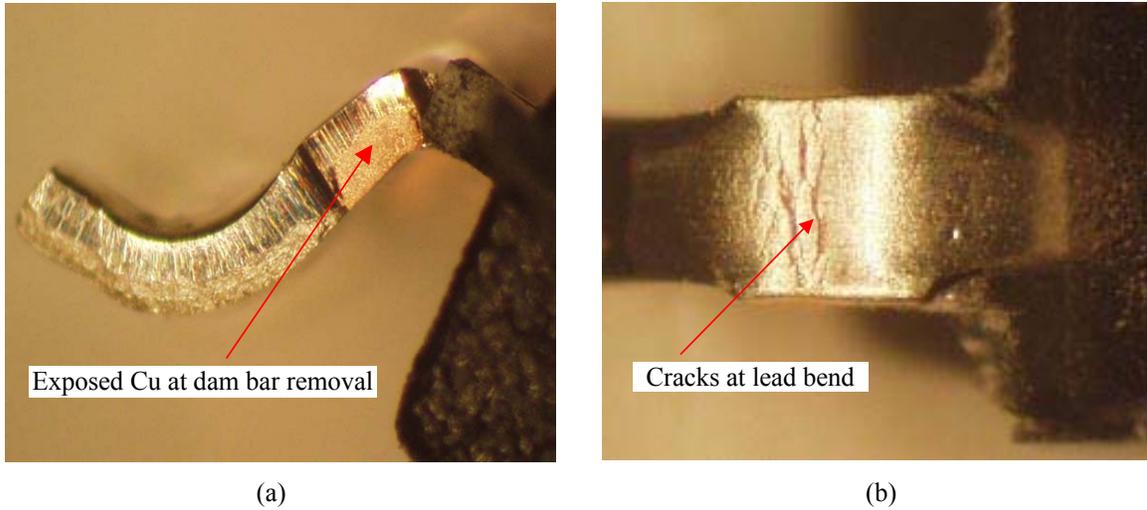
Figure 1.6 Areas of exposed base metal on a SOIC package with pre-plated leadframe after “trim and form”

Sites of base metal exposure can corrode in pollutant environments. For noble metal plated materials, the most deleterious effect of the base metal corrosion is that the generated corrosion product may migrate over the surface of noble metal plating without attacking it [14], which is later defined as creep corrosion over the metallic surface.

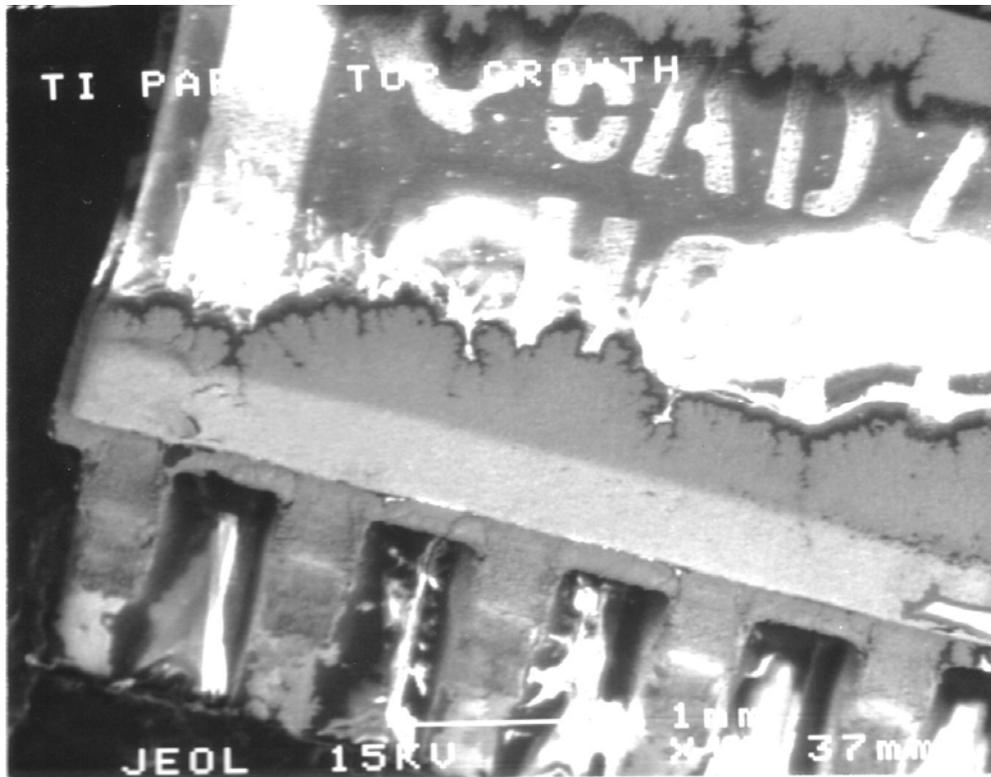
Figure 1.7 SEM overview of a failed component with creep corrosion over package

In a Telecom application, field failure due to corrosion products migration external to the package was found. Figure 1.7 is a SEM picture of a field failure component [15]. This is a component with a palladium pre-plated leadframe. This photo highlights the conductive material growth onto the molding compound surface of the plastic package. The corrosion products have completely bridged the adjacent leads and have advanced over the plastic package. Electrical short and current leakages have been verified on this component.

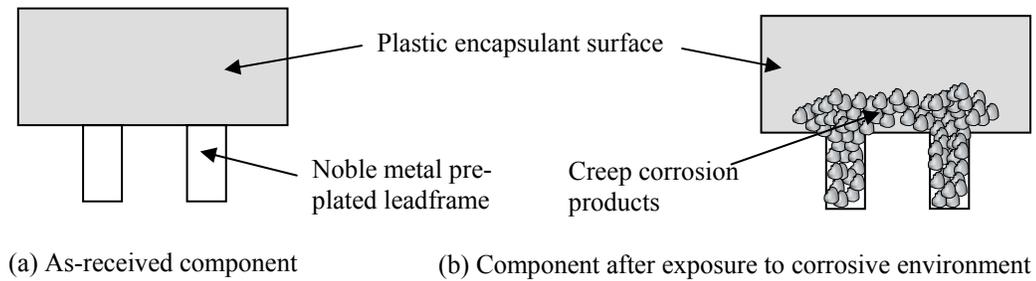
Figure 1.8 Hypothesized process for the field failure

The molding compound for IC package is the inert material, which usually does not induce direct chemical reaction with the atmospheric contaminants. For this field failure case, it is believed that the corrosion products initiate from the leadframe material, and eventually migrate onto the molding compound surface to cause the bridging of leads. This hypothesized process is illustrated in Figure 1.8. This phenomenon is similar to the effect of corrosion migration behavior on noble metal plated materials. However, the surface over this the migration occurs is not only metallic plating but also non-metallic molding compound surface. This phenomenon is defined as creep corrosion over plastic encapsulated microcircuit packages with noble metal pre-plated leadframes.

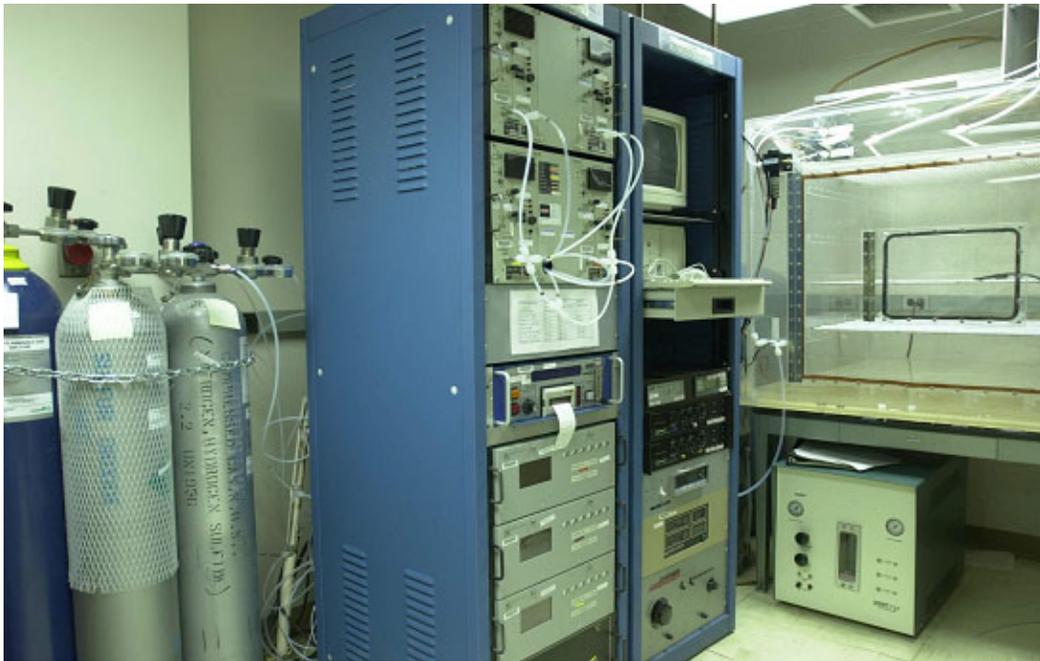
Figure 2.1: MFG Chamber Located in CALCE Center at the University of Maryland

According to the section above, three most popular MFG test conditions are chosen for this study, which are Telcordia Indoor MFG environment, Telcordia Outdoor MFG environment, and Battelle Class III environment, listed in Table 2.7. The test facility is shown in Figure 2.1, while its schematic diagram is shown in Figure 2.2.

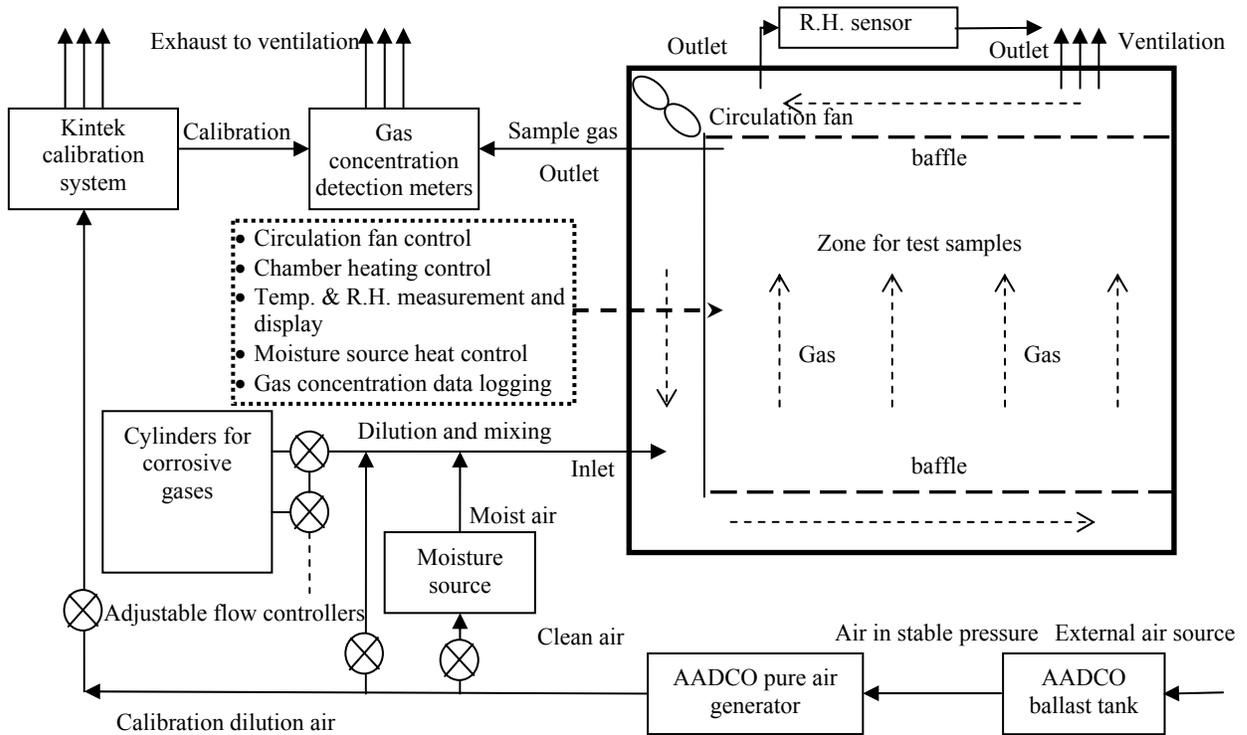
Figure 2.2 Schematic diagram of CALCE MFG test system

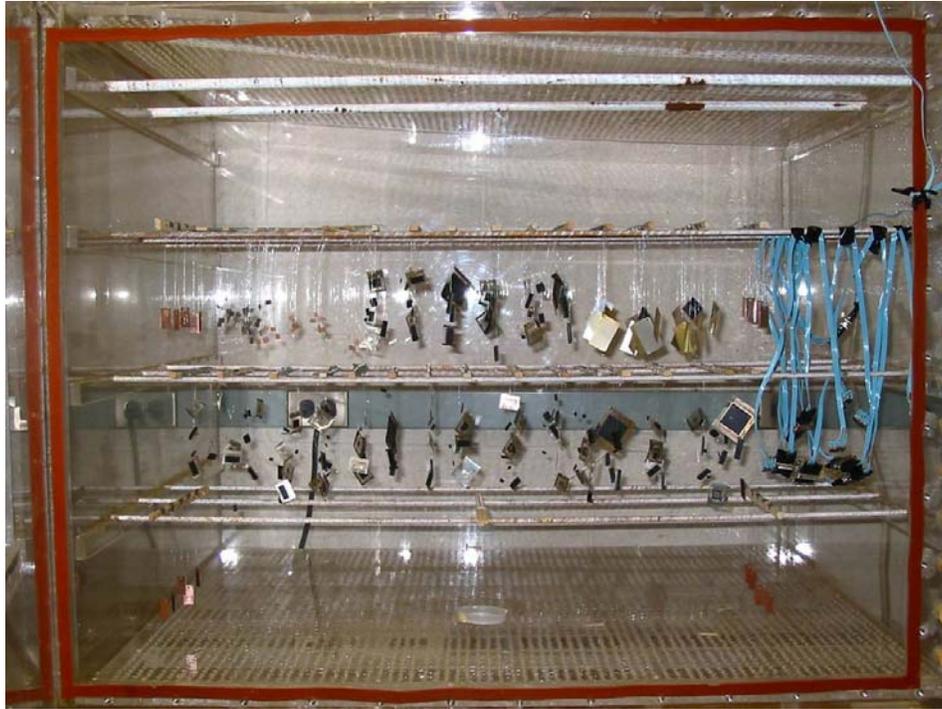
Figure 2.3 Test samples set-up for a MFG test during the study

The MFG test process follows the guidelines provided by ASTM B827 [27]. As for the set-up of test samples inside the MFG chamber, for most cases, epoxy thin thread was used to tie the samples with the wood rode, then the wood rode was placed on the stainless steel racks inside the chamber. In this way, the flow of the gas mixtures inside the chamber would not be restricted and shielding effect was minimized. Figure 2.3 shows a typical set-up of test samples for a MFG test during this study.

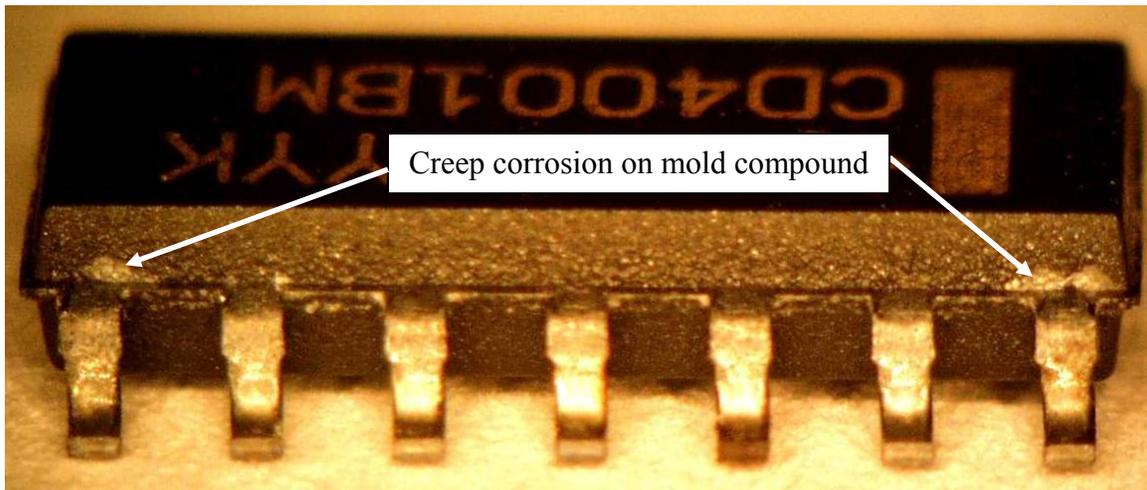
Figure 3.1 Creep corrosion over mold compound after 64 hours of Telcordia Outdoor MFG exposure

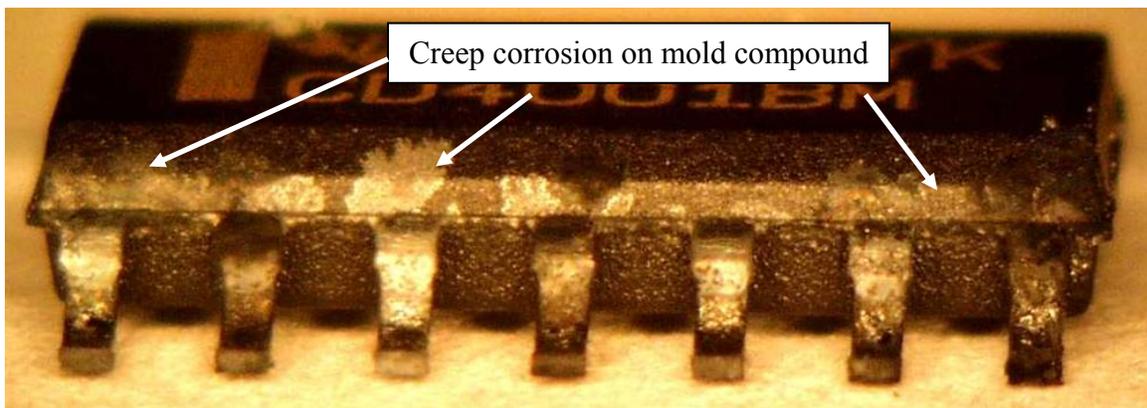
Figure 3.2 Creep corrosion over mold compound after 240 hours of Telcordia Outdoor MFG exposure

corrosion products were expanding in coverage on the surface of molding compound. After 240 hours of exposure, many leads of the test samples had corrosion products migrated onto the vicinity area of the molding compound surface near the lead. Some lead pairs were visibly bridged by the corrosion products, see Figure 3.2.

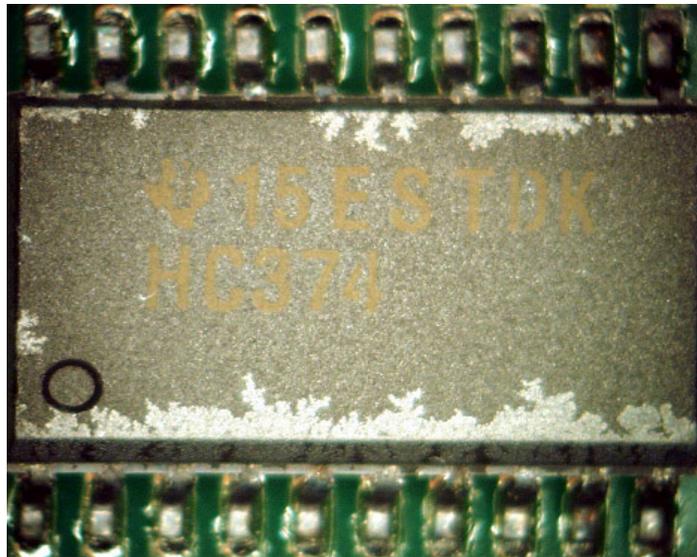
Figure 3.6 Mounted components on TI board with creep corrosion over mold compound

On TI boards, after 10-day test, creep corrosion over mold compound was observed on almost all components (see an example in Figure 3.6). On TI board I, 25 out of 32 components had electrical short, while on TI board II, 18 out of 32 components had electrical short. Using a multi-meter, the resistance between the bridged lead pairs ranged from  $5\text{M}\Omega$  to  $15\text{M}\Omega$ . On the TI boards, there were two kinds of leadframe plating structures, Ni/Pd and Ni/Pd/Au plating. However, no significant difference in corrosion behavior was found over those two groups of components (see Figure 3.7).

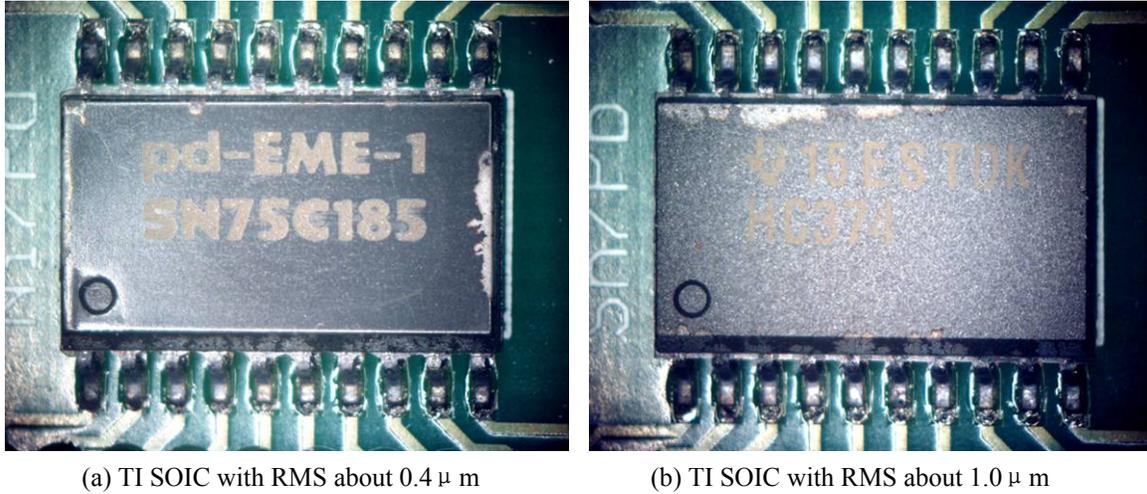
Figure 3.8 Creep corrosion on components with different surface roughness values

of components with different surface roughness values (RMS at 0.4 microns and 1.0 microns respectively), no significant difference on creep corrosion behavior was found after the 10-day test, see Figure 3.8.

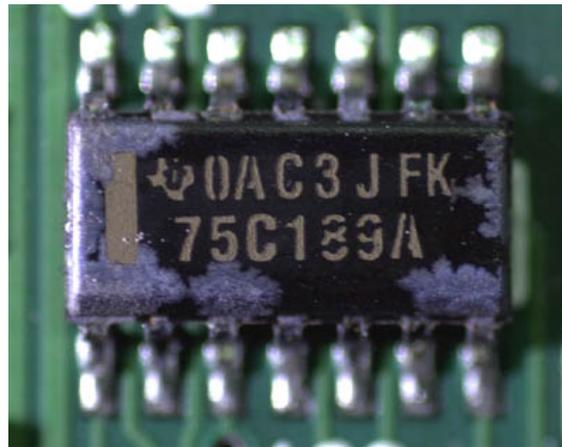
Figure 3.9 Creep corrosion on TI component over Telcordia board after 10-day test

On Telcordia test boards, all TI components were found with creep corrosion over mold compound. One example of creep corrosion on TI component is shown in Figure 3.9. On board I, 6 out of 8 TI components had lead pairs bridged by creep corrosion products; while on board II, 7 out of 8.

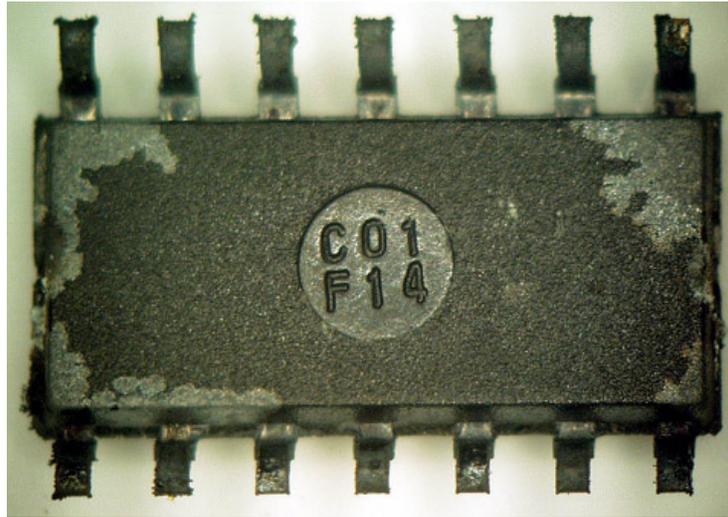
Figure 3.11 Creep corrosion on un-mounted TI SOIC in as-received conditions

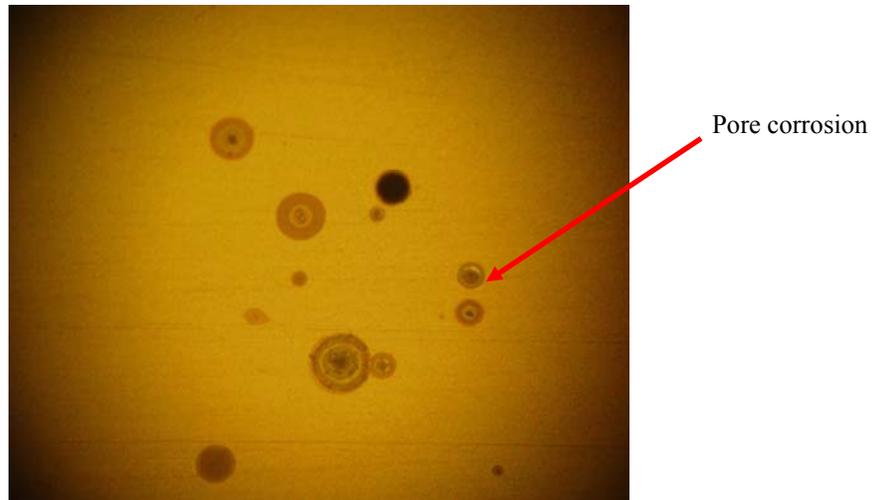
Figure 3.13 Pore corrosion on Ni/Au plated coupon after 5-day Telcordia Outdoor MFG exposure

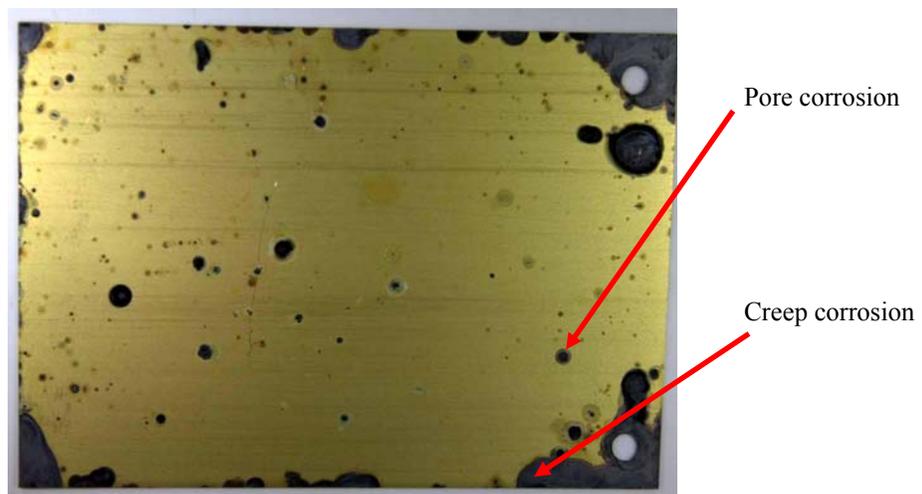
Figure 3.14 Pore corrosion and creep corrosion effect on the Ni/Au plated coupon after 5-day Telcordia Outdoor MFG exposure

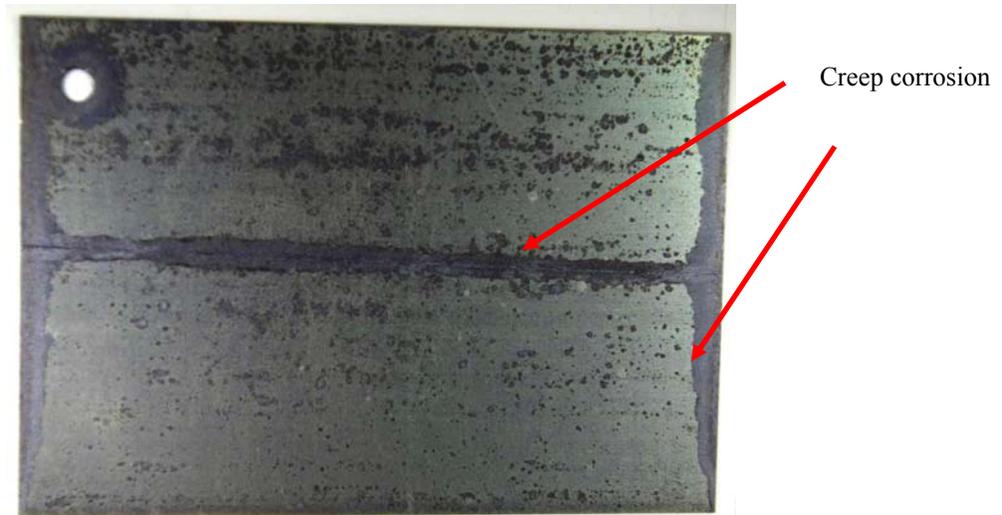
Figure 3.15 Creep corrosion effect on the Au/Pd/Ni/Ni-Pd/Ni plated test coupon

corrosion effect was observed. On Ni/Ni-Pd/Ni/Pd/Au plated coupons, creep corrosion effect was observed starting from the cutting edges and introduced centerline scratches, see Figure 3.15. On all other coupons, gross attack of corrosion was found on the majority area of the coupon surface, while slight creep corrosion effect was sometimes found near the cutting edges.

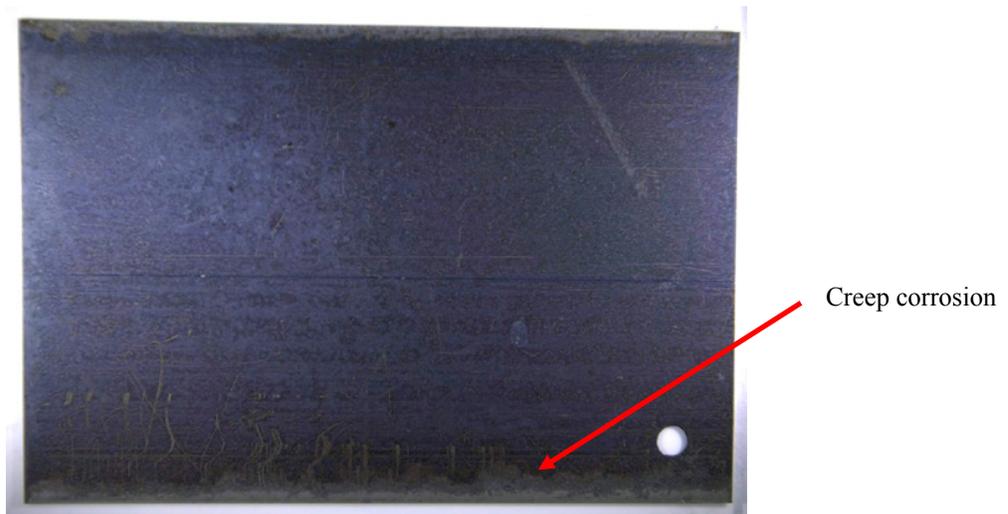
Figure 3.16 Gross corrosion and creep corrosion effect on the Ni/Ni-Pd/Ni/Pd plated test coupon after 10-day Telcordia Outdoor MFG test

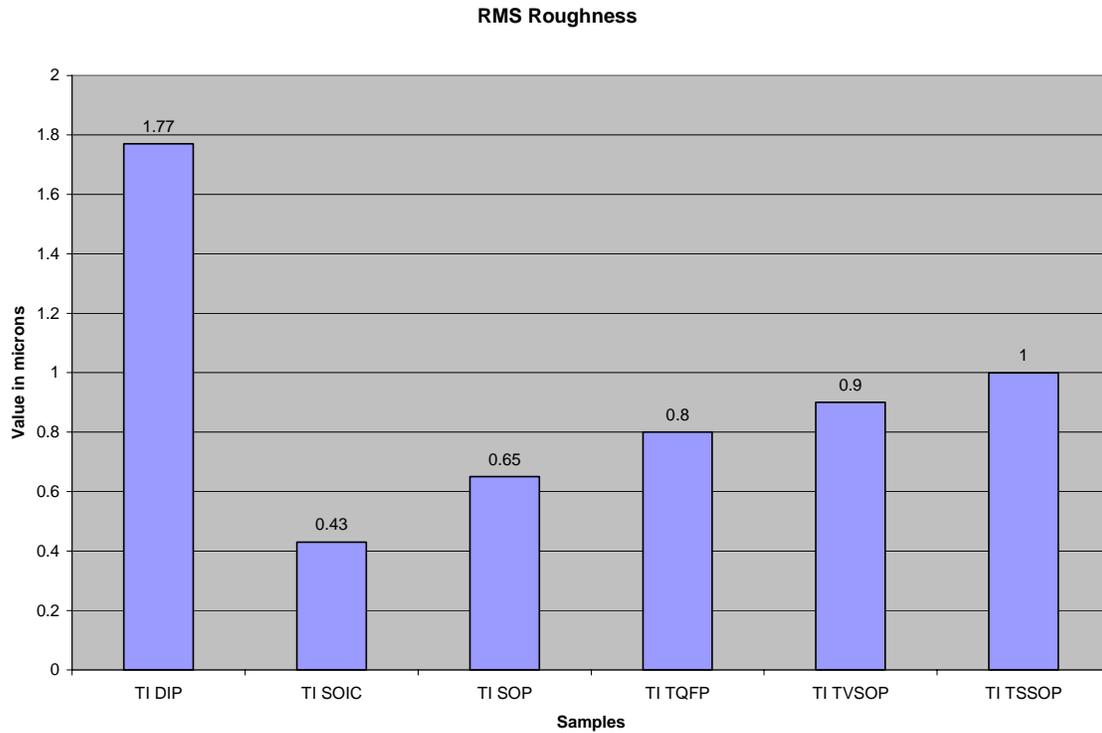
Figure 3.17 Surface roughness (RMS) values for TI un-mounted samples in Telcordia Outdoor test 3

Because mold compound surface is the media over which the migration of corrosion products occurs, there is a belief that surface roughness of the mold compound surface may be a dominant factor to determine the migration speed and coverage. For TI samples in this test, the RMS surface roughness values were measured prior test on as-received components, see Figure 3.17.

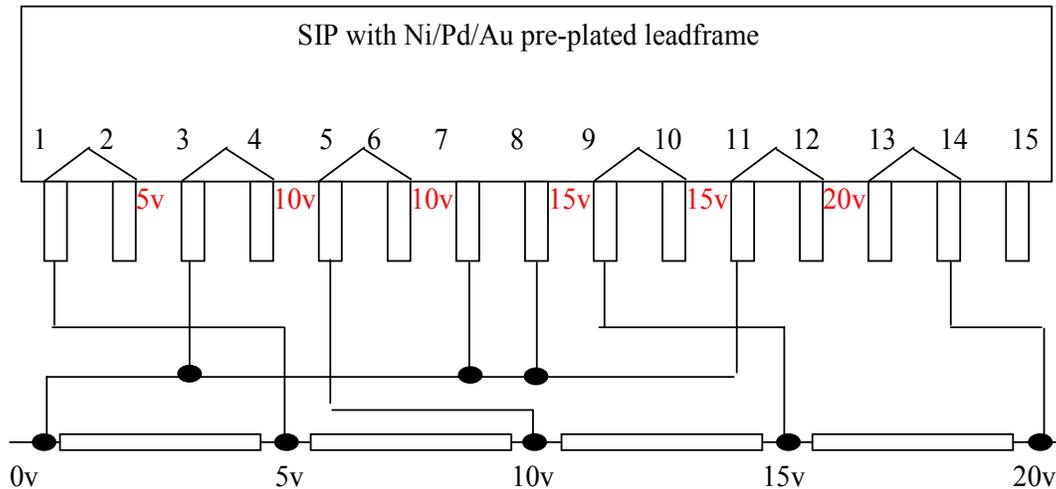
Figure 3.19 Diagram to apply electrical bias to SIP with Ni/Pd/Au pre-plated leadframe

Since creep corrosion products over the mold compound surface had the dendritic formation, which was similar to the dendritic formation in electro-chemical corrosion process [34], it was suspected that electrical bias may play a roll in this process. To evaluate this effect, electrical bias was applied on the components lead pairs during the MFG test. Based on the information found in Telcordia Outdoor MFG test 2, dummy samples should be the best choice for this purpose. 15-pin single-inline-packages (SIP) with Ni/Pd/Au pre-plated leadframes were purchased from Topline, in which no functional die existed and some lead pairs were internally connected by wire-bonding and others intentionally left electrically-open. The diagram to apply voltage bias to the package is shown in Figure 3.19. Voltage biases at 5, 10, 15, and 20v were applied to the specific lead pairs.

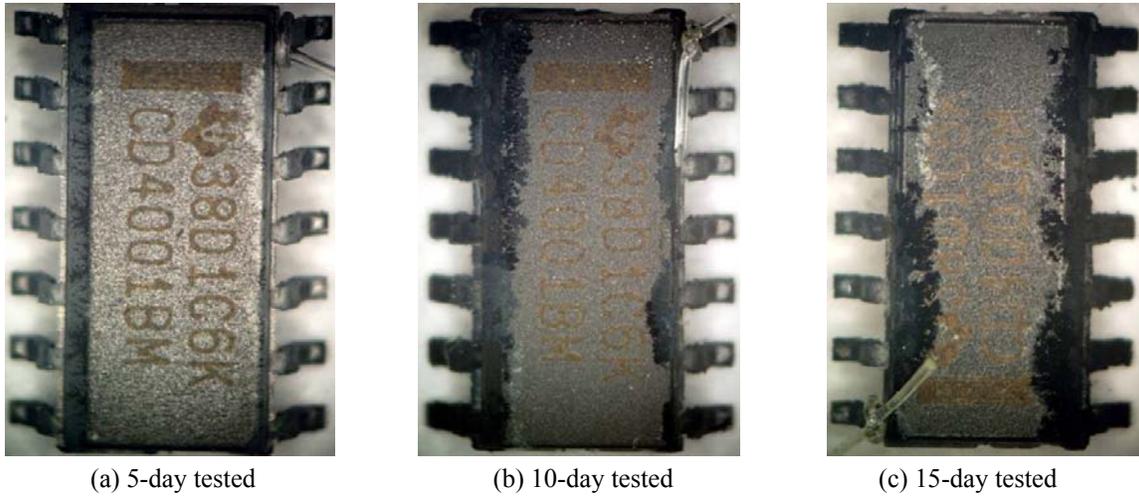
Figure 3.20 Creep corrosion on TI SOIC along with increased test exposure

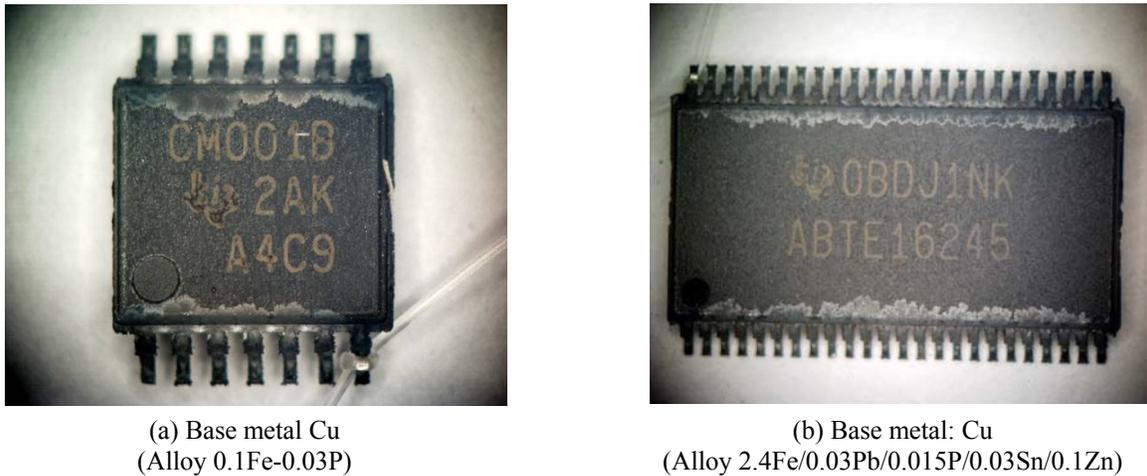
Figure 3.21 Creep corrosion over mold compound on components with different base metals after the 5-day Telcordia Outdoor MFG exposure

surface roughness effect. Creep corrosion occurred over the mold compound on samples with different leadframe base metal materials. There was no significant difference in corrosion products morphology and coverage on those two types of packages, see Figure 3.21. The same trend went for components with different resin systems and different surface roughness values, see Figure 3.22 and Figure 3.23.

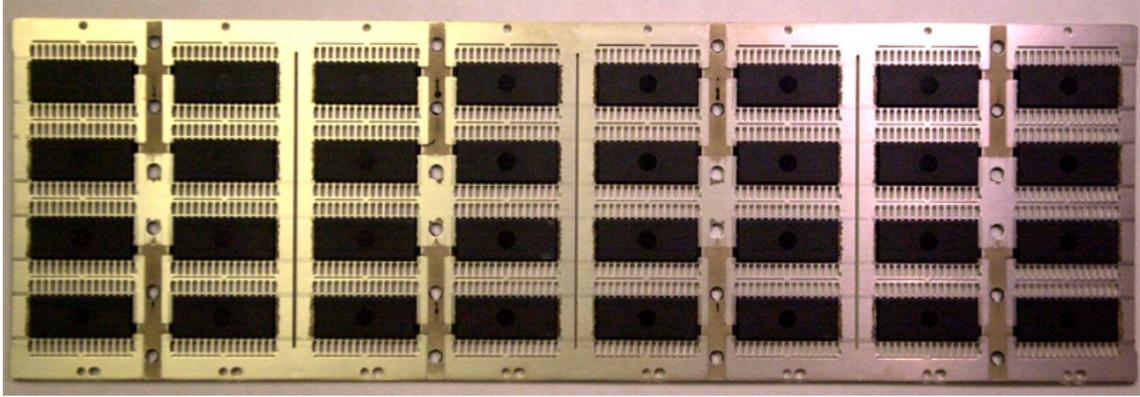
Figure 3.25 Components on leadframe strip with Mitsui noble pre-plated leadframes

Components provided in leadframe strips were included in the test. They were either QFP with Shinko pre-plated leadframe or SOIC with Mitsui pre-plated leadframe, see Figure 3.25 and Figure 3.26. Details about those samples on strips are provided in Table 3.6 Those components were molded packages on leadframe strip. That is to say, no “trim and form” was conducted on the components, so that there was no exposed copper in dam-bar removal area and cracks at lead bend.

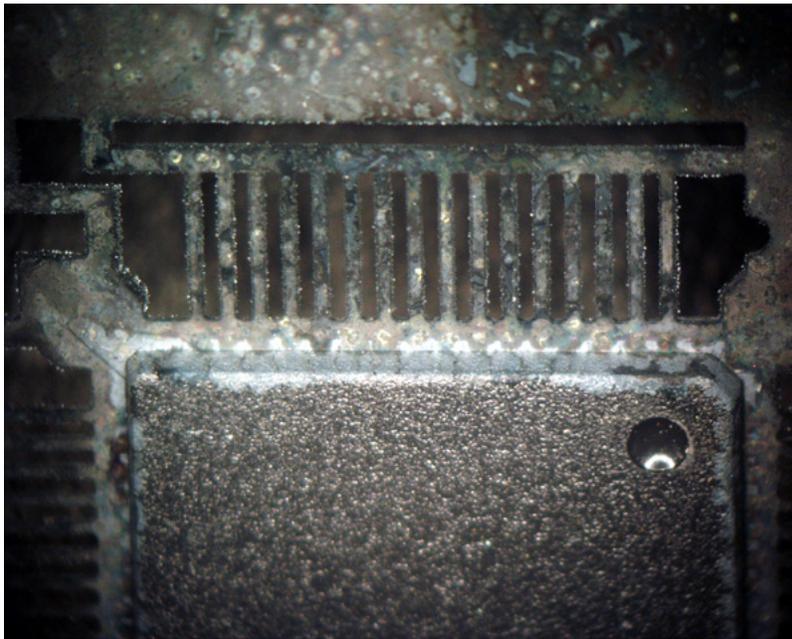
Figure 3.27 Creep corrosion over mold compound on QFP with Shinko noble pre-plated leadframe

After exposure to Telcordia Outdoor MFG environment, creep corrosion products were observed on mold compound surface after 5, 10, 15-day test, see Figure 3.27. It appeared that bulk area of exposed copper is not necessary to be the initiation source for creep corrosion over mold compound surface. Those corrosion products may start from the porosity of the plating on leadframe surface.

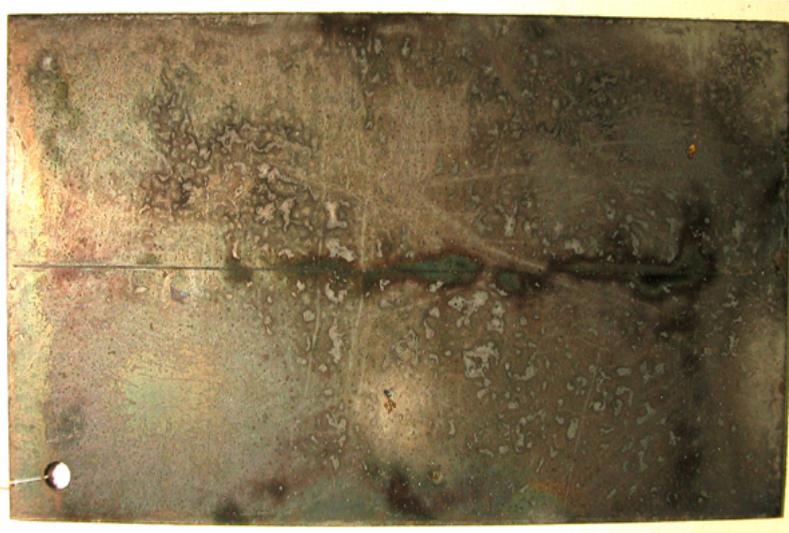
Figure 3.28 Corrosion on sample B after 10-day Telcordia Outdoor MFG test

After 5, 10, 15-day Telcordia Outdoor MFG exposure, gross corrosion was observed on the majority area of the coupons. In some locations near the cutting edges and the introduced centerline scratches, slight indication of creep corrosion was noticed, see Figure 3.28. The reason is likely that in such a corrosive environment, thin noble metal plating did not protect the majority area of base metal in an effective way, so that gross attack appeared a dominant effect.

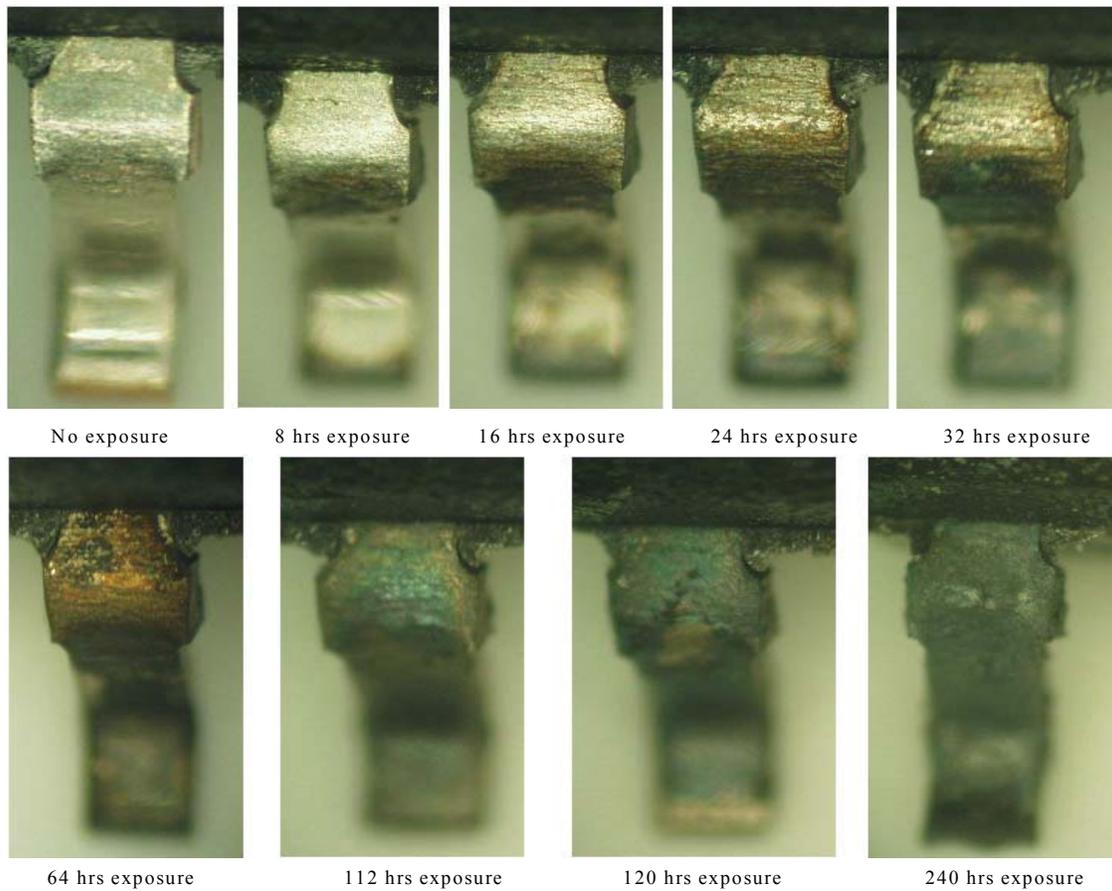
Figure 3.31: Corrosion on component type 1 leads after specific exposure period in Battelle Class III MFG environment

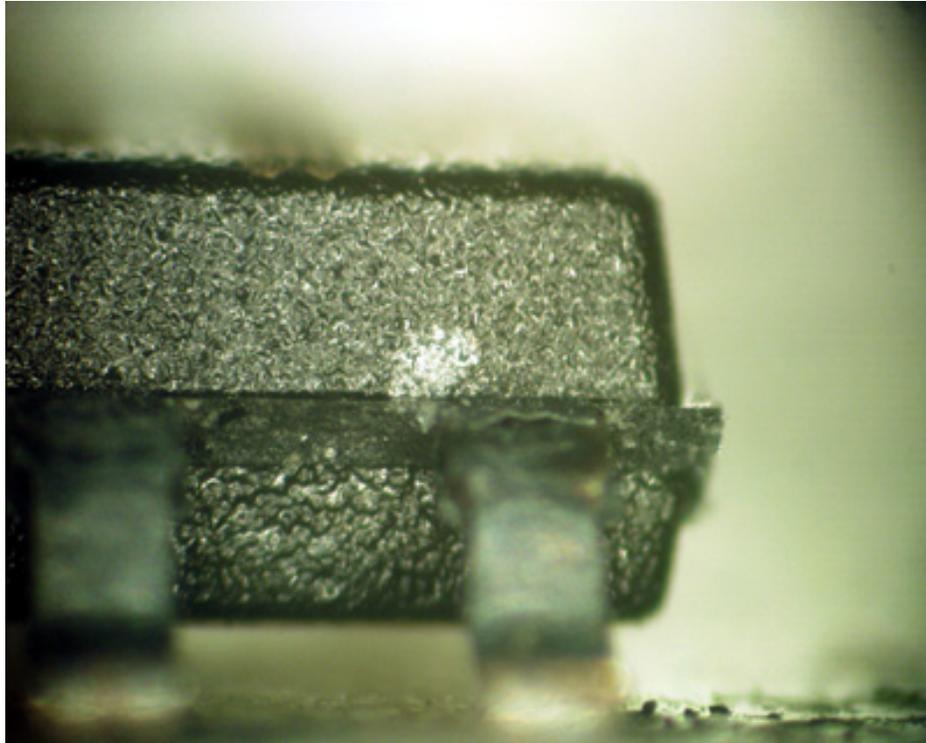
Figure 3.32 Creep corrosion over mold compound surface on 10-day Battelle III tested Philips type 1 components

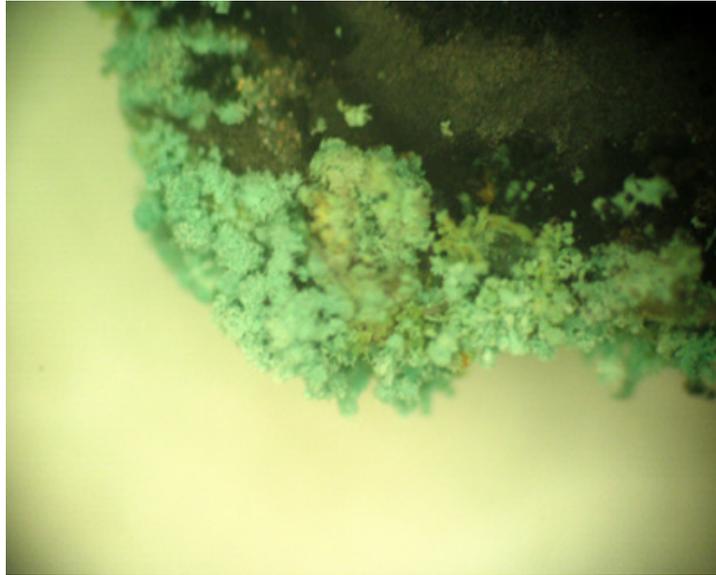
Figure 3.44 Porous corrosion products on un-mounted QFN package after Battelle Class III 15-day exposure

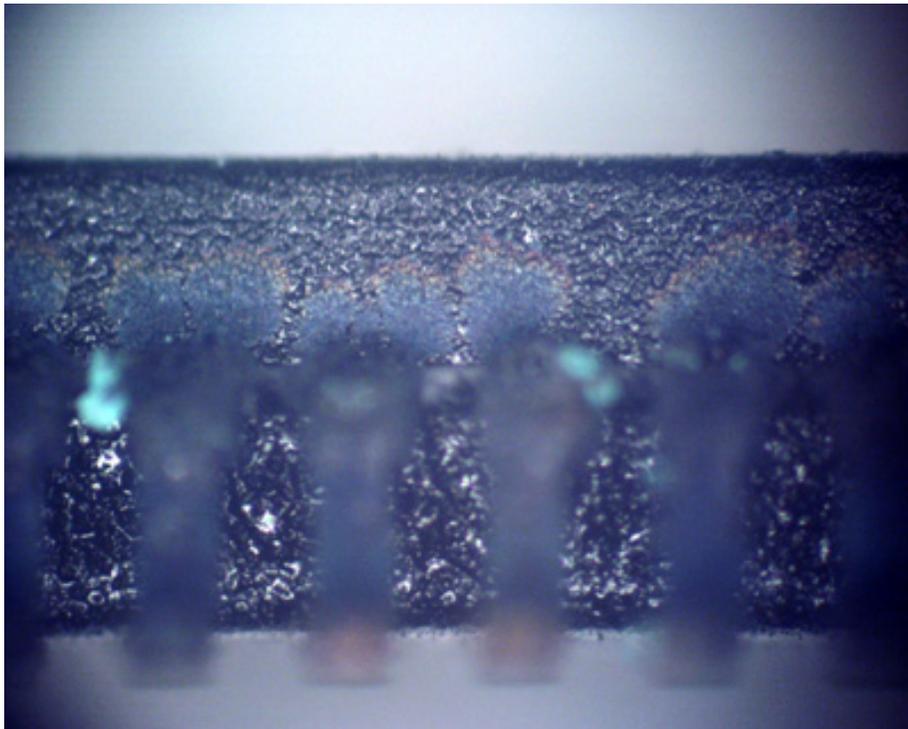
Figure 3.46 Creep corrosion over mold compound after the 15-day Battelle Class III test

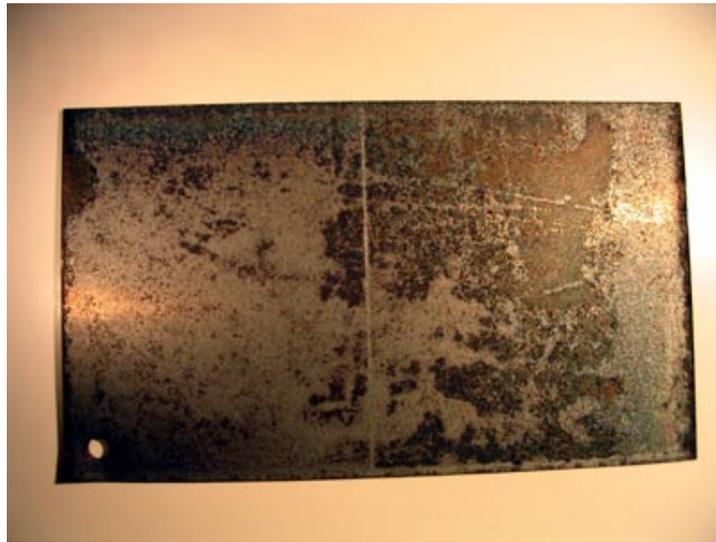
Figure 3.50 Corrosion on coupon type A after 15-day Battelle Class III test

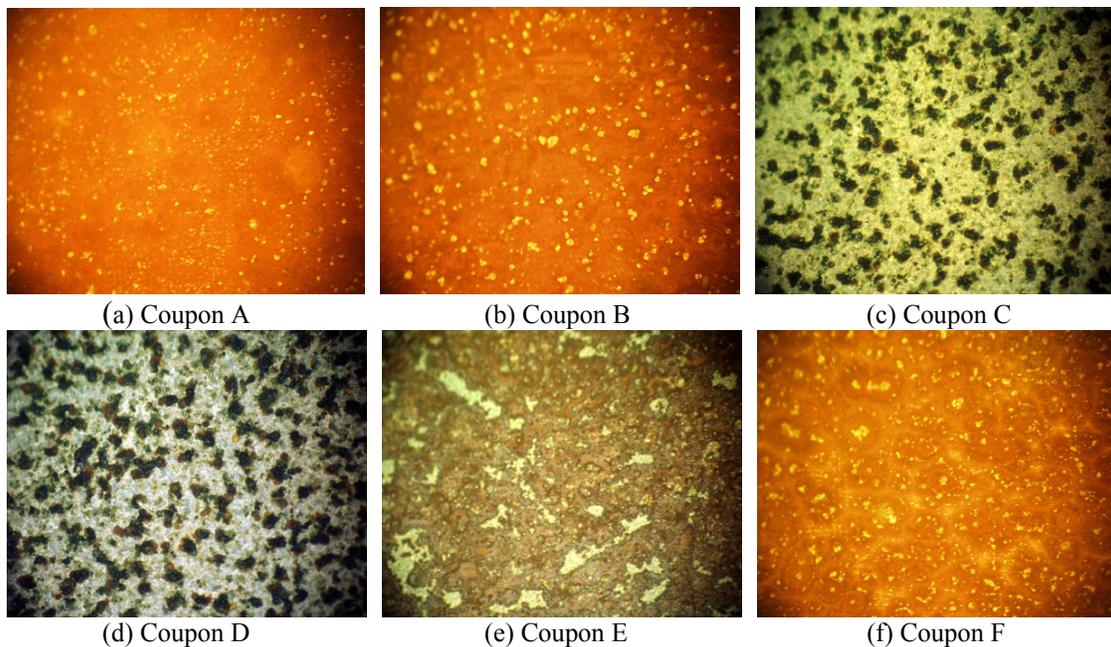
Figure 3.53 Pore corrosion effect on coupons after 10-day Telcordia Indoor MFG test

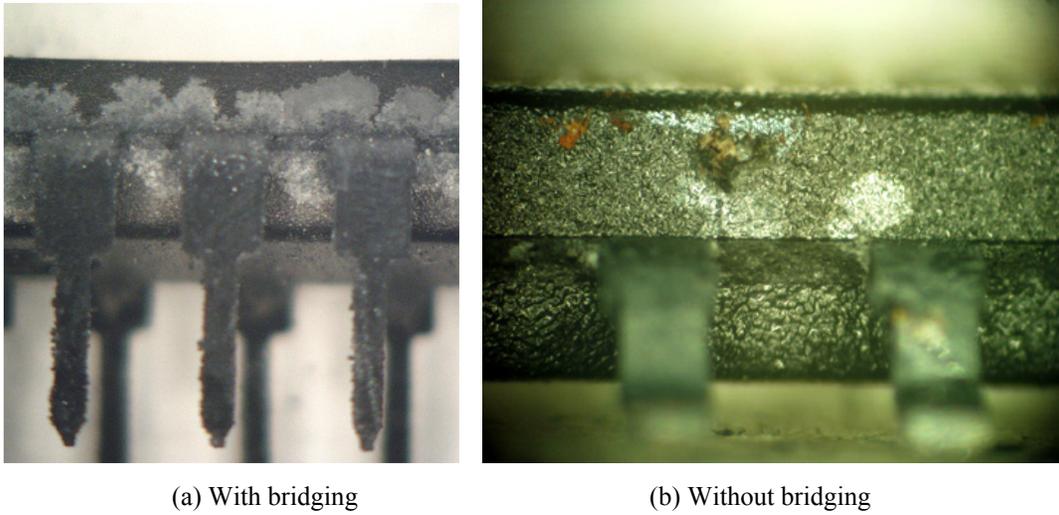
Figure 4.3 Lead pairs with or without bridging by creep corrosion products

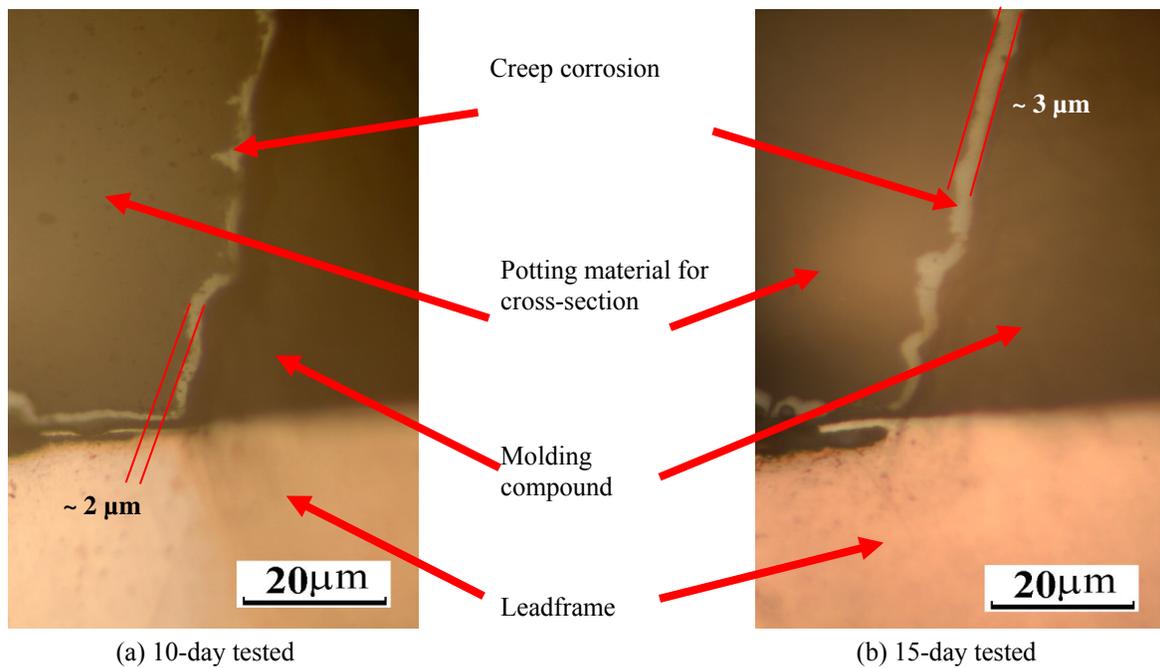
Figure 4.6 Evaluation of creep corrosion layer thickness on TI TSSOP after Telcordia Outdoor MFG exposure

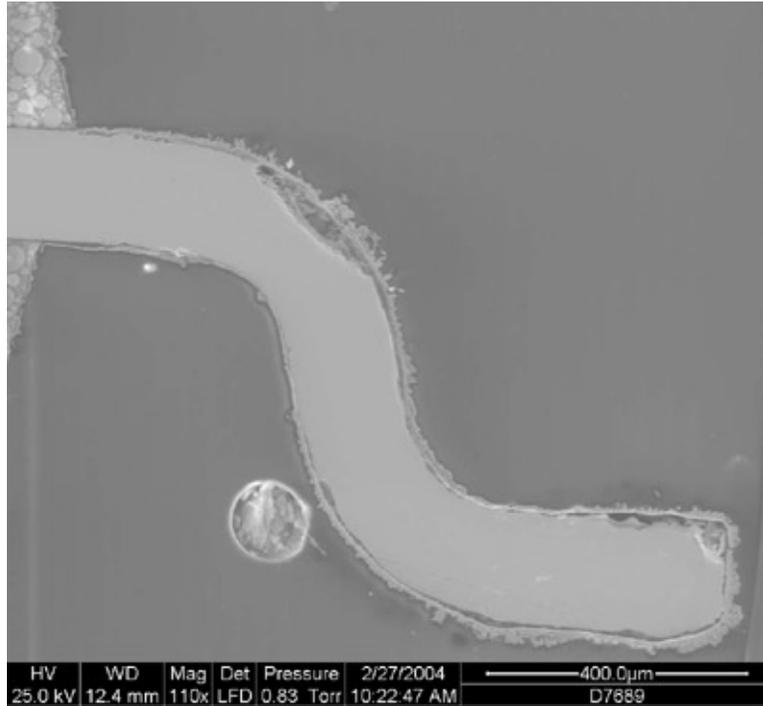
Figure 4.7 SEM overview of the cross-section of TI SOIC lead with corrosion after 15-day Telcordia Outdoor MFG test

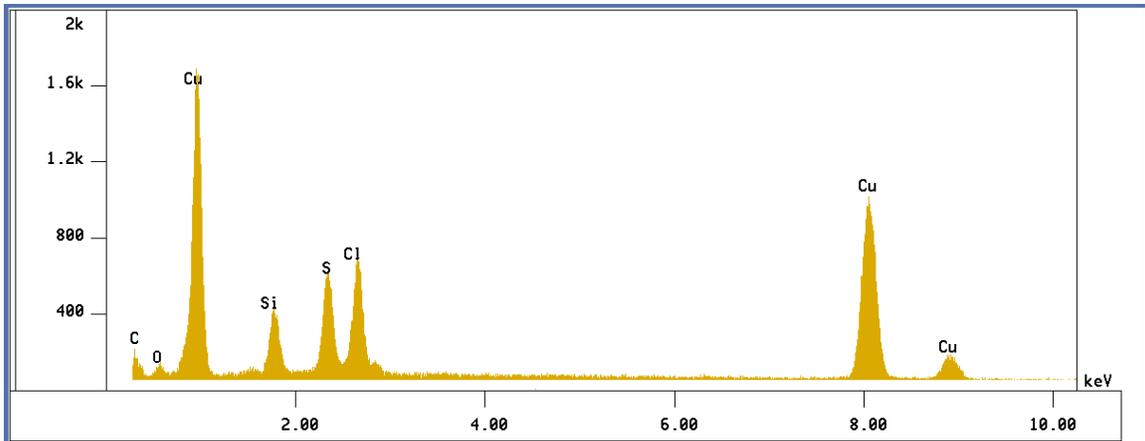
Figure 4.11 EDS analysis of creep corrosion products over molding compound surface

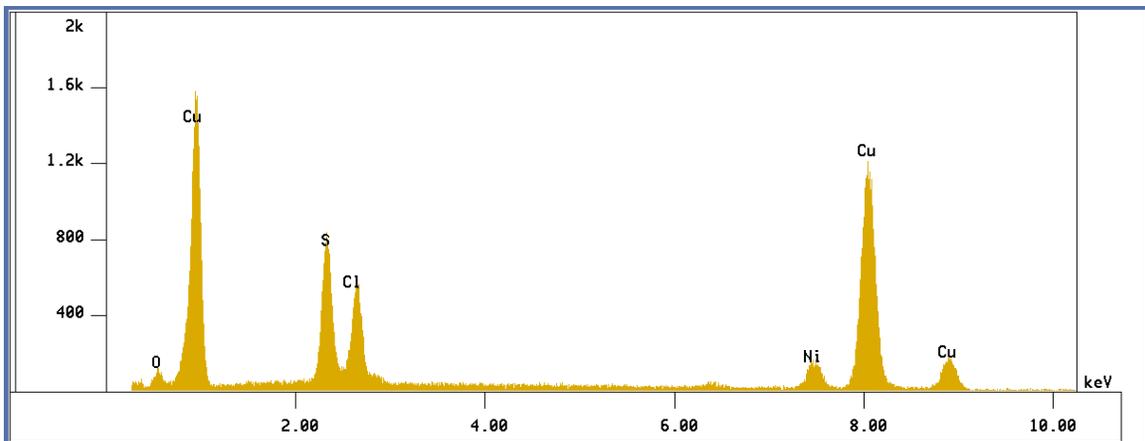
Figure 4.12: EDS analysis of creep corrosion products over lead
