Title of Dissertation: CREEP CORROSION OVER PLASTIC  
ENCAPSULATED MICROCIRCUIT  
PACKAGES WITH NOBLE METAL PRE-  
PLATED LEADFRAMES

Ping Zhao, Doctor of Philosophy, 2005

Dissertation submitted to the Faculty of the Graduate School of the  
University of Maryland, College Park, in partial fulfillment  
of the requirements for the degree of  
Doctor of Philosophy  
2005

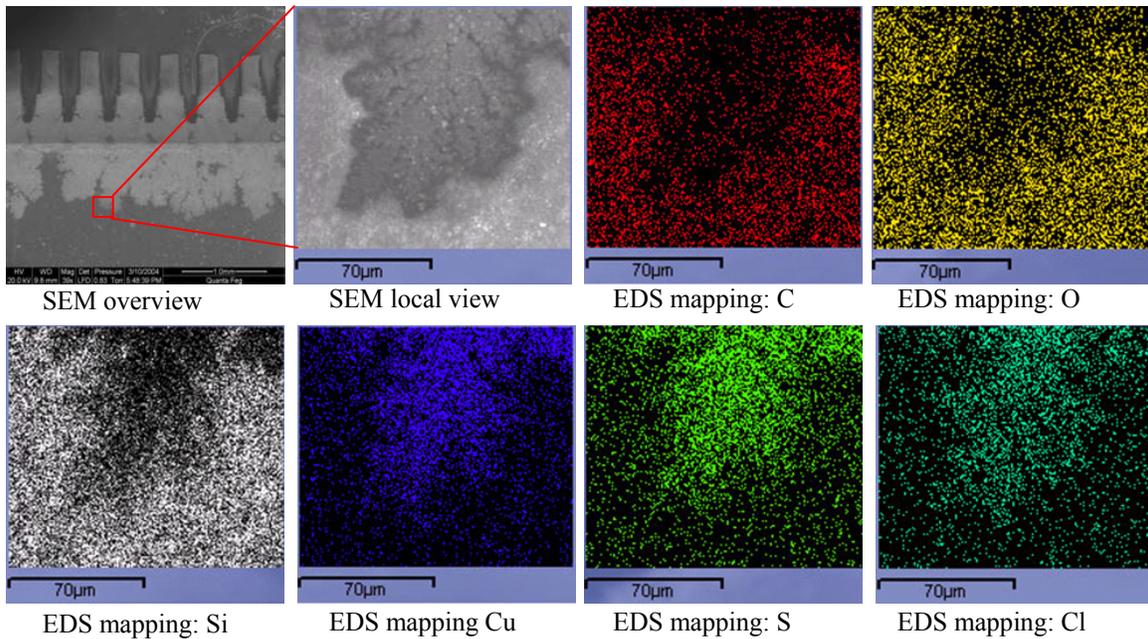
Figure 4.13 EDS mapping on a 10-day Telcordia Outdoor MFG tested TI TSSOP

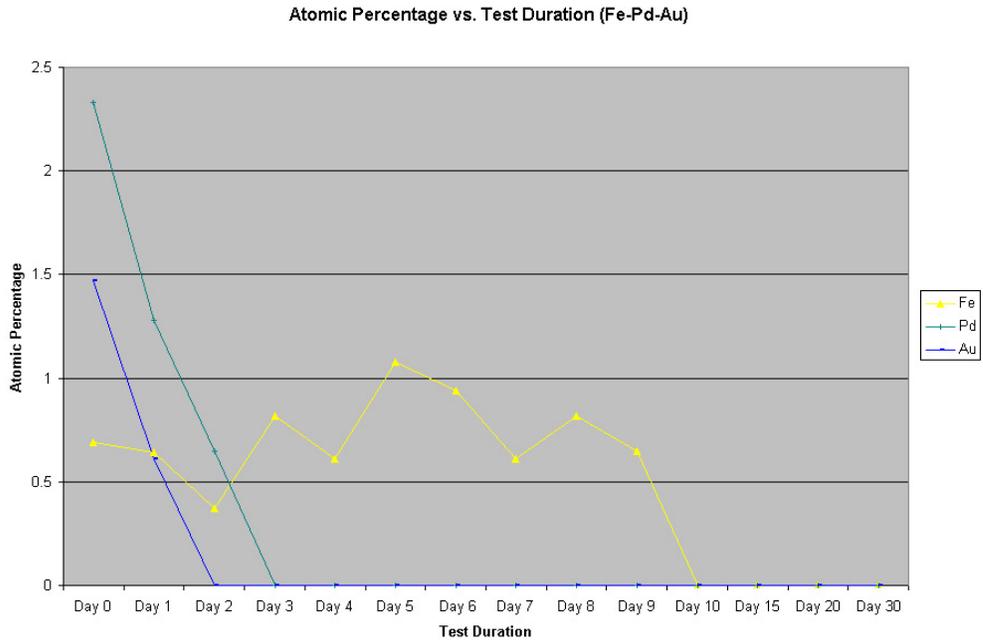
Figure 4.14 Elemental percentage changes on TI DIP lead corrosion products during a 30-day Telcordia Indoor test (part I for low content elements)

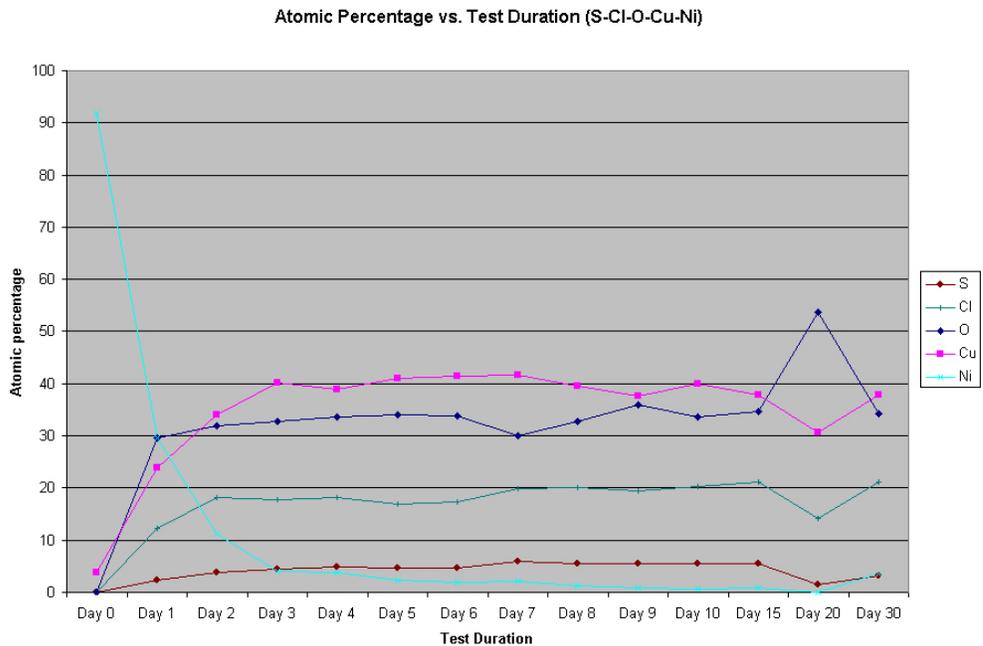
Figure 4.15 Elemental percentage changes on TI DIP lead corrosion products during a 30-day Telcordia Indoor test (part II for high content elements)

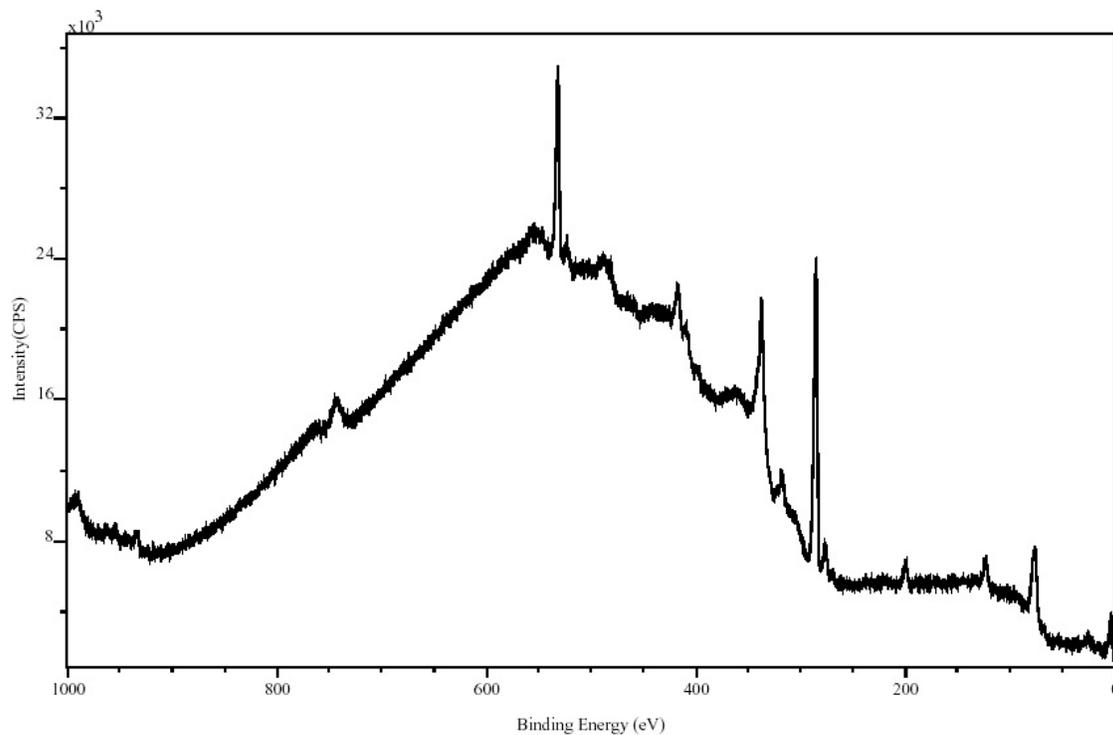
Figure 4.16 A survey scan for corrosion on lead after MFG exposure

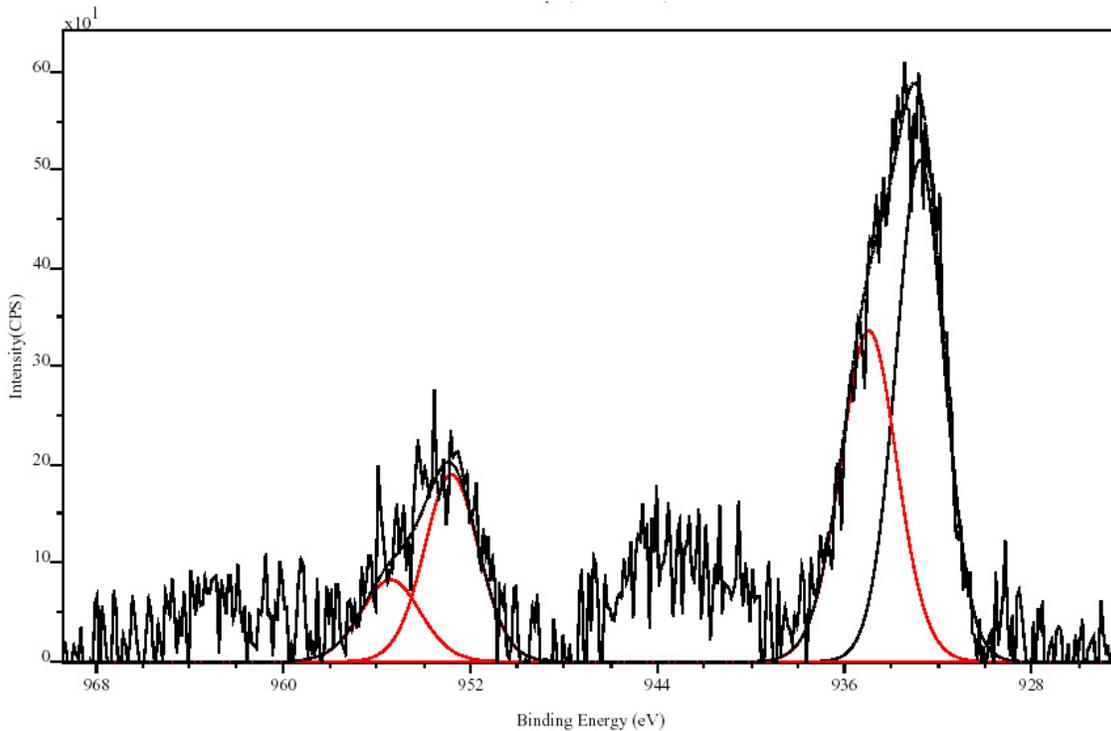
Figure 4.17 High resolution scan for Cu in an XPS spectrum

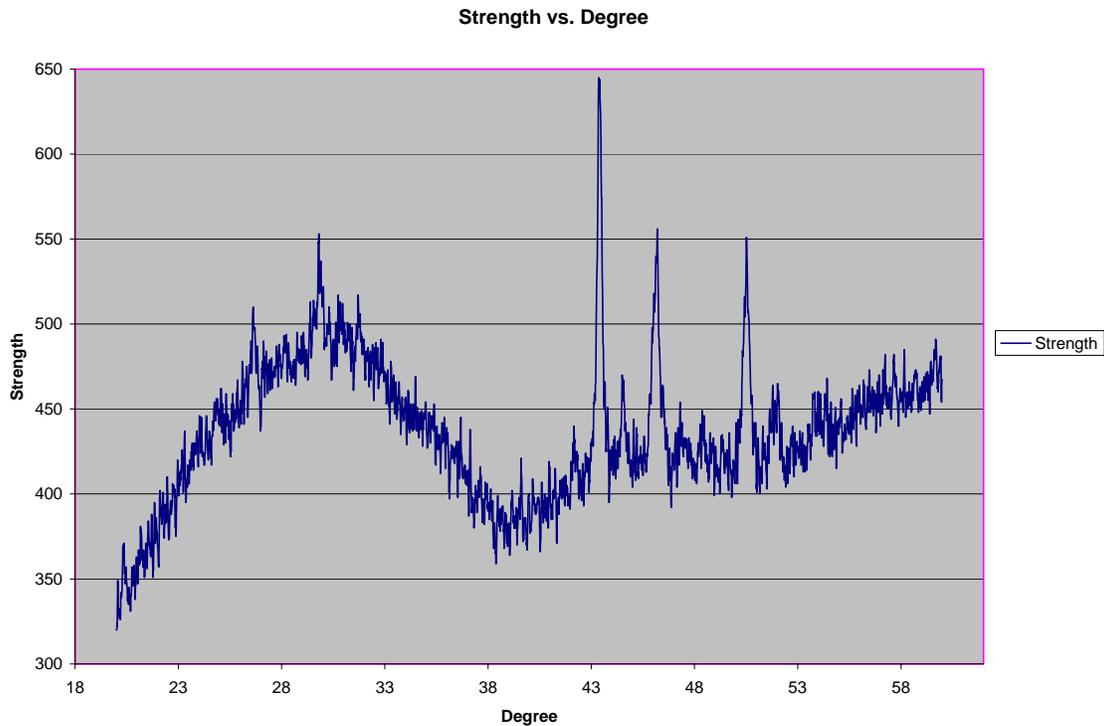
Figure 4.18 A spectrum by XRD for corrosion products on TI DIP after 10-Telcordia Outdoor MFG test

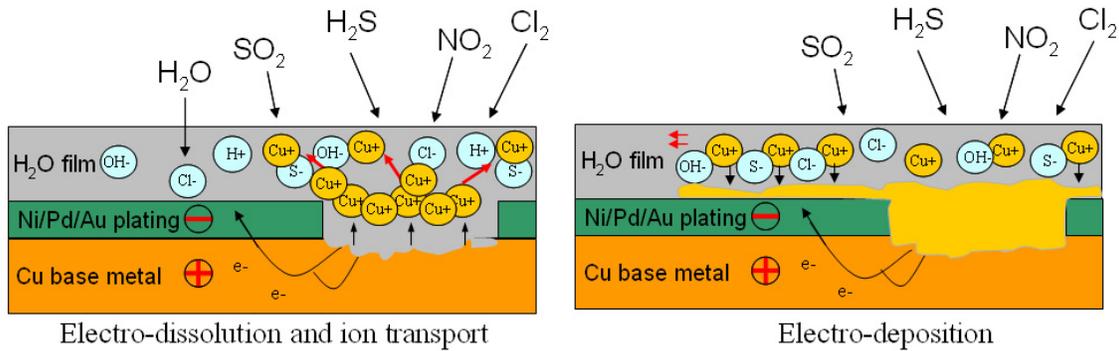
Figure 5.2: Schematics for corrosion initiation and accumulation on lead

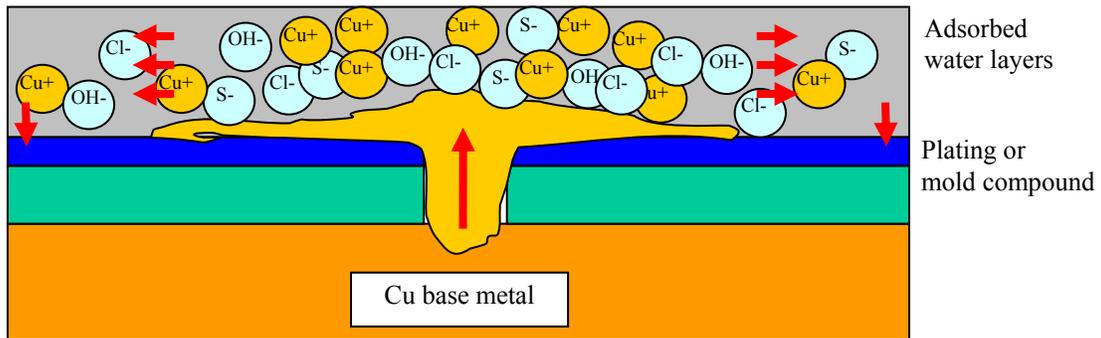
Figure 5.3: Diagram to illustrate creep corrosion by dissolution/diffusion/redeposition

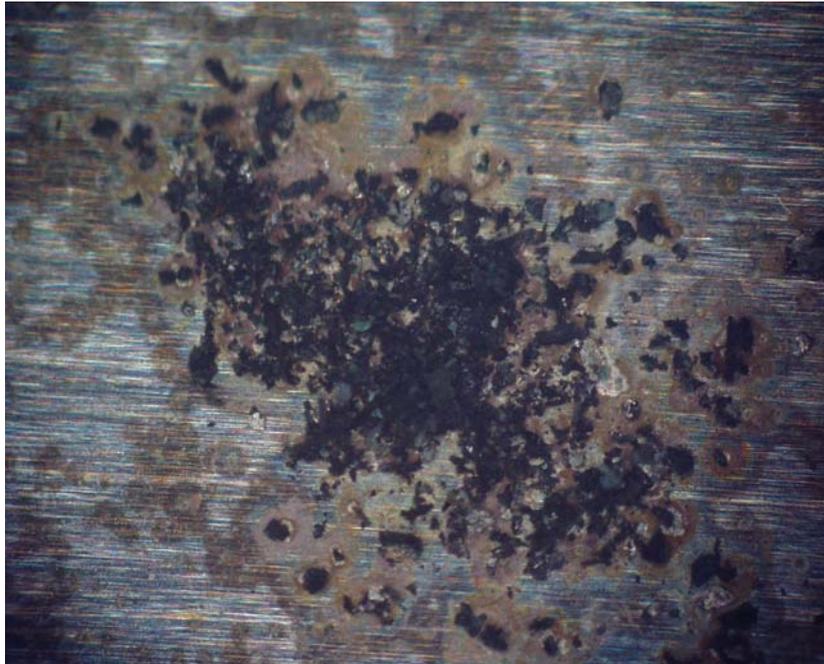
Figure 5.10: Deposit of corrosion product on Ni/Pd/Au plated copper coupon after 15-day 85°C/85% RH exposure

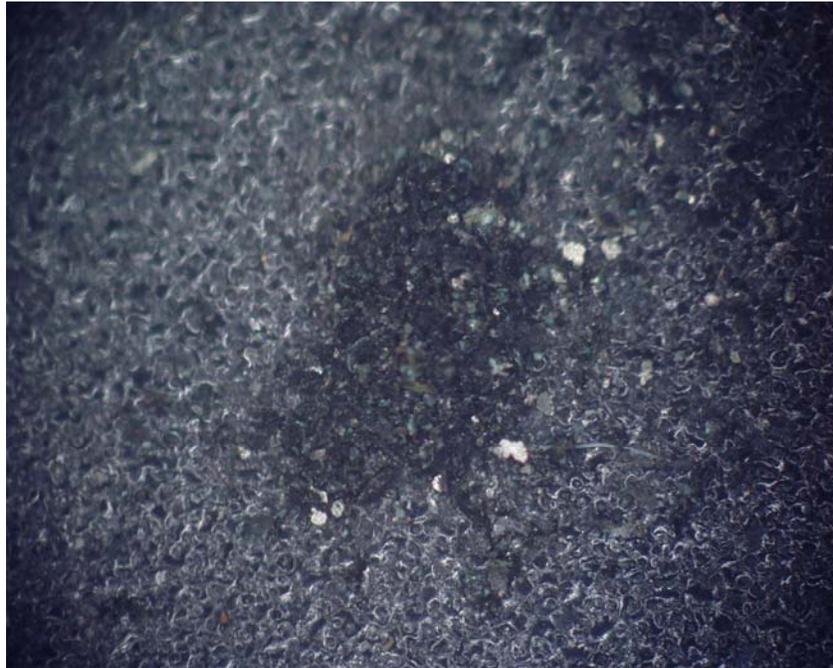
Figure 5.12: Deposit of corrosion product on mold compound after 15-day 85°C/85% RH exposure
