**REPORT ON ARCHAEOLOGICAL INVESTIGATIONS
CONDUCTED AT THE ST. MARY'S SITE (18AP45), 107 DUKE
OF GLOUCESTER STREET, ANNAPOLIS, MARYLAND, 1987—
1990**

VOLUME I: SITE HISTORY, RESULTS AND RECOMMENDATIONS

Archaeology in Annapolis

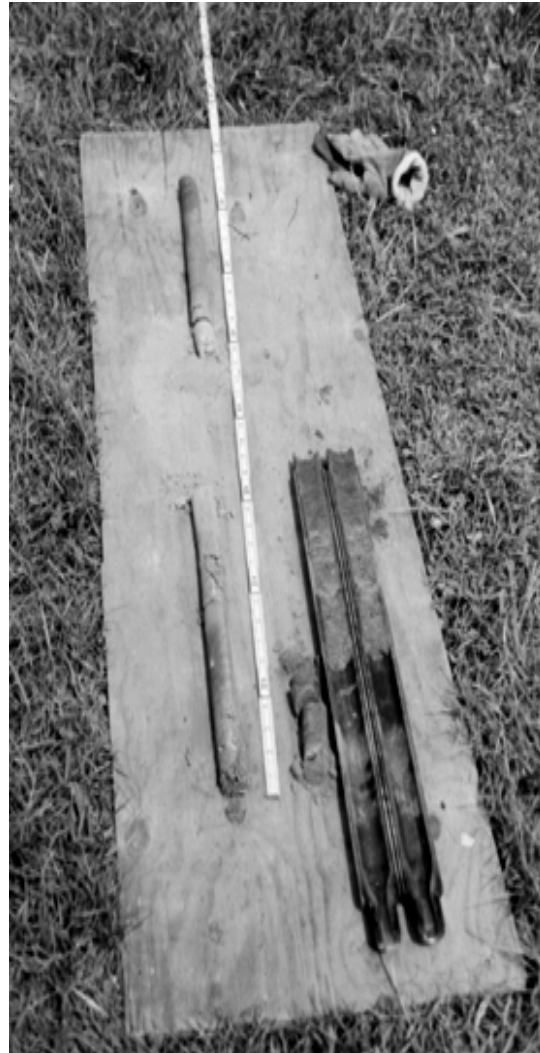
For the present study, soil cores were taken systematically along transects at the St. Mary's Site in July and August of 1988, and the locations of coring transects and individual cores are presented in **Figure 4.4**. These cores extend stratigraphic information known from excavation units opened in different areas laterally across the site into areas that were not examined through destructive excavation procedures, allowing the stratigraphy of garden areas to be better understood. The formal objective of coring at the St. Mary's Site was to demonstrate or disprove the survival of the Carroll garden, since it was not certain at the outset whether the terraces visible in the garden at the Carroll House were original or a reconstructed or revival garden. The methodology for this survey is reported in Kryder-

Reid's dissertation (1991:140--184). A split spoon coring assembly powered by hand was driven into the ground using a 35-pound weight, in a method similar to the one described by Stein (1986). The spoon assembly could be split for easy extraction of two-foot core sections measuring 1 1/4 inches in diameter. In this way cores were taken to depths of over eight feet in some areas of the site by extending to coring device repeatedly down the same hole. Stratigraphic information in extracted cores was diagrammed to scale and represented soils were described as to their composition, inclusions and munsell color.
