VAŽNOST ISPITIVANJA DOBOŠASTOG RAZMENJIVAČA TOPLOTE NAFTA-NAFTA ZA POTREBE ODRŽIVOG RAZVOJA I ZAŠTITU ŽIVOTNE SREDINE

IMPORTANCE OF INSPECTION OF THE OIL-OIL SHELL AND TUBE HEAT EXCHANGER FOR NEEDS OF SUSTAINABLE DEVELOPMENT AND ENVIRONMENTAL PROTECTION

In this paper, the test plan is presented, including the methods and test results, the corrosion rate and the remaining service life of the oil heat exchanger are calculated, in order to ensure the quality of production, the protection of the environment and living beings.

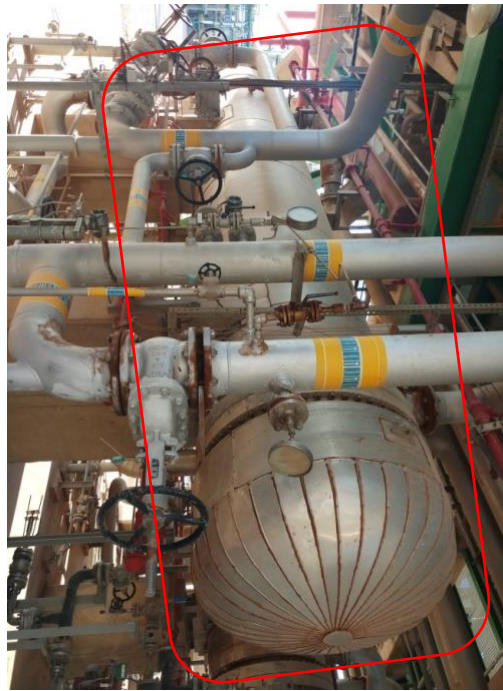
Figure 1. Oil-oil shell and tube heat exchanger

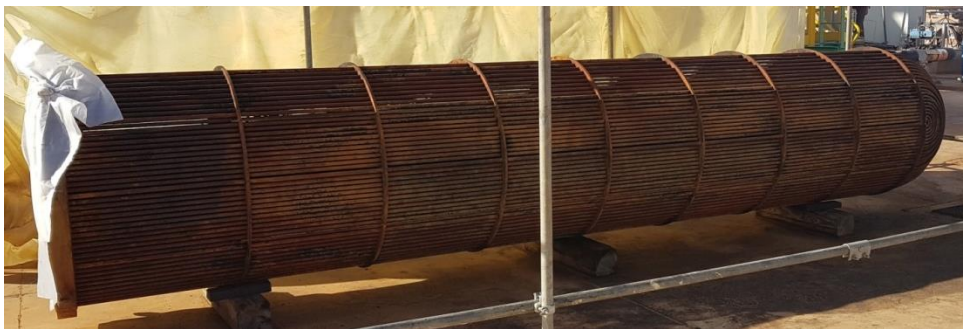
The appearance of the tube bundle after cleaning reveals that no corrosion occurred, and the metal surfaces are crack and damage free as presented in Figure 2.

Figure 2. The tube bundle after cleaning

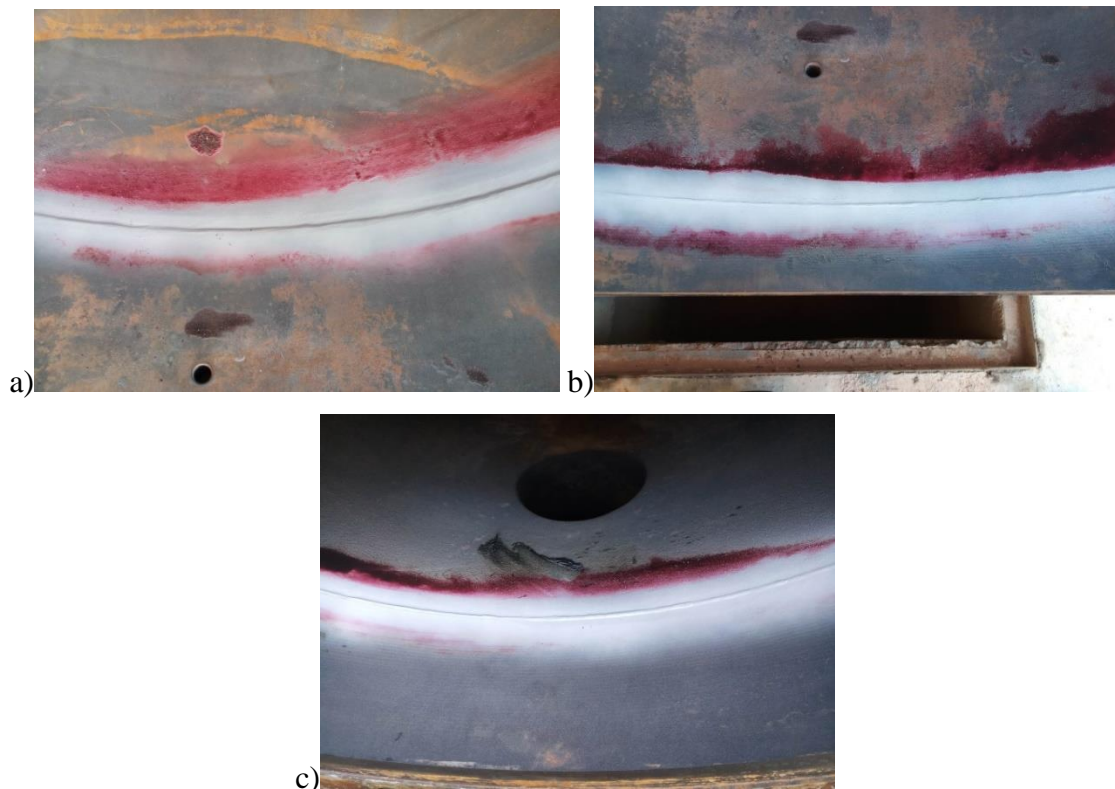
Sketch of liquid penetrate testing performed on oil heat exchanger is presented in Figure 5. The results of test performed at weld joint 1, weld joint 2 and weld joint 6 are presented in Figure 6 a, b and c respectively. Cracks were not found on inspected weld joints during inspection.

Figure 6. Results of PT tested of the weld joints a) 1 b) 2 and c) 6.
