ANALYSIS OF INSPECTION PLAN OF AIR COOLED HEAT EXCHANGER FOR NEEDS OF MAINTANCE AND SAFETY OF OIL&GAS PLANTS

Abstract: The paper shows preparation of inspection plan for air cooled heat exchanger in refinery. The importance of proper inspection, traceable prepared plan of inspection is discussed. The inspection of heat exchanger, according to the presented plan, includes visual testing - internal and external, ultrasound testing and liquid penetrate testing. The inspection plan is essential for maintenance the pressure equipment in refineries and is performed according to API 572 and API 510. The inspection of air cooled heat exchanger shows satisfactorily results.

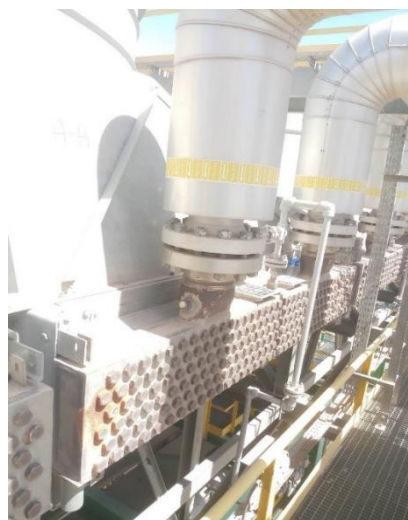
External Metal Surfaces / External Evidence of Corrosion External metal surfaces were found in good condition. Corrosion was not observed on them in time of inspection.

Figure 1. Air cooled heat exchanger (view from the front side)

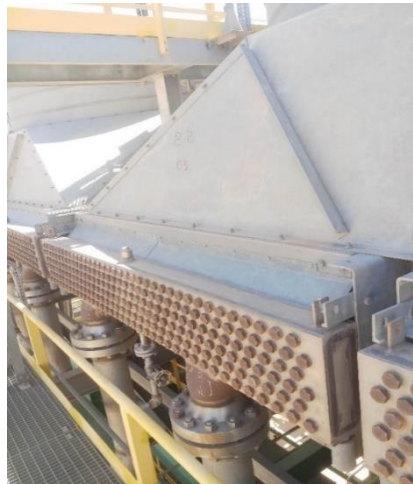
Figure 2. Air cooled heat exchanger (view from the back side)

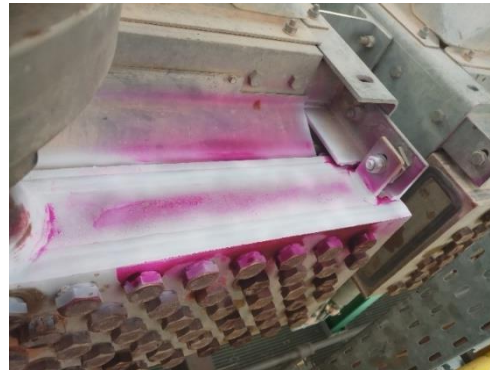
Liquid penetrant testing shows no cracks in air cooled heat exchanger (Figure 4).

Figure 4. Results of PT testing of the weld joints
