Title of Document: RELIABILITY ASSESSMENT OF VOIDED MICROVIAS IN HIGH DENSITY INTERCONNECT PRINTED CIRCUIT BOARDS UNDER THERMO MECHANICAL STRESSES

Roozbeh Bakhshi, Master of Science, 2013

Thesis submitted to the Faculty of the Graduate School of the  
University of Maryland, College Park, in partial fulfillment  
of the requirements for the degree of  
Masters of Science  
2013

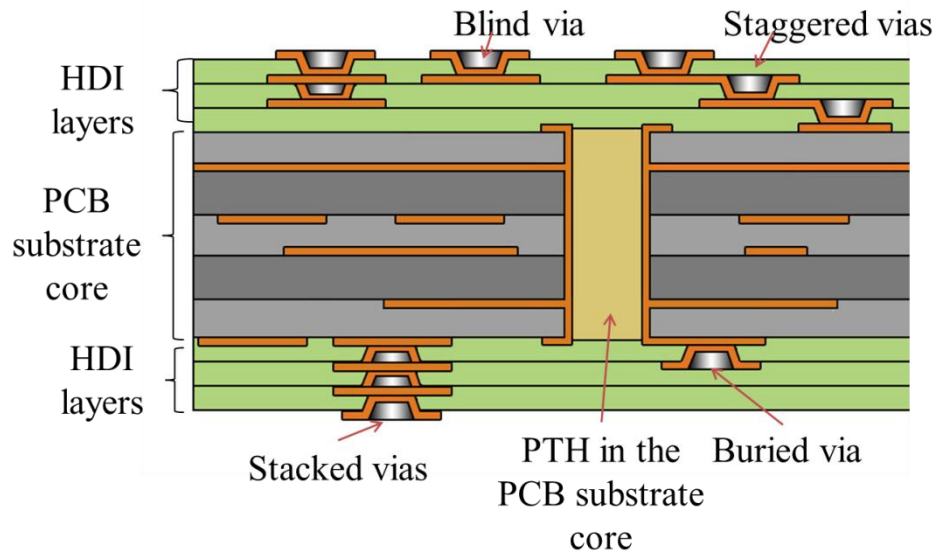
Depending on the location of the Microvias, they are defined by IPC-2226 standard [4] as two main types, blind and buried vias, the buried Microvias are the ones that make connection between the inner layers of the board and do not have any connection to the surface mount component whereas for blind vias, one end is connected to the outer layer of the PCB while the other end is in contact with the inner layers. With the advancement in HDI technology, more than one layer of micro via was needed. In the multi-layer HDI boards, microvias can be stacked or staggered. Staggered microvias, were the initial design for the multi-layer HDI boards were several single layer microvias were put together in different layers in a staggered formation however with further advancement in technology, multi-layer stacked microvias were introduced were several single layer microvias are put on top of each other and form stacked formation. Figure 3 is an illustration of different types of Microvias.

Figure 3- Schematic of different types of microvias

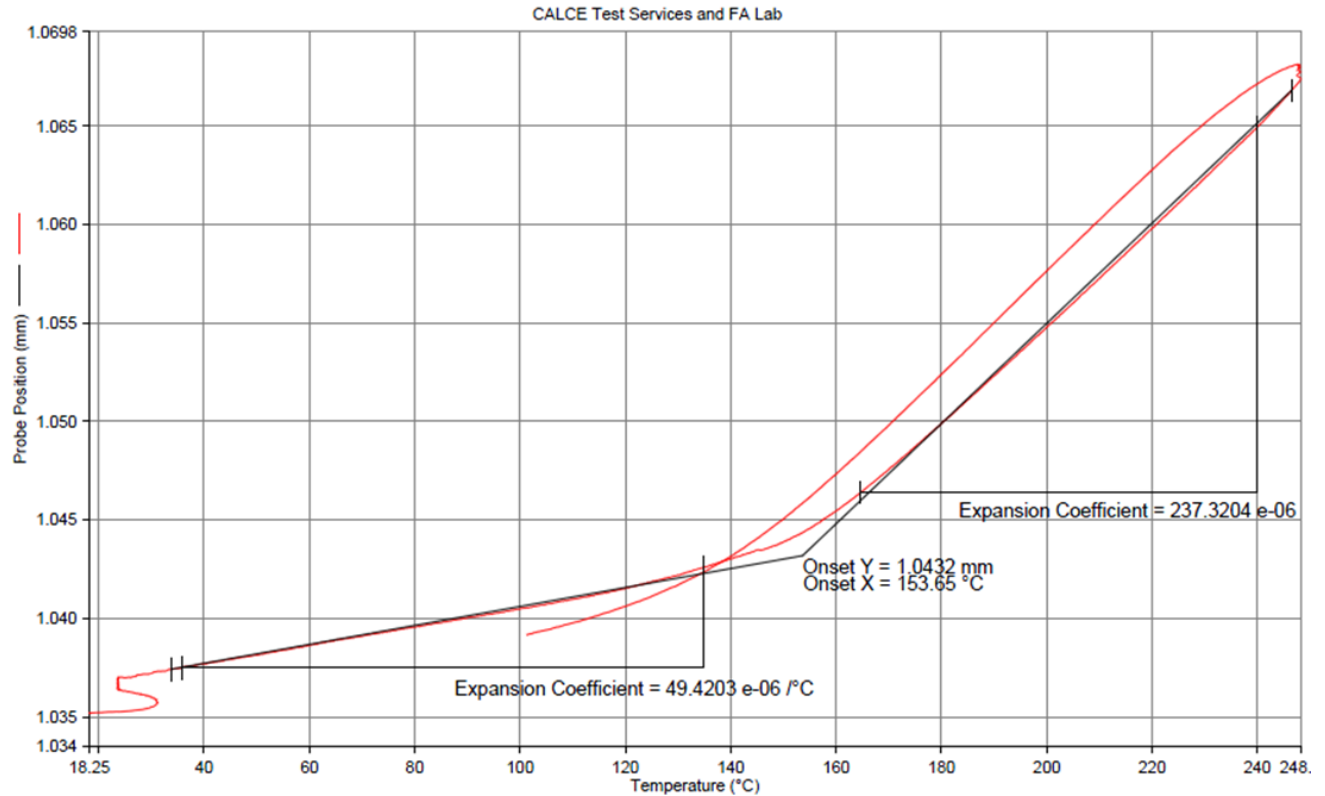
In order to choose the maximum temperature of the thermal shock test, the glass transition temperature ( $T_g$ ) of the board had to be measured. To avoid testing artifacts, such as material delamination and breakdown, the maximum temperature in the test should be lower than the glass transition temperature ( $T_g$ ) of the dielectric materials.  $T_g$  can be obtained by performing thermo-mechanical analysis (TMA) test. The procedure and requirements of the TMA test are presented in the IPC-TM-650, 2.4.24C standard. Figure 12 shows the results of the TMA test on the board and it can be seen that the glass transition temperature is 154 °C.

Figure 14- TMA results of the PCB

Glass transition temperature of 154 °C means that any extreme temperature below this number is appropriate for the test without damaging the dielectric material of the boards.

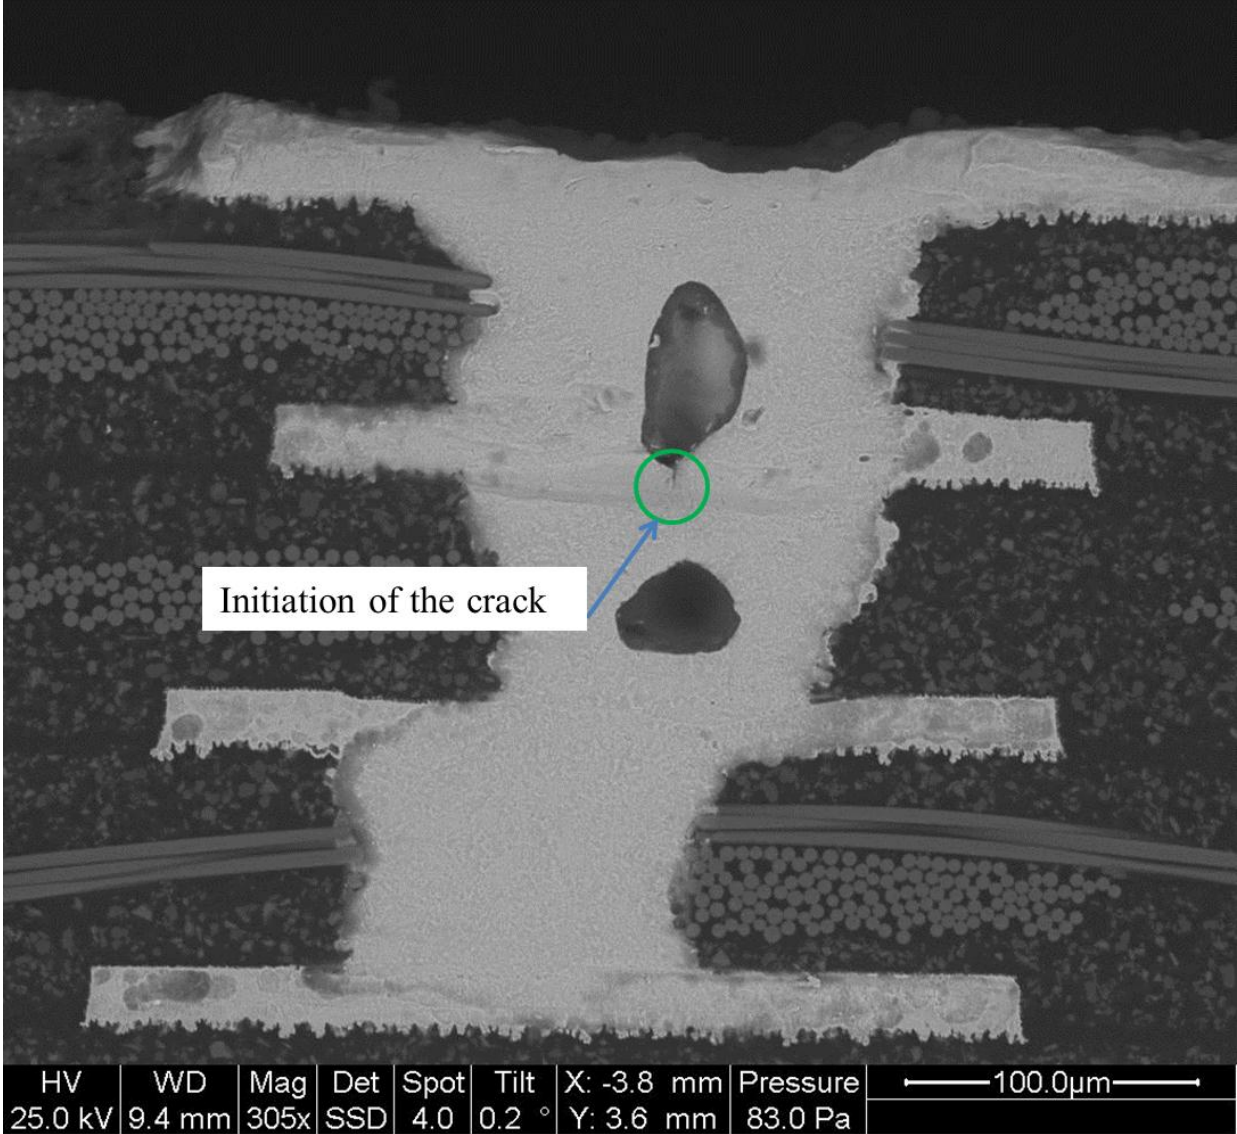
To further investigate this anomaly and make sure that it is a crack initiation, extra nondestructive test was performed. E-SEM analysis was used for the confirmation. Figure 22 shows an image of the failure at the bottom of the upper void.

Figure 22-Initiation of the crack at the bottom of the void

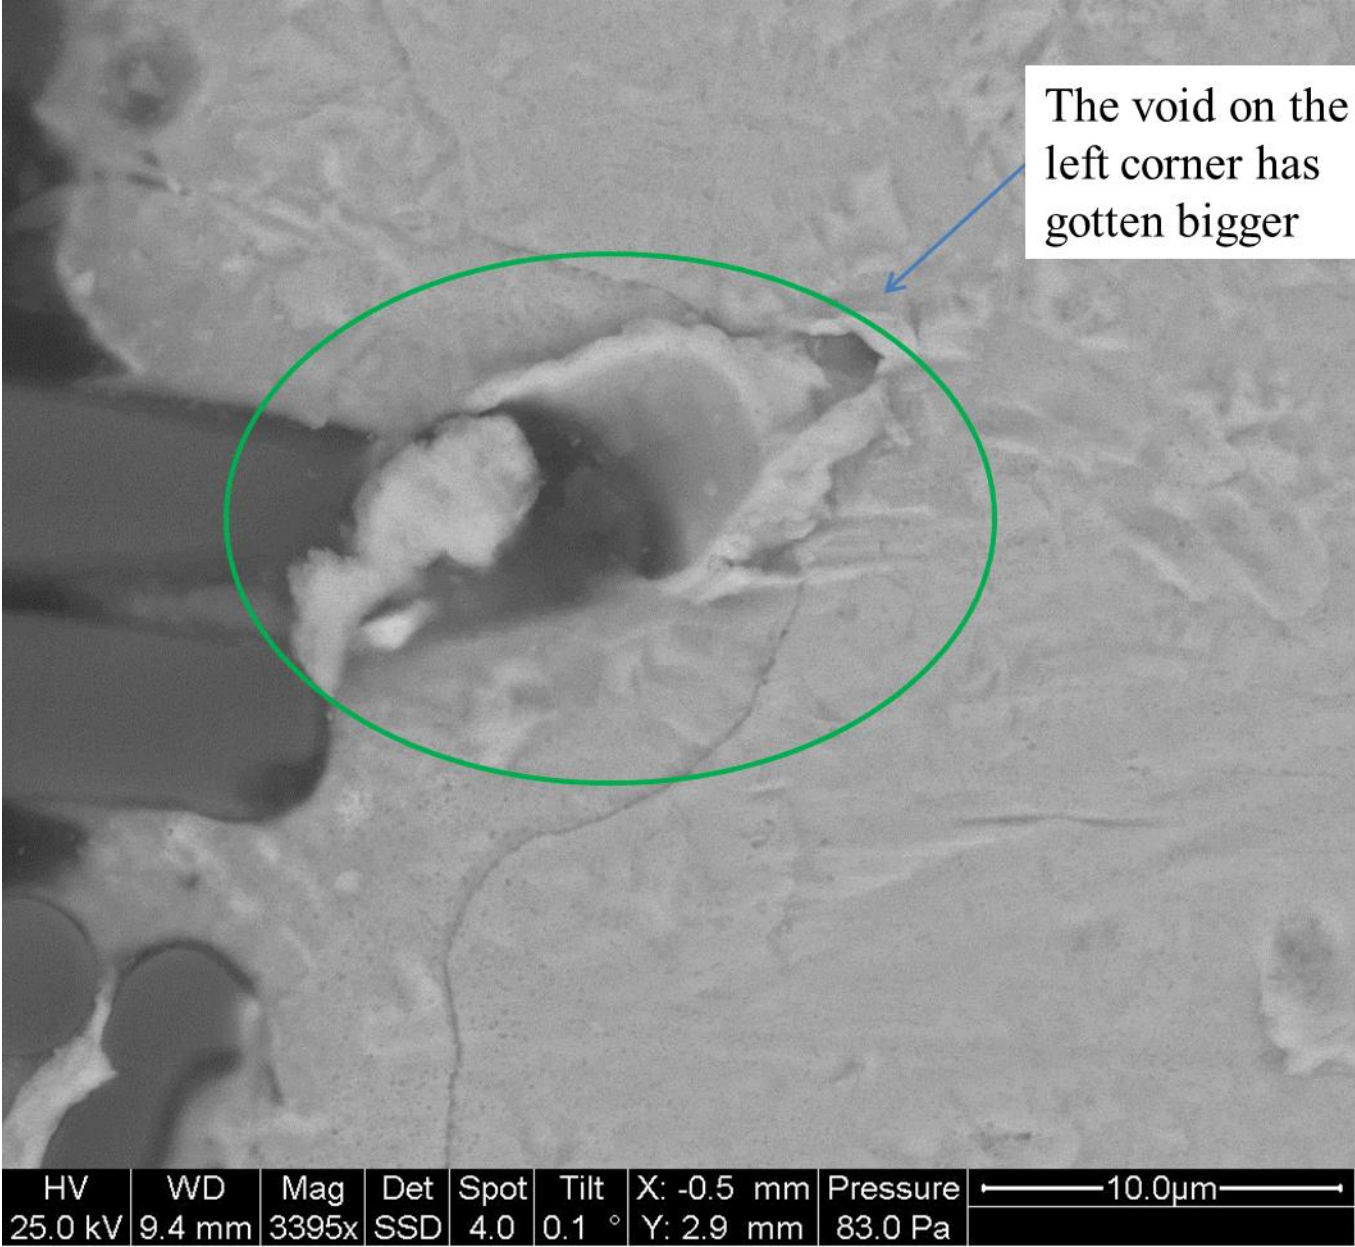
after 150 cycles. In order to confirm this expansion of the void E-SEM analysis was performed on the samples. Figure 29 shows the E-SEM image of the new void.

Figure 29- Void expansion after 150 cycle on the single layer microvia

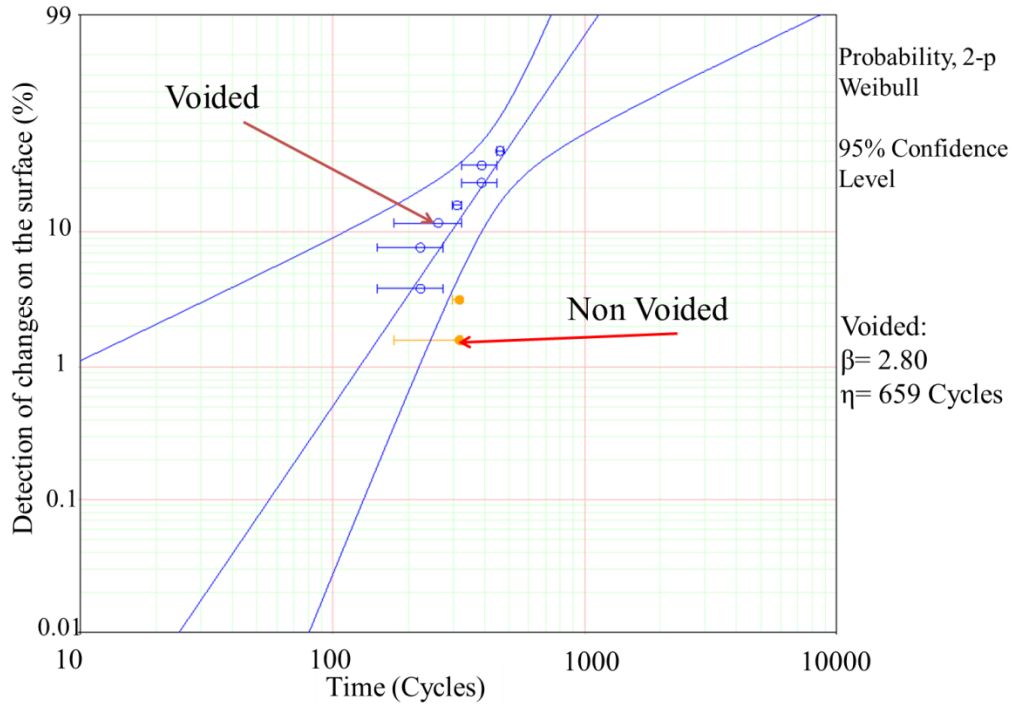
**Error! Reference source not found.** shows the statistical analysis of the samples that howed degradation during the cycling.

Figure 32- Weibull plot of the results

1. Samples are experiencing only one failure mechanism, this failure mechanism is low cycle fatigue due to occurrence of plastic deformation on locations where there is a stress concentration
2. Beta value over one indicates that these are wear out effects and not infant mortality
3. Characteristic life indicates that 63.2% of microvias will show signs of surface degradation after 659 cycles.
4. Lack of enough data for non-voided samples makes it impossible to make a conclusive judgment about their reliability other than the fact that they have less susceptibility to cracking compared to the voided samples.
