**Phase II Archaeological Testing on Wye Greenhouse (18TA314), Talbot
County, Maryland, 2008**

Report Prepared for
Tilghman Family

Abstract

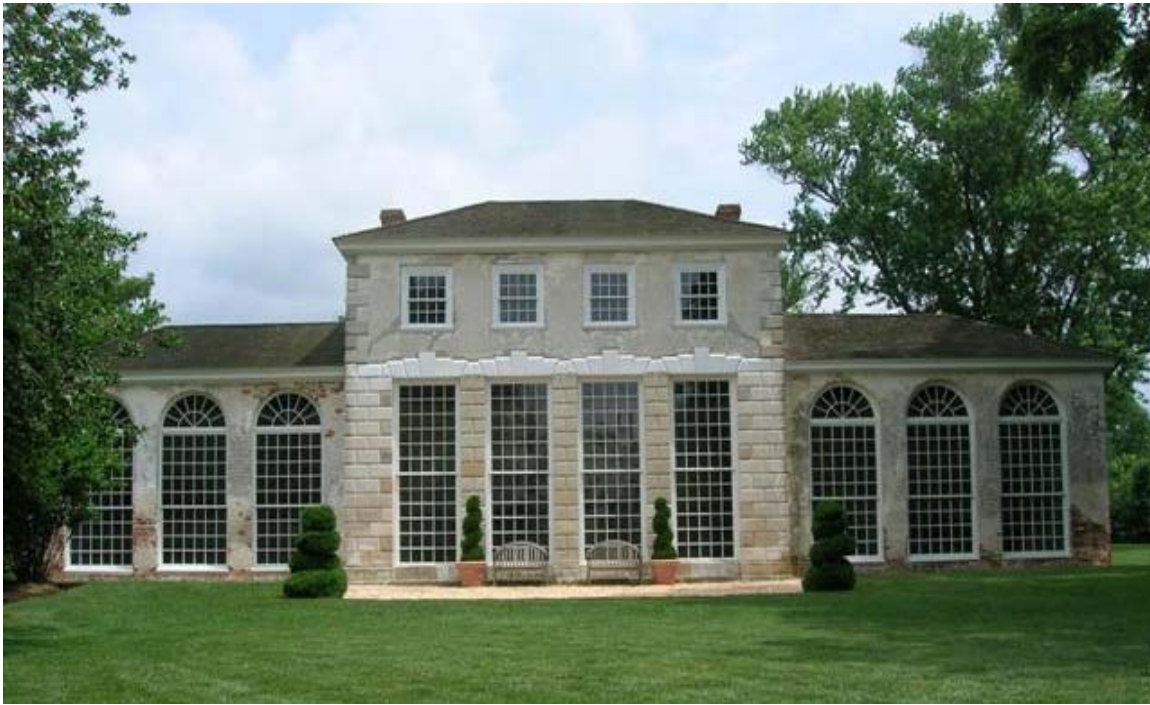
Figure 3.8 – The Greenhouse at Wye House in Talbot County, Maryland. – This 18th Century Greenhouse is the only surviving example from the period. Other original greenhouses from surrounding locations, such as Mount Vernon and Mount Airy in Virginia, were destroyed and then either rebuilt or left in ruin. Photo by Stephanie Duensing

In the fall of 2008, architectural historian Raymond Cannetti visited the Wye Greenhouse and explained the heating system and how it worked (see figure 3.8, 3.9 & 3.10). Mr. Cannetti said that this structure was designed originally to contain a heating system, even if it was originally absent. This system would have been located on the north-eastern section where there is now a small doorway, currently with a clearance of

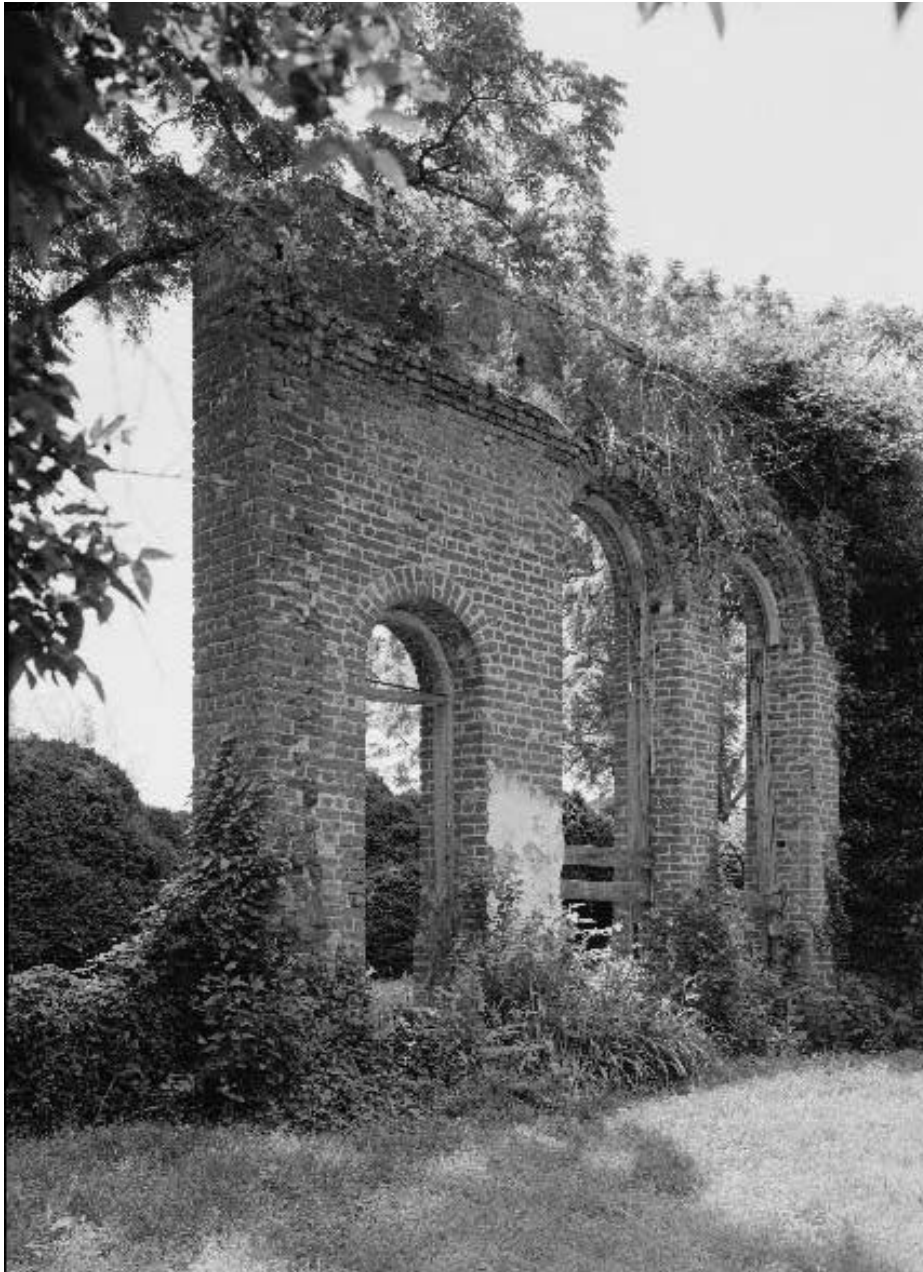
Figure 3.11 – The Ruins of the Greenhouse at Mount Airy, Richmond County, Virginia. The wall of the south façade is all that survives from what was once the crowning jewel on this impressive estate. Photo retrieved from HABS database.

Mount Airy had been the childhood home of Elizabeth Tayloe Lloyd. Mount Airy was regarded at that time as an impressive display of modern architecture at the highest level of quality and style. As one of the few stone houses built in Virginia during the 18th century, it represented the first instance of the achievement of the ideal full Palladian villa in the colonies, with dependent wings connected to the main house by quadrant passages. The entire composition of the facade is copied from a design in James Gibbs' *Book of Architecture* (Morrison 1952; Waterman 1946; Sale 1909). In the height of its glory, Mount Airy possessed a greenhouse that would have rivaled any other in the region. Today, the greenhouse has been nearly completely destroyed (See Figure 3.11). All that remains is a fragment of one of the walls. However, according to records, the greenhouse was heated and had the ability to produce lemons and oranges. Completed by 1760, is now a romantic ruin, draped with trumpet vine. The house, considered one of the finest Palladian residences in the United States, was begun in 1748 for John Tayloe. It is believed that the orangery was part of the original garden, which was constructed along with the house during the 1750s. The ruin of the orangery now comprises the foundation walls and part of the southeast facade in which there are three arched window openings measuring almost twelve feet to the spring of the brick arch (Britz 1996).

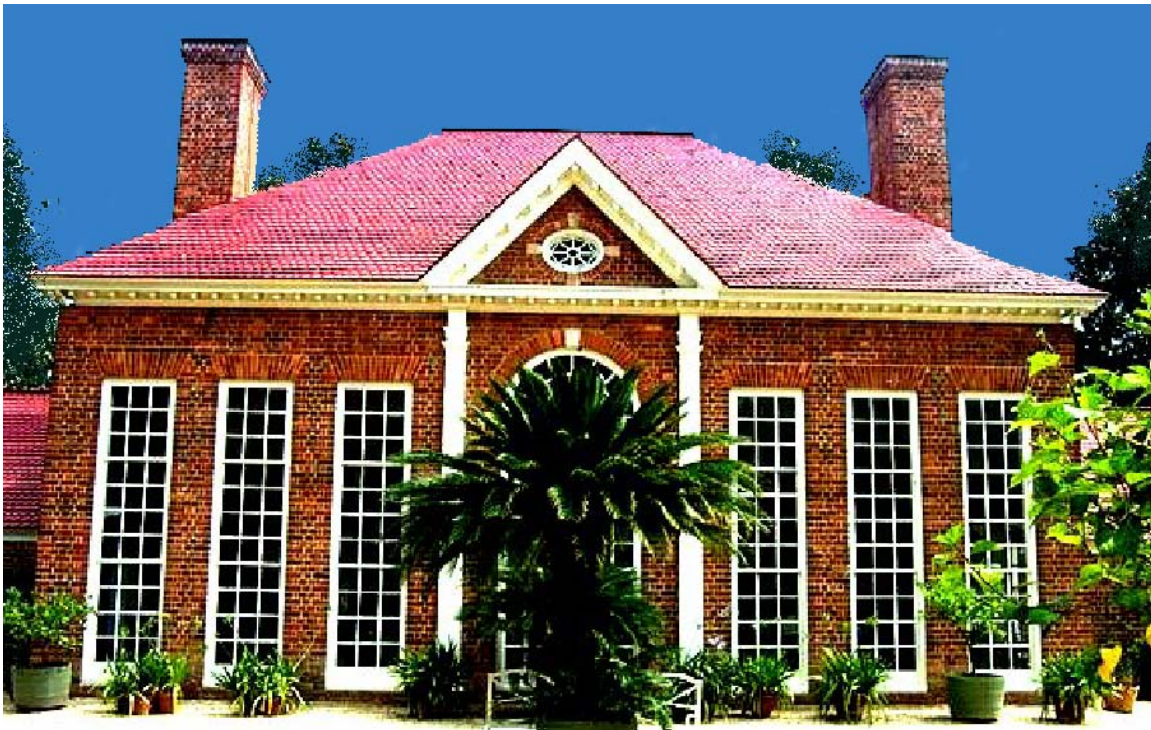
Figure 3.13 – Greenhouse at Mount Vernon, Virginia – Though the original was destroyed in 1835. The Mount Vernon Ladies Association had the current structure rebuilt on the original site in 1951. Photo edited by Stephanie Duensing, retrieved from <http://libertybelle78.blogspot.com/2008/10/when-i-was-child-i-always-pictured-same.html>

Archaeological excavations at the time the Mount Vernon orangery was reconstructed confirmed that Washington enlarged the building after receiving Tilghman's letter (see Figure 3.13). The original south wall was taken down and rebuilt four feet further into the garden. The revisions delayed the completion of the original building by almost three years. When the roof was raised on May 18, 1787, a special ration of rum was issued to the workmen by order of Martha Washington, for the general was in Philadelphia (Britz 1996).

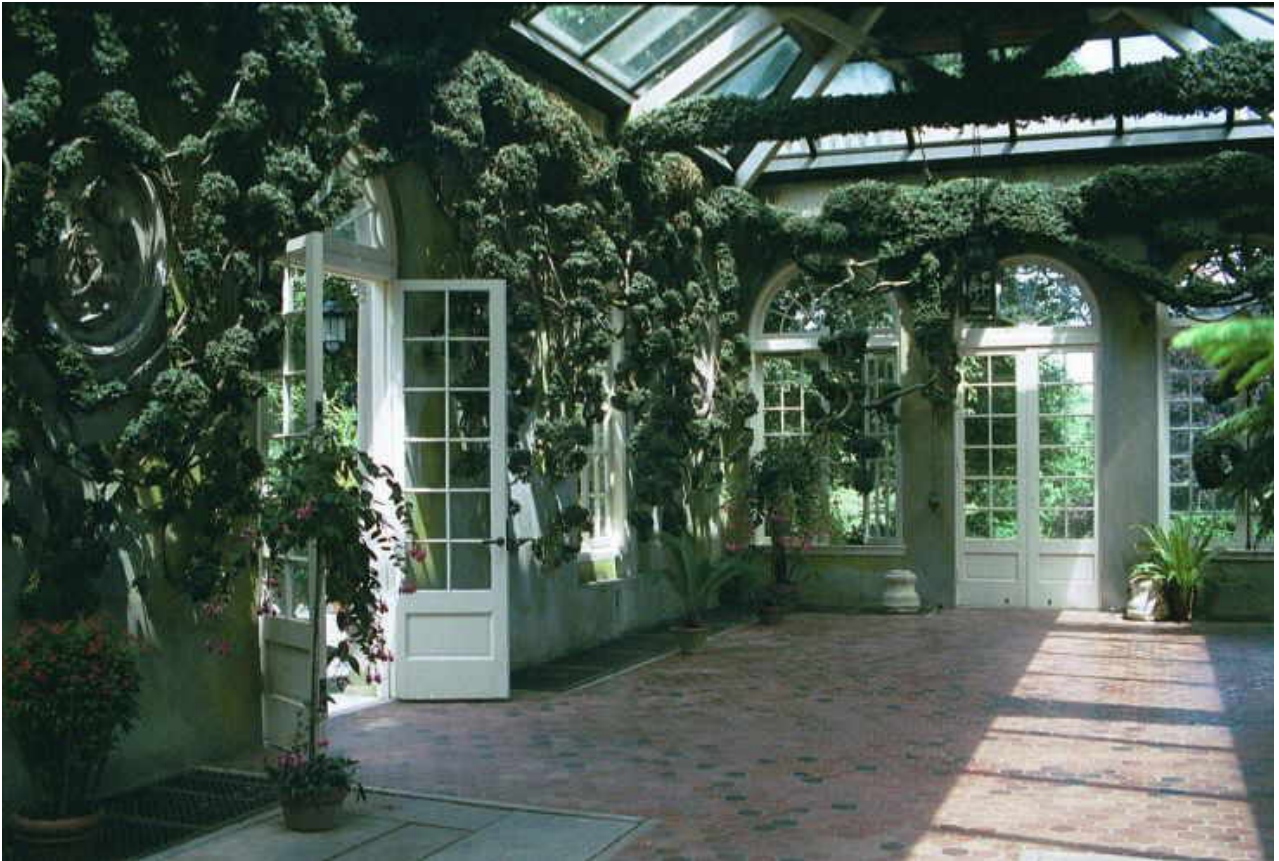
Figure 3.14 – The Greenhouse at Dumbarton Oaks in Washington, D.C. – Pictured here can be seen the vastly different utilization of glass and window features. This new experimentation with light and glass was a mile marker in the stylistic advancements and benefits of better and more scientific methods of construction. Photo retrieved from www.gardentraveler.com

The use of the orangery in the pleasure garden continued into the early nineteenth century. The major changes seen in the 19th century are primarily in the location and usage of glass. With more efficient heating methods and better construction materials, many new concepts were able to be cultivated. Two examples from that period are intact and open to the public. The greenhouse at Dumbarton Oaks in Washington, D.C. was probably built between 1805 and 1812. It is still used as a conservatory and retains much of its original form, although the roof has been replaced and now incorporates some glass, whereas the original roof had none (see Figure 3.14).

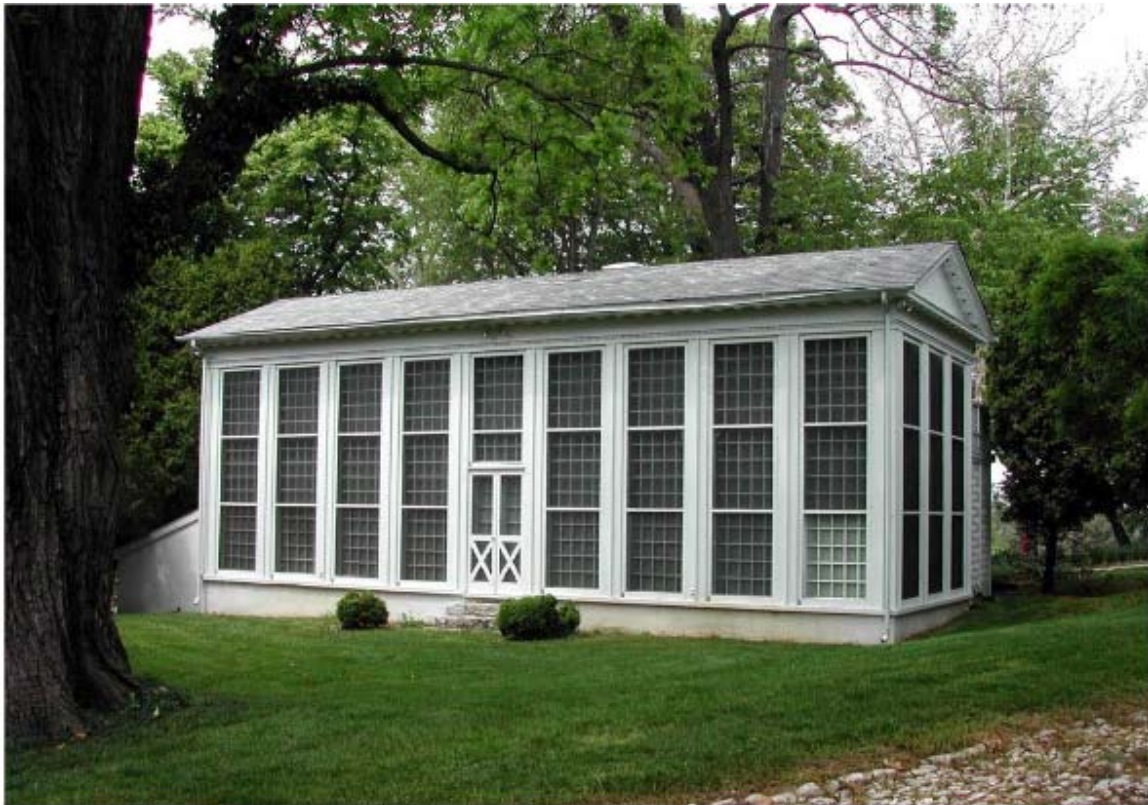
Figure 3.15 – The Greenhouse at Hampton, in Towson, Maryland – This reproduction was done in 1976, and depicts a fairly accurate representation of the original. Again you can see the emphasis on glass on multiple sides and the additional light exposure. Photo retrieved from National Park Service website.

The orangery at Hampton, in what is now Towson, Maryland, is a 1976 reconstruction based on physical evidence and period photographs of the Greek revival building erected about 1824 (see Figure 3.15). The original burned in 1928, leaving only the brick north and west walls. The orangery, which now contains no plants, is used as a meeting room. To gain access a door has been incorporated into the central triple-hung window in the south facade - a variance from the original design.

These two later orangeries provide an insight into the evolution of the building type since the eighteenth century. In both cases over-sized windows are set not only into the south wall, but also into other walls to provide additional light and ventilation. At Hampton, wood replaced masonry on the south and east walls, allowing for an even larger expanse of glass. Better heating methods and larger, cheaper panes of glass made the rigid restrictions of the eighteenth-century orangery obsolete (Britz, 1998).

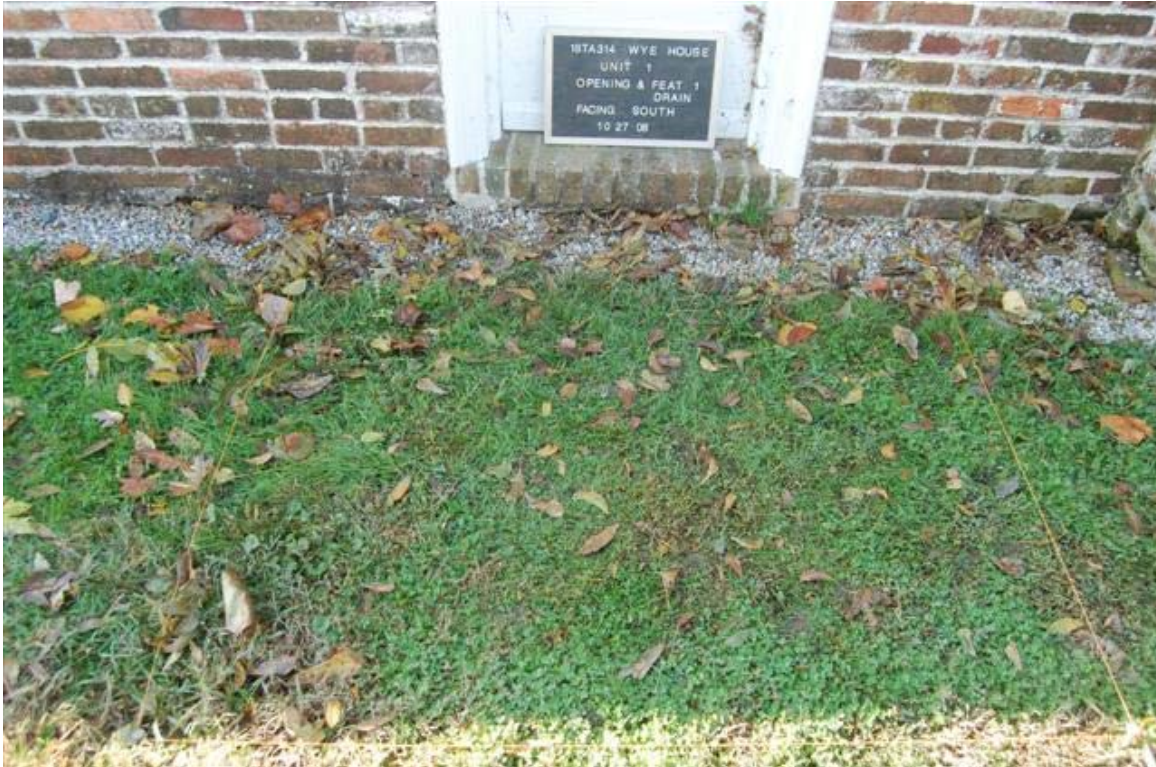
Figure 5.1 – Unit 1 Level A and Modern Drain (Feature 1) – This is the existing condition of Unit 1 prior to excavation. Photo by Matthew Cochran

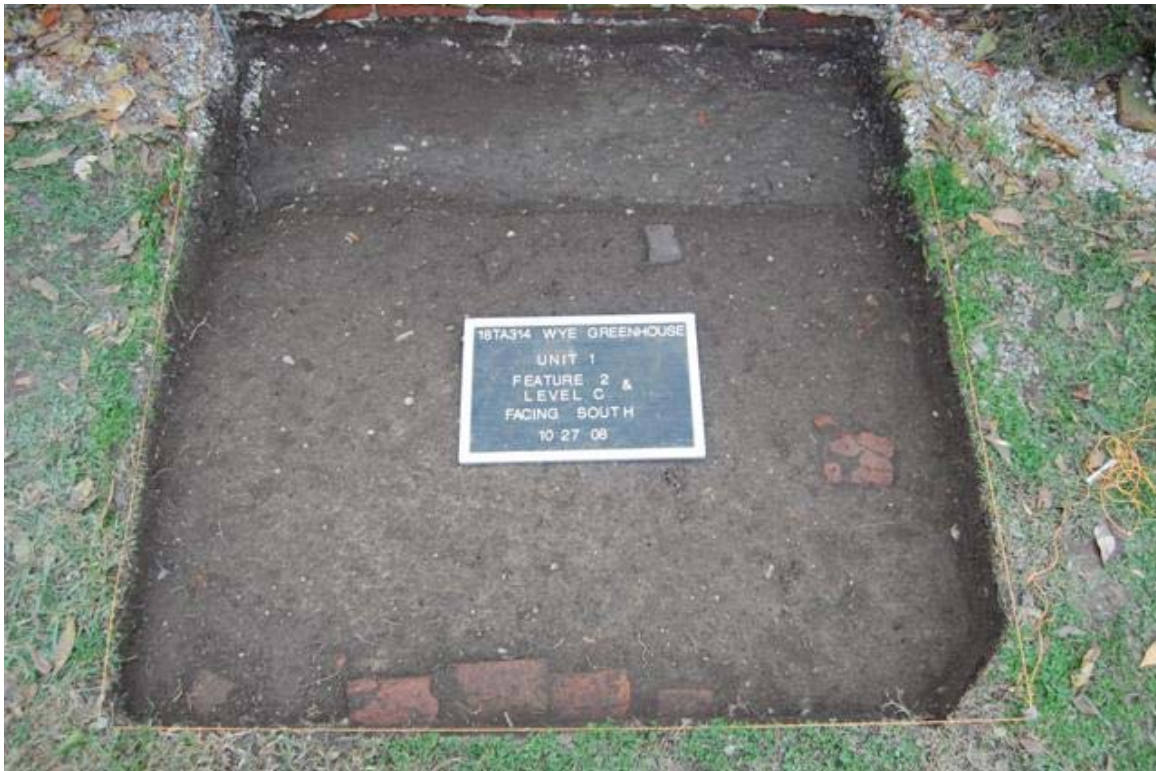
Figure 5.2 – Unit 1 Feature 2 – This is the brick pad that is contiguous with the one from Unit 2. Photograph by John Blair.

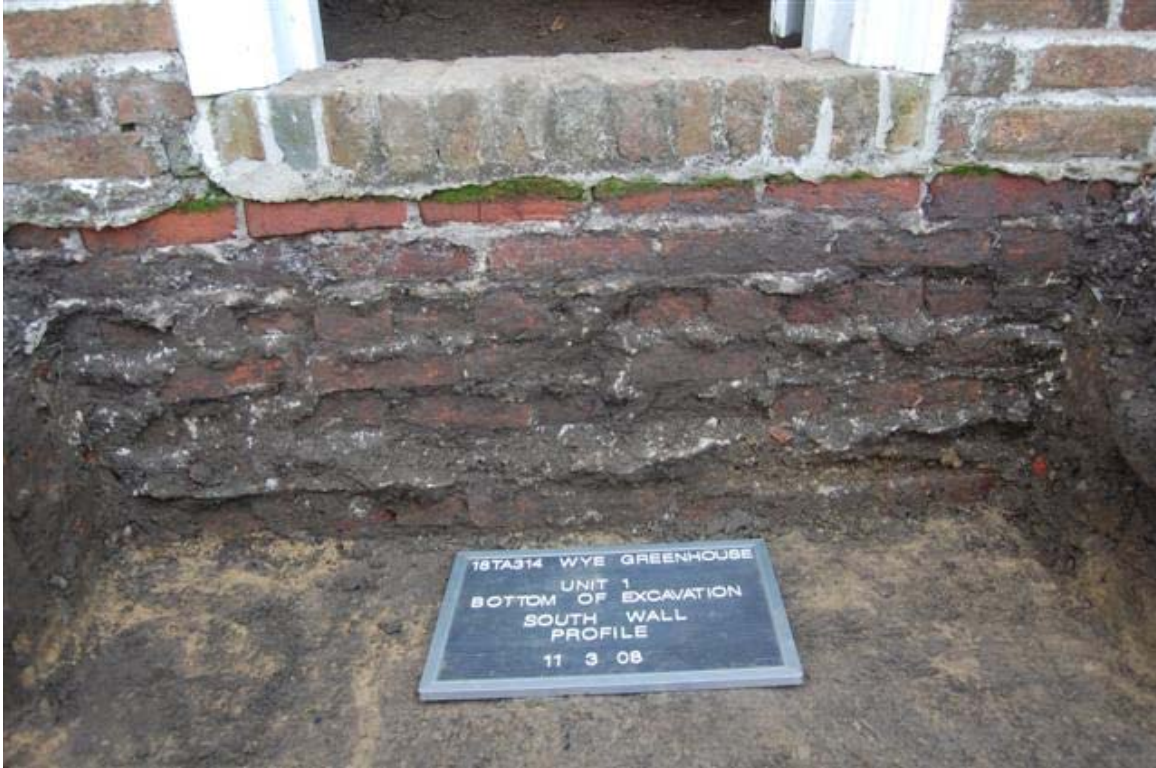
Figure 5.3 – Unit 1 Foundation – This is a photograph that shows the mortar being compressed between the bricks so that that mortar has come out the front of the bricks and has set on the face of them. Photograph by John Blair.

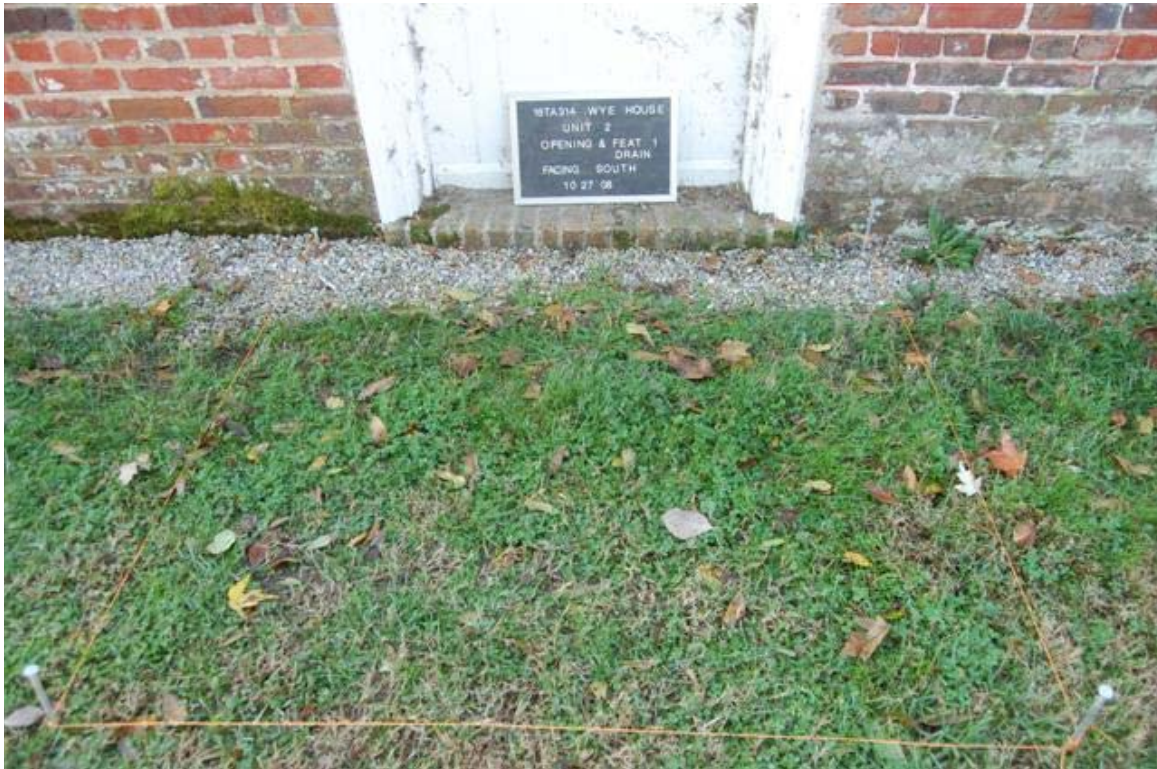
Figure 5.5 – Unit 2 Level A and Modern Drain (F.1) – This is the existing condition of Unit 2 prior to excavation. Photo by Stephanie Duensing

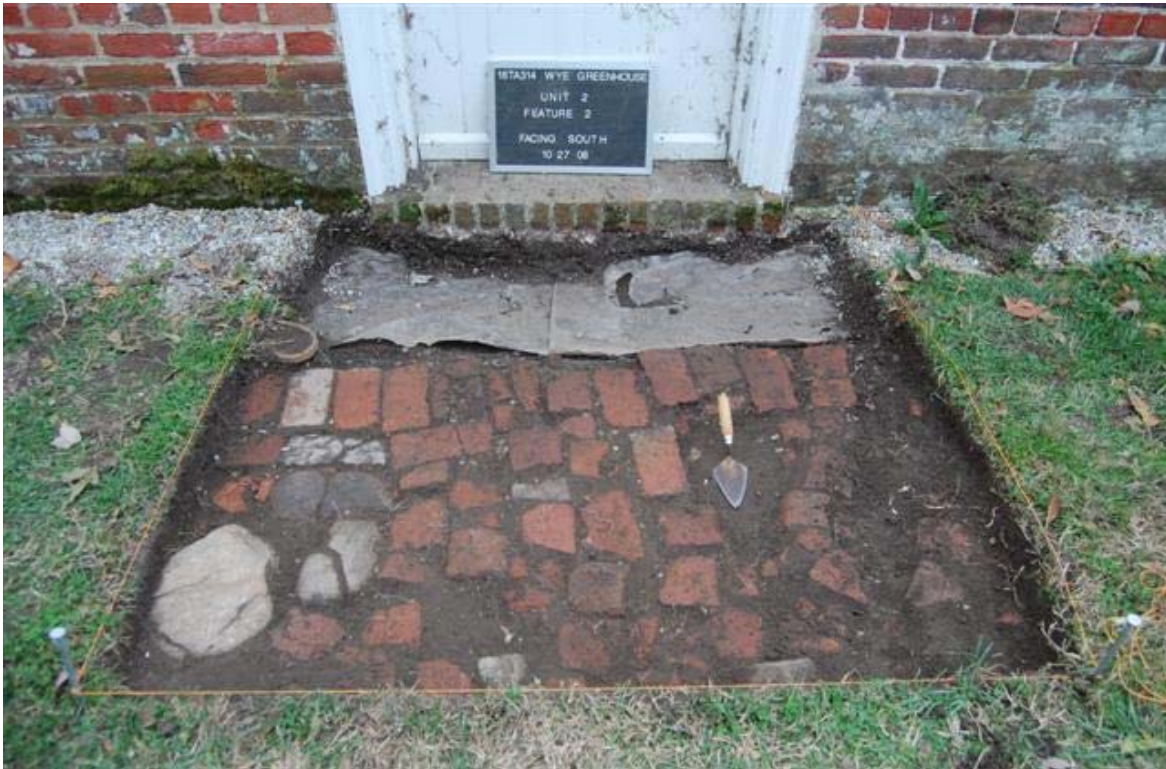
Figure 5.6 – Unit 2 Brick Pad (F.2) – This brick feature was constructed out of both whole and fragmented brick as well as natural stone. Photo by Stephanie Duensing

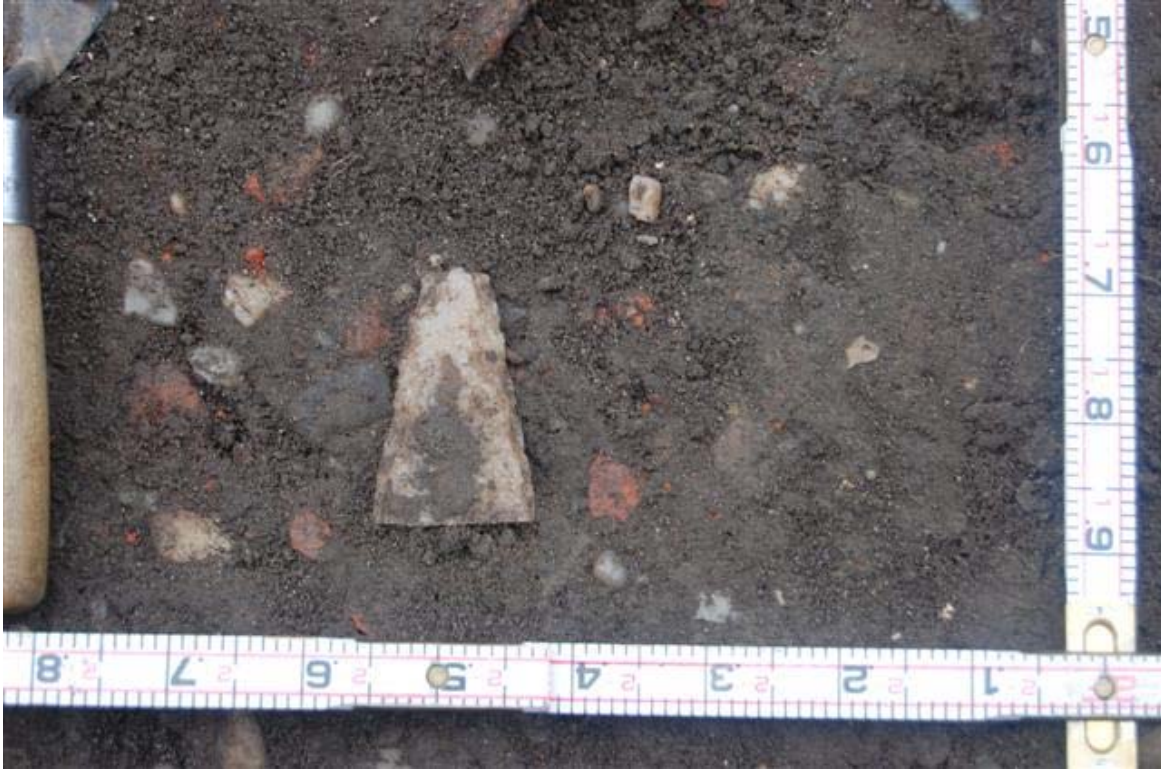
Figure 5.7 – Unit 2 Quartz Point – After removal of the brick feature (F.2) a prehistoric quartz projectile point was discovered. It is similar other prehistoric points found in the area that date to the late woodland period (500-1000CE). Photo by Stephanie Duensing

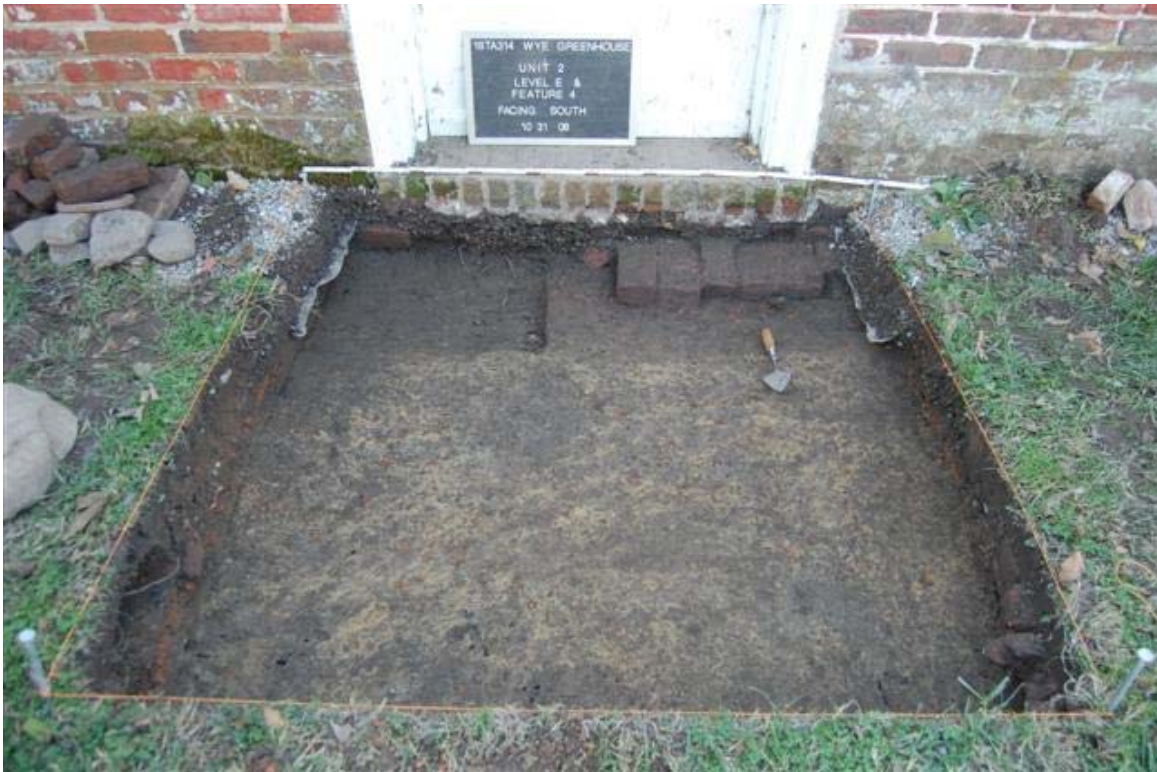
Figure 5.8 – Unit 2 Drip Line (Feature 4) – The Builder’s Trench revealed a dry-laid foundation supporting the living quarter behind the main block of the greenhouse. The clay subsoil showed “pockets” or small voids, most likely due to rodent and root disturbance. Photo by Stephanie Duensing

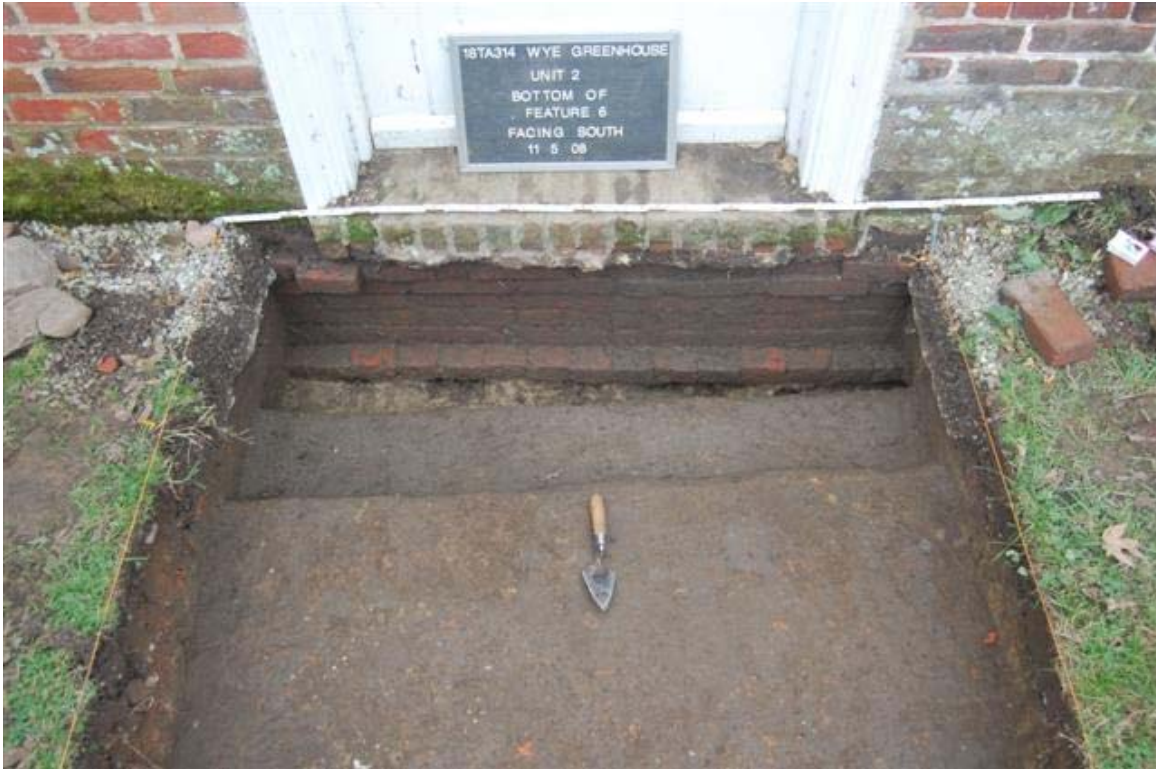
Figure 5.9 – Unit 2 Builder’s Trench (Feature 6) – The Builder’s Trench revealed a dry-laid foundation supporting the living quarter behind the main block of the greenhouse. The clay subsoil showed “pockets” or small voids, most likely due to rodent and root disturbance. Photo by Stephanie Duensing

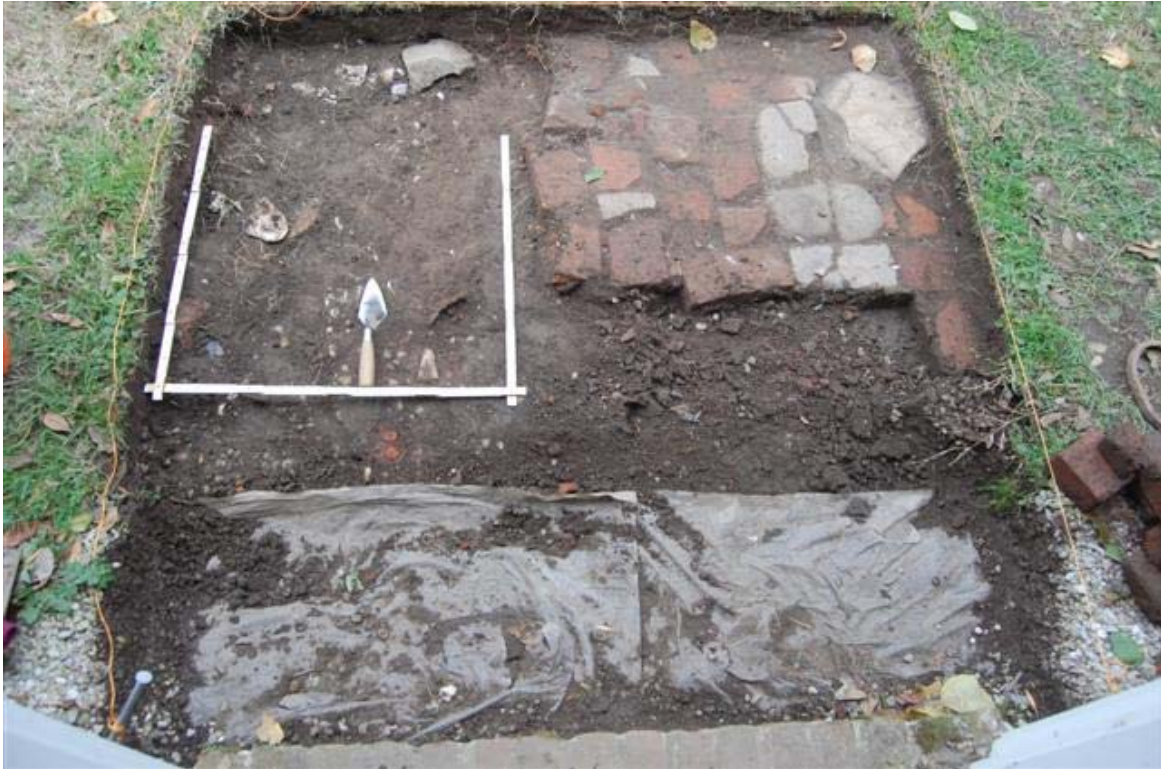
Figure 5.10 – Unit 2 Quartz Point – After removal of the brick feature (F.2) a prehistoric quartz projectile point was discovered. This point was situated facing North under the walking surface of the threshold. Photo by Stephanie Duensing

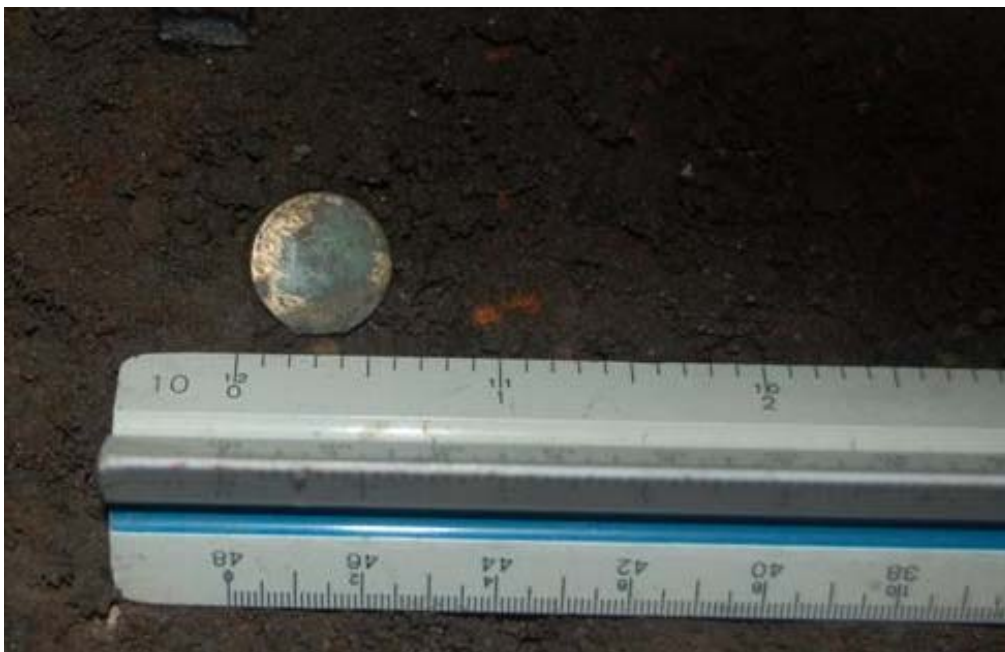
Figure 5.11 – Unit 2 Brass Button – This small, brass button was found in association with the brick pad (Feature 2) and the prehistoric projectile points also recovered in Level C. Photo by Stephanie Duensing

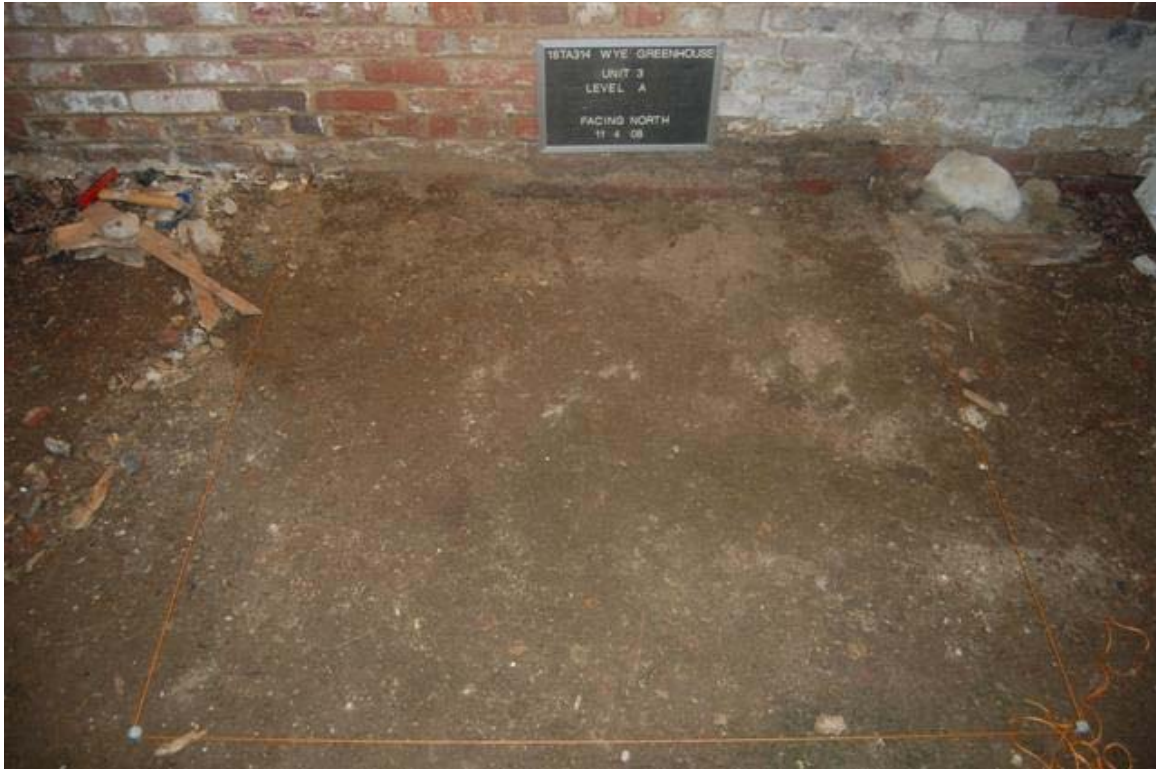
Figure 5.14 – Unit 3 Level A Opening of Excavation – This is the existing condition of Unit 3 prior to excavation. Photo by Matthew Cochran.

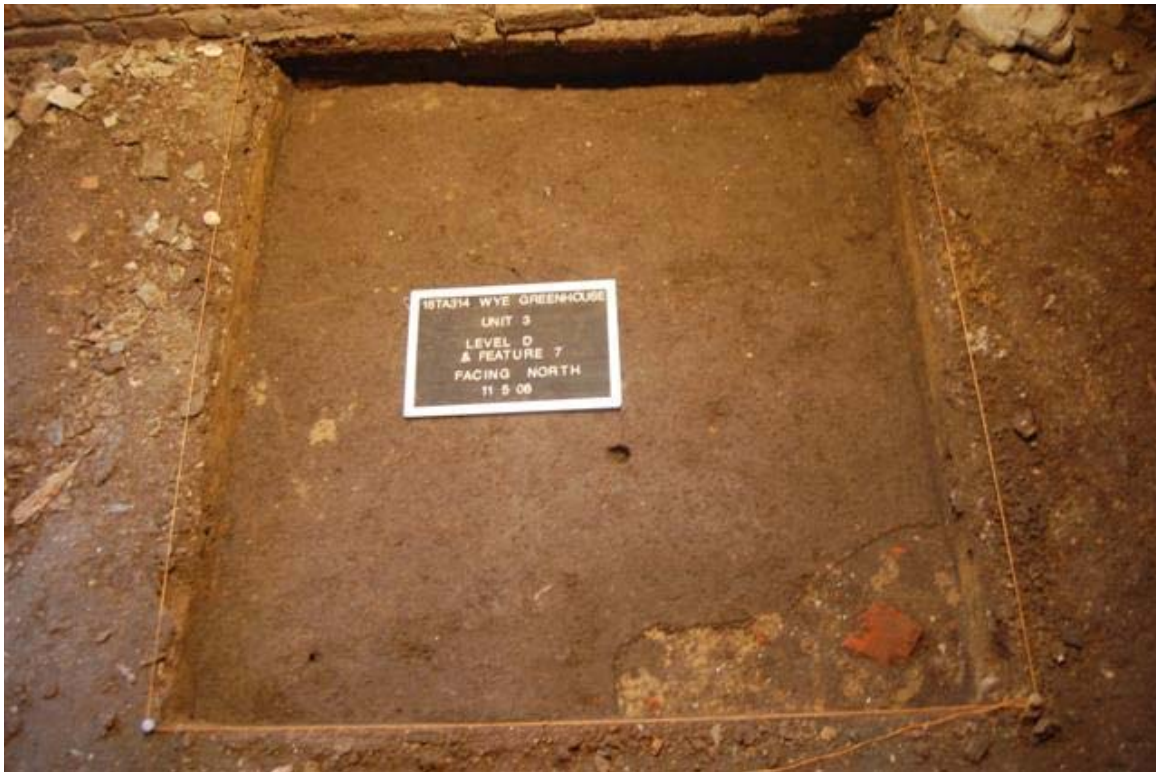
Figure 5.15 – Unit 3 Feature 7 – This is the outline of the post hole and post mold that was found in Unit 3. Photograph by John Blair

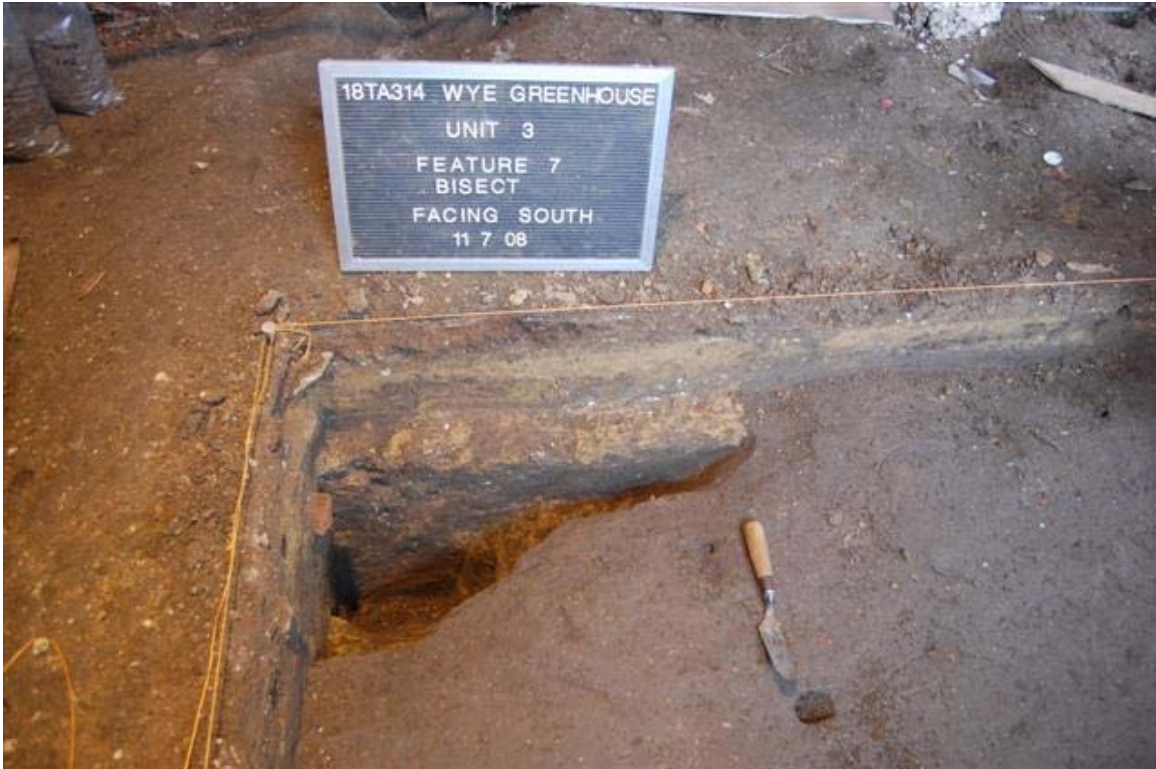
Figure 5.16 – Unit 3 Feature 7 – This is the post hole and post mold mid excavation. The bottom of the post hole was lined with bricks that would have been used to support the post. Photograph by Matthew Cochran.

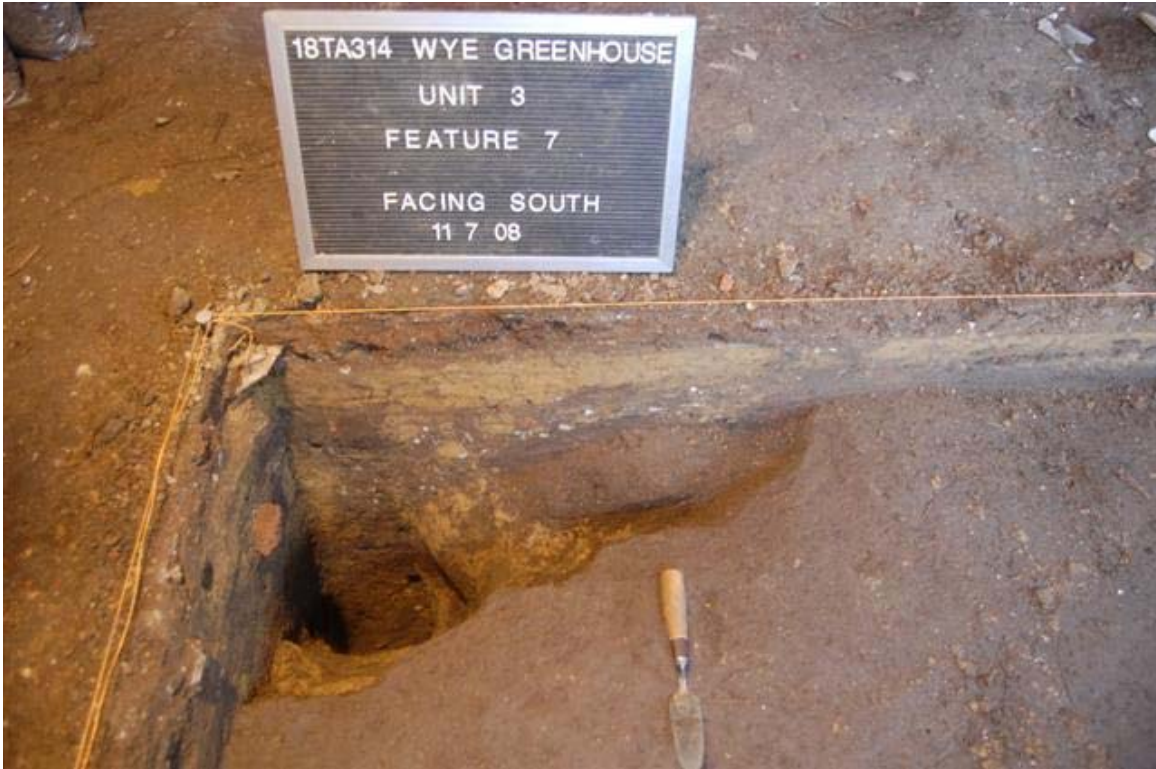
Figure 5.17 – Unit 3 Feature 7 – Post hole fully excavated. The post hole was excavated to almost a depth of three feet, and was a scaffolding post or a structural post. Photograph by John Blair

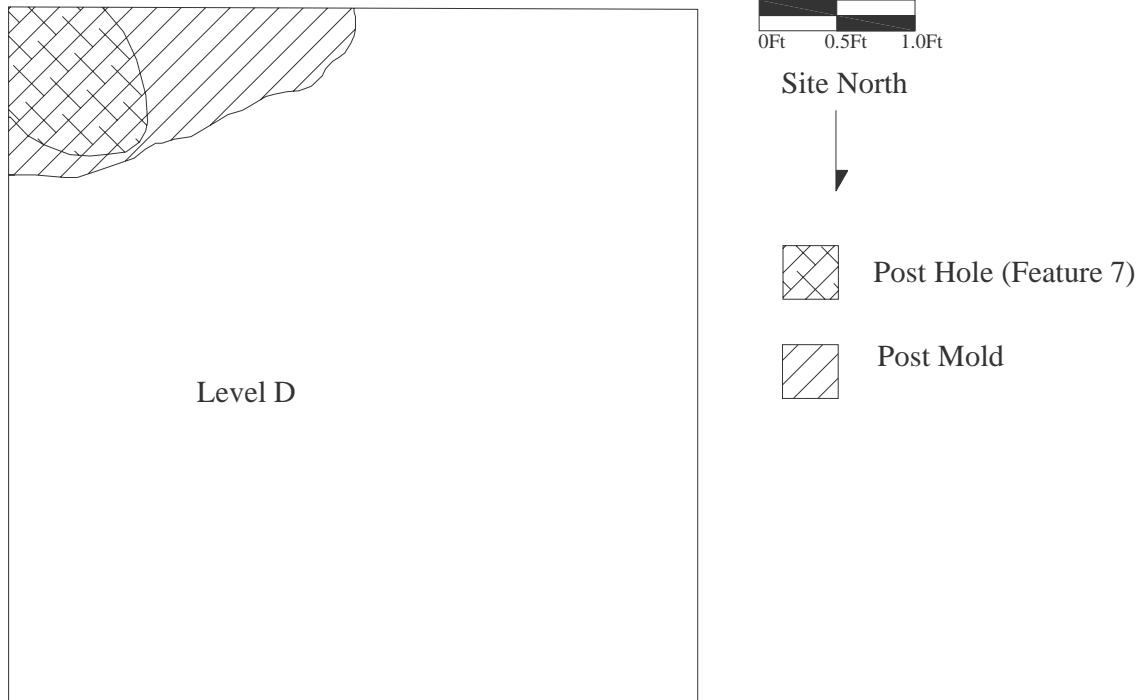
Level D	10YR3/2 with	A horizon
	10YR5/4Clay loam	
Feature 7	10YR3/4 With	
	10YR5/6Clay	Post hole

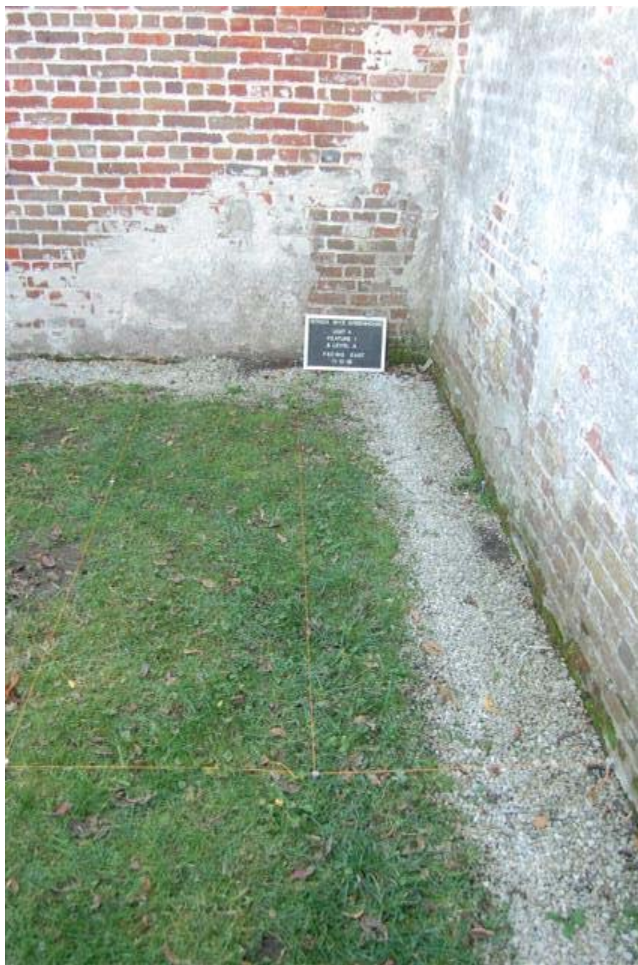
Figure 5.20 – Unit 4 Level A and Modern Drain (Feature 1) – This is the opening view of Unit 4. This photo was taken facing east and shows the western wall of the living quarter straight ahead and the northern wall of the Greenhouse to the right.
Photo by Stephanie Duensing

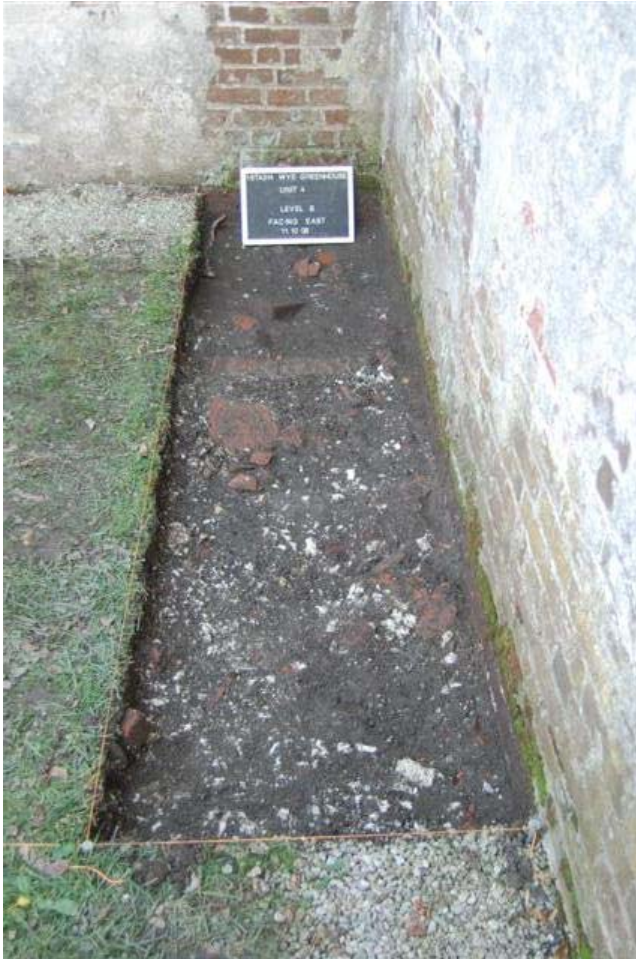
Figure 5.21 – Unit 4 Rubble Layer (Level B) and Brick Pier (Feature 8) – The rubble seen here is Level B and abruptly ends once it reaches the brick pier (Feature 8). This led us to the conclusion that the rubble was localized to the westernmost portion of the wing.
Photo by Stephanie Duensing

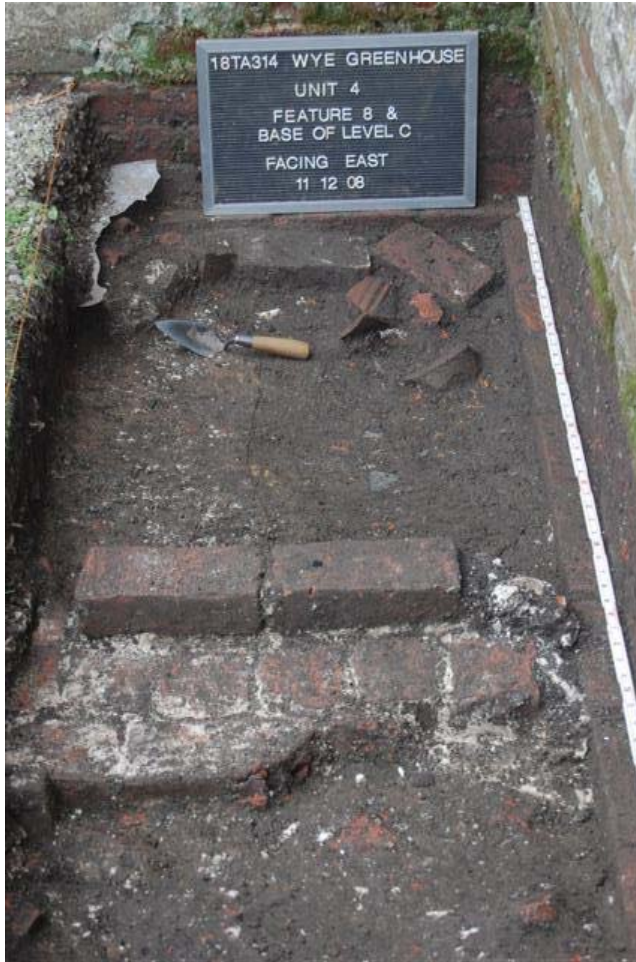
Figure 5.22 – Unit 4 Domestic Deposit (Level C), Brick Pier (Feature 8) and Architectural Layer (Level D) – The rubble seen here is Level C and is composed primarily of domestic materials. West of the brick pier (Feature 8) the content changed to brick, mortar and nails. Photo by Stephanie Duensing
