**Phase II Archaeological Testing on Wye Greenhouse (18TA314), Talbot
County, Maryland, 2008**

Report Prepared for
Tilghman Family

Abstract

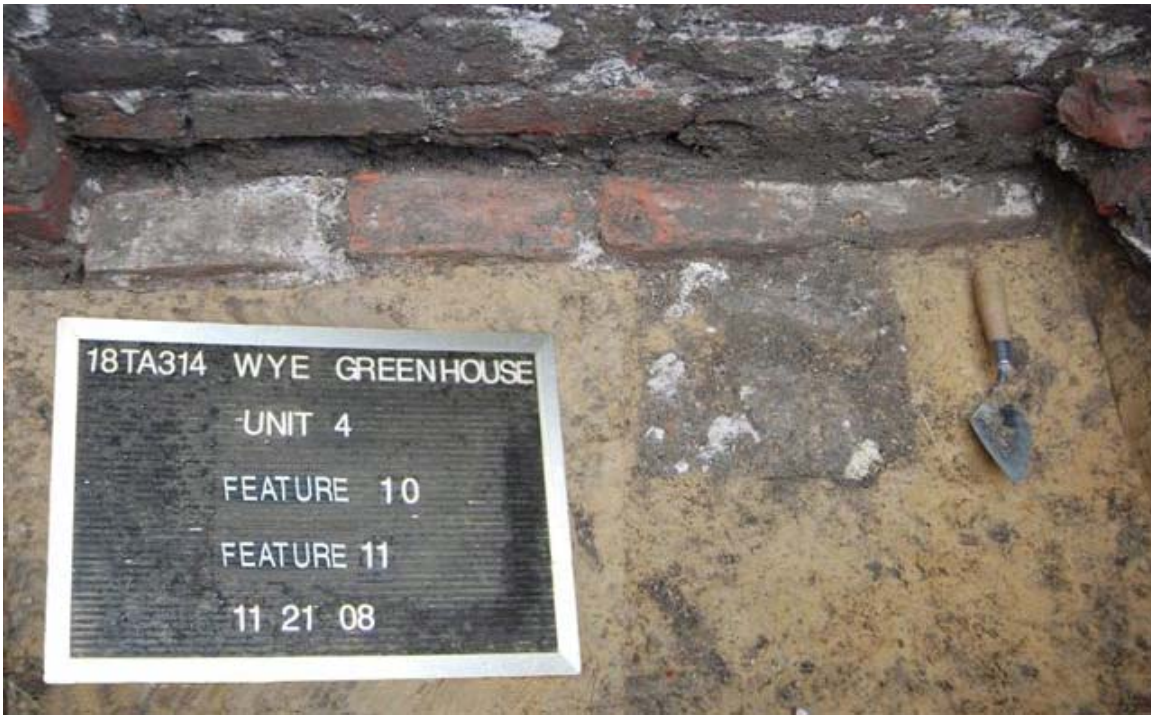
Figure 5.23 – Unit 4 Brick Footer (Feature 10) and Post Hole (Feature 11) – The course of brick seen here is Feature 10 and is completely unattached to the current foundation wall. It is off-set where it attaches to the footer of the eastern foundation (on the left side) and ends just after the fourth brick (on the right side). This is believed to be the remnants of a preexisting structural wall. Photo by Stephanie Duensing

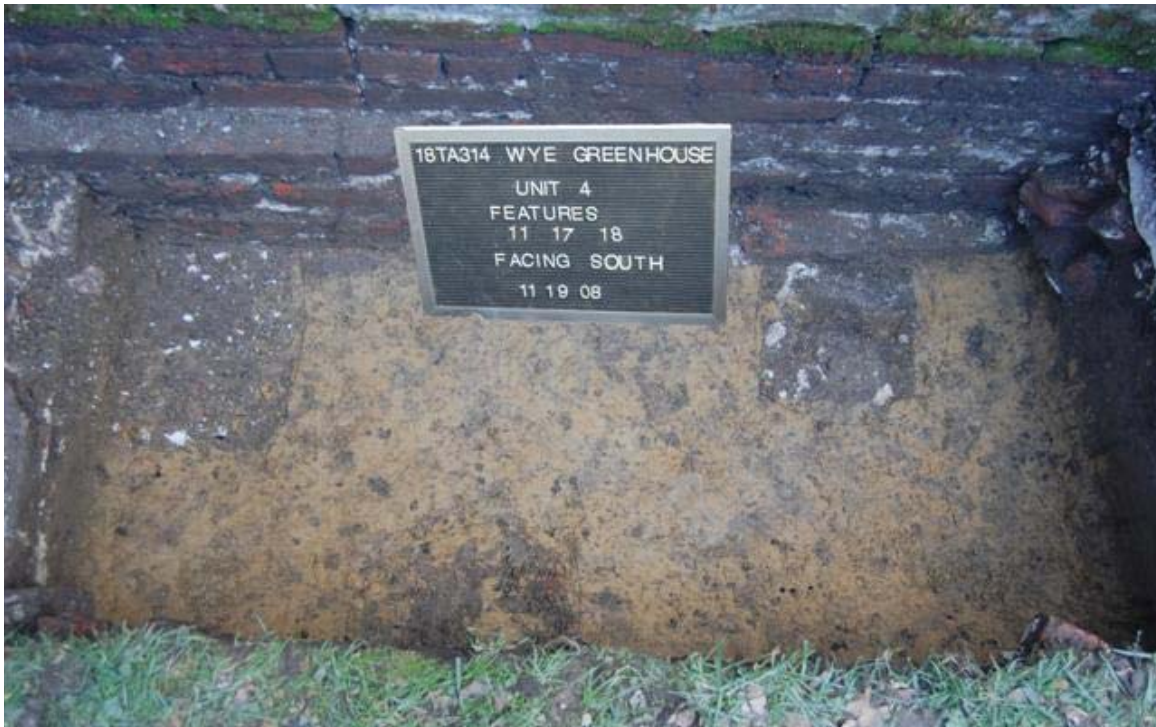
Figure 5.24 – Unit 4 Post Holes (Features 11, 17 & 18) – The post holes pictured here were discovered in Unit 4, cutting into the subsoil. They were most likely associated with entry stairway to the second story loft above the main block of the Greenhouse. Photo by Stephanie Duensing

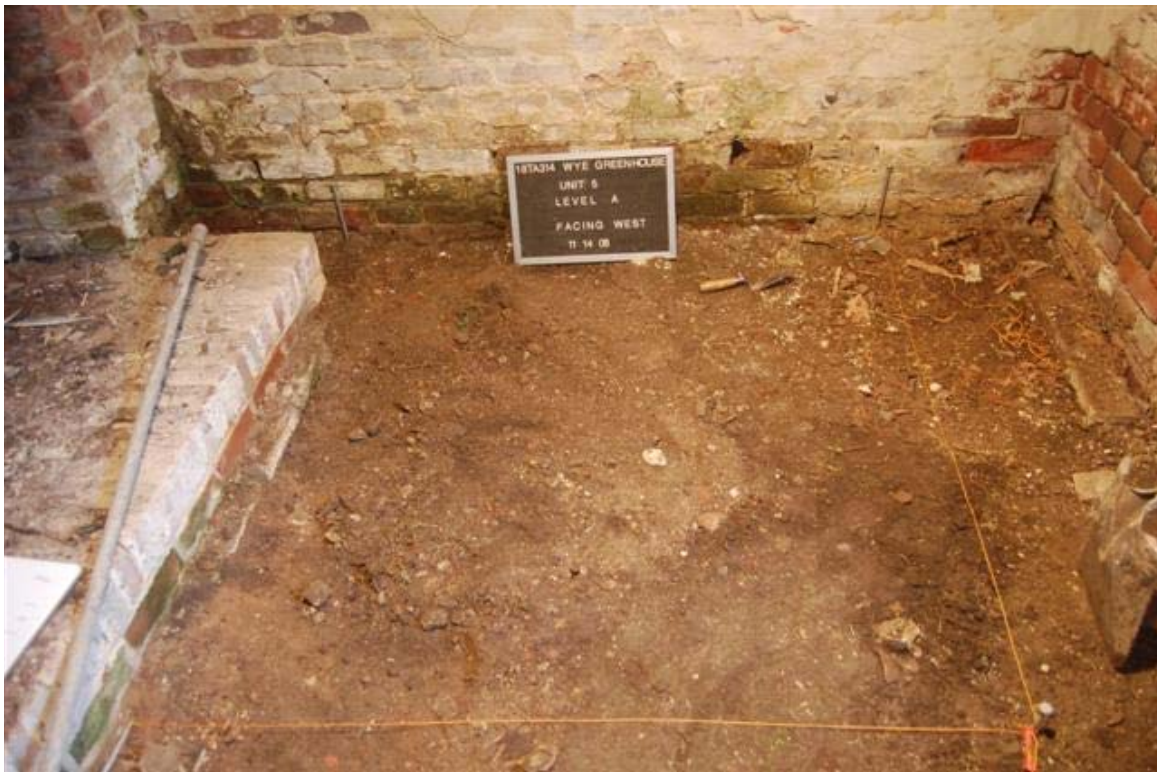
Figure 5.27 – Unit 5 Level A1 – This is the existing condition of Unit 5 prior to excavation. Photo by Matthew David Cochran

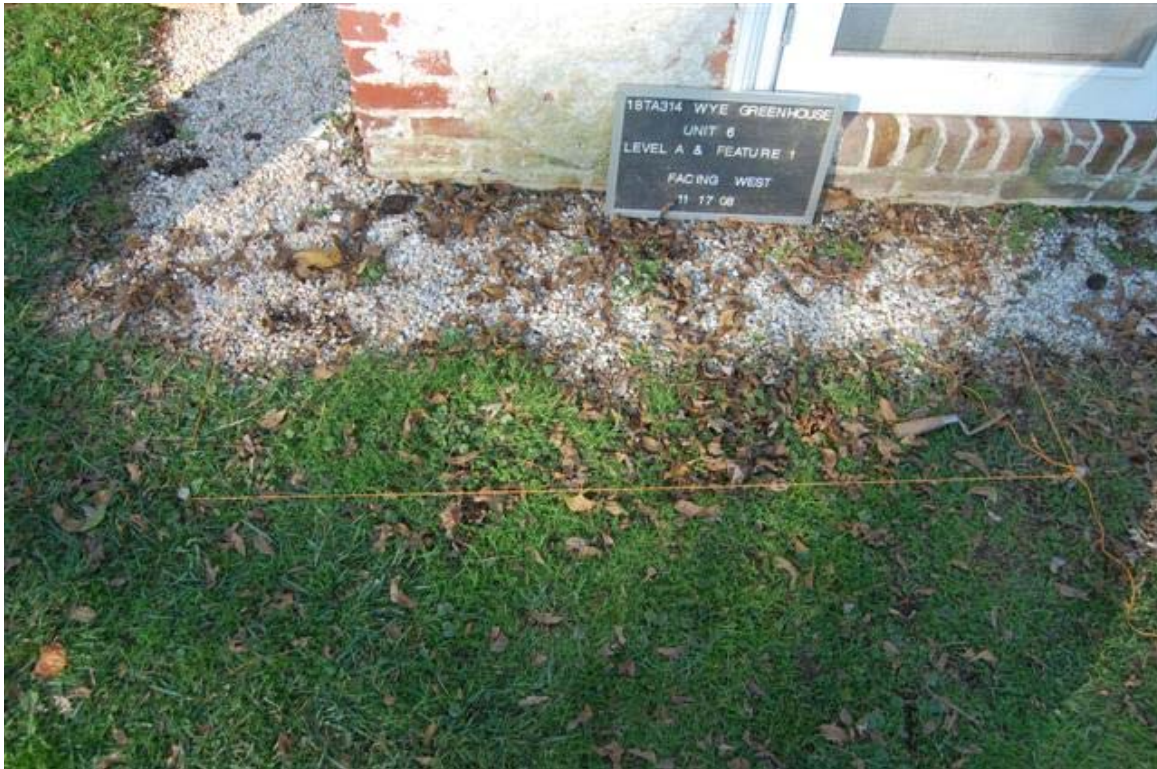
Figure 5.30 – Unit 6 Level A and Modern Drain (Feature 1) – This is the existing condition of Unit 1 prior to excavation. Photograph by John Blair.

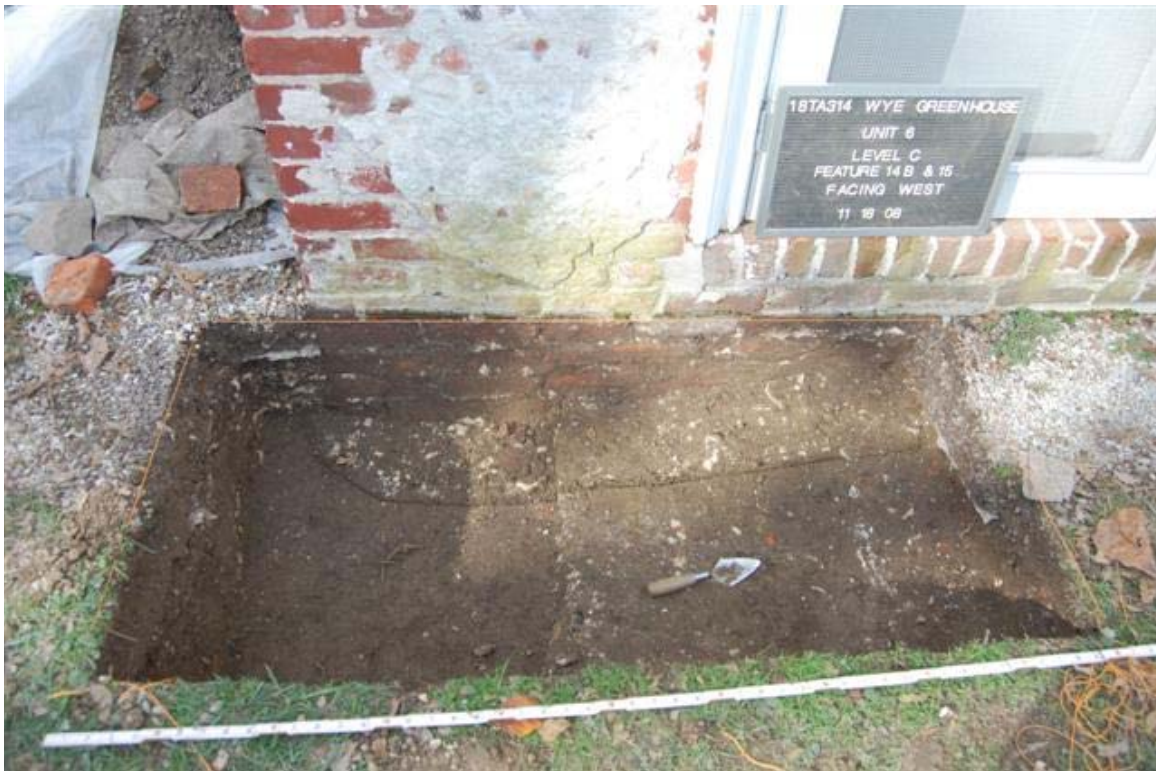
Figure 5.31– Unit 6 Feature 15 – This is the builders' trench for the east wall of the Greenhouse. The trench exposed a seven layer brick foundation. Photograph by John Blair.

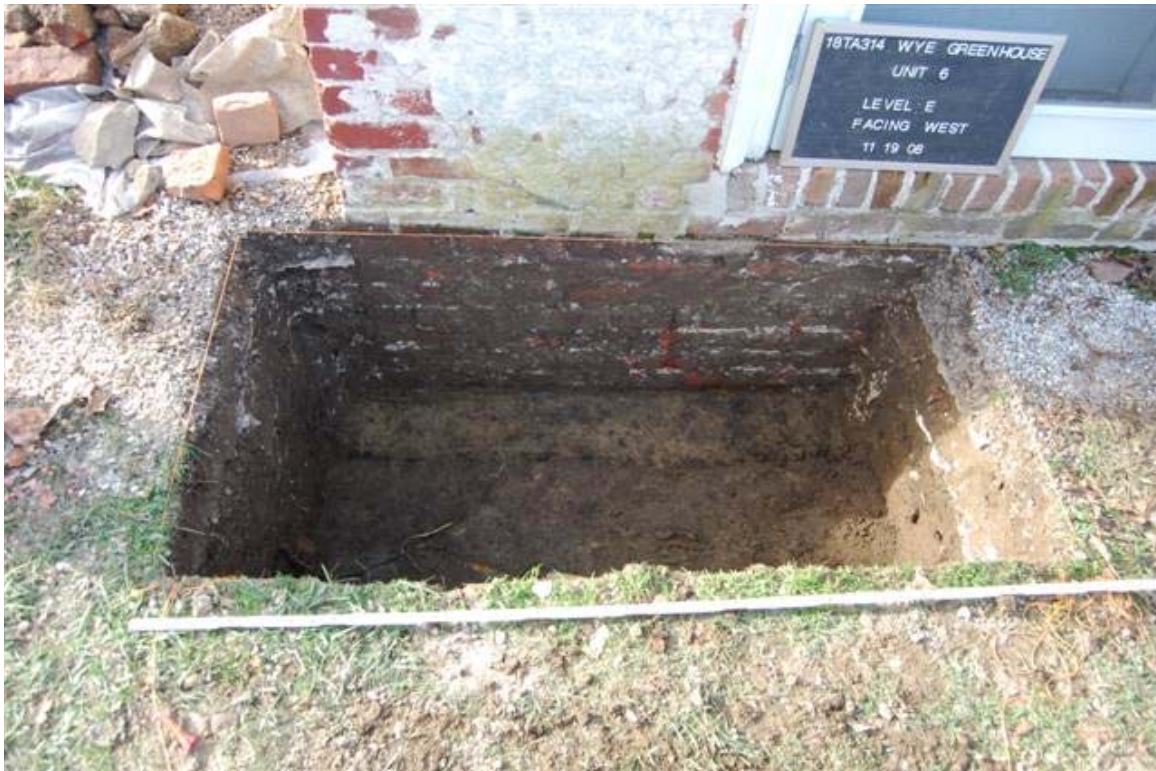
Figure 5.32 – Unit 6 Level E – This is the buried “A horizon” in this unit. The soil that represents the buried A horizon is generally rich in organic nurturance and was once the topsoil. Photograph by John Blair.

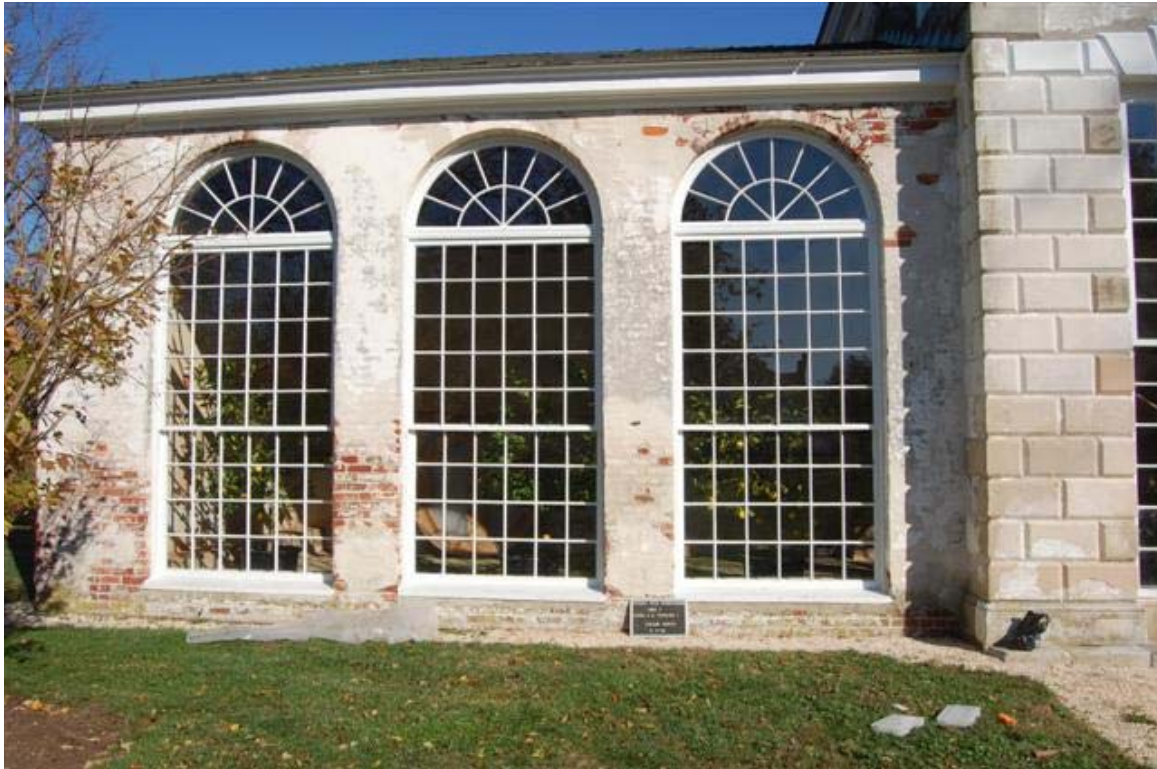
Figure 5.34 – Unit 7 Level A and Modern Drain (Feature 1) – This is the existing condition of Unit 7 prior to excavation. Photo by Matthew David Cochran

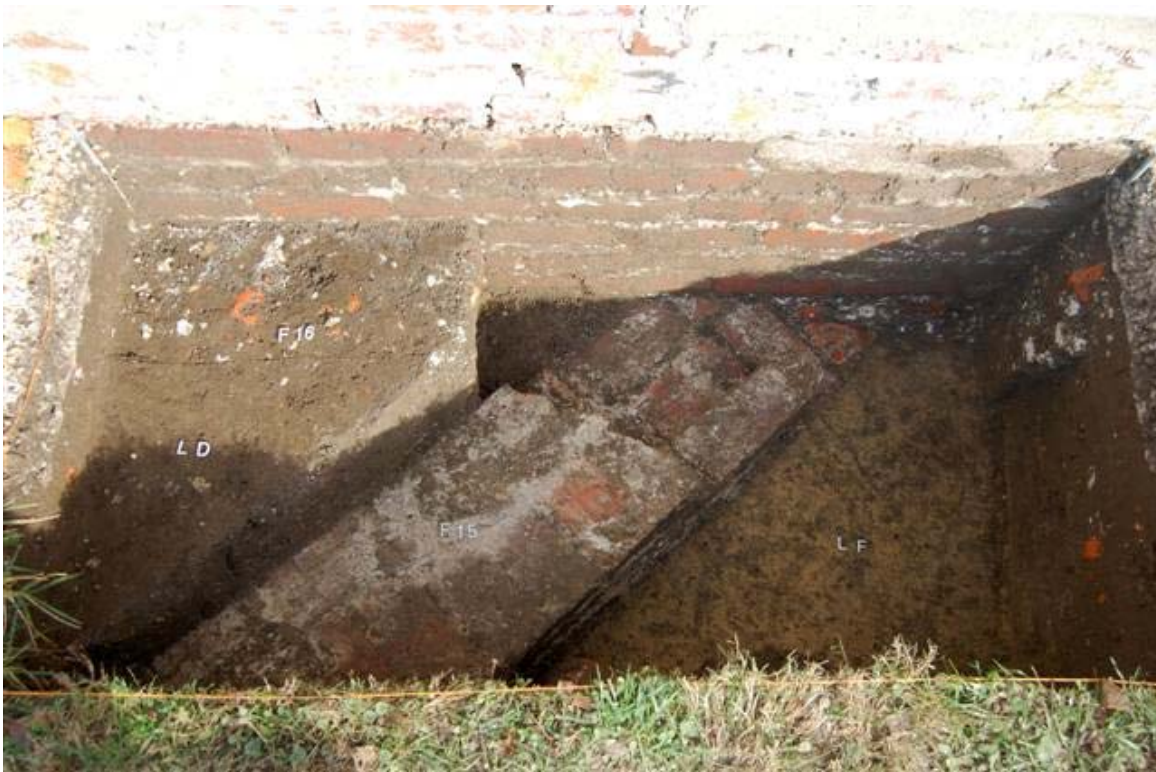
Figure 5.35 – Unit 7 Feature 15 – The pre-1784 brick wall extended out from the Greenhouse foundation at roughly a 45 degree angle. Photo by Matthew David Cochran.

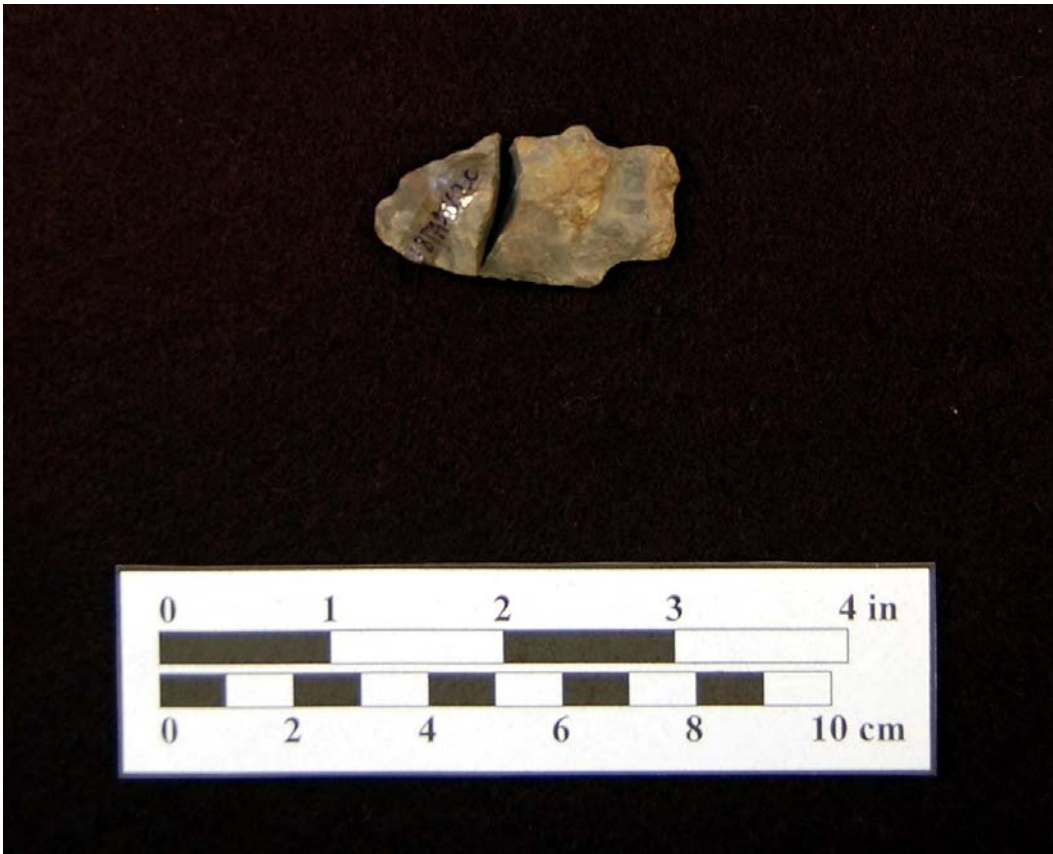
Figure 5.38 – Chert Projectile Point – A limited number of Native American Artifacts were recovered during the Wye Greenhouse Testing. Artifacts such as this chert projectile point show that the area was inhabited by Native Americans prior to European colonization. Photo by Molly Robbins.

In Test Unit 1 there was a single chert projectile point recovered from the builder's trench. Since it was recovered from the builder's trench, it does not give us much insight into the prehistoric era. However, we did recover prehistoric artifacts once we excavated the buried "A Horizon." A single pottery sherd was recovered along with an oyster shell feature. The feature did not reveal anything except oyster shell, but we could identify the ceramic sherd as Accokeek.

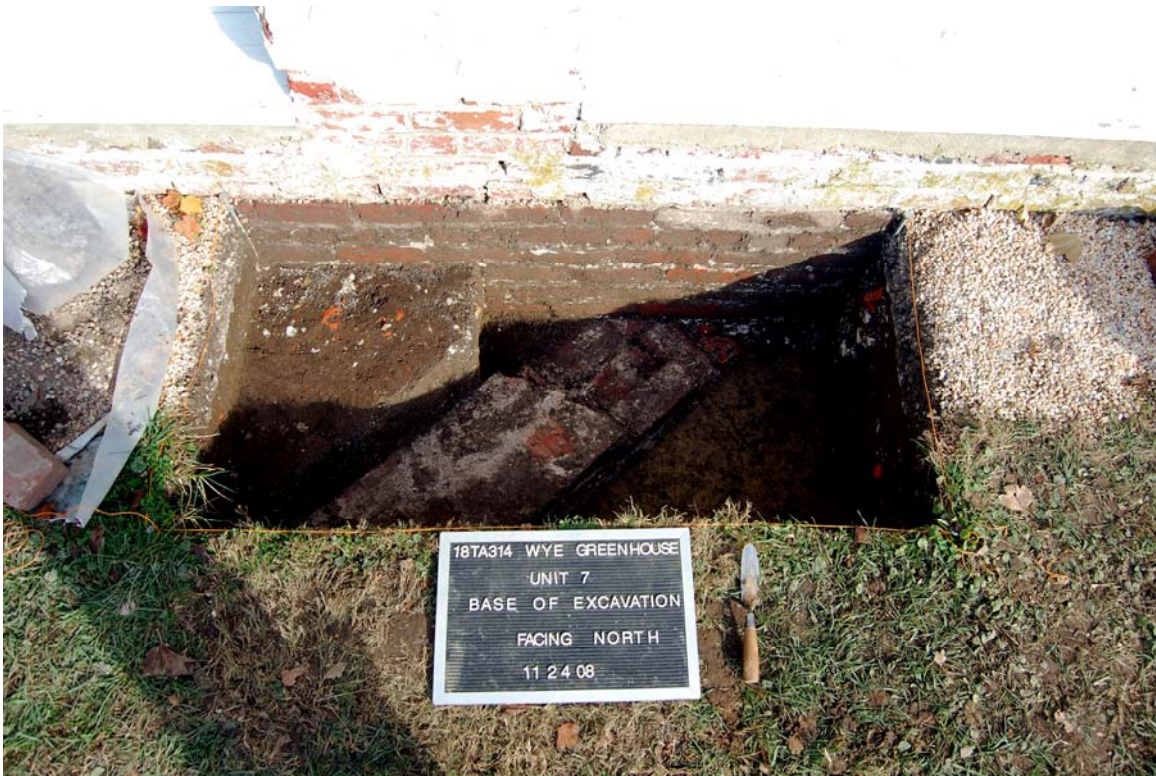
Figure 5.39 – Unit 7, Angled Wall – The remnants of a partially destroyed wall jutting out from the south façade of the Greenhouse suggests that the original Wye Greenhouse had a different architectural footprint prior to the 1784 redesign. Photo by John Blair

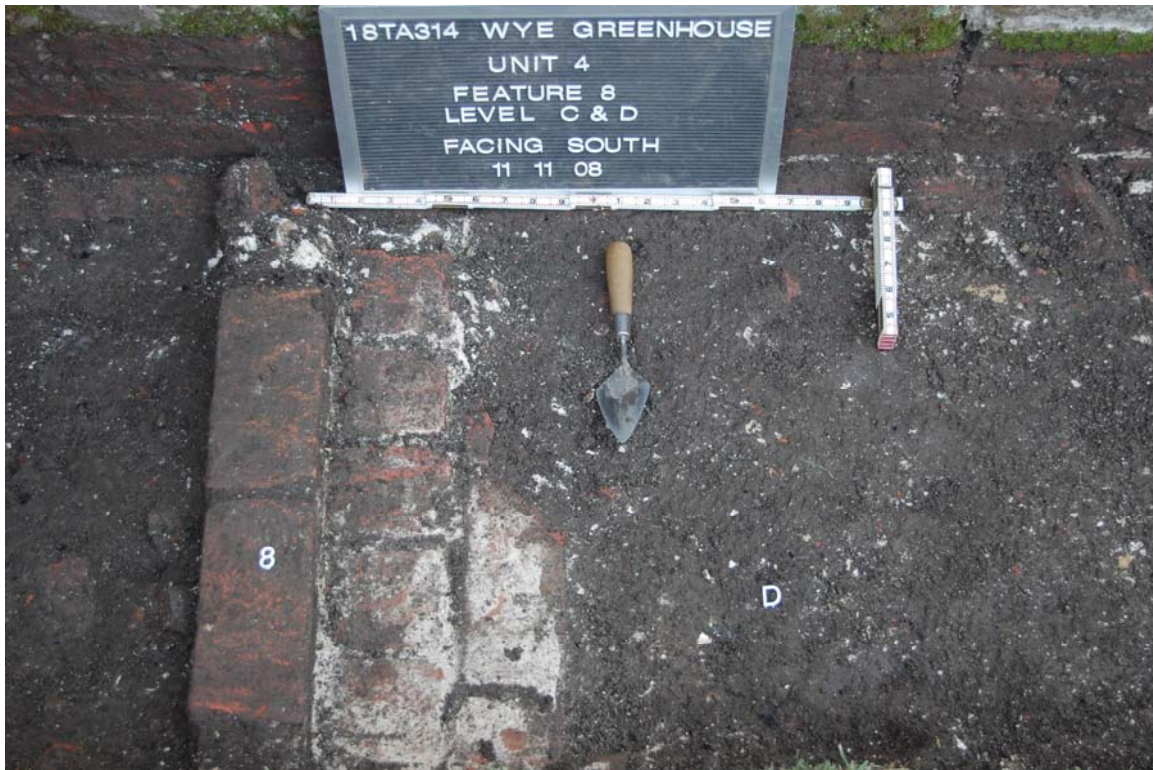
Figure 5.40 – Brick Staircase Footer – A brick staircase footer found in Test Unit 2 was part of the 1784 redesign. This footer was part of a staircase used to access the greenhouse's second floor social space. Photo by Stephanie Duensing

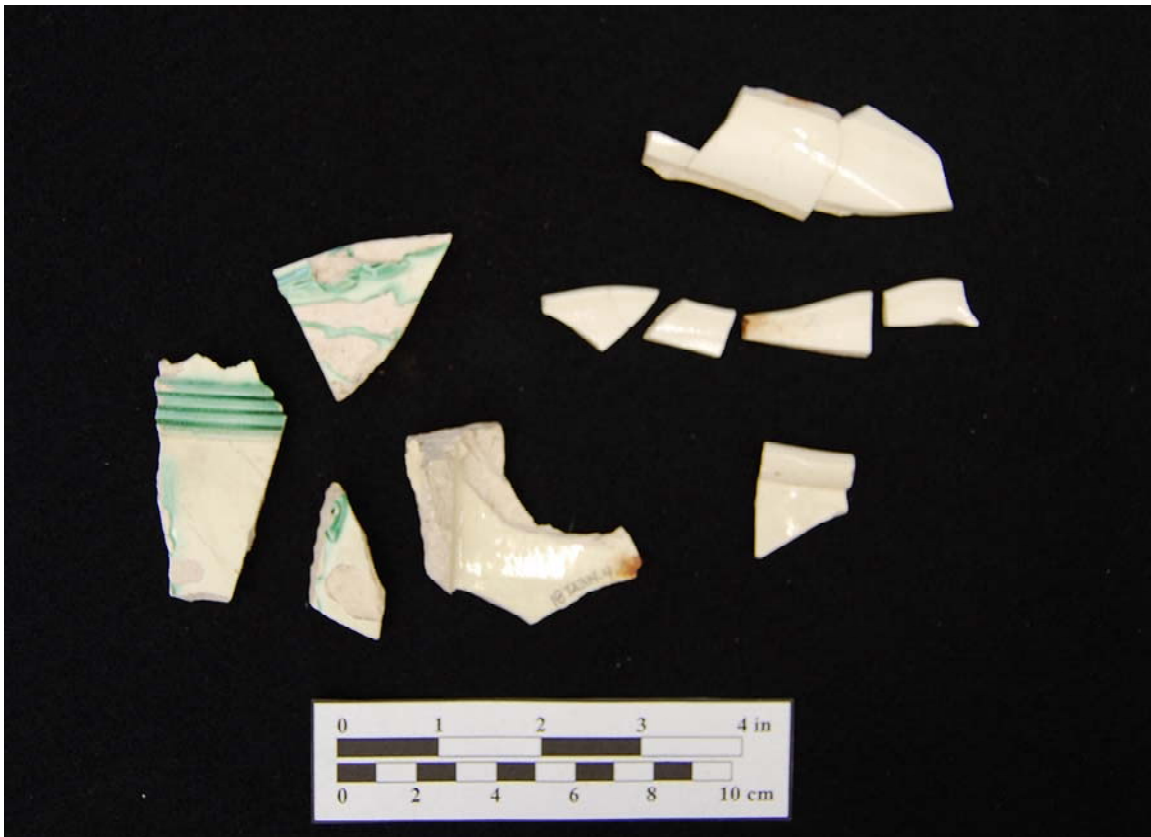
Figure 5.41 – Sherds of 18th Century English Creamware From Unit 4 – A minimum vessel count (MVC) conducted on sherds of ceramics identifies vessel ware types, vessel forms and use. Ceramics in this photo likely represent three distinct table vessels (left-pitcher, upper right-plate, lower right-unidentified table ware. Photo by Molly Robbins

The MVC conducted on the two specific contexts mentioned previously sorted ceramics by ceramic type (i.e. creamware, pearlware, etc.); by vessel form (i.e. plate, bowl, etc.), and finally by use (gardening wares, food preparation wares, table wares, tea wares, and table/tea Wares). The sorting of particular ceramic vessels into the generalized categories outlined above was done to create a base comparison. While the sorting categories of ceramic types and forms are rather straightforward, the last sorting category, ceramic use, is slightly more complicated. After all, finding a ceramic tea cup does not necessarily mean that it had to have been used for the consumption of tea. Likewise a sugar bowl does not have to have been used for sugar within a tea service. The use of any given ceramic vessel depends on the cultural, social, and economic context within which that ceramic vessel was associated. For instance, it seems rather likely that high-style tea service vessels associated with the Lloyd family's use of the second floor pool/social room were associated with long-standing patterns of Anglo-American tea consumption. This may or may not be true when it comes to tea vessels associated with the Greenhouse's enslaved residents of the north shed/slave quarter. Tea vessels associated with this particular context were most certainly used within much different economic circumstances and potentially within different cultural/social circumstances. The

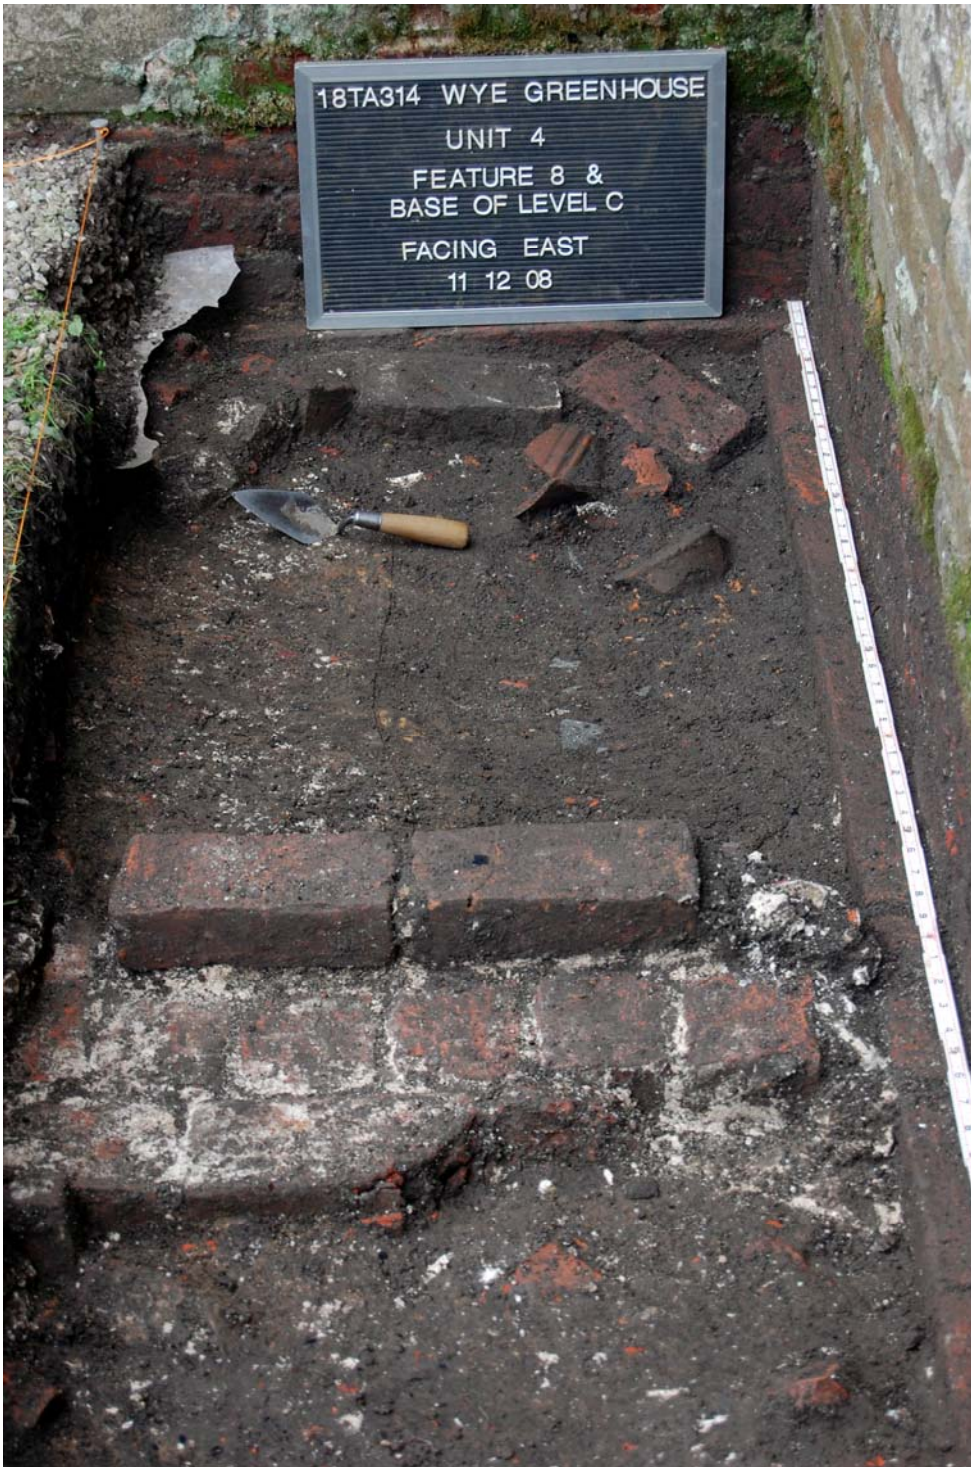
Figure 5.42 – Ceramics Behind 18th Century Staircase Footer in Unit 4 – A large number of English and American-made ceramics were found behind a stair footer used to access the Greenhouse’s second floor. This dump of ceramics contained flower pots, as well as table and tea vessels likely used by the Lloyd family. Photo by Stephanie Duensing

Ceramics recovered from Unit 4, and associated with both 18th and early 19th century gardening practices as well as the Lloyd family's use of the Greenhouse's second floor, were found in a unique archaeological context. Located between a stair footer for the Greenhouse's second floor and the north shed/slave quarter's exterior west wall, archaeological testing uncovered what is best described as an intentional ceramic dump (see Figure 5.42; see also Unit 4 Summary for further details). These ceramics, dating from roughly the 1790s through the 1830s, appear to have been intentionally placed behind the stairs and adjacent to the exterior wall. Out of immediate sight, it seems probable that this dump of ceramics was used as a convenient place to deposit broken ceramic vessels as well as a dump that may likely have been used in 18th and early 19th century gardening practices. Broken ceramics are often used as filler materials placed in the base of flower pots, both to take up soil space and to aid in drainage. The unusually high percentage of ceramic sherds recovered from this context indicates that these scenarios are likely the case.

A Ceramic MVC determined that there were a total of 30 distinct ceramic vessels within this context. The overwhelming majority of vessels represented in this assemblage were medium to large sized unglazed course earthenware flower pots (60%). Also found within this assemblage was a smaller percentage of English and American-made ceramics related to domestic consumption (40%). These particular ceramics include a high percentage of table and tea wares (see table for specific ceramics vessels). Nearly absent from this assemblage are ceramic forms related to the production of food. Based on this observation, it seems likely that this assemblage, minus the unglazed course earthenware flower pots, is related to eating and drinking on the Greenhouse's second floor.

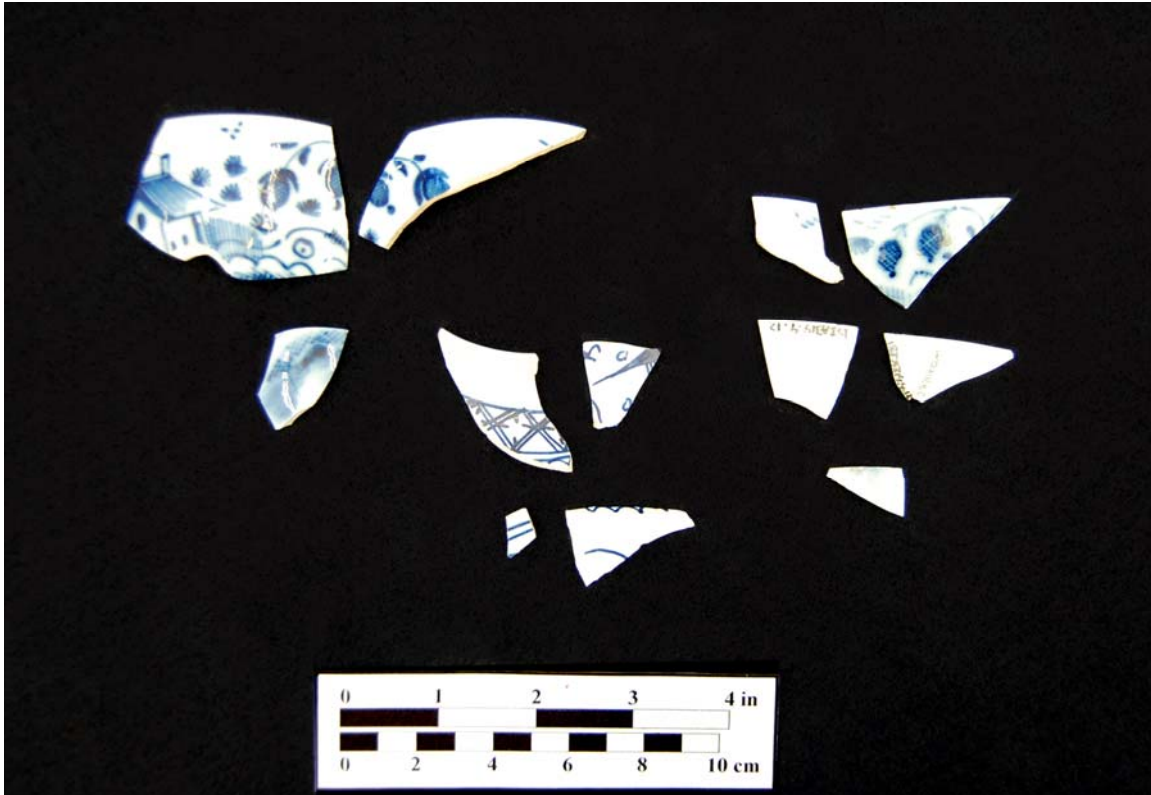
Figure 5.44 – Late 18th/Early 19th Century Chinoiserie Pearlware – Matching sets of ceramics associated with the Lloyd family’s use of the Greenhouse’s second floor included a high percentage of tea wares. One set of Chinoiserie pearlware included a slop bowl – upper left, a tea canister – center, and a tea cup - right. Photo by Molly Robbins

Of particular interest in this assemblage are what appear to be two matching sets of tea and table wares. One creamware plate and a matching creamware pitcher may represent a single table setting. Another set of hand-painted Chinoiserie pearlware pieces may represent a tea ware set. Included within this set are one tea cup, one slop bowl, and one tea canister, all with Chinese-house patterns. Also included within this range of tea and table settings are a number of polychrome vessels including a Mocha ware tea service bowl on a pearlware body, and a unidentified Peasant Palette pearlware tea/table hollow-ware form. Taken together, these two matching sets and pieces of other potentially matching sets span a date range from the early 1790s through the early 1830s.

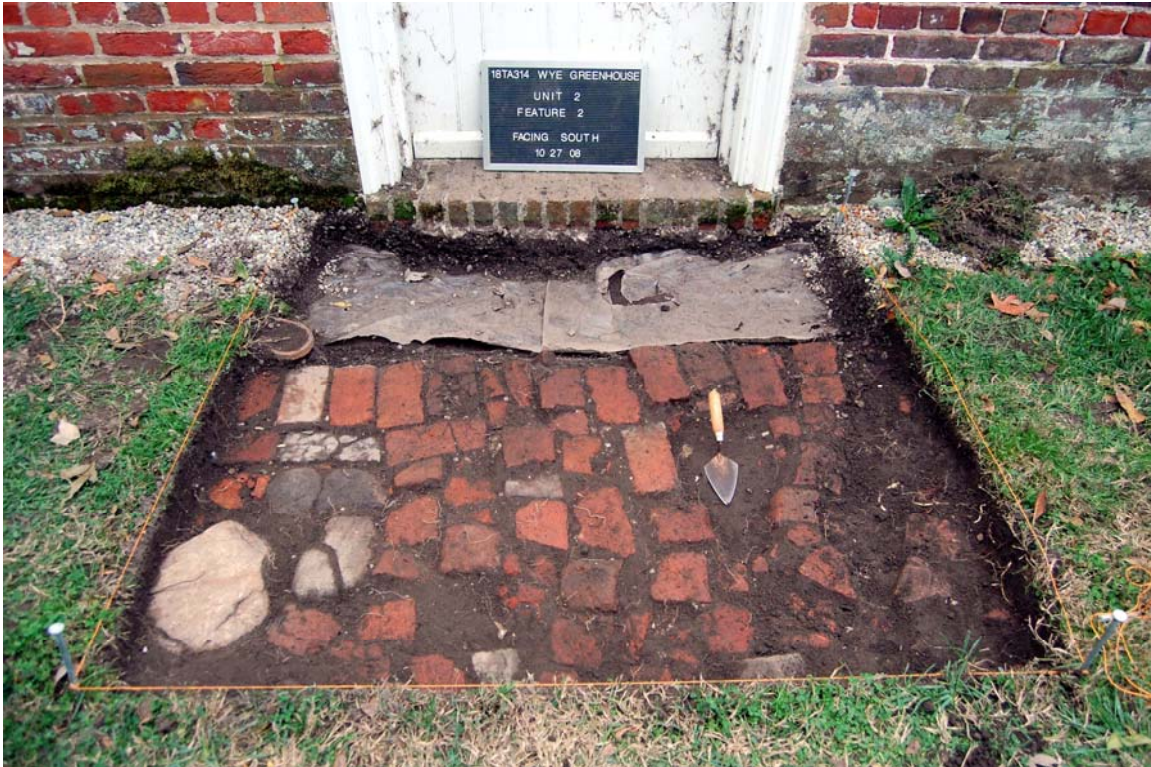
Figure 5.45 – Unit 2, 19th Century Workyard – Test Units 1,2,3, and 5 contained material culture associated with late 18th and 19th century enslaved African-American residents of the Greenhouse's north shed/slave quarter. Photo by Stephanie Duensing

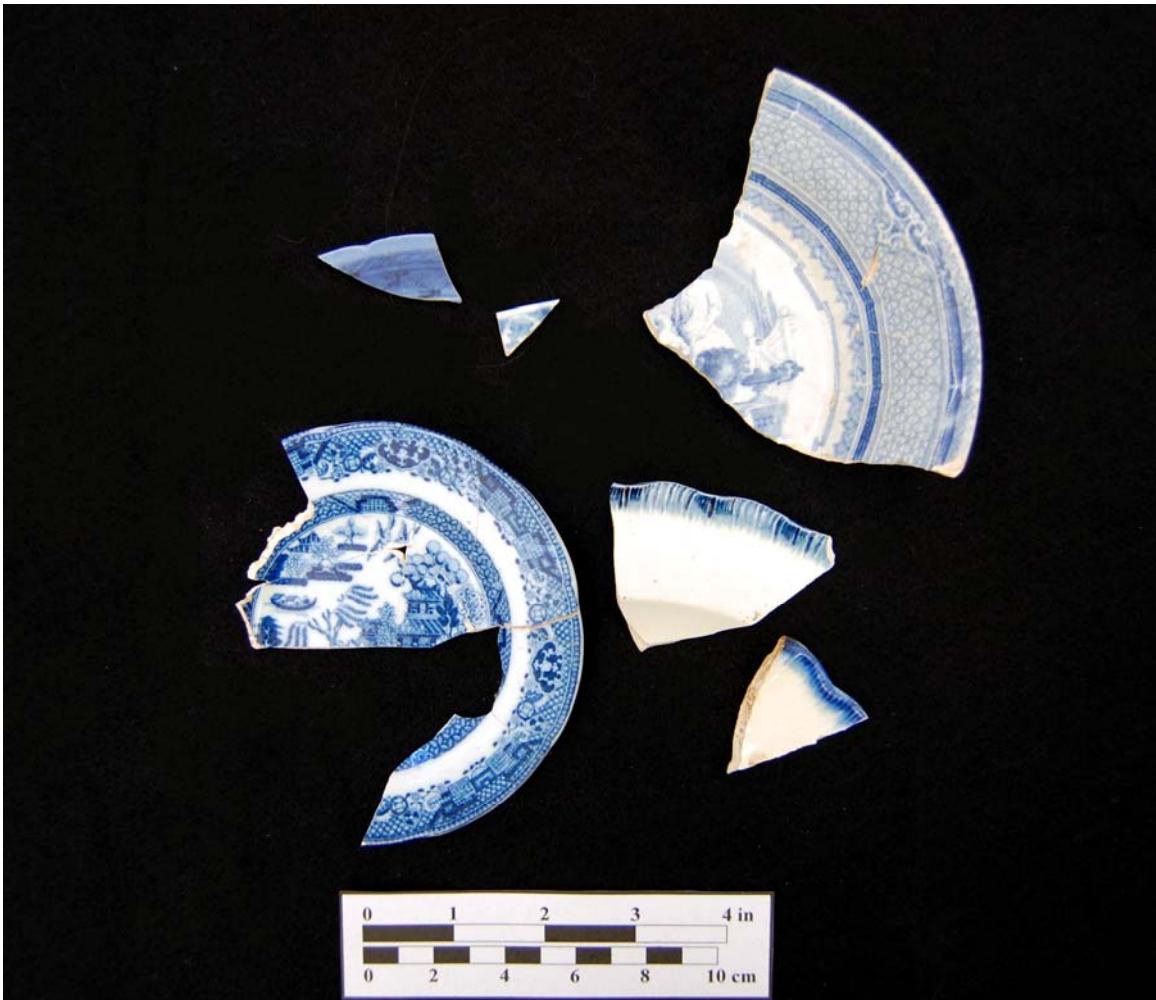
Figure 5.47 – Blue Edge Decorated Ceramics – Ceramics associated with the Greenhouse’s enslaved African-American residents dated from the 1790s to the 1840s. Included within this assemblage were a high percentage of blue edge decorated wares. Photo by Molly Robbins

Of particular interest in this assemblage are a moderately high percentage of ceramic vessels related to food production, and a lack of matching sets of tea and table wares. Four food production vessels were identified within this assemblage including one English Brown Stoneware jug, one black glazed coarse earthenware milk pan, and two unidentified glazed coarse earthenware hollow-ware vessels. Table vessels represented in this assemblage include one Rhenish stoneware tankard, pearlware and porcelain plates, creamware and whiteware bowls, and unidentified flatware and hollow-ware vessels. Tea vessels within this assemblage include three whiteware tea cups and one pearlware tea cup, as well as three pearlware saucers and one whiteware saucer. Also included within this assemblage are Jackfield, Canary ware, and Yellow ware vessels (see table for specific ceramics vessels). Taken together this mixed assemblage spans a date range from the early 1790s through the 1840s.

Unlike the ceramics analyzed from Unit 4, no matching sets of vessels were identified within this particular assemblage. Food preparation vessels, table ware vessels, and tea ware vessels were diverse in their ceramic types and forms, and spanned the range of available late 18th and early 19th century ceramics. It is worth mentioning that there are a number of blue edge decorated plates, as well as blue transfer-printed wares in this assemblage. While these vessels do not necessarily equal a matching set, they may represent a particular aesthetic within this ceramic assemblage. The apparent lack of matching sets of vessels within this assemblage should come to no great surprise. In all likelihood ceramic vessels associated with the Greenhouse’s enslaved African-American inhabitants were accumulated piecemeal, rather than en masse. It should also be pointed out that unmatched sets of ceramics may represent an accumulation strategy based on economic necessity rather than aesthetics. In short, the Greenhouse’s slaves had rather limited access to ceramic markets and perhaps obtained them from the Lloyd family, or

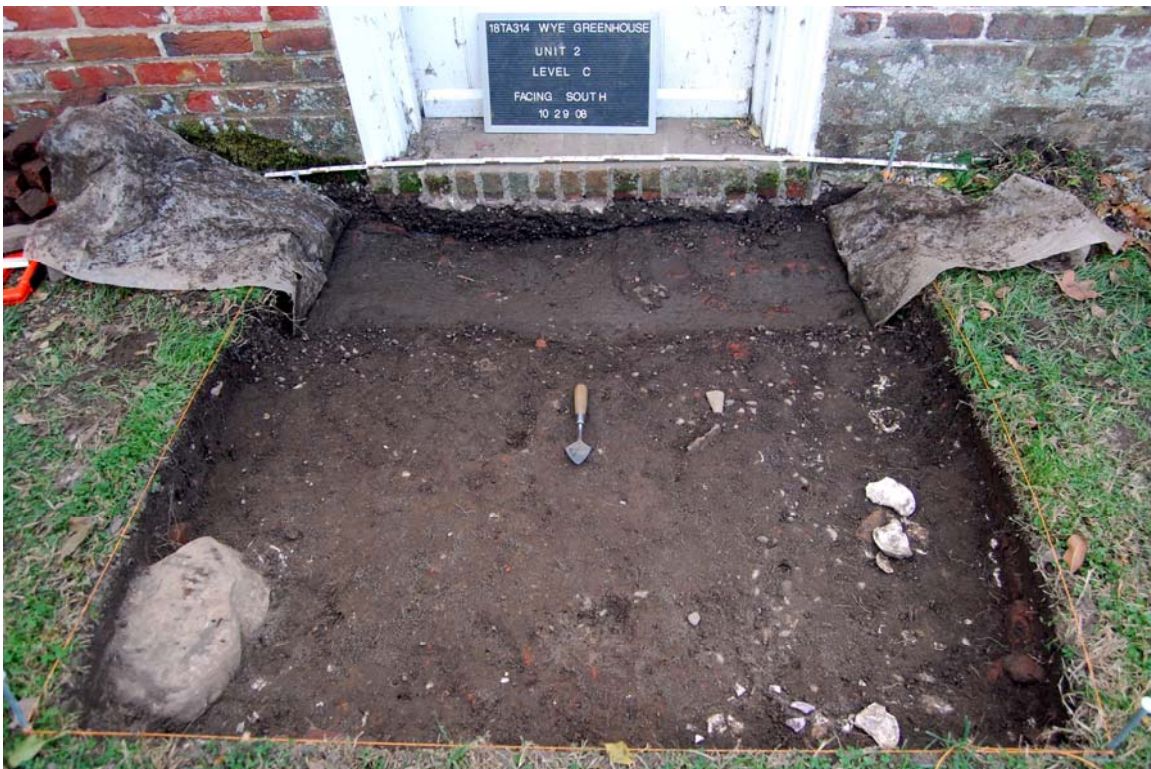
Figure 5.48 – Unit 2, Spear Point in Front of Slave Quarter Door – Artifacts related to African-American Hoodoo practices are widely found throughout the Southern United States. A spear point found in front of the doorway to the Greenhouse's slave quarter may bear witness to cultural tradition. Photo by Stephanie Duensing

Perhaps more telling of the labor relations and potential aesthetics of the Greenhouse's enslaved residents is a single artifact found associated with this ceramic assemblage, from a context dated to c. 1820-1840. Located in front of the north shed/slave quarter's doorway, directly beneath a brick-work yard, was a single white quartzite prehistoric spear point, roughly four inches long by two inches wide. The point was carefully placed facing north and away from the entrance of the quarter. Similar finds of white quartzite and quartz projectile points are ubiquitous on Slave sites in Maryland, Virginia, Tennessee, and a host of Southern States (Leone and Fry 1999, 2001). In many instances these points have been located near doorways, fireplaces, house foundations and interior root cellars. These finds have been interpreted by archaeologists and historians as belonging to a set of African/African-American spiritual practices colloquially referred to as Hoodoo. Widely practiced by African-Americans throughout the 19th century, these practices were often associated with utilizing spirits believed to help or protect individuals. In this particular case, a spear point may have been meant to point or direct a spirit away from the house, or quarter.

The significance of this particular object lies not in its uniqueness. Rather, the ubiquity of these finds across the Southern United States demonstrates the presence of West African cultural practices. That this set of particular cultural/spiritual practices survives into the mid to late 19th century (and in some instances the late 20th century) suggests that the culture of enslaved African-Americans was different from that of Anglo-European cultures of the same time period. As such, if Hoodoo can be read as a testament to cultural differences, then it may comment on the ceramic assemblage associated with the Greenhouse's enslaved inhabitants. Artifacts recovered from the assemblage detailed above, such as domestic-related ceramics, food-related faunal remains, personal objects such as buttons and a shoe buckle, and a single Hoodoo related white quartzite spear point, are direct archaeological evidence of the lives of the Greenhouse's enslaved African-American inhabitants.
