Title of Document: RELIABILITY EVALUATION OF LIQUID
AND POLYMER ALUMINUM
ELECTROLYTIC CAPACITORS

Anshul Shrivastava,
Doctor of Philosophy (Ph.D.), 2014

Dissertation submitted to the Faculty of the Graduate School of the
University of Maryland, College Park, in partial fulfillment
of the requirements for the degree of
Doctor of Philosophy
2014

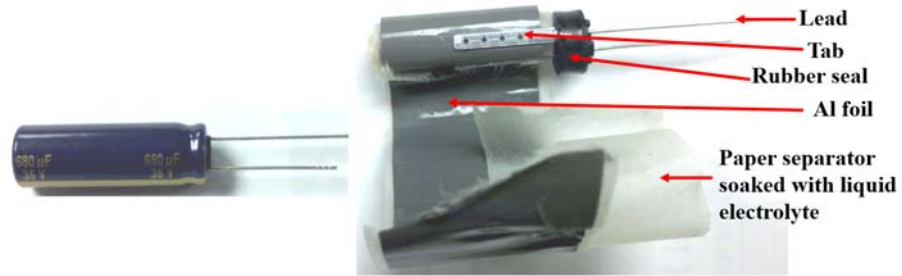
LIQUID Electrolytic Capacitor

POLYMER Electrolytic Capacitor

Figure 3: Aluminum electrolytic capacitor construction

Polymer aluminum (PA) electrolytic capacitors were introduced as an alternative to liquid aluminum electrolytic capacitors. The liquid electrolyte was replaced by a solid conductive polymer electrolyte in polymer aluminum (PA) capacitors. The only difference in construction between the liquid aluminum electrolytic capacitors and PA electrolytic capacitors is the electrolyte. In liquid electrolytic capacitors, the electrolyte is liquid and is soaked in a paper layer between cathode and anode foil. In PA electrolytic capacitors, the electrolyte is a solid conductive polymer and is also soaked in the paper layer which is located between cathode and anode foil. Both electrolytes are part of cathode in the electrolytic capacitors. Figure 3 below shows comparison of construction between the liquid and polymer aluminum electrolytic capacitors. A drawback of liquid electrolytic capacitor is the low conductivity of the liquid electrolyte of about 0.01 S/cm [12]. Solid polymer electrolyte overcame the tendency of liquid electrolytes to evaporate over time and as the polymer used were conductive, the ESR of polymer aluminum capacitors was much lower than the liquid electrolytic capacitors. Some common polymers used in the capacitors are tetracyanoquinodimethane (TCNQ), polypyrrole (PPY) and poly (3, 4-ethylenedioxythiophene) also known as PEDOT [13-14]. Conductivity of these polymers is shown in Figure 4. PEDOT has higher conductivity than other electrolytes as shown in Figure 4. During lead-free soldering, conducting polymers in electrolytic capacitors have to withstand a peak temperature of about 260°C. The elevated temperature stability of PEDOT is much better than other polymers [15-16].

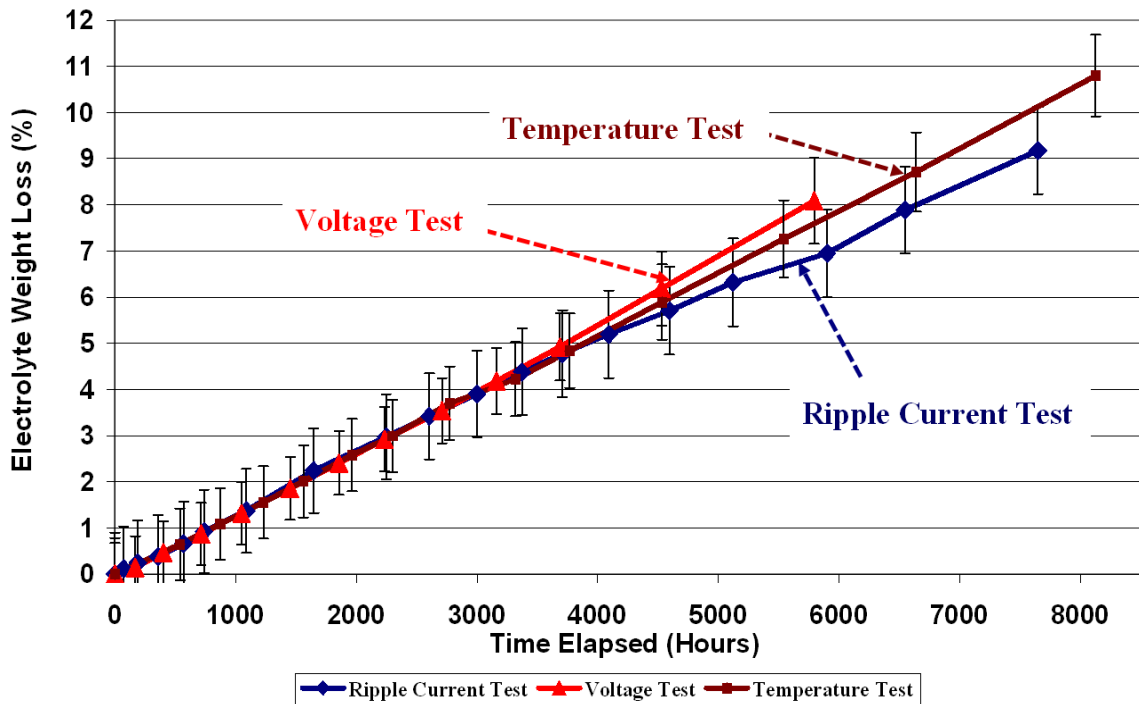
Figure 9: Plot showing electrolyte weight loss during life tests of C1

capacitance drop was quickest for the voltage test followed by ripple current test and temperature test. The weight change of the capacitors is shown in Figure 9. The weight loss observed at a particular time in the capacitors from three different tests was about the same which can be seen due to overlapping error bars.

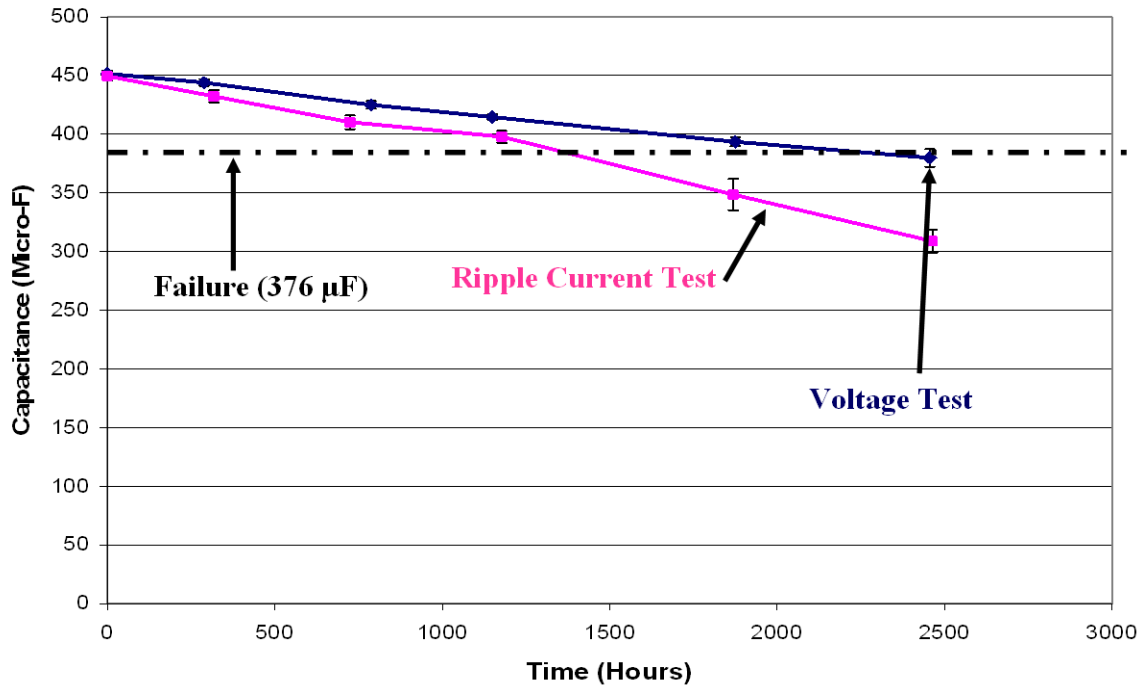
Figure 11: Capacitance plot showing drop in average capacitance for C2

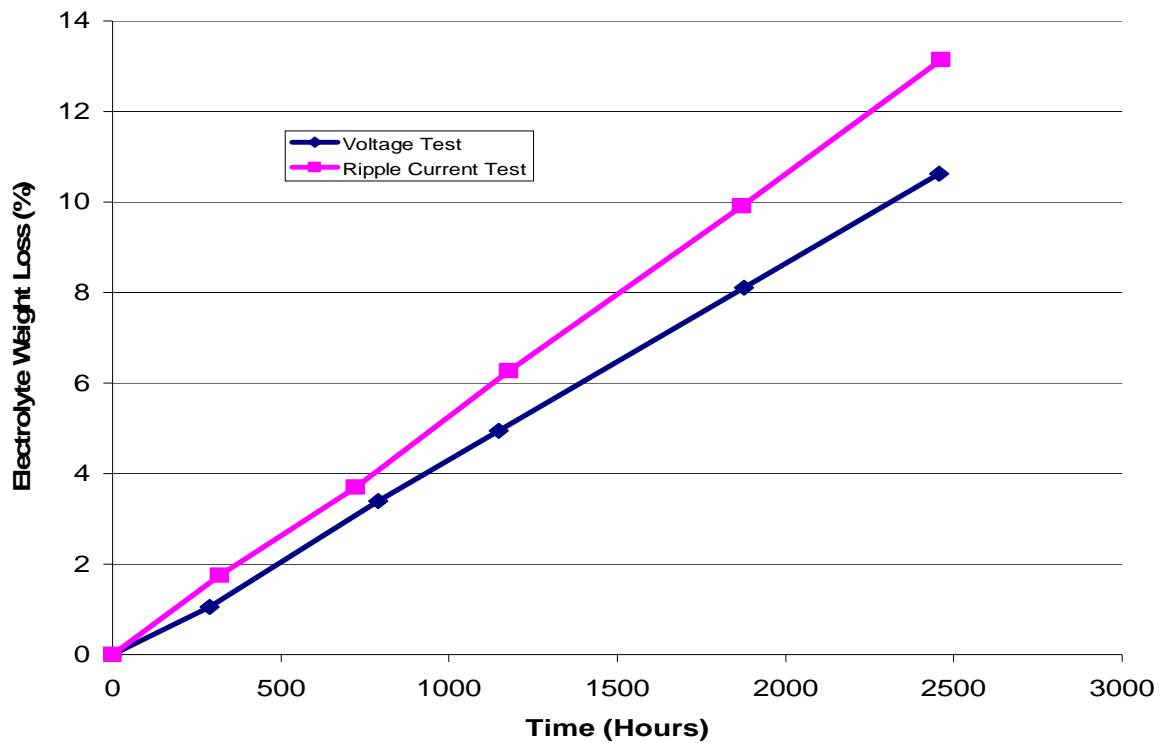
Figure 12: Plot showing average electrolyte weight loss during life tests of C2

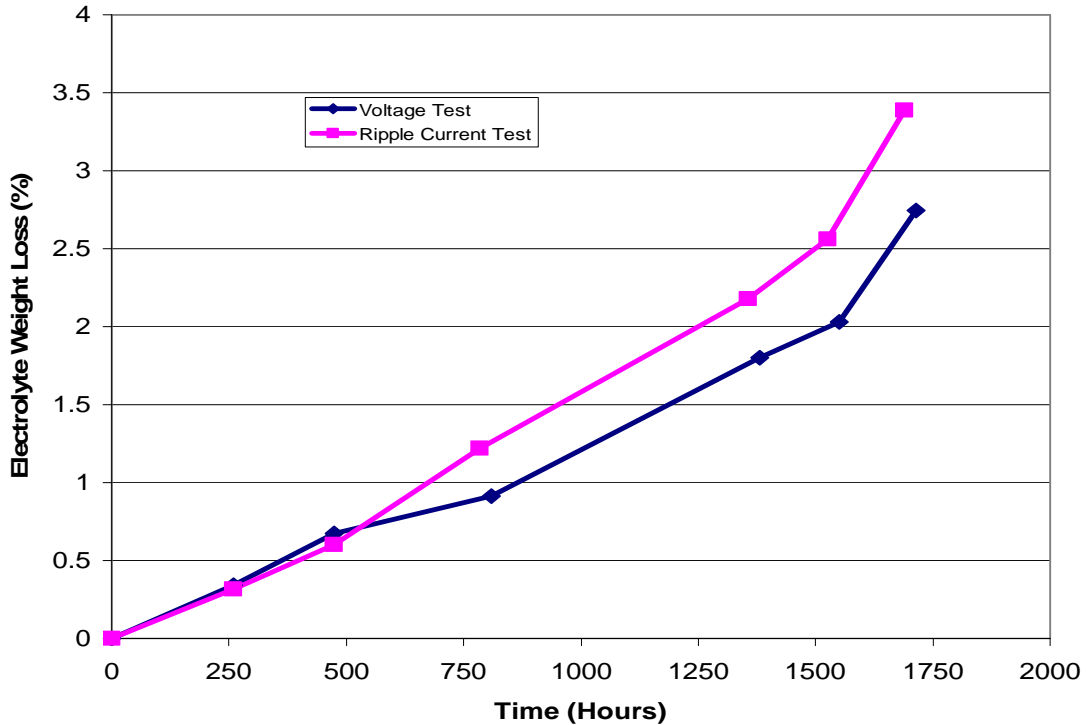
Figure 15: Plot showing average electrolyte weight loss during life tests of C3

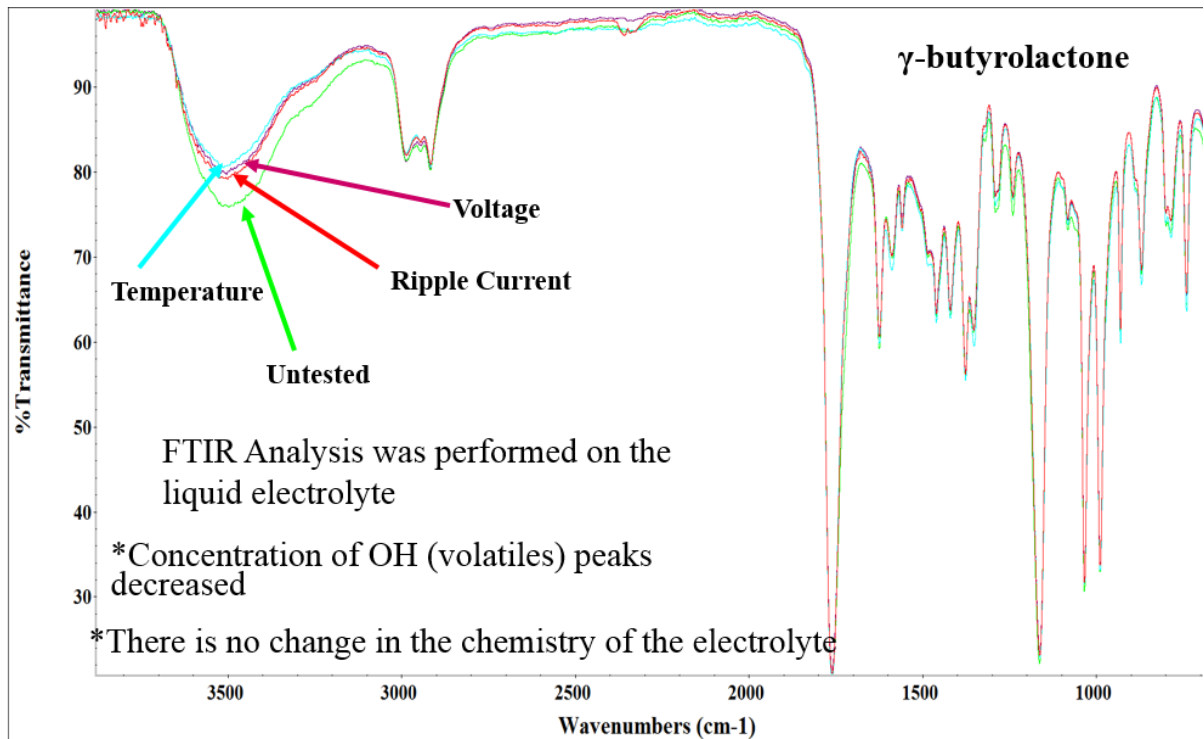
Figure 19: FTIR spectra of failed and unused C1 capacitor electrolyte

C1 capacitor liquid electrolytes from failed capacitors in temperature test, ripple current test and voltage test were compared to the liquid electrolyte of the unused C1 capacitor to determine the chemical changes in electrolyte after the capacitor failed. Figure 19 shows the comparison of FTIR spectra of the liquid electrolytes from failed C1 capacitors in temperature test, ripple current test, voltage test and unused C1 capacitor. There were no new peaks found in the failed capacitor electrolyte which meant that the chemistry of electrolyte did not change after the capacitors failed. The

only difference which was found was the peaks related to volatiles close to 3500cm^{-1} decreased in concentration.

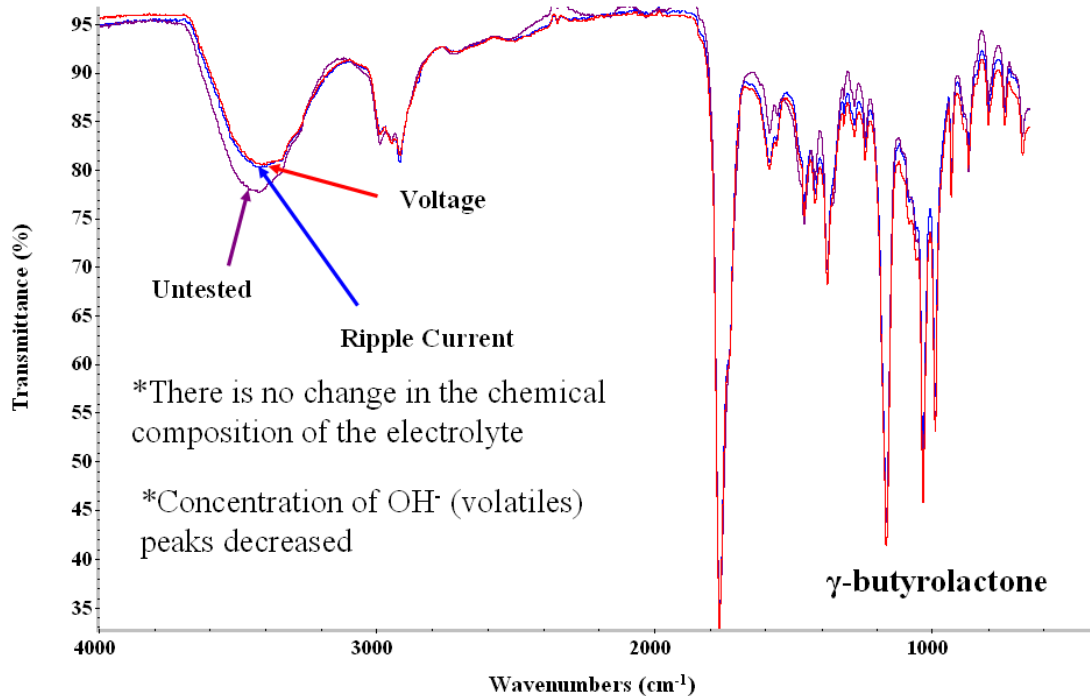
Figure 20: FTIR spectra of failed and unused C2 capacitor electrolyte

C2 capacitor liquid electrolytes from failed capacitors in the ripple current and voltage test were compared to the liquid electrolyte of the unused C2 capacitor to determine the chemical changes in electrolyte after the capacitor failed. Figure 20 shows the comparison of FTIR spectra of the liquid electrolytes from failed C2 capacitors in the ripple current and voltage test and unused C2 capacitor. There were no new peaks found in the failed capacitor electrolyte which meant that the chemistry of electrolyte did not change after the capacitors failed. The only difference which was found was the peaks related to volatiles close to 3500cm^{-1} decreased in concentration.

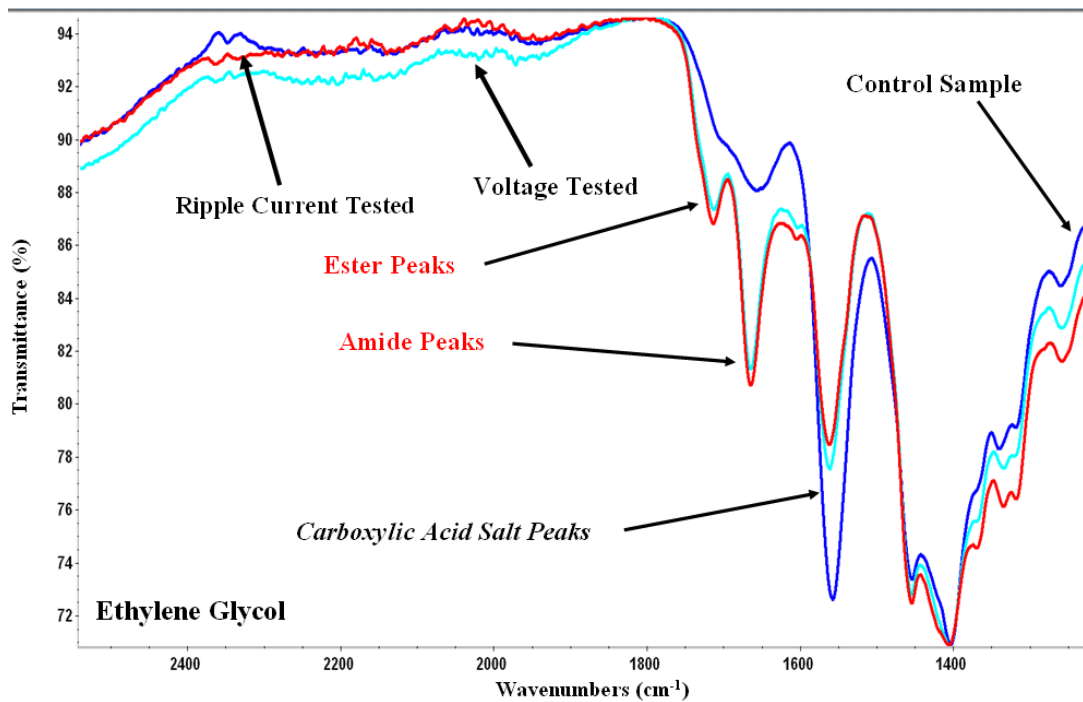
Figure 21: FTIR spectra of failed and unused C3 capacitor electrolyte

C3 capacitor liquid electrolytes from failed capacitors in the ripple current and voltage test were compared to the liquid electrolyte of the unused C3 capacitor to determine the chemical changes in electrolyte after the capacitor failed. Figure 21 shows the comparison of FTIR spectra of the liquid electrolytes from failed C3 capacitors in the ripple current and voltage test and unused C2 capacitor. There were new FTIR peaks found in the ripple current and voltage test failed capacitor electrolyte which meant that the chemistry of electrolyte changed after the capacitors failed. The new FTIR peaks found in the ripple current and voltage test failed capacitor electrolyte corresponded to esters and amides. Another difference was that the FTIR peak corresponding to carboxylic acid salts decreased in the failed capacitor

electrolyte. Formation of ester and amide and decrease in concentration of carboxylic acid salt group decreased the conductivity of the electrolyte of failed capacitors. Below are the chemical equations showing how esters and amides can be formed in liquid electrolyte.

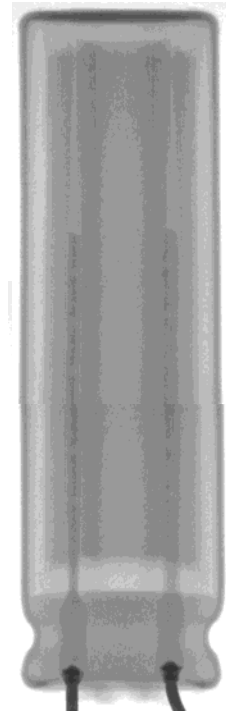
Figure 22: X-ray image of a good untested capacitor (C1)

Figure 22 shows X-ray image on a good capacitor and figure 23 shows X-ray image of a C1 capacitor that failed in voltage test. No anomalies were observed in this or any other failed capacitors in X-ray analysis.

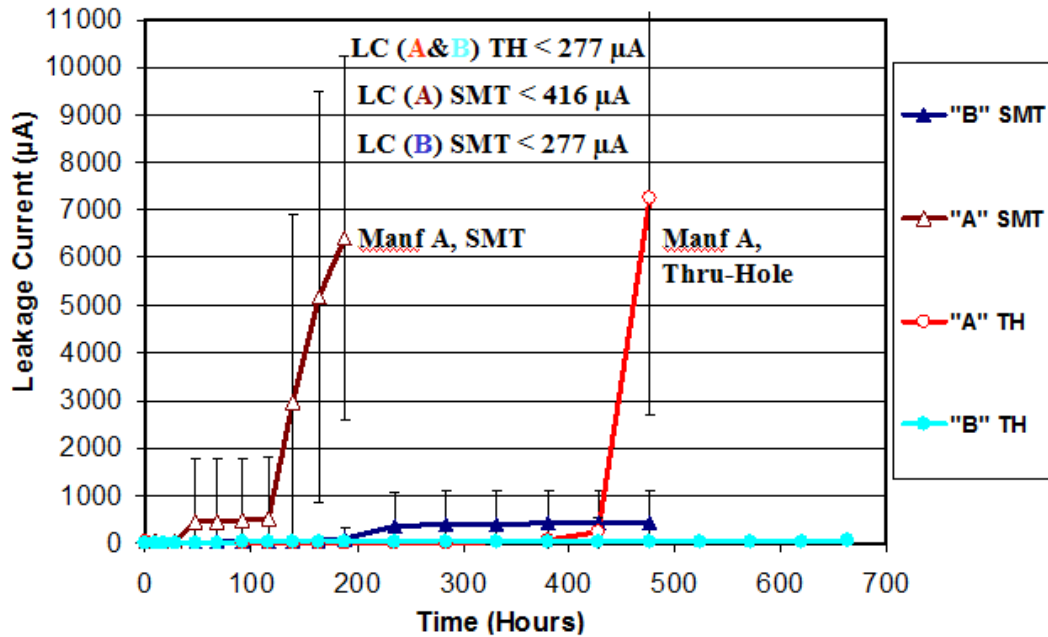
Figure 34: Average leakage current plot of capacitors from manufacturer A under HAST testing

85%RH), different dominant failure modes were observed in PA capacitors from both the manufacturers. Dominant failure mode for capacitors from manufacturer ‘A’ was increase in leakage current and for capacitors from manufacturer ‘B’, dominant failure mode was increase in ESR.

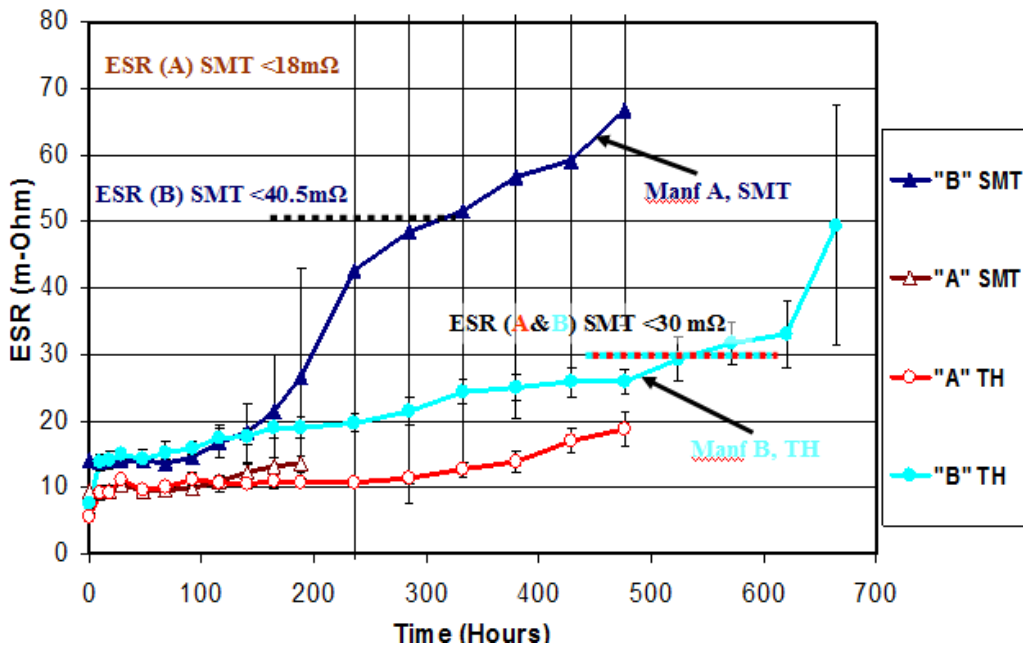
Figure 35: Average ESR plot of capacitors from manufacturer B under HAST testing

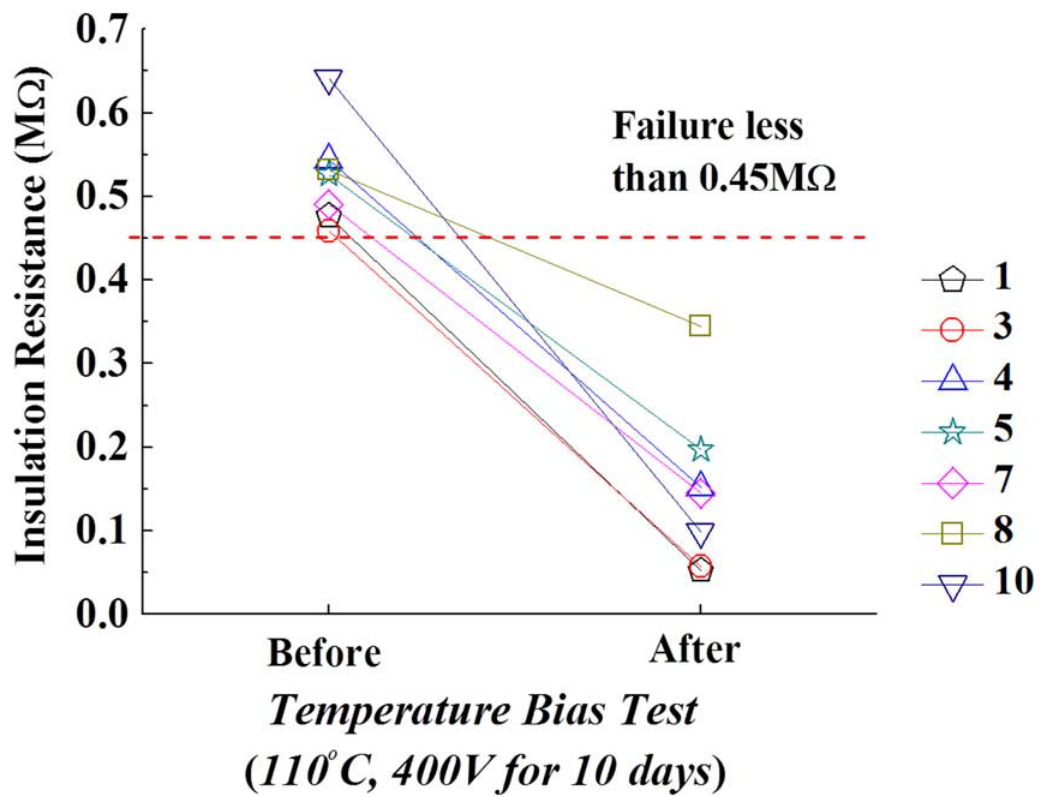
Fig. 53. Plot showing that seven counterfeit capacitors failed due to a decrease in insulation resistance after temperature bias test. The other three capacitors failed because the seal ruptured, and they were not charged for insulation resistance measurement.
