Pilot Project and Field Study: Data and Quality-Based Geomembrane Field Seaming Evaluation for CCR Projects

Evan Andrews, P.E.,¹ Kenneth R. Daly, P.E.²

The authors summarize the background of long-established geomembrane destructive seam sampling approaches and outline an alternative using data and quality-based geomembrane field seaming techniques. Furthermore, the authors present the data and quality-based geomembrane field seaming framework as implemented on a pilot project and field study evaluating threshold welding parameters.

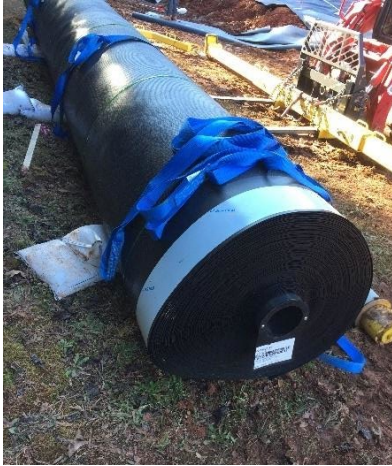
Figure 2: Geomembrane with taped edge.

The owner contracted Sequoia Services, LLC (Sequoia), of Greensboro, North Carolina as the general contractor. Sequoia subcontracted CCS of Statesville, North Carolina to install geosynthetics. The liner system was installed over the course of one week in early December 2020 and consisted of approximately 0.2 acres (0.08 hectare) of secondary geomembrane overlain by 0.2 acres (0.08 hectare) of primary geomembrane. Agru America produced the 60 mil (1.5 mm) double-sided textured HDPE geomembrane with smooth edges for seaming. The geomembrane was fabricated with a 6 inch (15.2 cm) wide film (tape) adhered to the geomembrane smooth edge as shown in Figure 2. Tape was applied on the top edge of one side of the roll alternating to the bottom edge on the opposite side of the roll so that top and bottom edges matched up when the geomembrane was deployed. Welding technicians removed the tape immediately ahead of the welding machine thereby exposing fresh and clean geomembrane surfaces for seaming as shown in Figure 3.

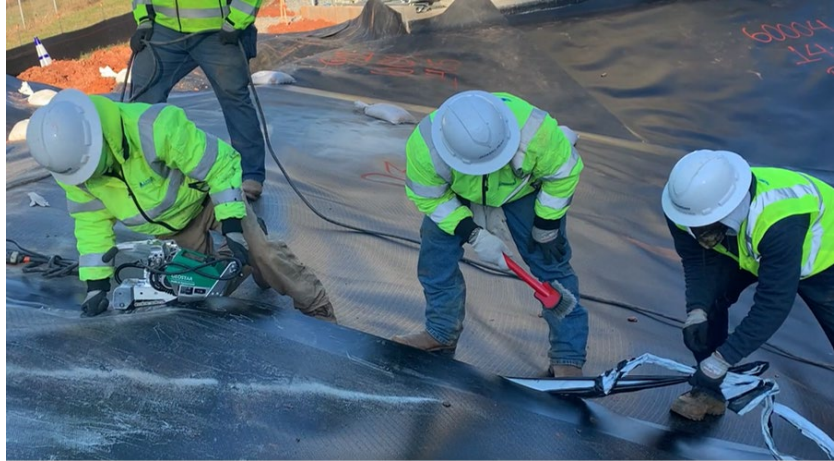
Figure 3: Geomembrane seaming in progress – tape removal (right) ahead of seaming (left).

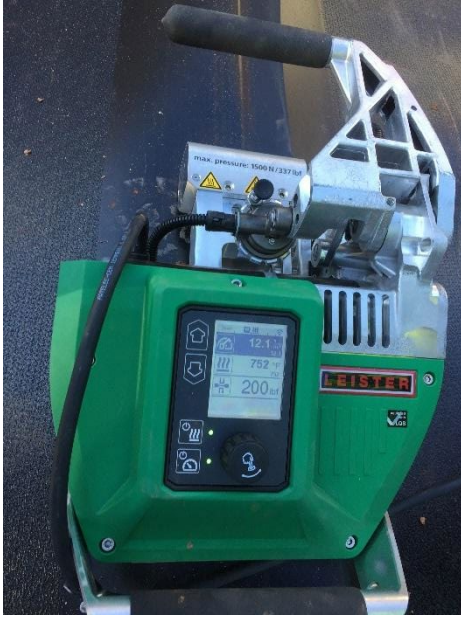
Figure 4: Data Acquisition Welding machine with visual display showing speed, temperature, and pressure.

CCS seamed approximately 520 lineal ft (158 m) of double-track fusion seam on the primary geomembrane and approximately 550 lineal ft (168 m) on the secondary geomembrane. The welding machine with its visual display is shown in Figure 4. In addition to the machine display, the geosynthetic installer CQC personnel monitored seaming using a tablet PC (connected to the welding machine by Wi-Fi) as shown in Figure 5.

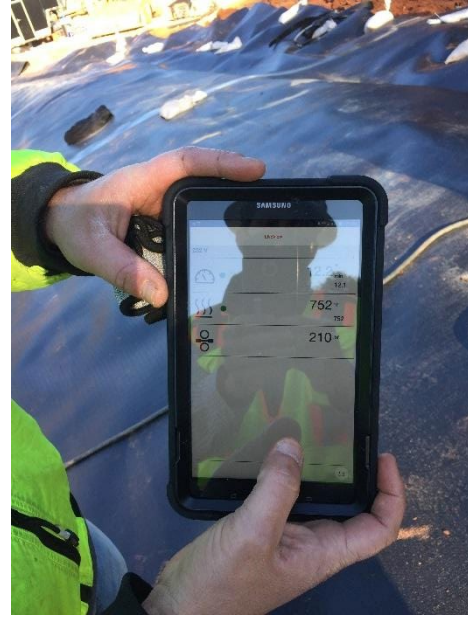
Figure 5: Tablet PC connected to the Data Acquisition Welding machine displaying seaming parameters.

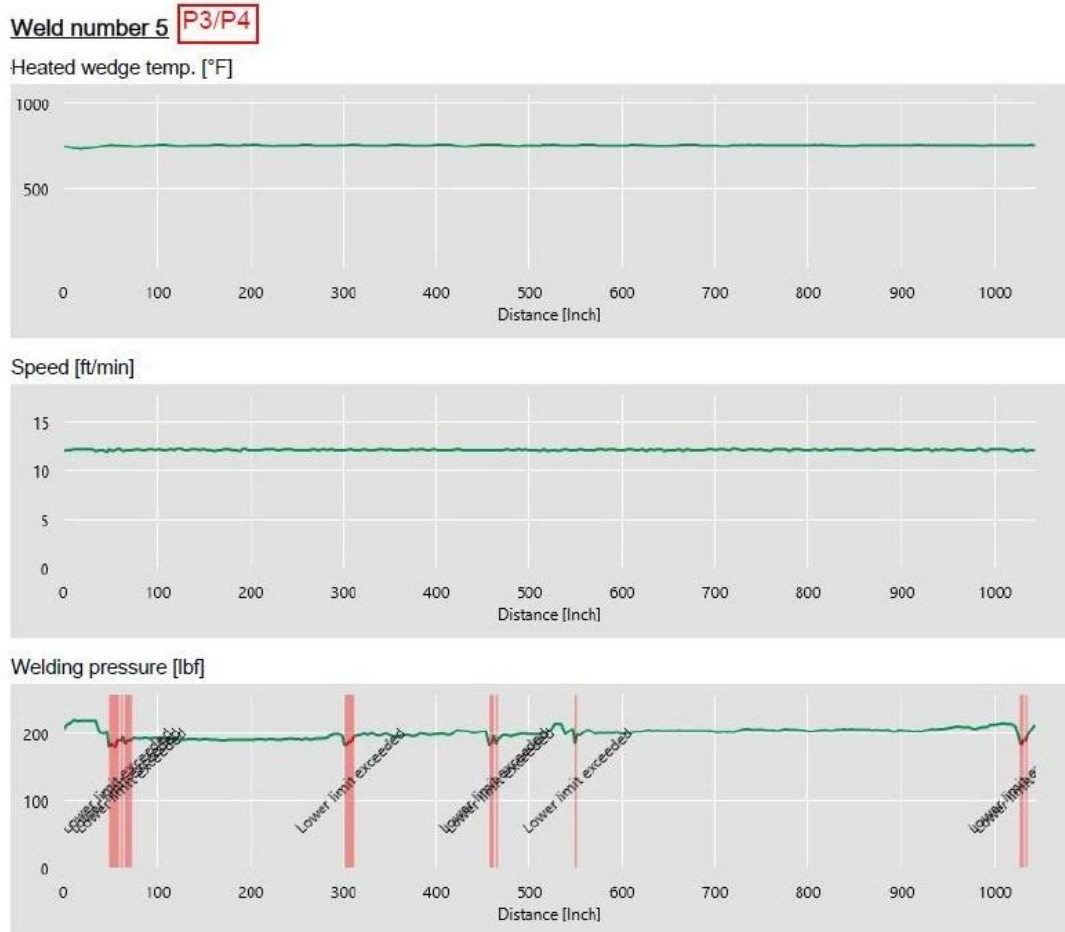
Figure 8: Data Acquisition Welding Report – Graphical Report showing the temperature, speed, and pressure plotted versus the data measurement position (distance).

- Graphical Report: One page showing the temperature, speed, and pressure plotted versus the data measurement position (distance) and color coded to visually identify out of tolerance seaming parameters (Figure 8).

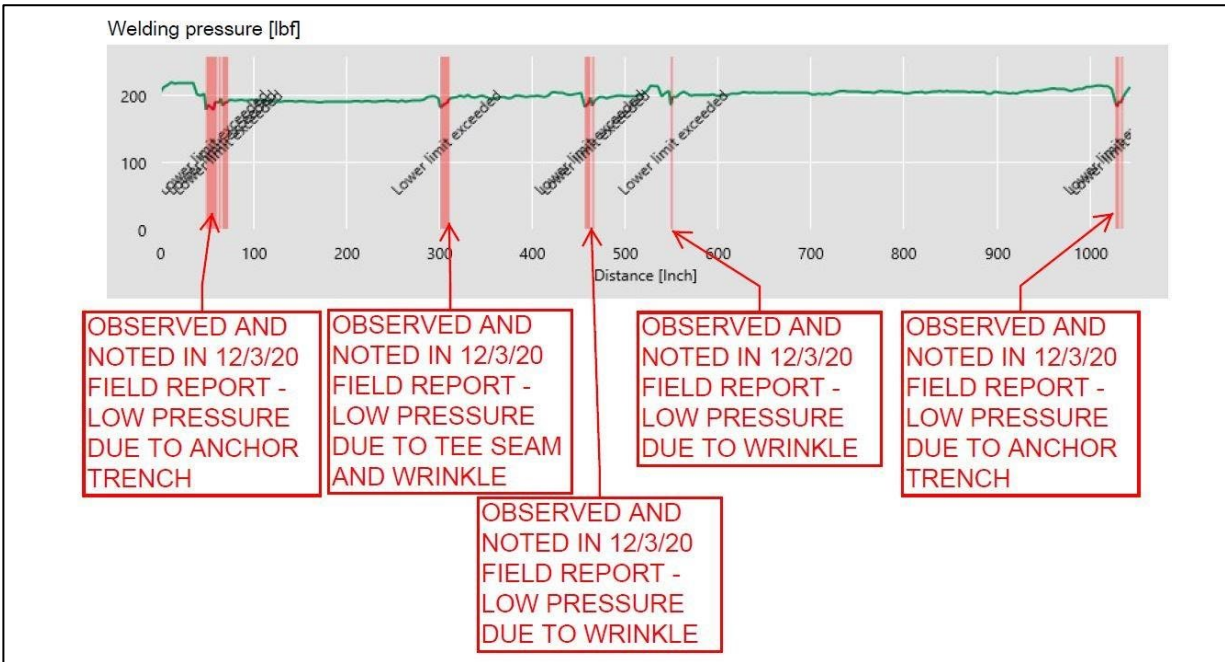
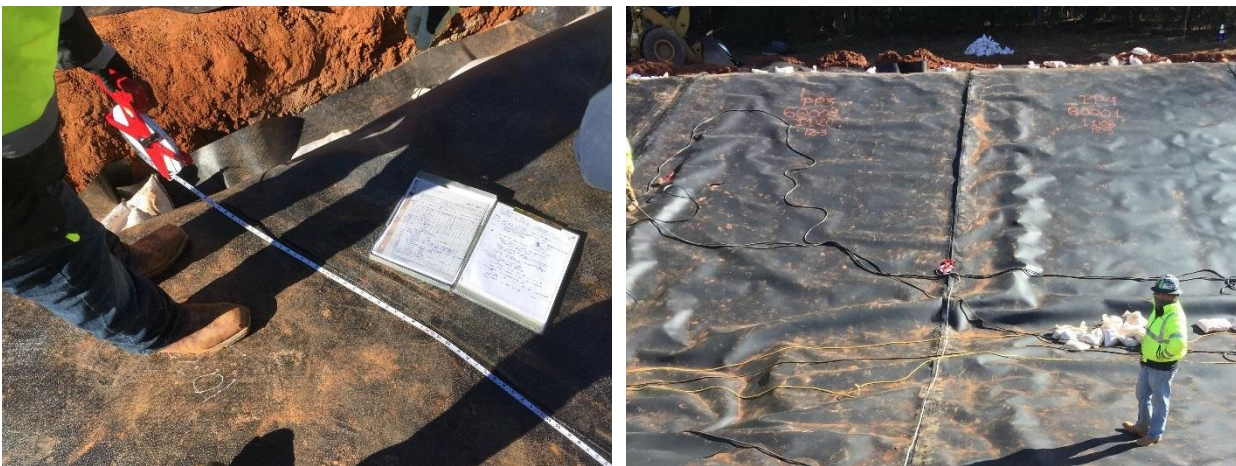
Figure 10: Top shows graphical pressure report of out of tolerance pressure readings with CQA location descriptions and explanations. Photo on the bottom left shows a typical anchor trench location recorded with low pressure; photo on the bottom right shows the location of a wrinkle that recorded low pressure.

and observations indicated that the majority of out of tolerance data were low pressures recorded at anchor trenches, seam ends, and wrinkles (Figure 10); and high pressures recorded at geomembrane tee seams. Geosynthetic installer and CQA personnel attributed low pressures to technicians holding the welding machine by its handle and lifting, guiding, or directing the machine across anchor trenches and wrinkles. High pressure records at tee seams were attributed to the welding machine passing over three layers of geomembrane.
