# Landslide Monitoring Methods: Application of Existing Technologies to Long-Term and Real-Time Monitoring of Slope Movements

February 2023  
Final Report

Project number TR202016  
MoDOT Research Report number cmr 23-002

**MONITORING LANDSLIDE ON ROUTE 465 NEAR BRANSON  
BRANSON, MISSOURI**

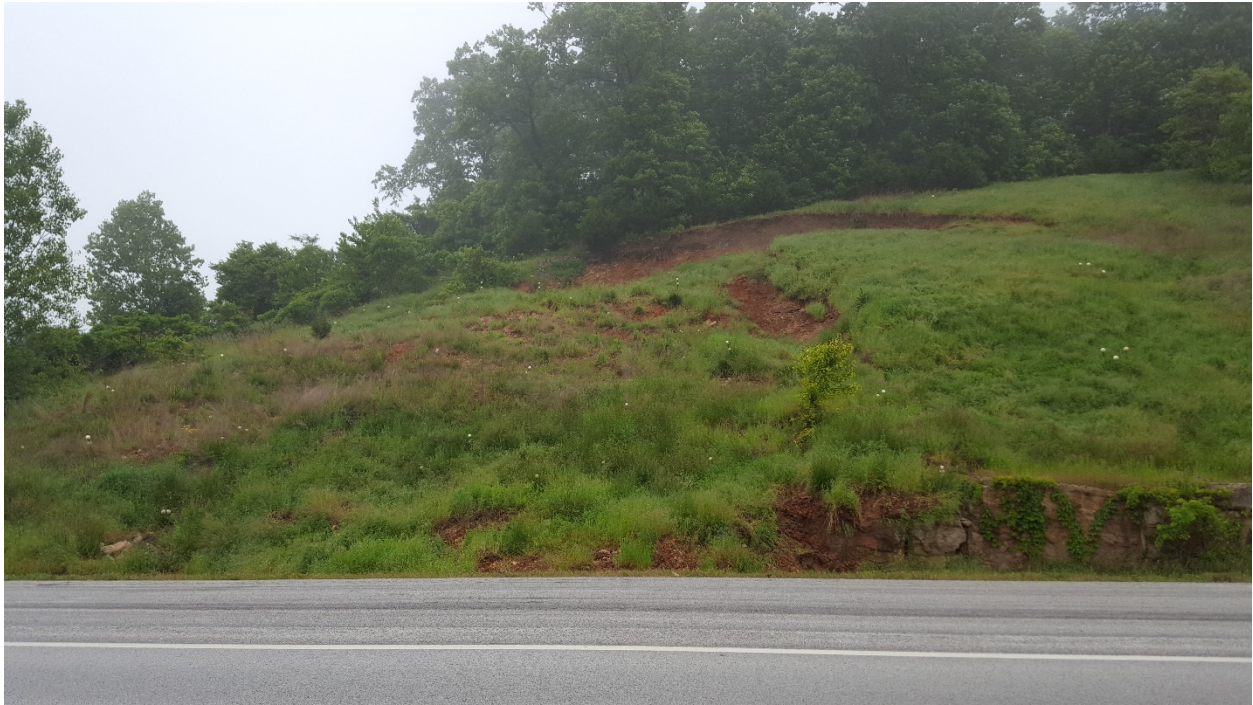
*Figure 4: Reflective monitoring stations from previous research on the Ozark Mountain Highroad Slide in May 2020.*

The reflective targets from the MST investigation remain onsite, as shown in Figure 4 below. Significant slide movement and growth occurred in May 2020 following an extended period of heavy precipitation. The landslide expanded to the north (right side of frame) and reflective targets that were previously intended to be control points are now within the slide mass.

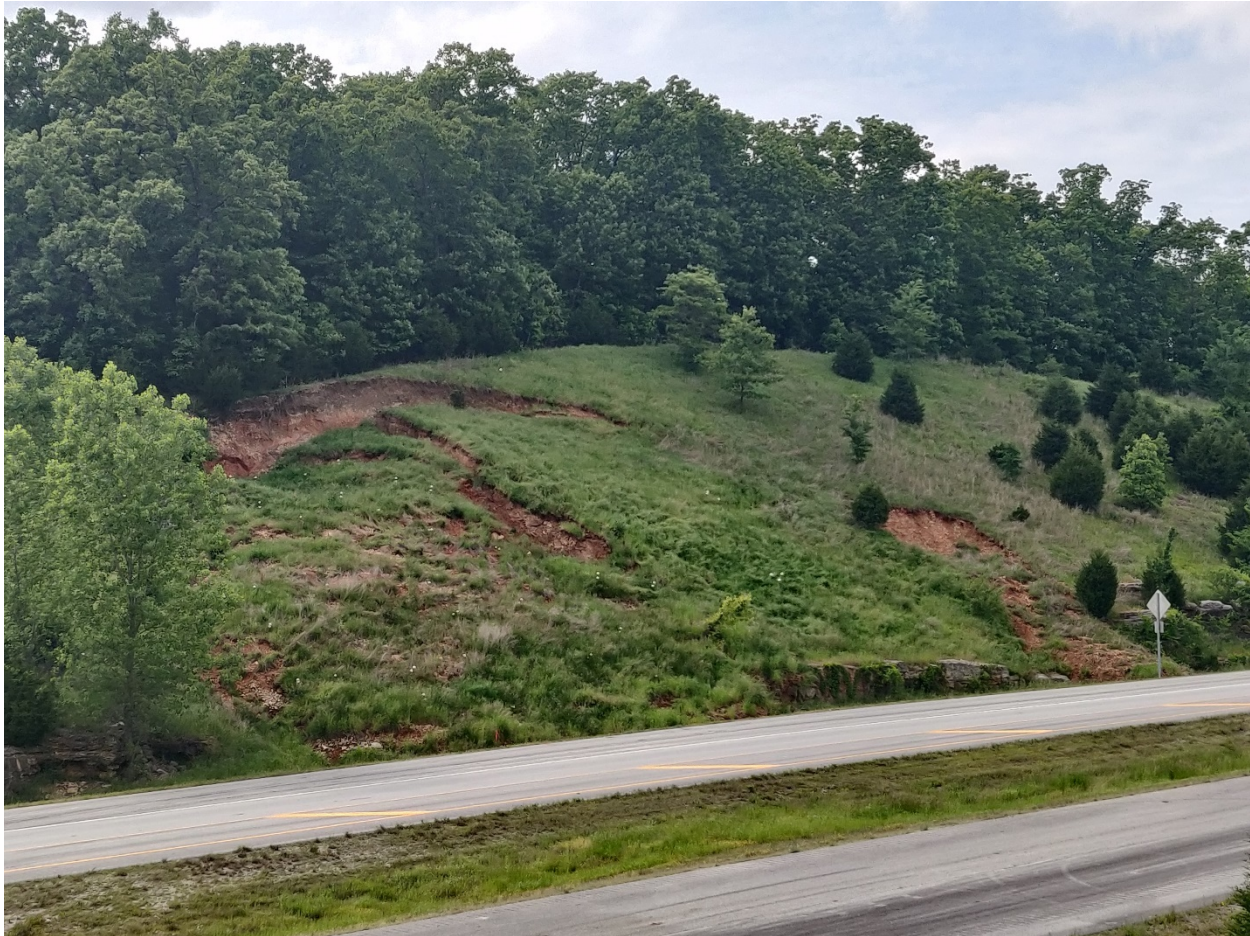
*Figure 8: View of cut slope landslide complex taken from the Route 76 overpass May 2020.*

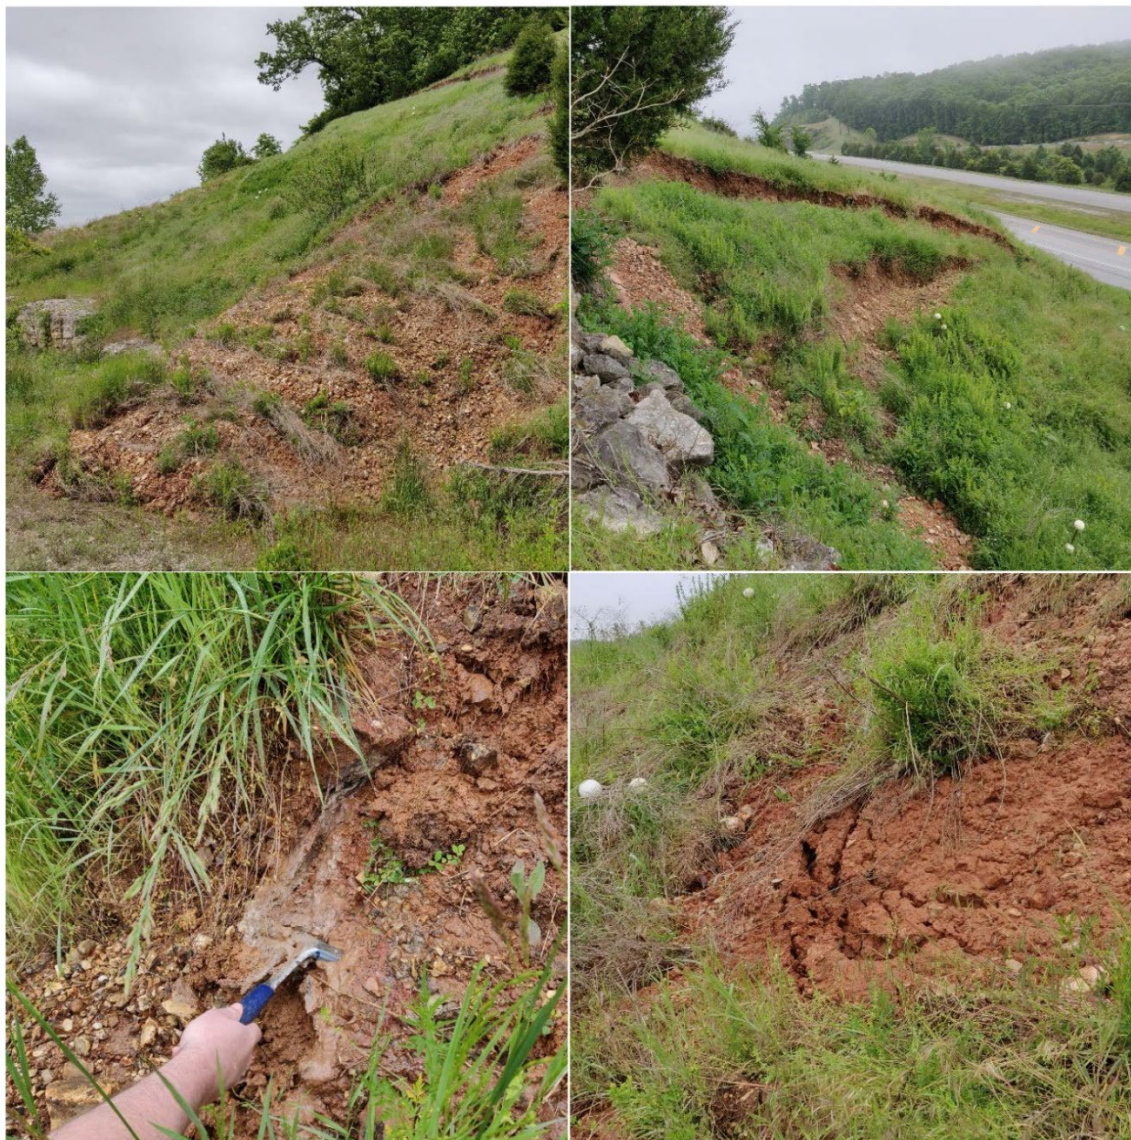
*Figure 9: Slide features from May 2020. Clockwise from left, toe deposit in the roadway ditch, nested scarps at the head of the slide, an internal toe in the slide mass, and water seeping from the recently mobilized slide debris.*

A selection of photos taken during the site reconnaissance are compiled in Figure 9. These photos show the nested head scarps associated with the slides, along with the landslide toes and internal deformation. The clay in the slide was saturated and moisture was actively seeping from the slide debris in multiple locations. Both slides appeared to have moved as saturated masses, with further internal deformation occurring as the slides moved downslope. No landslide movement was observed during the site visit.

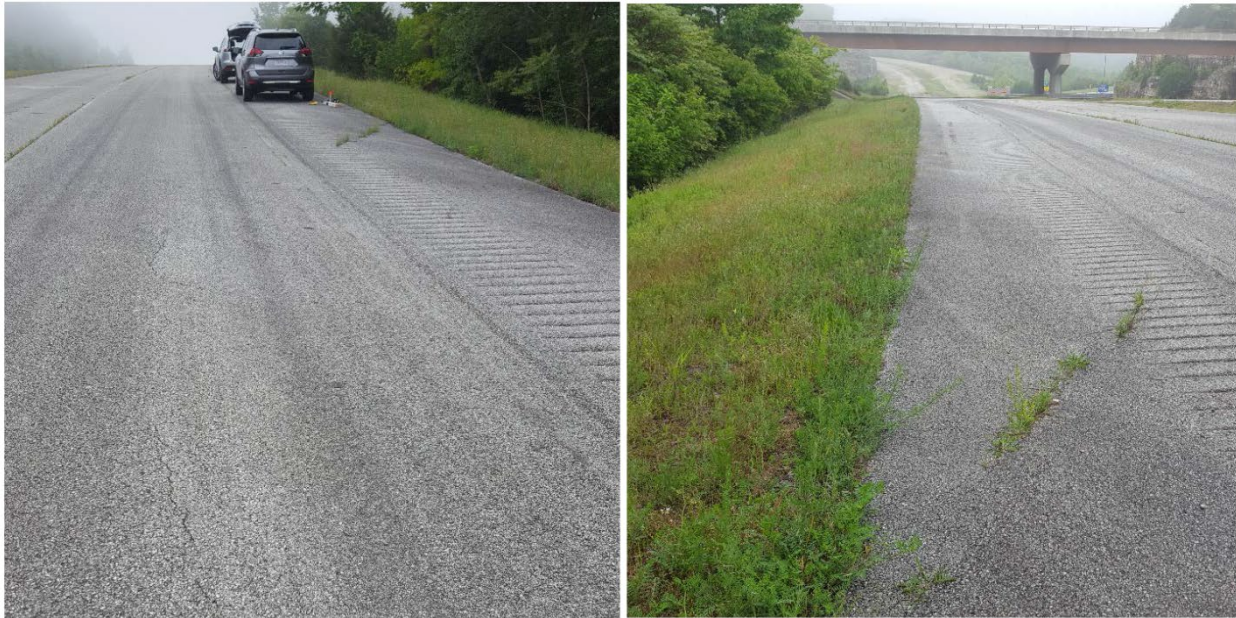
*Figure 10: Arcuate cracking and minor deformation of the shoulder in the northbound lanes upslope from the gabion basket retaining wall system.*

The first segment involved subsidence of the east lane and shoulder, located approximately 275 to 365 feet north of the Route 76 overpass bridge. A crescent shaped crack extended from the east shoulder at the south end of subsidence to 15 feet from the east shoulder, approximately 60 feet north of the starting point. A pair of photos of the pavement distress are shown in Figure 10.

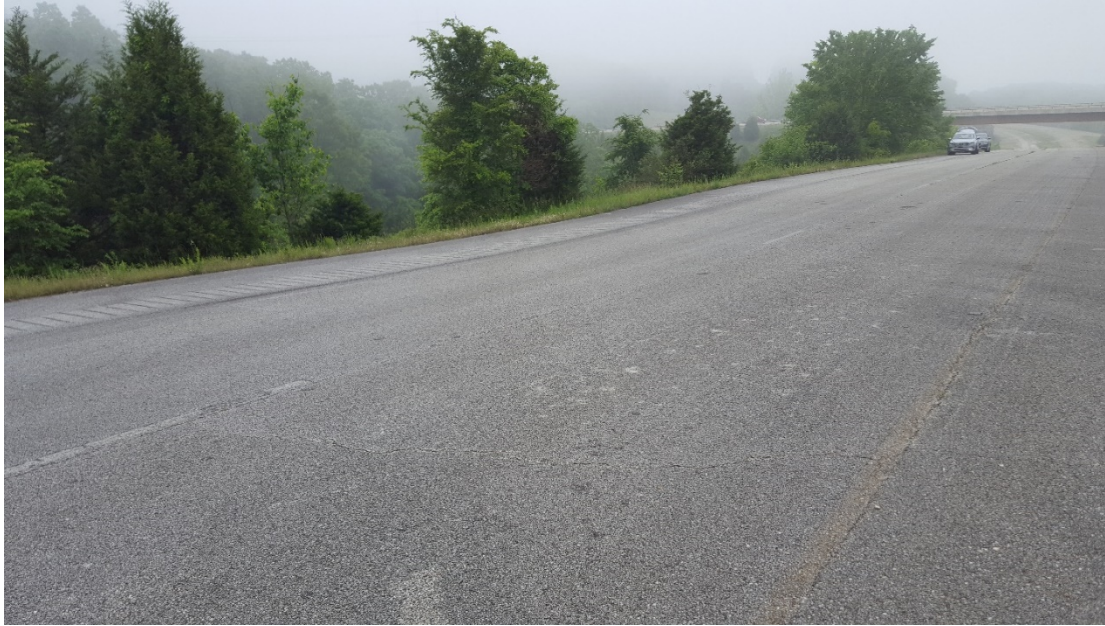
*Figure 11: Deformation in shoulder of northbound lanes evidenced by the observed pavement down drop.*

The second area of deformed pavement was located between 560 and 650 feet north of the Route 76 overpass bridge, north of the gabion wall system. It involved apparent subsidence of the entire paved northbound roadway, with increased subsidence to the east side of the embankment, as shown in Figure 11. No pavement damage or arcuate cracking was observed.

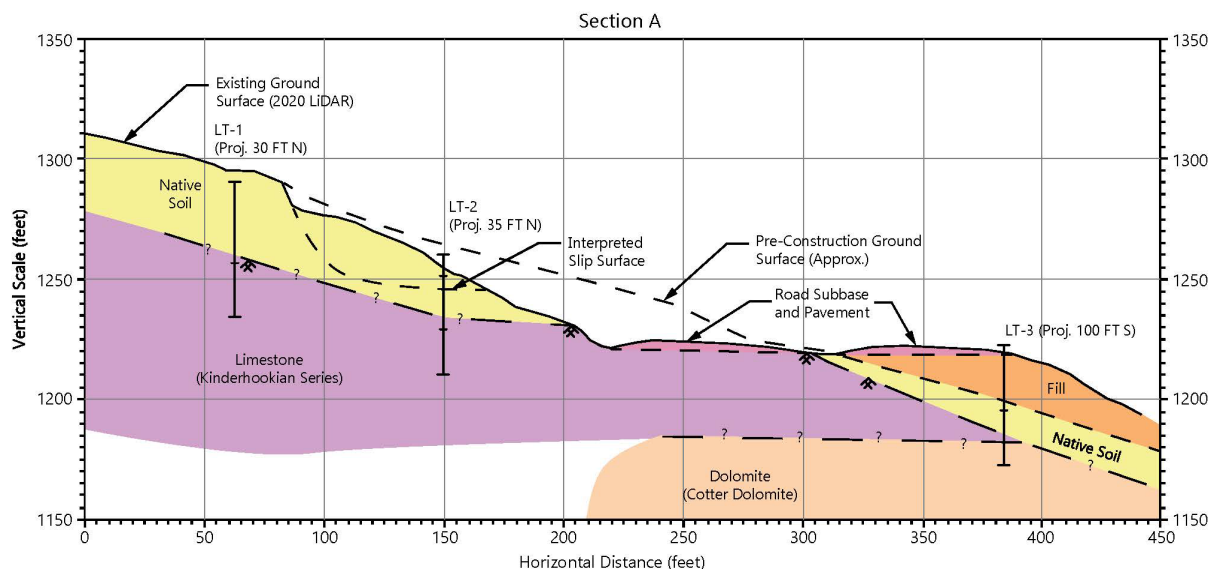
Figure 13: Geologic cross section through body of main slide showing cut-fill construction for this portion of the Ozark Mountain Highway.

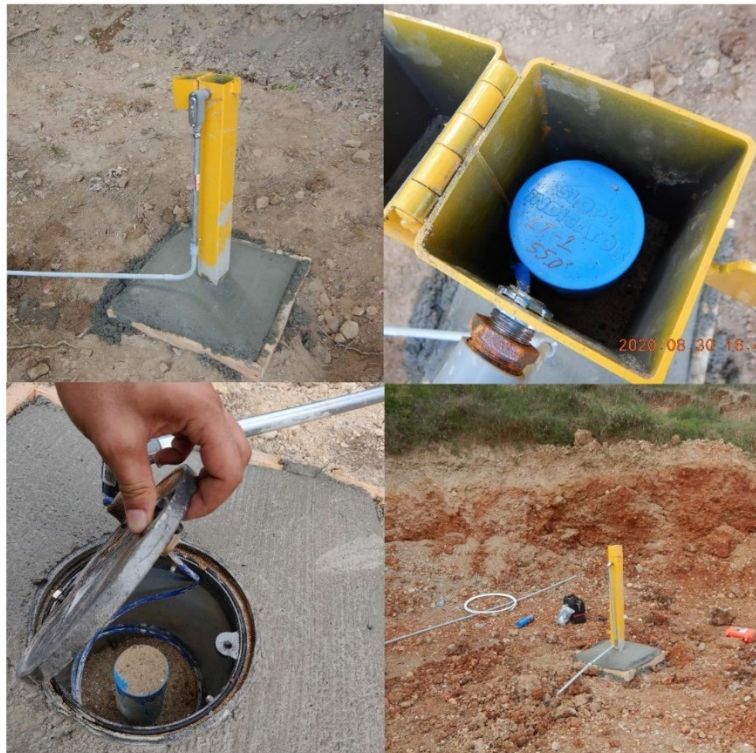
*Figure 16: SI Monuments at Branson Landslide. Clockwise from top left: LT-1 above-ground monument, LT-1 open showing inclinometer pipe, LT-2 above-ground monument, and LT-3 flush mount.*

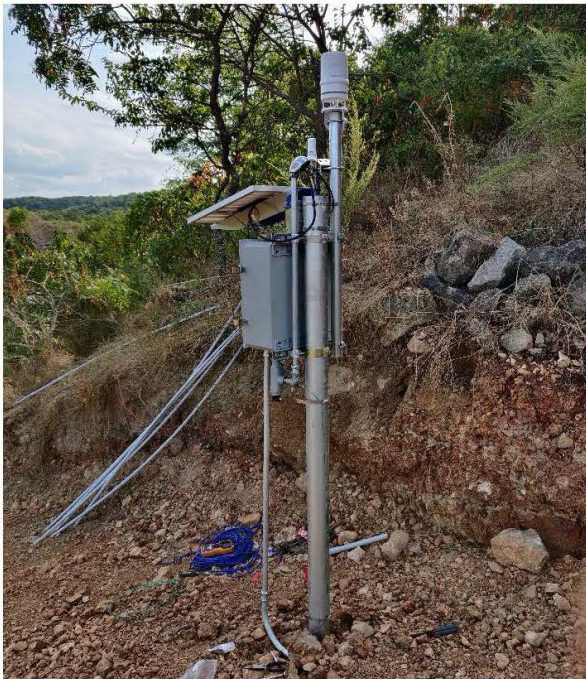
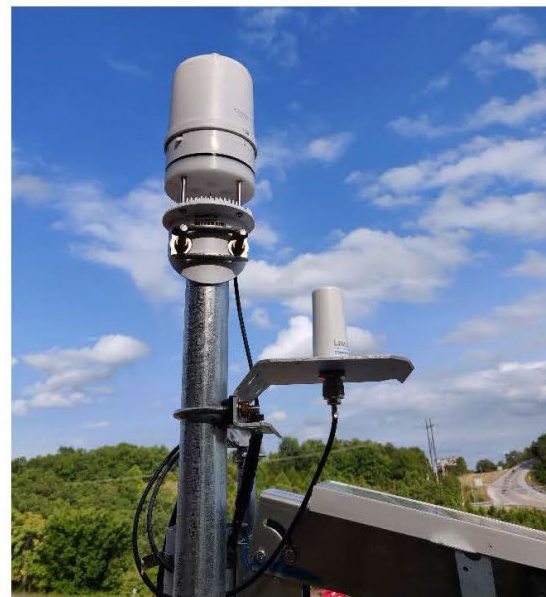
Figure 18: Pair of photos showing weather station as installed at base station (left) and a close up of the weather station and sensor (right).

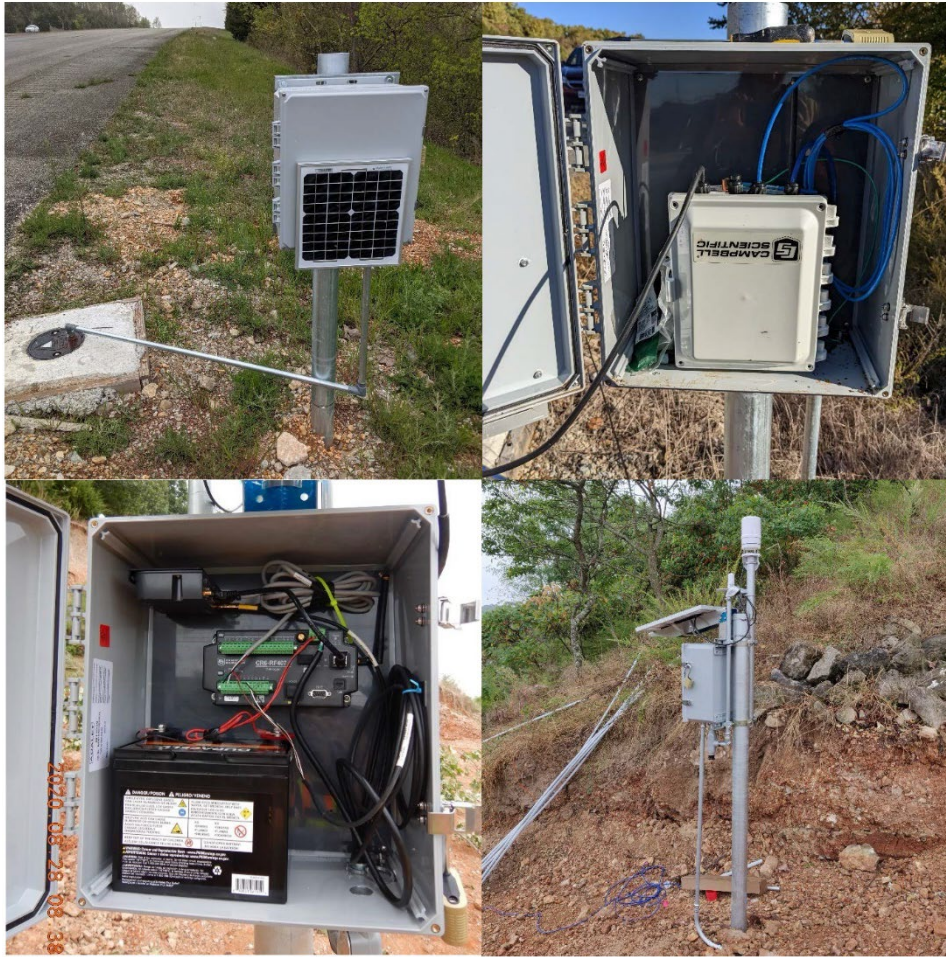
Figure 19: Clockwise from left: weatherproof box and solar panel at LT-3; enclosure with a CRVW3-407 datalogger at LT-3; weather station, solar panel, and weatherproof box at base station; and interior of base station with CR6 logger, peripherals, and rechargeable battery.

**Base Station.** The base station is built around CSI's CR6 datalogger with a built-in RF407 0.25W 900mHz radio to facilitate site communications. A Sierra Wireless Raven RV50 cellular gateway modem is connected to the CR6 via a short network cable for remote data collection. The modem's cellular connection was provisioned by CSI's subscription service with Verizon cellular service. The vibrating wire piezometers from LT-1 and LT-2 are connected directly to the CR6. The ClimaVUE50 weather station connected to the CR6. The CR6's solar controller manages the 20W 12V solar panel and 50ampHr battery. The modem's power was shut down via programming instructions at night to manage excess power drawdown while the site radio was always powered on. The site never lost power over the monitoring period with these power controls implemented. The code currently managing data collection and processing at the CR6 logger is included as Appendix C.

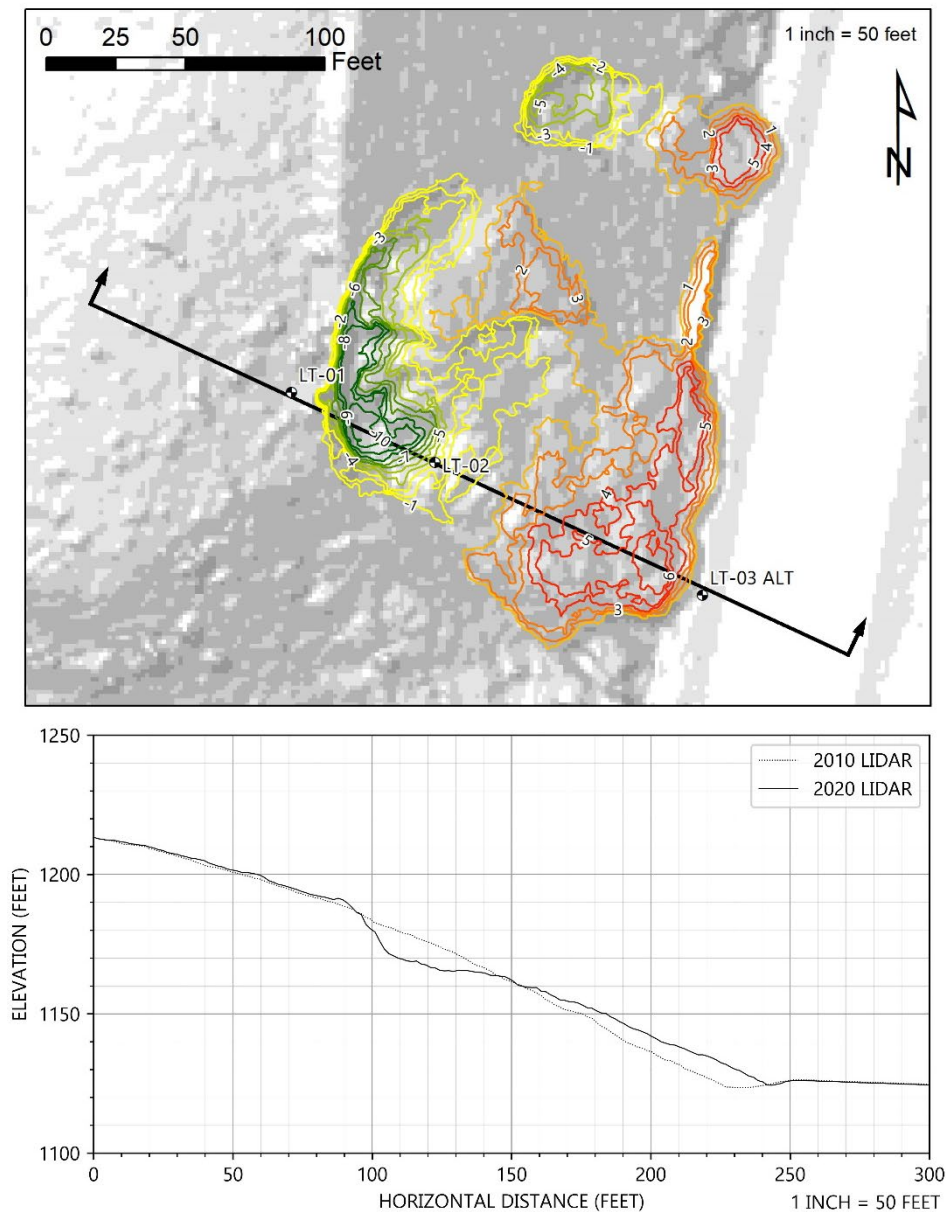
*Figure 21: Comparison of 2010 Stone County LiDAR data with this project's initial dataset collected in June 2020. Contour intervals are 1-foot, with green indicating a decrease in surface elevation and red indicating an increase in surface elevation.*

The change detection analysis shown in Figure 21, confirmed that Landslide Technology had sited borings LT-1 and LT-2 along the approximate center axis of the most active portion of the landslide. In the 1-foot contour intervals shown in the change detection map, green is areas of material loss at the head of the slides, while red shows areas of material deposition at the slide toes. The limited change in elevation in the main body of the slide, between the landslide head and toe, indicated that the main slide mass in this zone is moving parallel to the cut slope, with displaced material being deposited in the ditch. The cross-section comparison also shows the loss of ditch capacity since 2010, as the toe of the slide has deposited material in the ditch. The cross section also shows how much more fine resolution is available in the 2020 UAV survey, which has a more textured ground surface than the 2010 ground line.

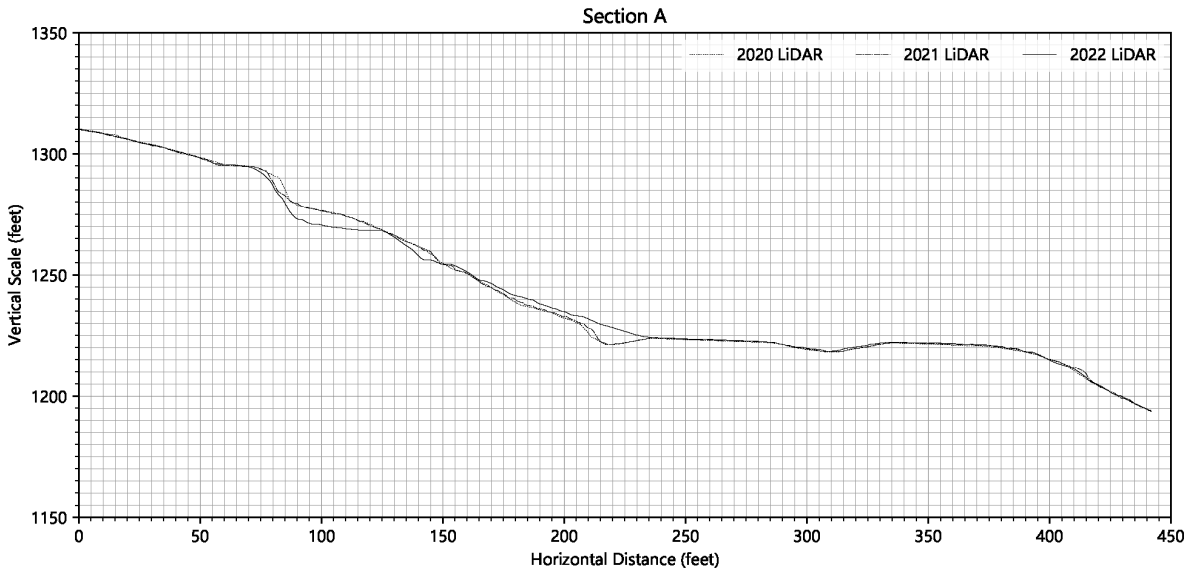
Figure 23: Cross section A-A' showing ground surfaces from 2020, 2021, and 2022 LiDAR surveys. Note encroachment of landslide deposits onto the edge of roadway.

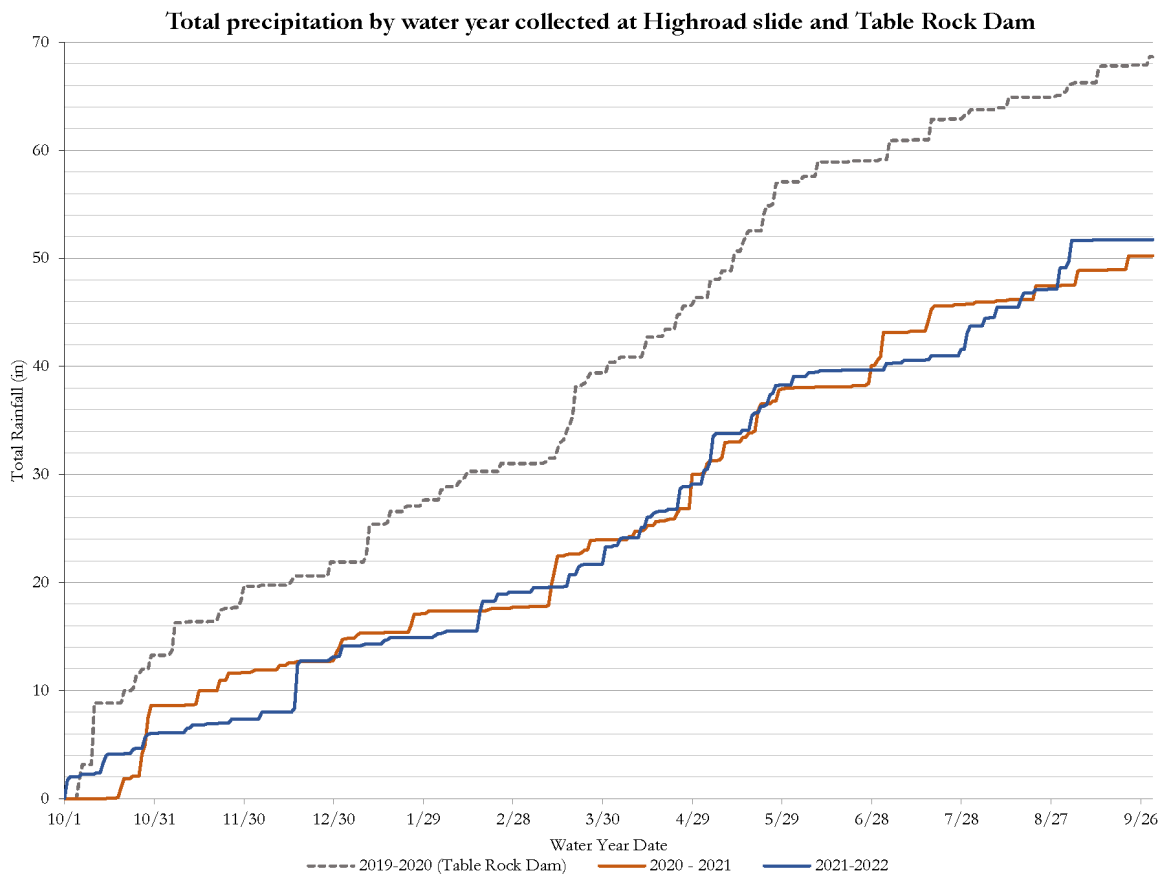
Figure 24: Cumulative precipitation collected in the project area and nearby Table Rock Dam during the study period.

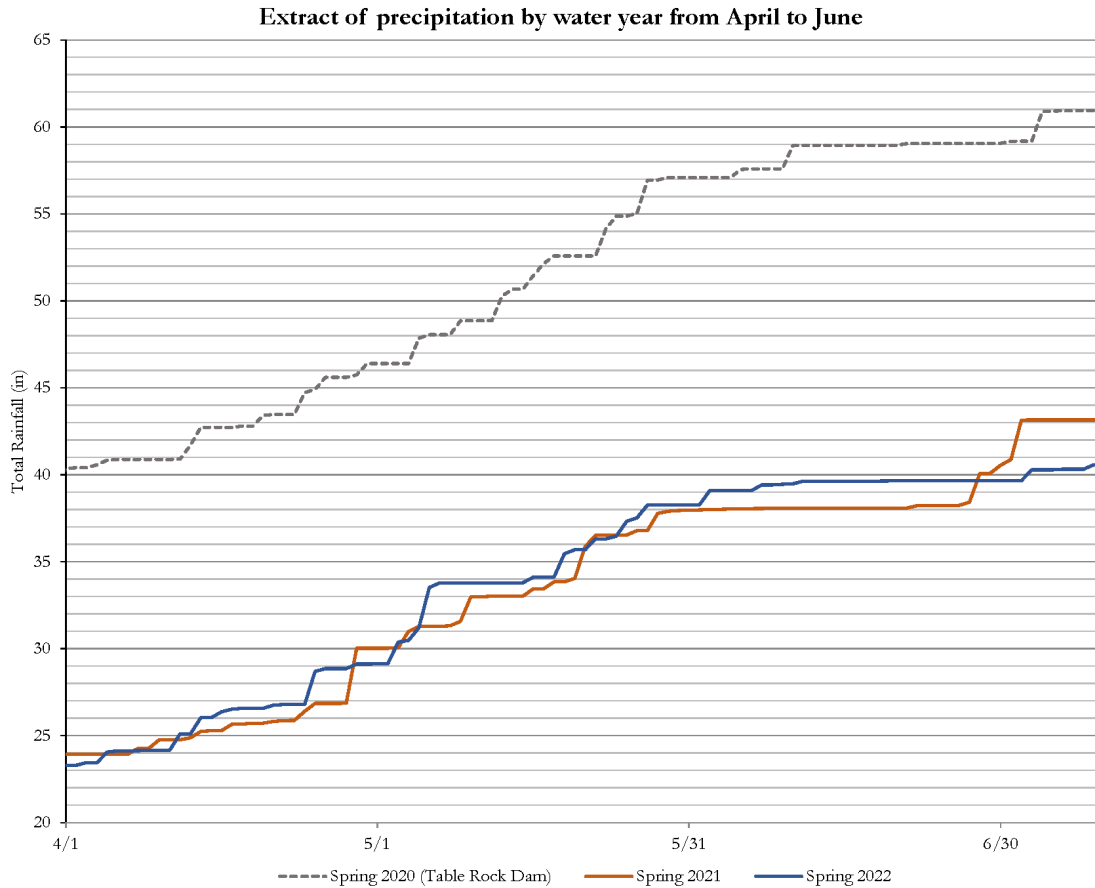
Figure 25: Extract of water year plot comparing April to June precipitation during the study period.

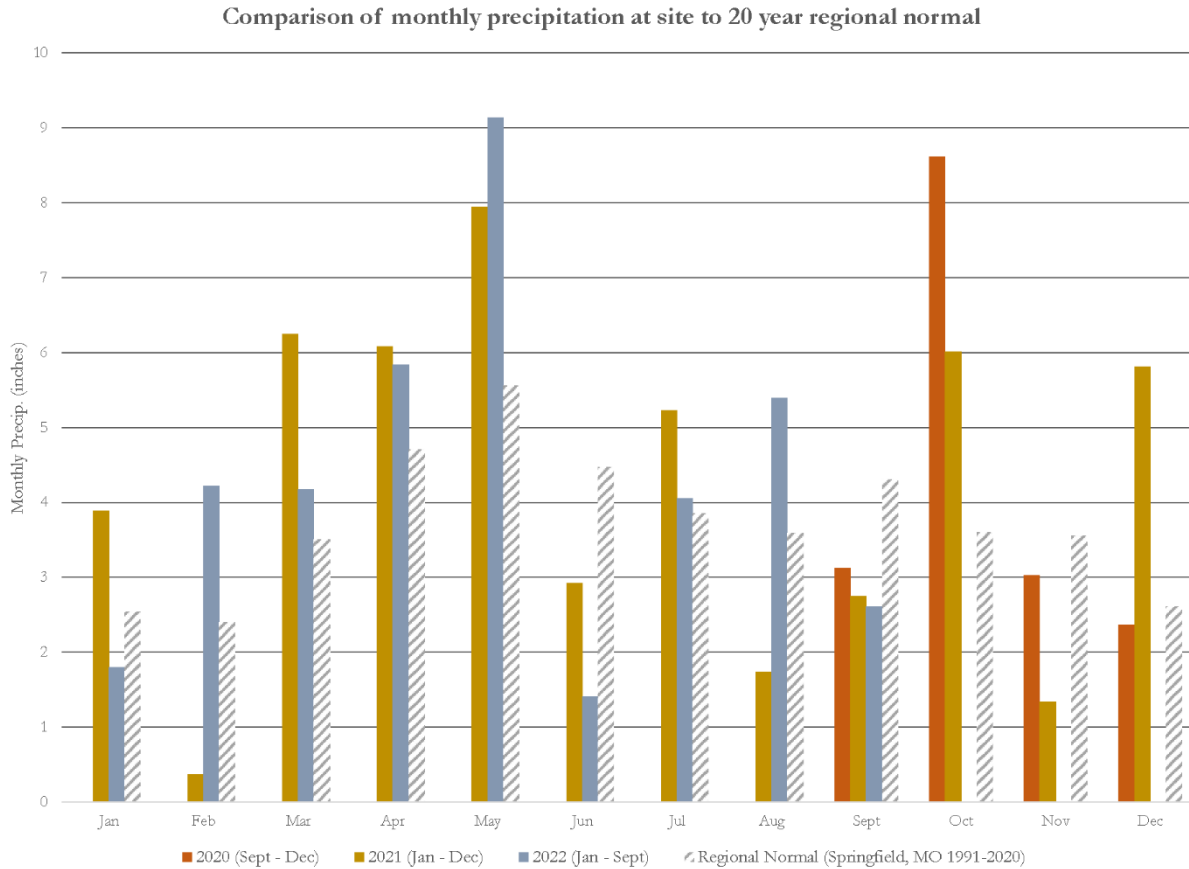
*Figure 26: Monthly Precipitation collected at the project site compared to the 20-year normal from the Springfield, MO regional office for the National Weather Service for water years 2020 through 2022.*

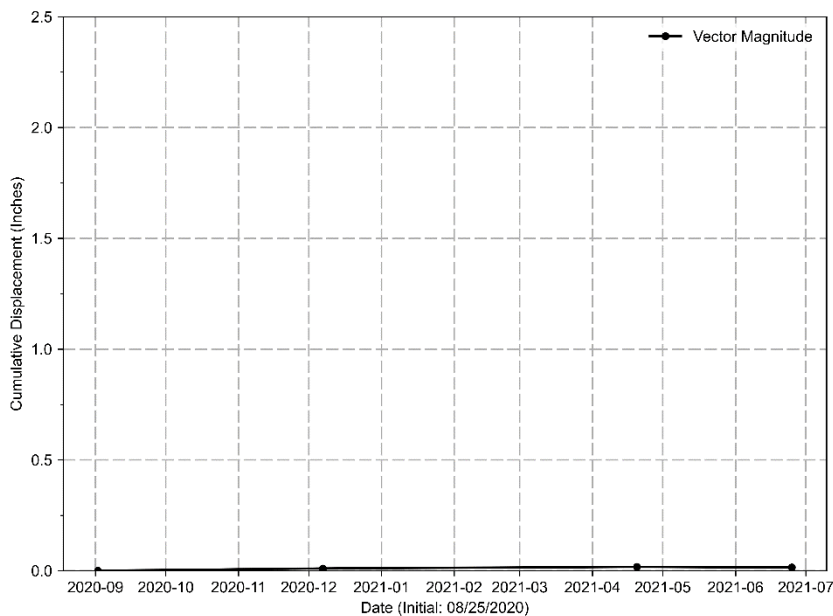
Figure 33: Time displacement plot for the lower shear zone of LT-3 between September 2020 and June 2021, prior to IPI placement.

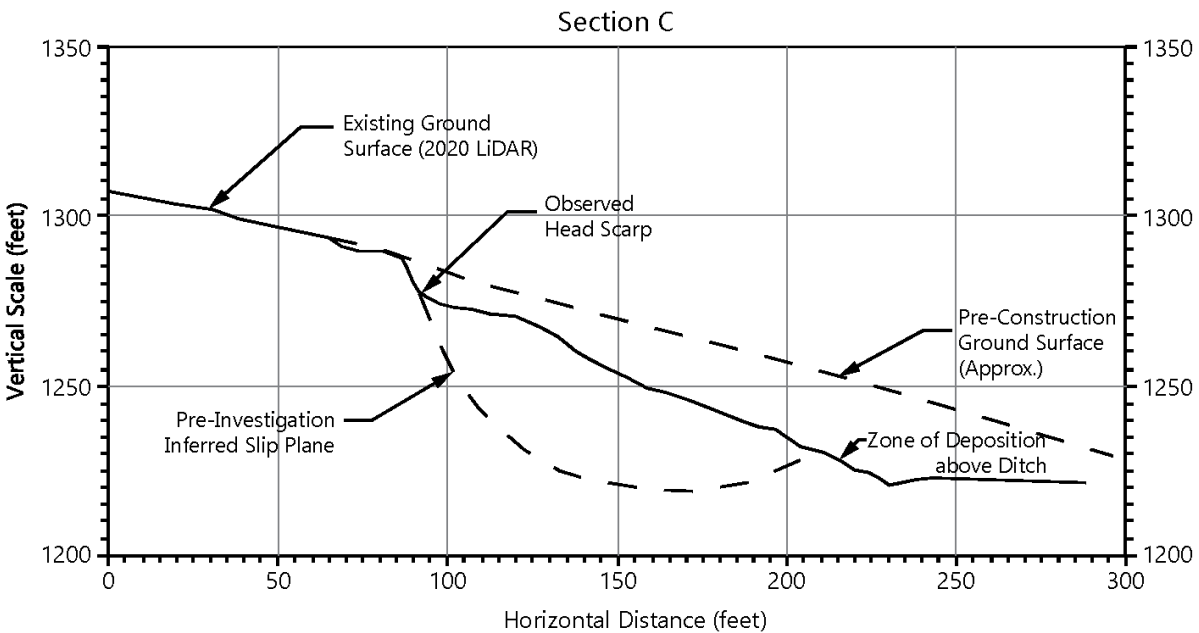
Figure 34: Estimate of slip surface geometry of the cut slope slide prior to subsurface investigation.

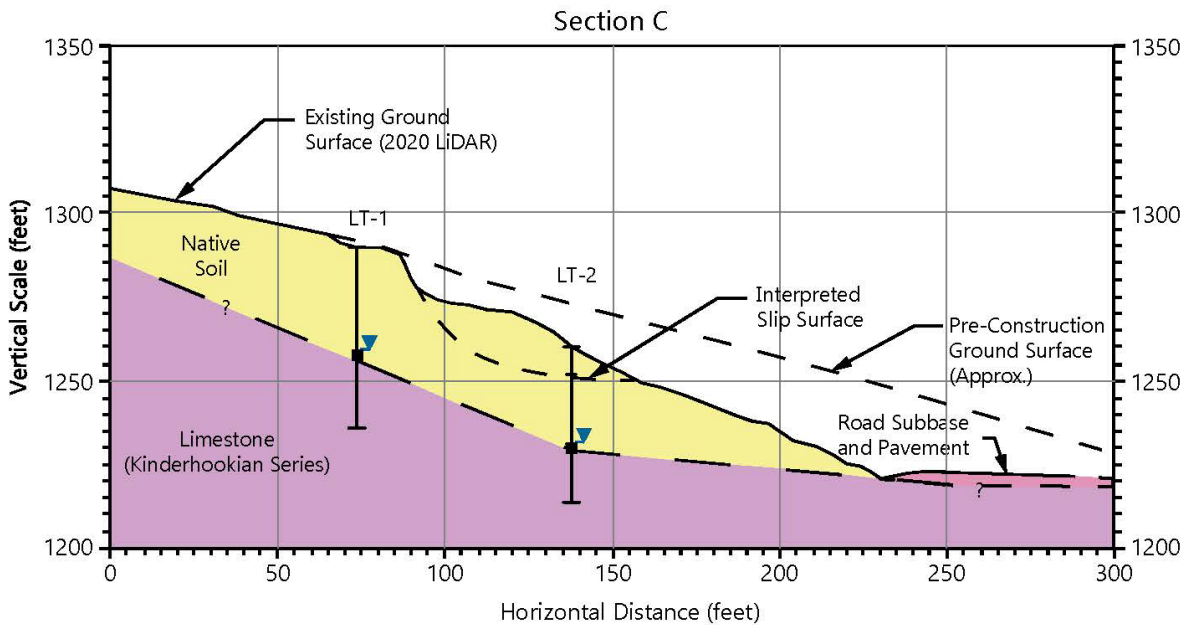
Figure 35: Geologic profile and subsurface geometry of the cut slope landslide based on subsurface samples and long-term monitoring.

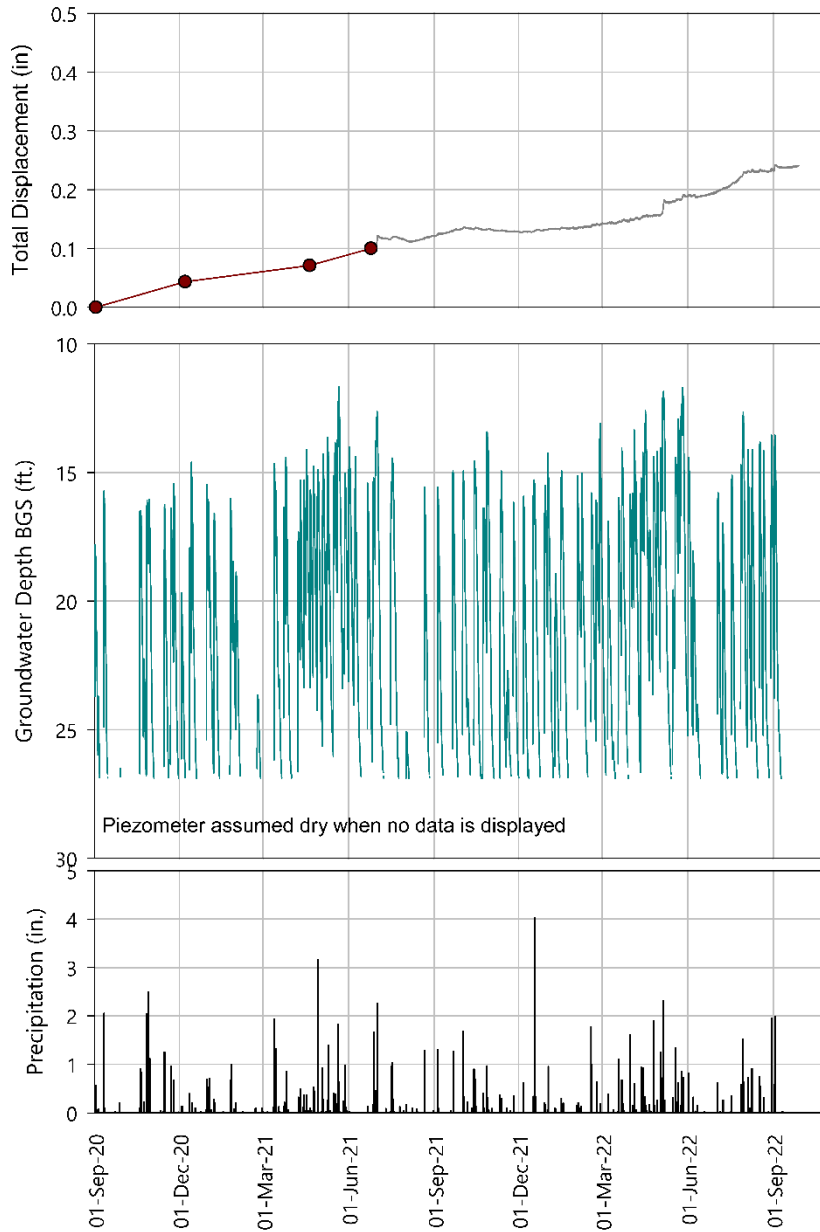
Figure 37: Plot summarizing all data collected at LT-3 - manual deflection measurements, IPI displacement, and groundwater elevation - combined with daily precipitation data collected at the weather station on the cut slope.

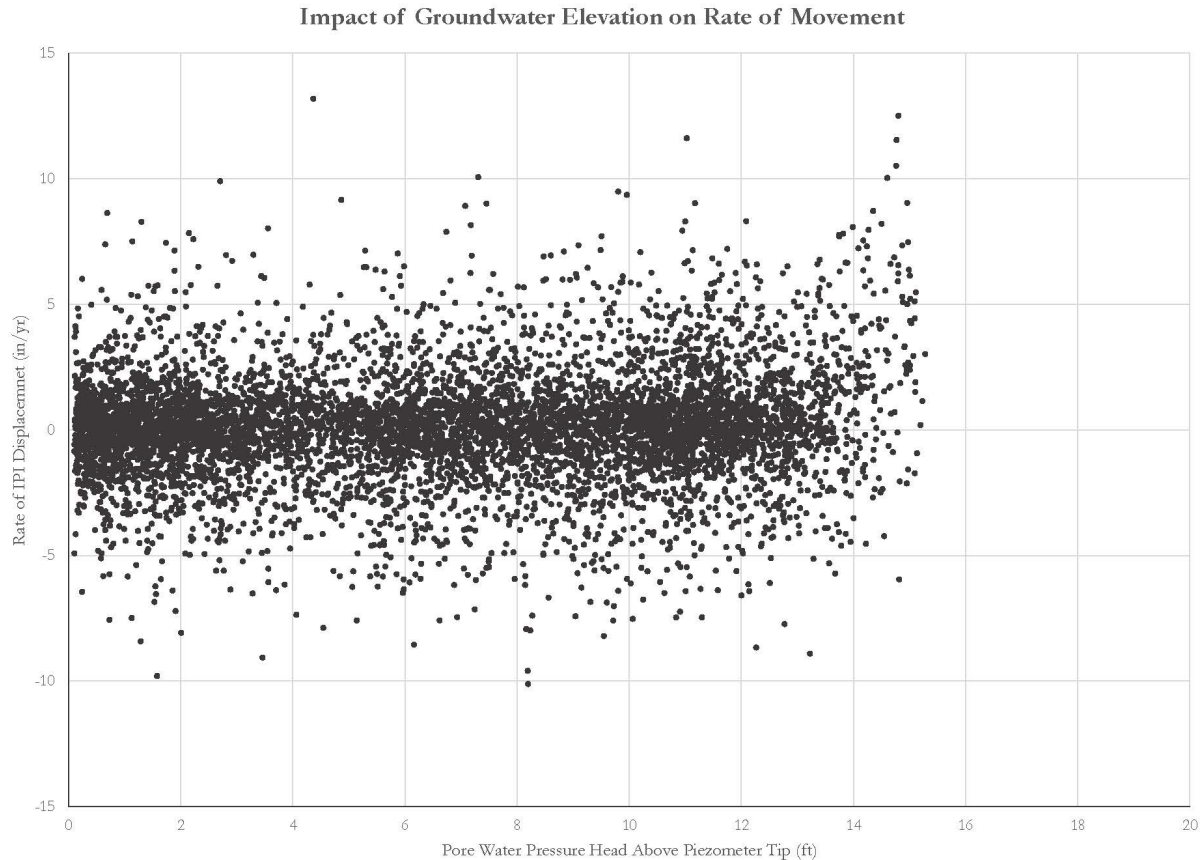
*Figure 39: Rate of IPI displacement vs pore water pressure head measured at the piezometer tip.*

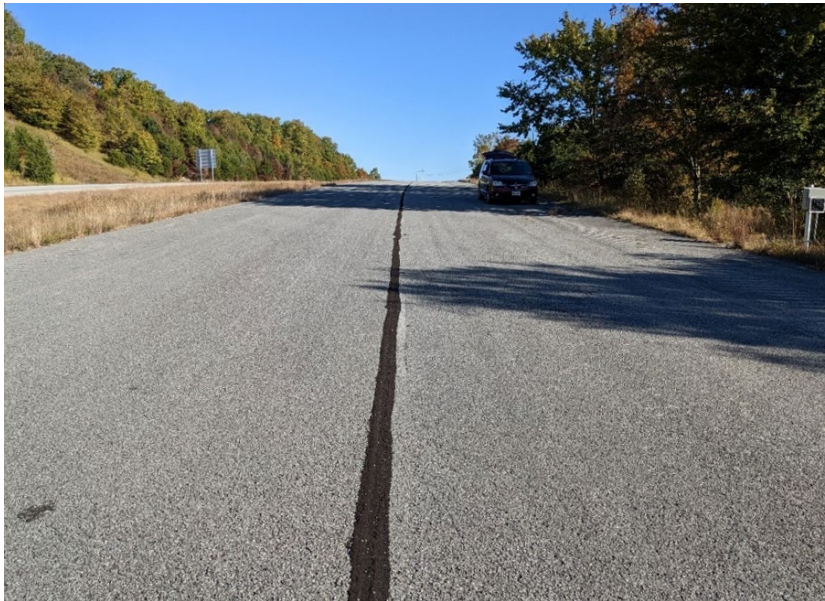
*Figure 41: Crack sealing in northbound lane. Photo taken October 2022. LT-3 data logger is visible left of the shoulder.*

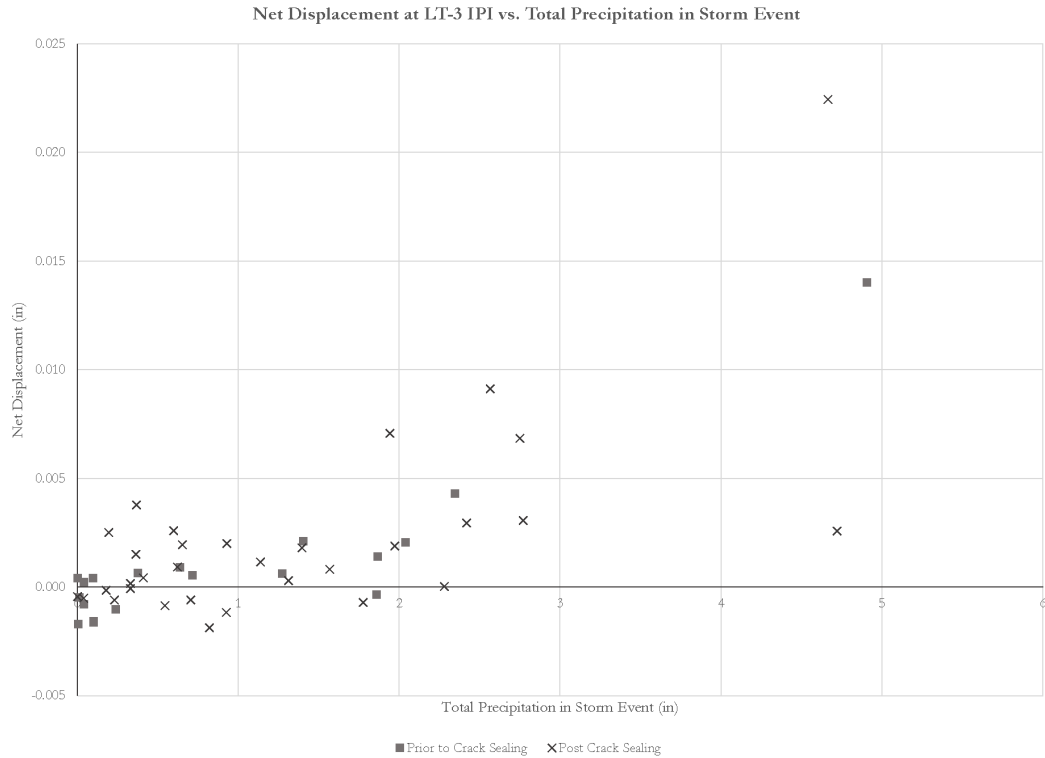
Figure 44: Comparison of measured net displacement and storm event size before and after crack sealing at LT-3.
