Asphalt Real-Time Smoothness (ARTS) for Asphalt Paving

George K. Chang, Principal Investigator
The Transtec Group, Inc.

Final Report NRRRA202302

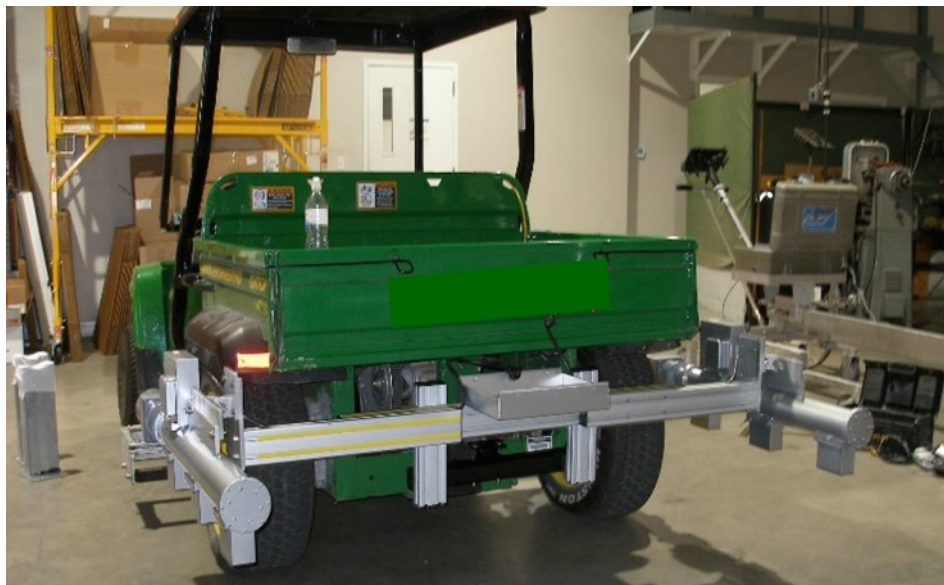
Figure 3. Vendor A initial ARTS prototype tests with sensors mounted on a small utility vehicle.

Vendor A performed initial tests on the ARTS sensor prototypes by mounting two ARTS sensors onto a small utility vehicle (Figure 3).

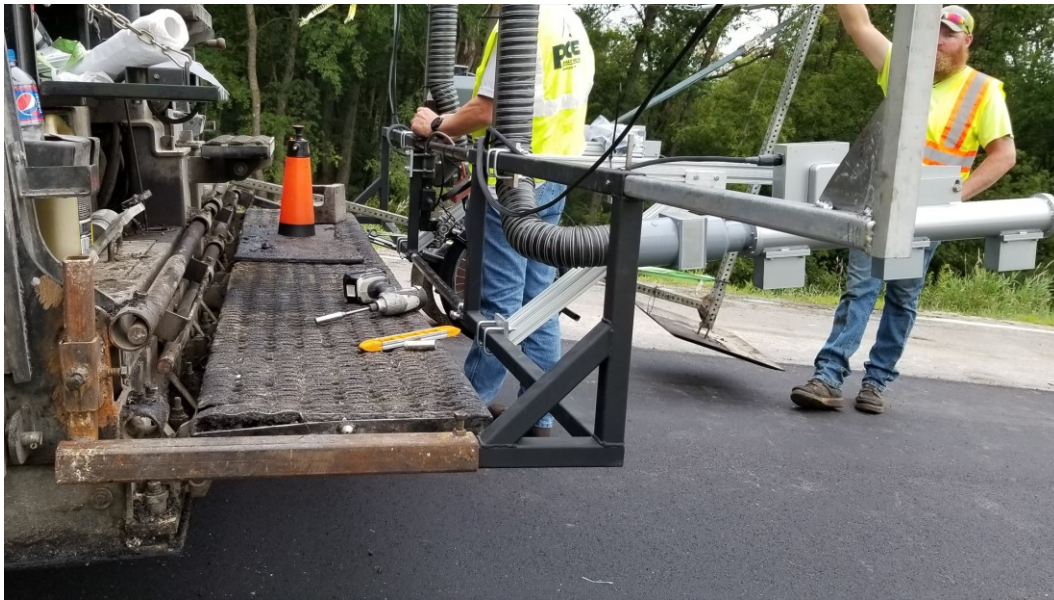
Figure 4. ARTS sensor assembly by Vendor A connected to the receiving bracket on the left side of a paver screed.

A vital feature of the prototype, unique to ARTS sensors (vs. concrete RTS sensors), is a cooling fan and chimney used to keep the laser sensors cool when paving over a hot mat. The fan draws cooler air several feet above the surface through the chimney (corrugated black tubing shown in Figure 4), which passes over the laser sensor housing to keep it cooler.

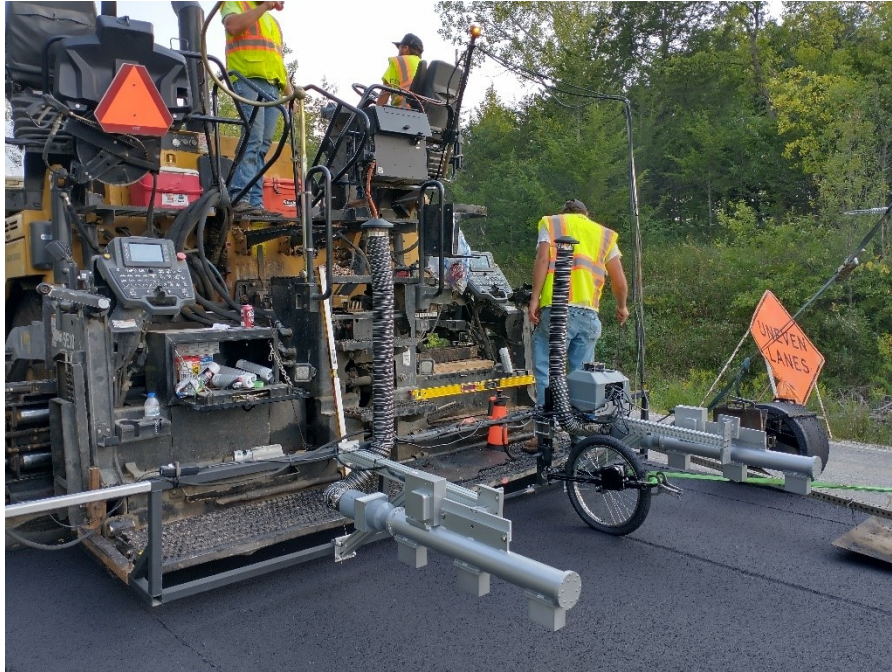
Figure 9. Demo No. 1 - ARTS sensor set up and operation.

The ARTS frame mounting and cabling were quick and straightforward. All equipment was mounted aft the screed catwalk, and cabling was run overhead to minimize interference for the paving crew. (Figure 9) The ARTS sensor mounting and connections before paving each day were also quick. Minor adjustment to the sensor mounting was required on Day 1 to ensure the sensors were within the operating working vertical measurement distance range (4"). The ARTS prototype's Acuity sensors were customized for high standoff height (13") and high resolution (.00023") within a 4" working range.

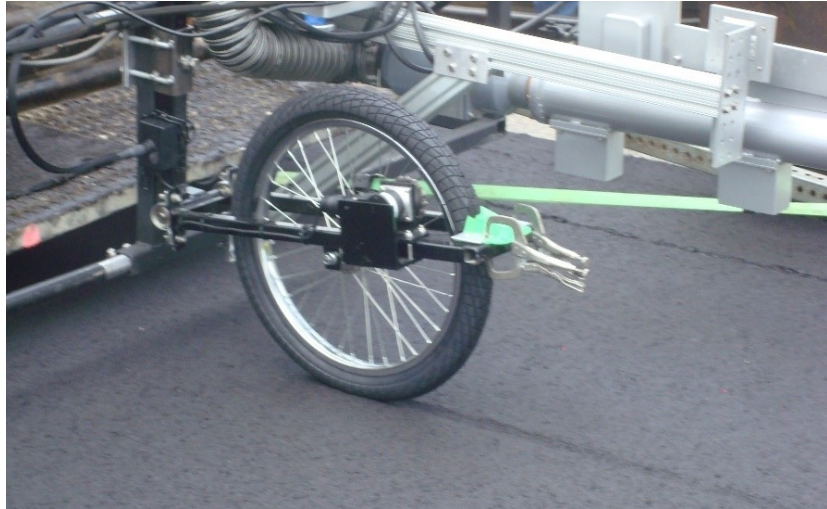
Figure 10. Demo No. 1 - ARTS Distance Measurement Instrument (DMI).

The DMI was mounted behind the screed, roughly 1 ft from the right-side ARTS sensor. The DMI was equipped with a scraper to prevent the build-up of asphalt on the DMI's wheel. (Figure 10) The paver operator would occasionally spray release agents on the wheel. A GPS receiver (not shown) was mounted near the paver operator's station, approximately 17 ft ahead of ARTS sensors.

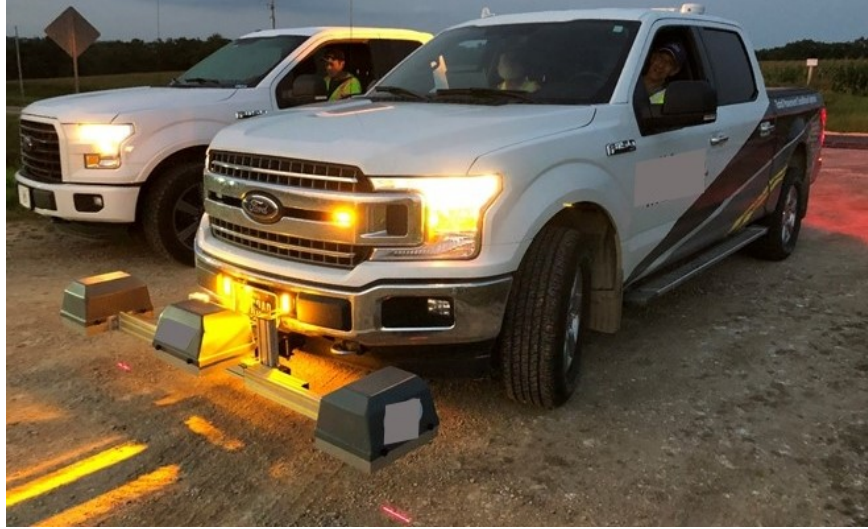
Figure 14. Demo No. 1 - Vendor A's highspeed inertial profiler.

Vendor A's HSIP was used for final surface profiling each day. (Figure 14) HSIP data were collected in the opposite direction of paving (i.e., in the direction of traffic due to safety concerns). On Day 2, there were still areas with surface moisture from rain and roller water when HSIP data were collected.

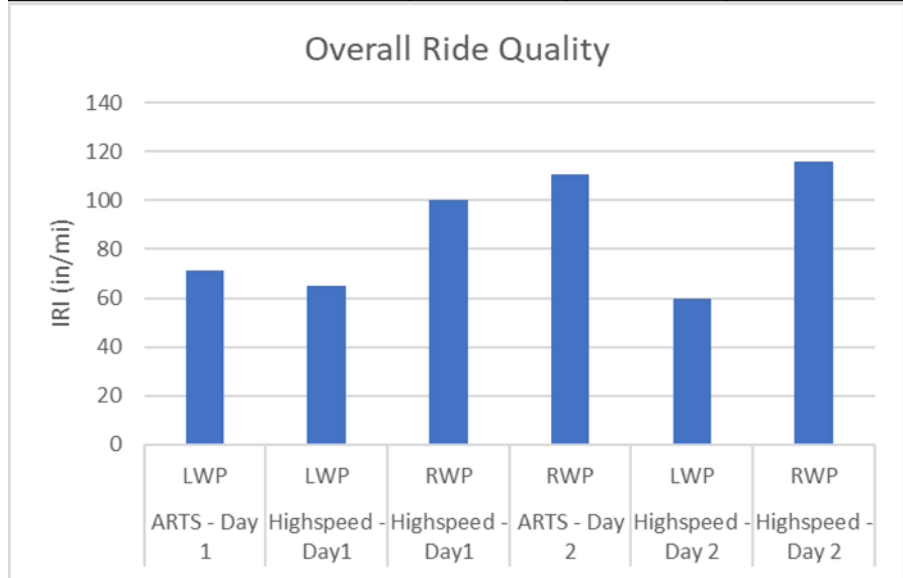
Figure 19. Demo No. 1 - Comparison of the overall roughness of ARTS and HSIP data.

Tests	Wheel Path	IRI (in/mi)	HSIP-ARTS (%)	RWP-LWP (%)
ARTS - Day 1	LWP	71		
Highspeed - Day1	LWP	65	-9%	
Highspeed - Day1	RWP	100		54%
ARTS - Day 2	RWP	111		
Highspeed - Day 2	LWP	60		
Highspeed - Day 2	RWP	116	5%	95%

Overall roughness measured by the ARTS system for Day 2 was higher than on Day 1 primarily because the functioning ARTS sensor was installed on the side of the paver with grade control (to match the adjacent pavement) on Day 1, and the side of the paver with slope control (to match the design cross-slope grade) on Day 2. The field team observed frequent and sometimes large tow point movements on the side of the paver using automatic slope control (shoulder edge), to which the higher roughness on that side of the paver can be attributed. The HSIP data confirmed this difference in roughness, with the RWP 54% and 95% rougher than the LWP for Day 1 and Day 2, respectively. HSIP data also revealed similar overall IRI between Day 1 and Day 2 for both the LWP and RWP.

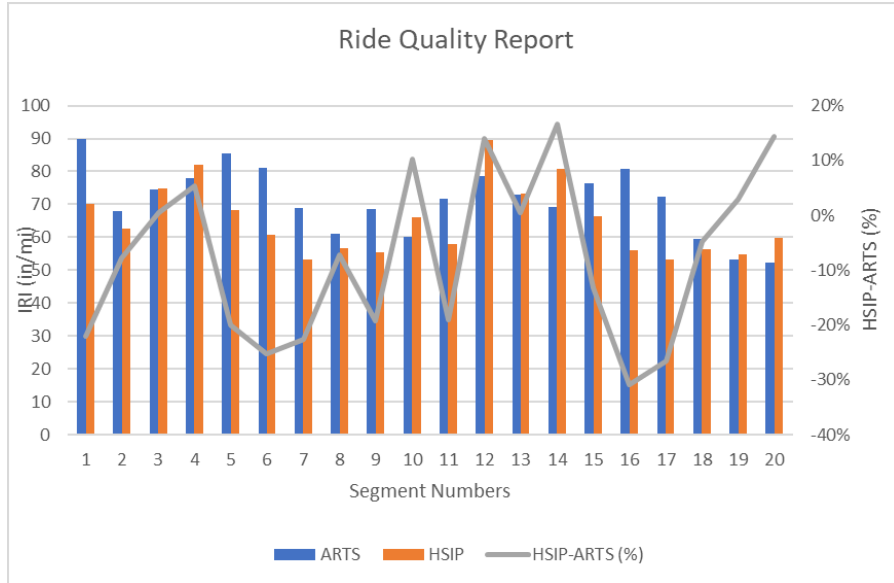
Figure 20. Demo No. 1 - Fixed-interval ride quality report for Day 1.

The 0.1-mile fixed-interval ride quality (IRI) report for Day 1 is shown in Figure 20. The IRI differences between (HSIP-ARTS) can be positive or negative. The differences range from +15% to -30%.

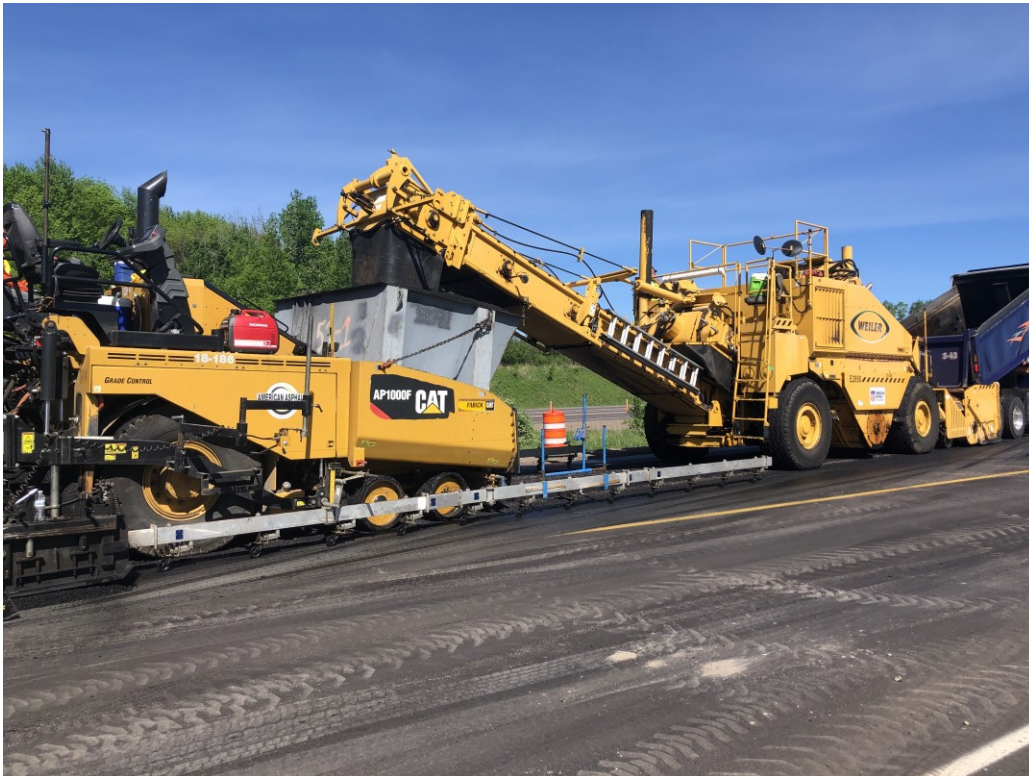
Figure 25. Demo No. 2 – Truck, MTV, and Paver Operations.

The total daily tonnage was 2,215 tons, delivered approximately 16 tons per truck. A Weiler material transfer vehicle (MTV) was used along with a hopper insert. The paver was a Caterpillar AP1000F wheeled paver with a Weiler screed and Willow Designs notched-wedge joint device. Two contact ski automatic grade control devices were used along the roadway centerline and the shoulder. The left ski appeared to have several unrounded wheels that slipped during the operation. (Figure 25) Three rollers were used for compaction, two for echelon breakdown, and one for finishing. All three were HAMM HD 120i double drum rollers. (Figure 27) A water truck sprayed water on the asphalt surface before the finishing compaction.

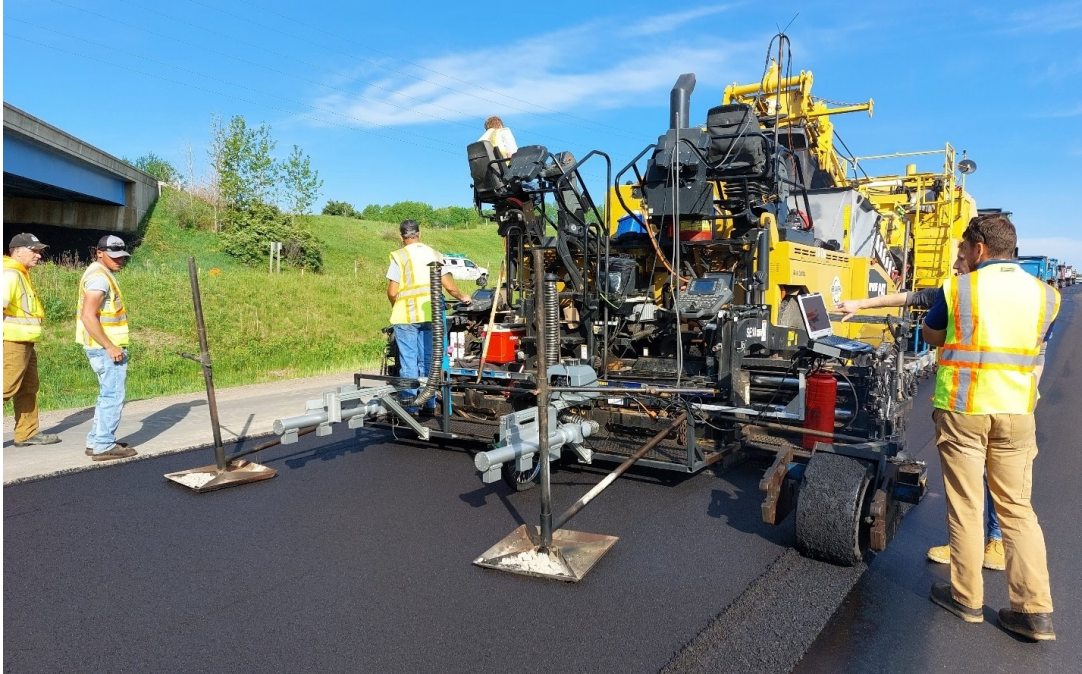
Figure 28. Demo No. 2 -ARTS data collection during paving.

Figure 28 shows the paving operation and ARTS data collection setup for paving of both the northern and southern sections, which was virtually identical to Demo Project 1.

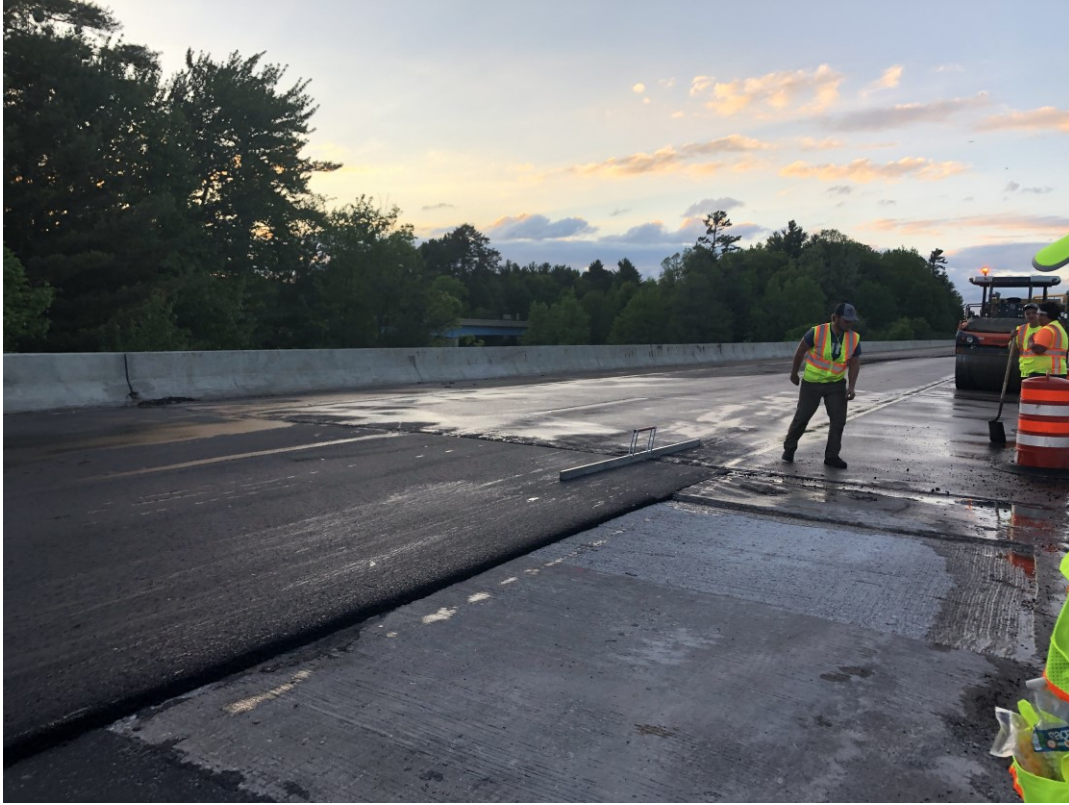
Figure 32. Demo No. 2 – Bridge Deck Tied-in.

The contractor stopped the paver about 20 ft from the bridge tie-in location and switched from automatic grade control (contact ski) to automatic slope control to tie into the bridge deck (Figure 32). A screed takes roughly 4 to 5 times the tow-arm length (~40 to 50 ft) to stabilize. This observed roughness may result from WisDOT’s exclusion for smoothness requirements 25 ft offset from a structure. If the exclusion distance was 50 ft, contractors may start this bridge tie-process at the 50-ft offset, which would provide a greater distance for the screed to reach equilibrium, resulting in a smoother transition or tie-in to the bridge deck.

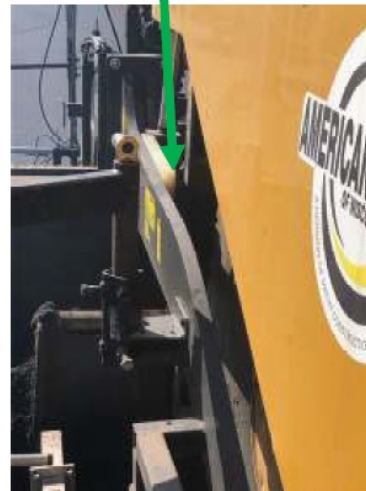
**Low side –
no contact**

Figure 66. Paving through superelevation may cause contact between the paver's tow arm and frame at the high side – Part 2.

Another factor influencing left-side and right-side real-time smoothness is when the paver goes through a superelevation. This causes the tow to “hang up” on the frame due to a thick after-market nylon block, and then the tow arms flick when they break free of the friction on the tractor frame. Two or three super-elevated sections may result in higher roughness in the high-side wheel path. The contractor noticed approximately 5 to 10 in/mile higher IRI on the “high side,” where this effect was happening on other projects. (Figure 65 and Figure 66) Based on results from Section 4.7.3, the ARTS’ LWP IRI is consistently higher than the RWP IRI.
