CATCH CONTROL IN THE BLUE WHITING PELAGIC TRAWL FISHERY

Research Cruise Report [2022825]: FV "Vikingbank"

TOKTRAPPORT
No.1 2023

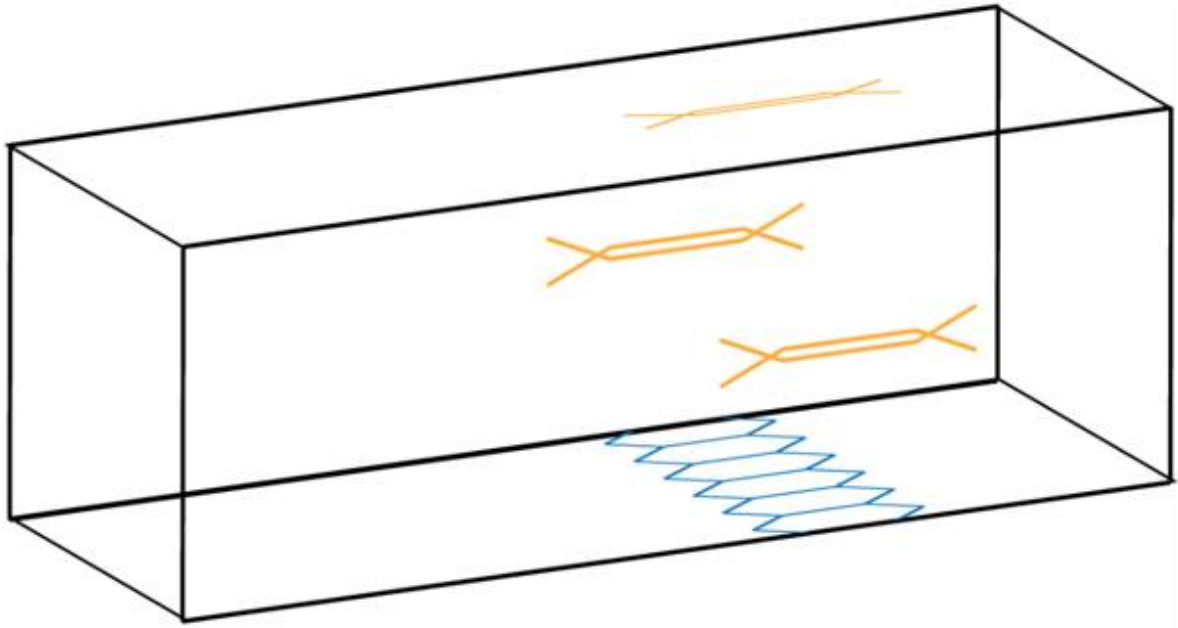
Figure 3.2 – Above: schematic diagram of 16m long fish release section (FRS) with 2.5m long slots on each of top and side panels and 2.7m Hexagonal Meshes in the bottom panel; for a detailed net drawing see appendix C.

The fish release section (FRS) used during this cruise consisted of a four-panel cylinder of netting, approximately 16m long, inserted between the trawl and cod-end, that incorporated two types of escape openings: 2.5m long slots on each of top and side panels and 2.7m Hexagonal Meshes in the bottom panel (figures 3.1 & 3.2). The distance from the openings to the cod-end was 6 m. The theoretical area of release openings: 18.9 m². The rig should allow free passage of the catch from the trawl into the cod-end during the fishing process, until the cod-end is full. The escape openings therefore should prevent escape during the normal fishing process, but once the cod-end is full should then enable fish to escape freely with minimal risk of crowding and abrasive injury.

When fitted to the trawl, the FRS appeared to be stable and adopt its designed geometry. The only exception was during the test hauls and hauls 01 and 07, when the bycatch release section (BRS) was attached. During these hauls it was noted that the vertical opening of the CLS during fishing was reduced by ~20% from ~2.5m to ~2.0m (table 2.2b).

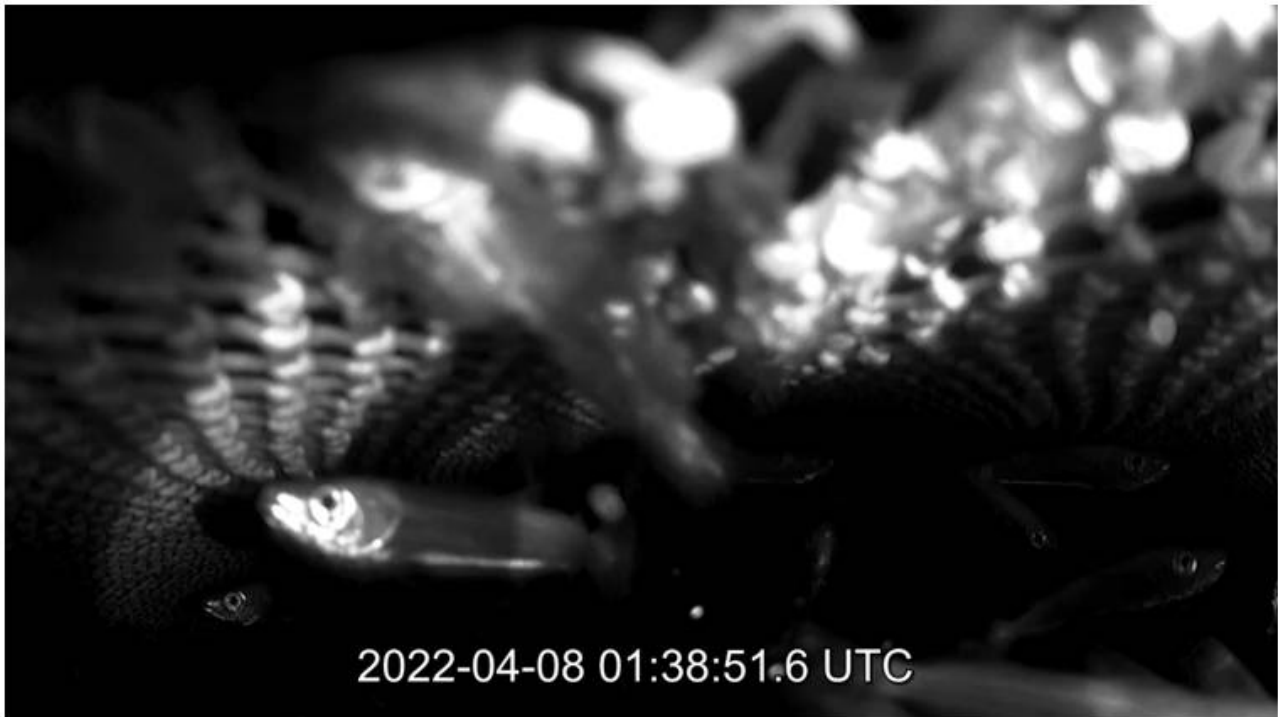
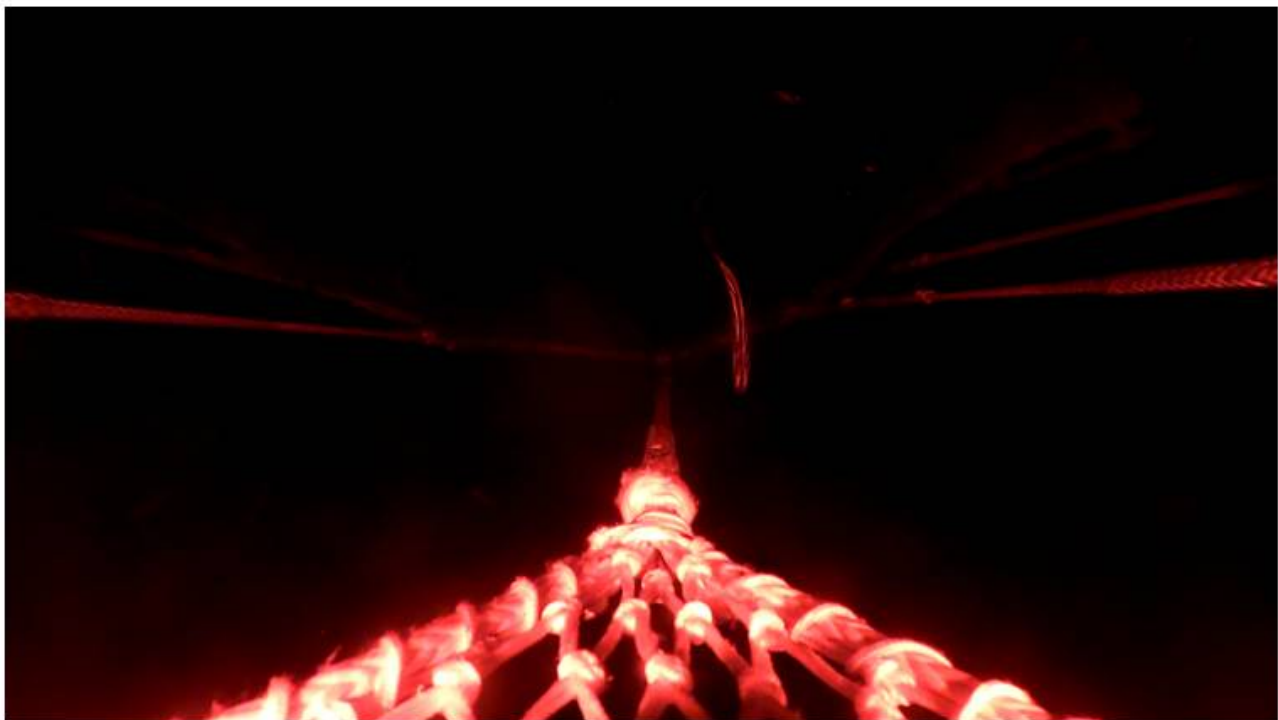
Figure 3.3 – Images from video taken during haul 11 at 01:38, just before the start of haul-back at 01:39. Top: from position 5iB looking aft toward the fish-lock and cod-end, showing medium densities of fish in the top of the FRS. Bottom: from position 4iB, looking aft over the escape opening, toward the fish-lock and cod-end, with three fish escaping. Note – the escape rate was approximately 12 fish/minute [01:38-01:39].

species through the release opening in the bottom panel. At low to medium densities in the upper part of the FRS, which were the most prominent catch densities observed, the typical escape rate was 0 to 15 fish per minute (figure 3.3). While at high densities, escape rates of between 23 and 65 fish per minute were observed (figures 3.4 & 3.5).

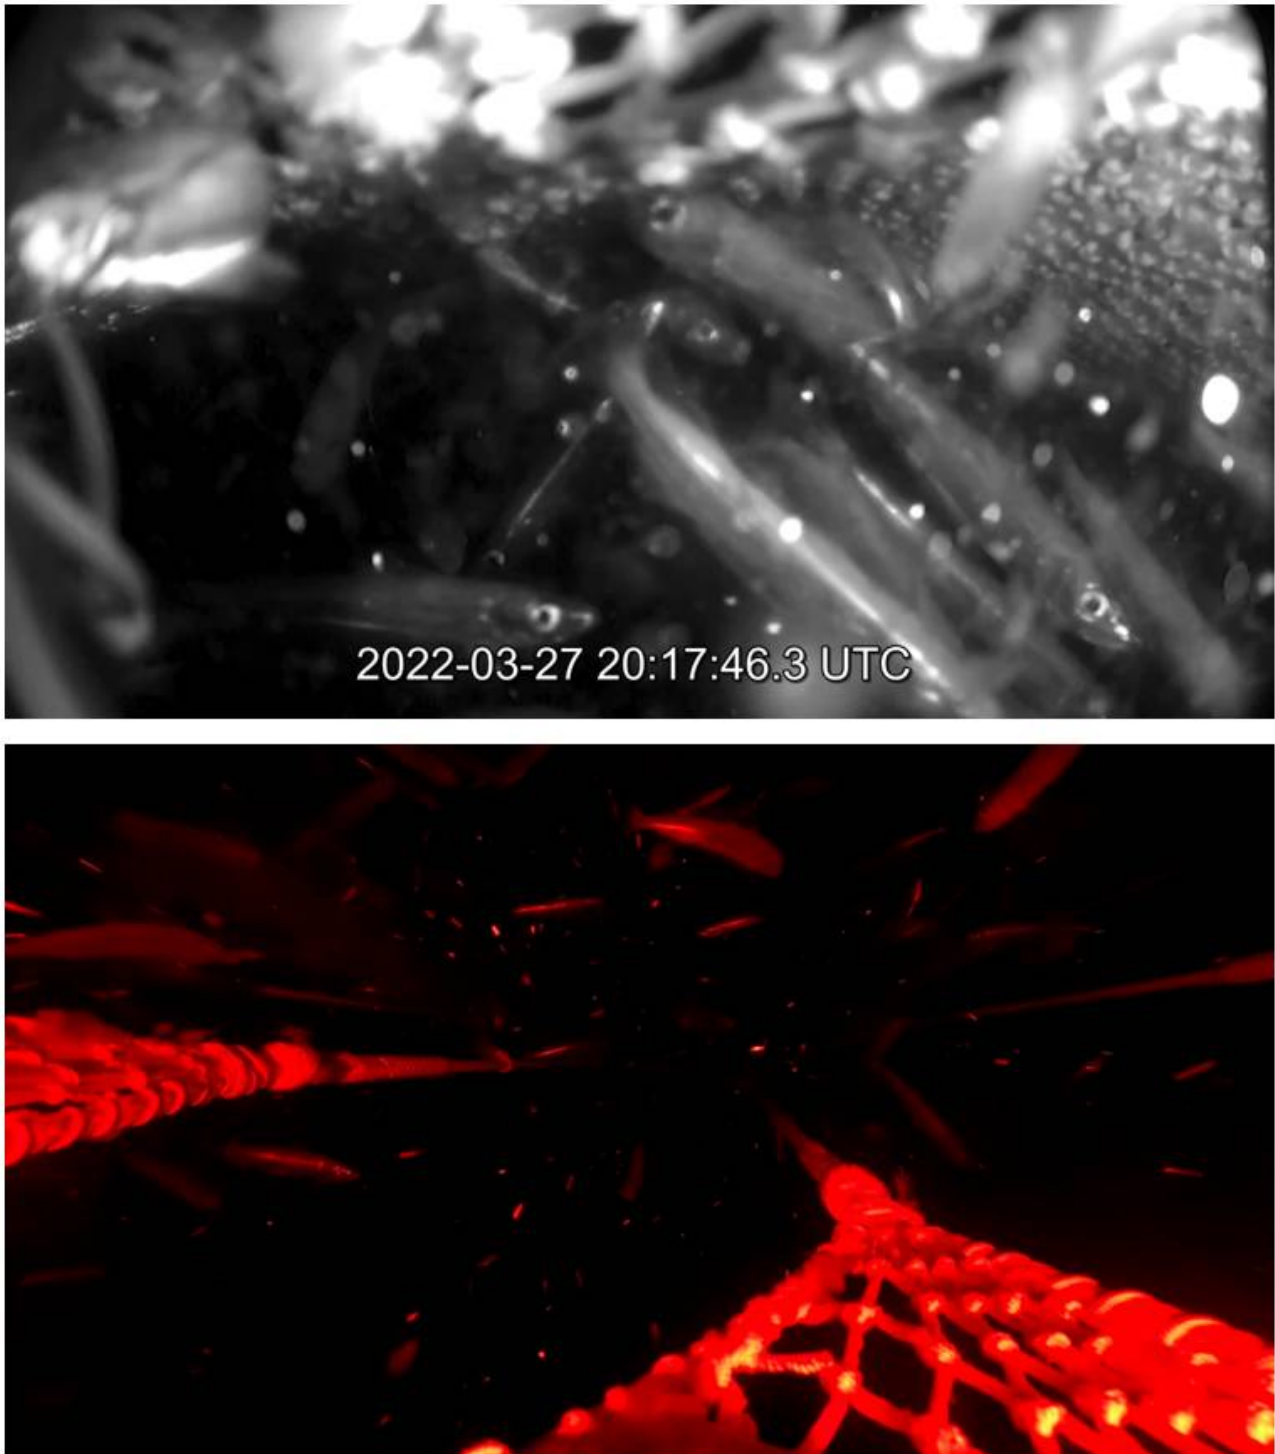
Figure 3.5 – Images from video taken during haul 03 at 20:17, 16 minutes before the start of haul-back at 20:33. Top: from position 5iB looking aft toward the fish-lock and cod-end, showing high densities of fish in the top of the FRS. Bottom: from position 2iF, looking forward over the escape opening, with medium densities of fish passing over the escaping open. Note – the escape rate was approximately 65 fish/minute [20:17 - 20:18].

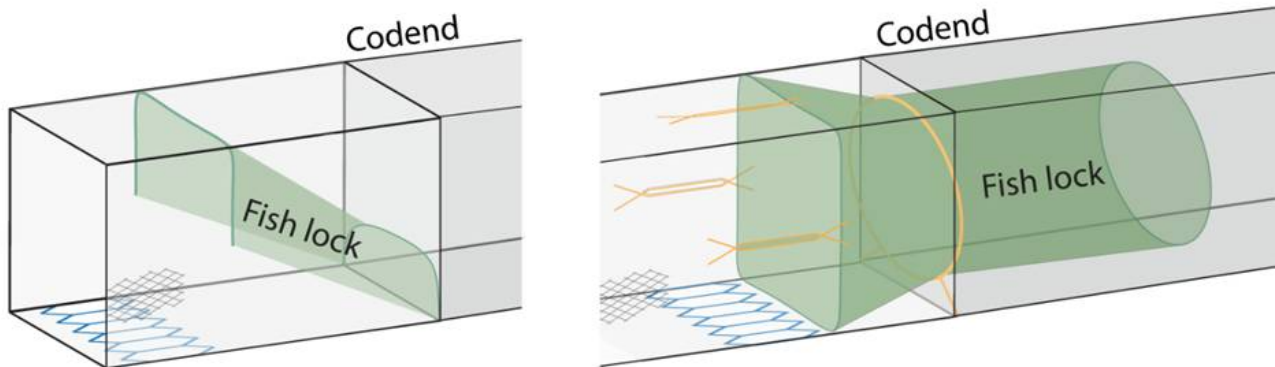
Figure 4.1 – Schematic diagrams of fish lock designs: Left – type 1, panel; Right – type 2, cylinder.

Two different “fish-lock” designs were tested during cruises 1 and 2. Type 1 was constructed of a netting panel 80 mm mesh size with 210/96 nylon (PA) twine, 74.5 meshes long (6 m). This was fixed to the top panel, approximately 0.3 m to the aft of the escape opening, and then fixed on a diagonal line down to about halfway down the side panels (and toward the cod-end). The operation of this design (type 1) was observed during cruise 1 and is described in Breen et al (2021). In summary, when water flow in the codend reduced during haulback, the lower/aft portion of the panel dropped to the bottom side of the codend preventing fish from escaping forward.

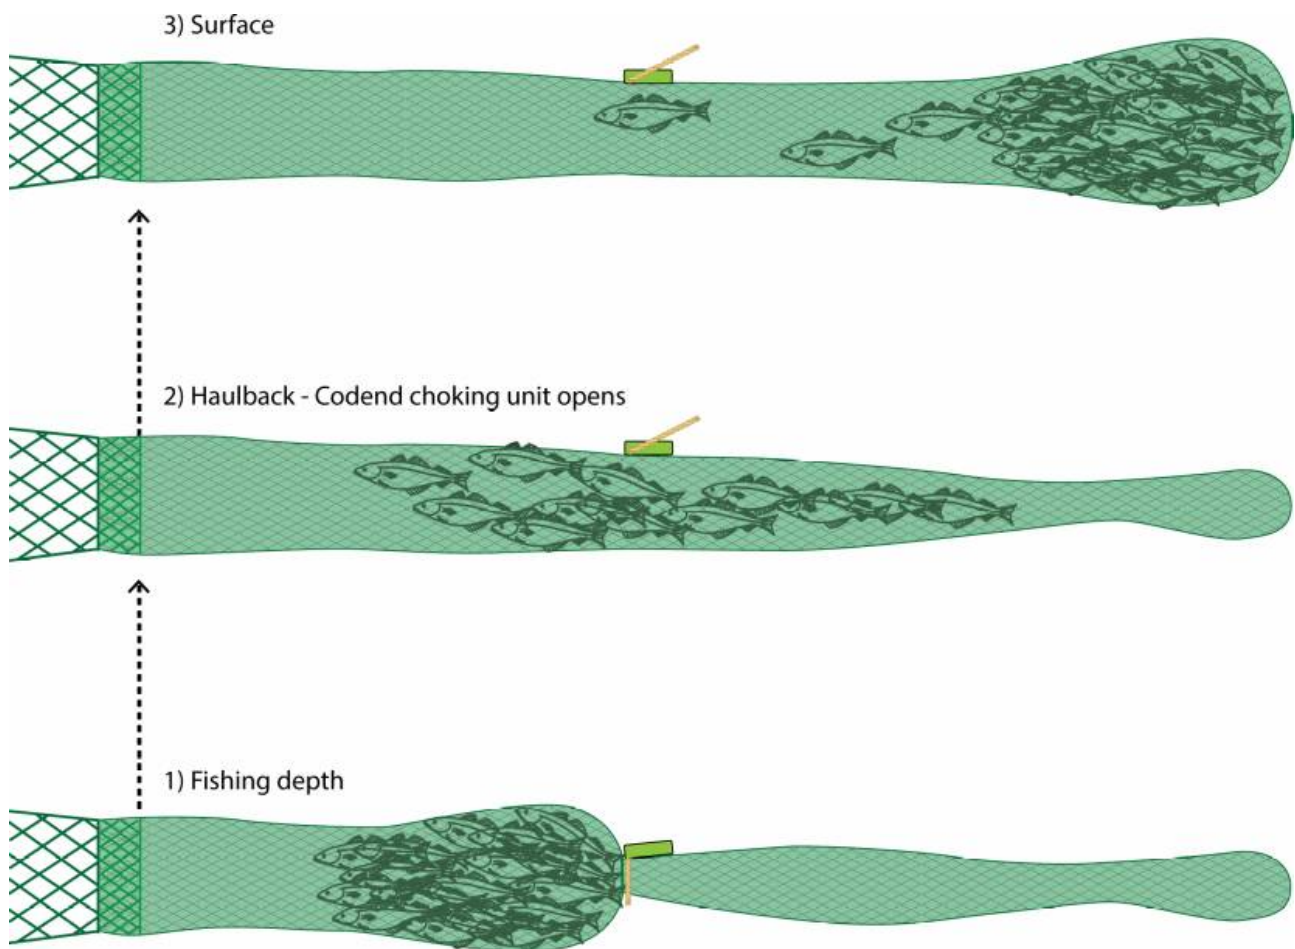
Figure 5.1 – Schematic diagram of the Cod-end choking unit in operation. 1: catch is retained in the cod-end ahead of the closed CCU; 2: the trigger depth is reached and the CCU opens; and 3: the retained catch dissipates into the residual component of the cod-end [Source: Ingolfsson et al, 2022].

The cod-end choking unit (CCU) is a prototype device (developed by FossTech AS) that can be placed at different locations along the length of the cod-end, to limit the effective volume of the cod-end and thus the volume of the retained catch (Ingolfsson et al, 2018; Breen et al, 2021). At a pre-determined depth (between 50 and 150m) during haul-back, the release mechanism opens allowing the restrictor-rope wrapped around the cod-end to release, which results in the retained catch moving (with the towing induced flow inside the trawl) into the residual cod-end (figure 5.1). If timed correctly, this transfer of the catch from the retaining cod-end into the residual cod-end should dissipate the catch over a larger volume within the cod-end. This will prevent the catch concentrating at the terminal end of the cod-end, which provides two key benefits: i) fish can freely decompress, evolving expanding gas from ruptured swim-bladders and body cavities during ascent; and ii) dissipate buoyant lift from the catch over a larger surface area in the ascending cod-end, thus increasing drag and reducing acceleration during ascent.

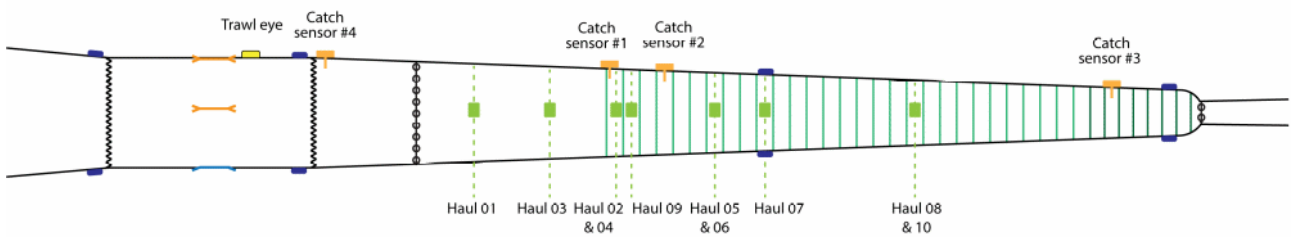
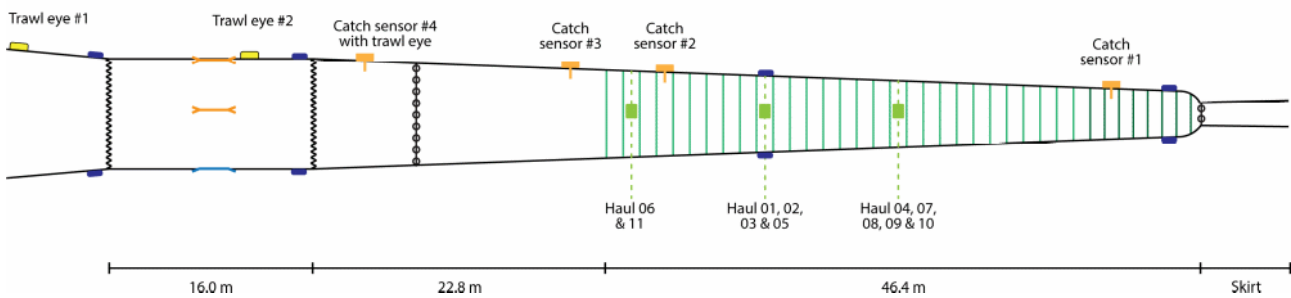
Figure 5.3 - positions on the cod-end of the Cod-end choking unit (CCU) and other instruments for cruise 1 (top) and cruise 2 (bottom). Releaser positions for each haul in both cruises are shown in green (see also table 5.2). Also shown are the relative positions of the “Trawl-Eye” echo-sounders (yellow), Catch Sensor units (orange) and depth-sensors (blue). [Source: Ingólfsson et al, 2022].

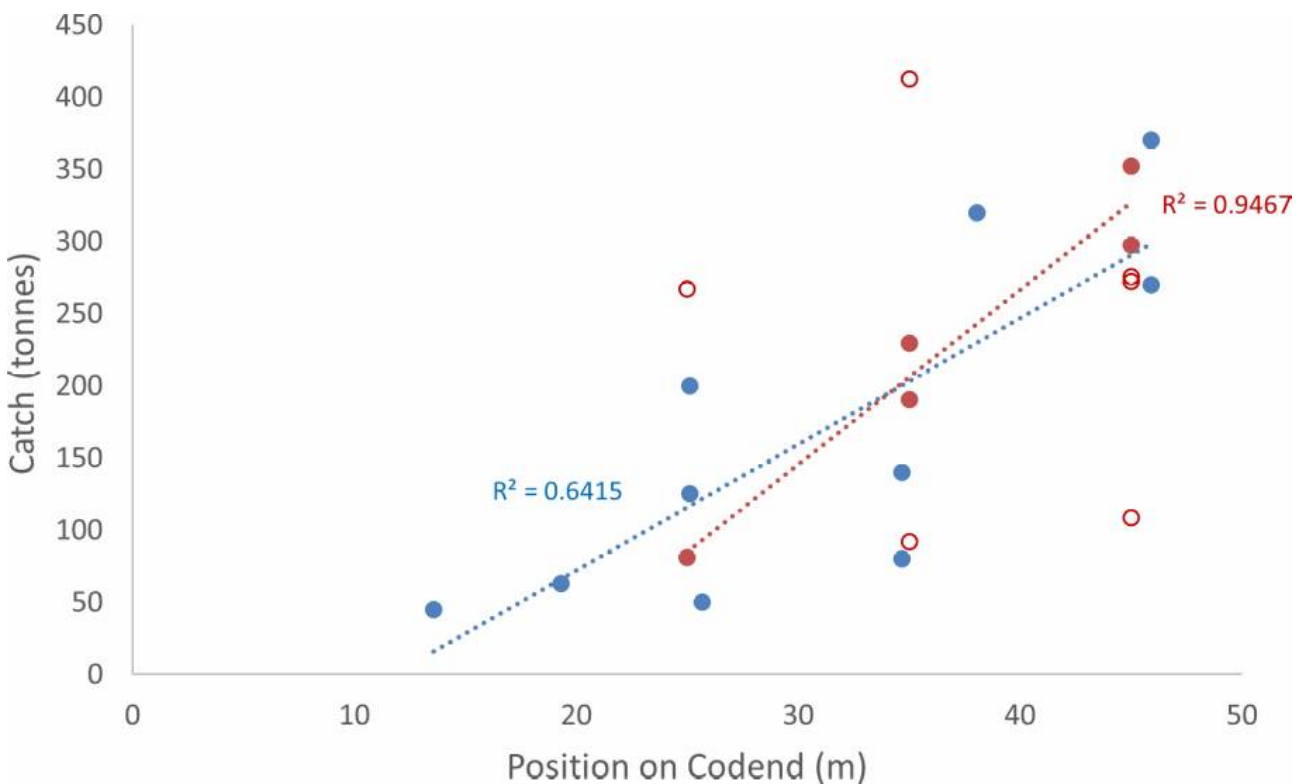
Figure 5.4 – The relationship between targeted catch size (tonnes) and the position (metres) of the CCU relative to the forward edge of the cod-end. Multiple linear regression analysis determined that catch size increased significantly the further aft the catch limitation releaser was positioned on the cod-end ($t = 5.41$; $p < 0.001$), while there was no significant difference between the relationships for either cruise ($t = -0.40$; $p = 0.699$). Blue dots show results from cruise 1 and red dots cruise 2. Open circles show hauls where problems with the releasers were experienced and are not included in the regression analysis. [Source: Ingolfsson et al, 2022].

There was a significant relationship between CCU position on the cod-end and the actual catch (in tonnes) ($t = 5.41$; $p < 0.001$) (figure 5.4). Furthermore, there was no significant difference in the relationship for either cruise ($t = -0.40$; $p = 0.6990$). The relationship for the valid hauls from cruise 2 was far more consistent than for the cruise 1 data (R^2 : 0.9467 and 0.6415, respectively), likely because known problems with catch control were deliberately removed from the dataset. Indeed, the spread of the invalid hauls (open circles in figure 5.4) are at least as variable as the cruise 1 data. This suggests that the higher variation in cruise 1 may be the result of catch leakage and prematurely terminated hauls, which were not appreciated at the time.

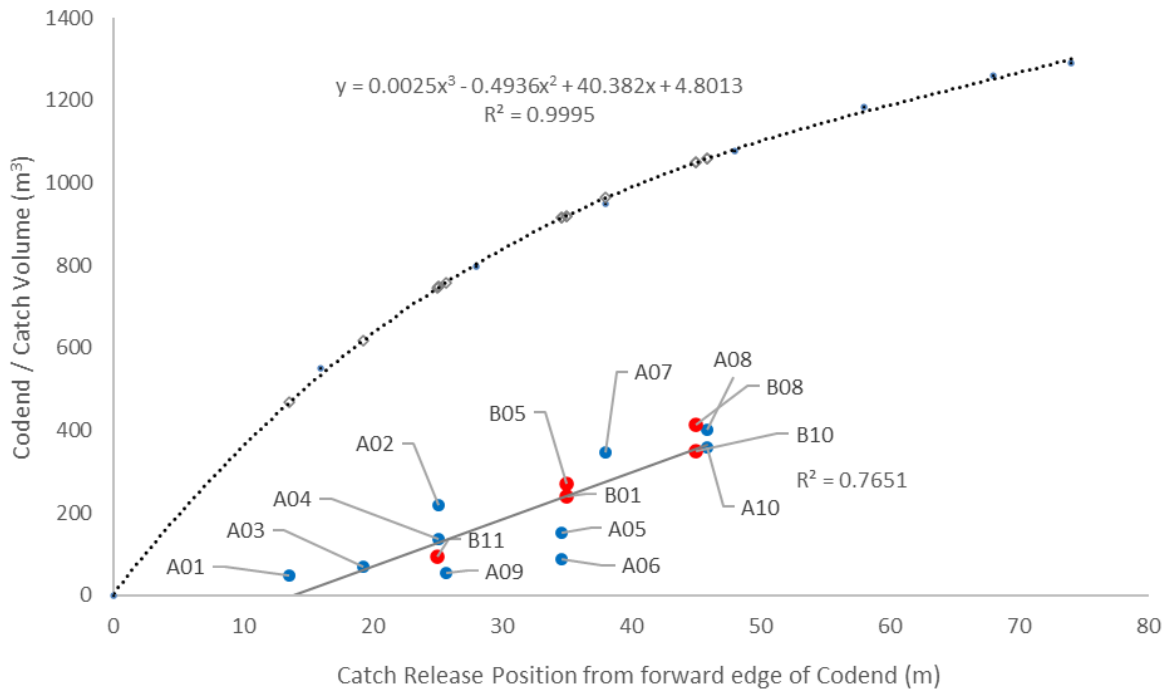
Figure 5.5 - The relationship between the position of the Catch Limit Releaser (CCU) and the resultant cod-end and catch volumes. Theoretical (third order polynomial; R^2 0.9995) cod-end volume estimates are shown in black, and theoretical volume calculated specifically for each haul as open grey diamonds. The resultant catch volume (m^3) for each haul is shown for cruise 1 (blue) and cruise 2 (red), with a combine fitted linear relationship (black solid line; R^2 0.7651).

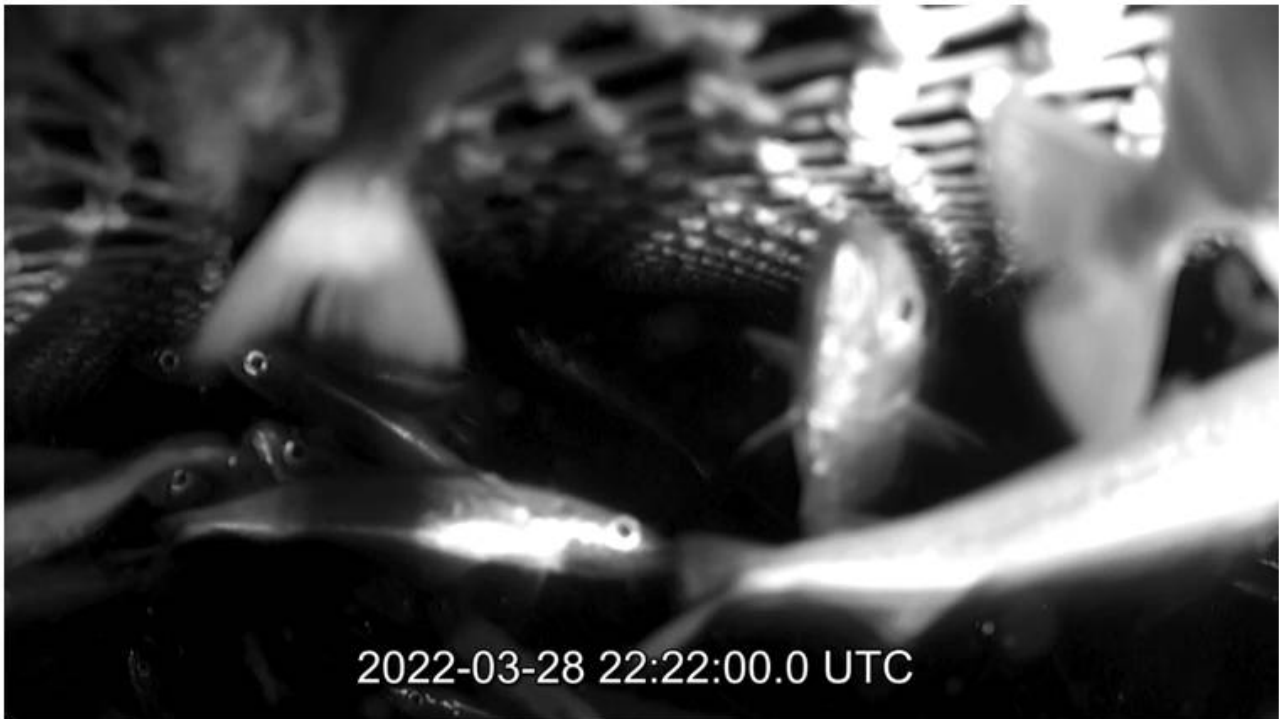
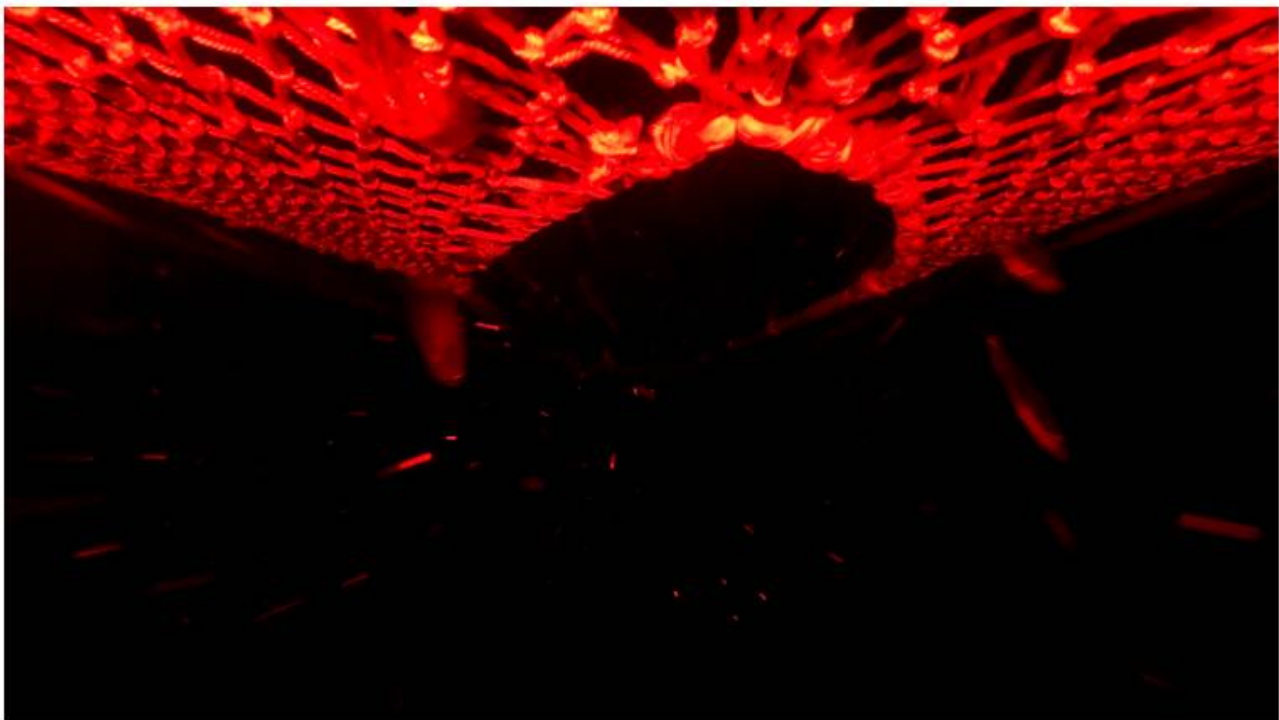
Figure 6.2 – Images from video taken at 22:22 during haul B05, just before the start of haul-back at 22:24. Top: from position 5B look aft toward the fish-lock and cod-end, showing high densities of fish in the top of the FRS. Bottom: from position 4F, looking forward below the escape opening, with three fish escaping. Note – the escape rate at this time was approximately 42 fish/minute [22:22-22:23] and 39 fish/minute [22:24-22:25].

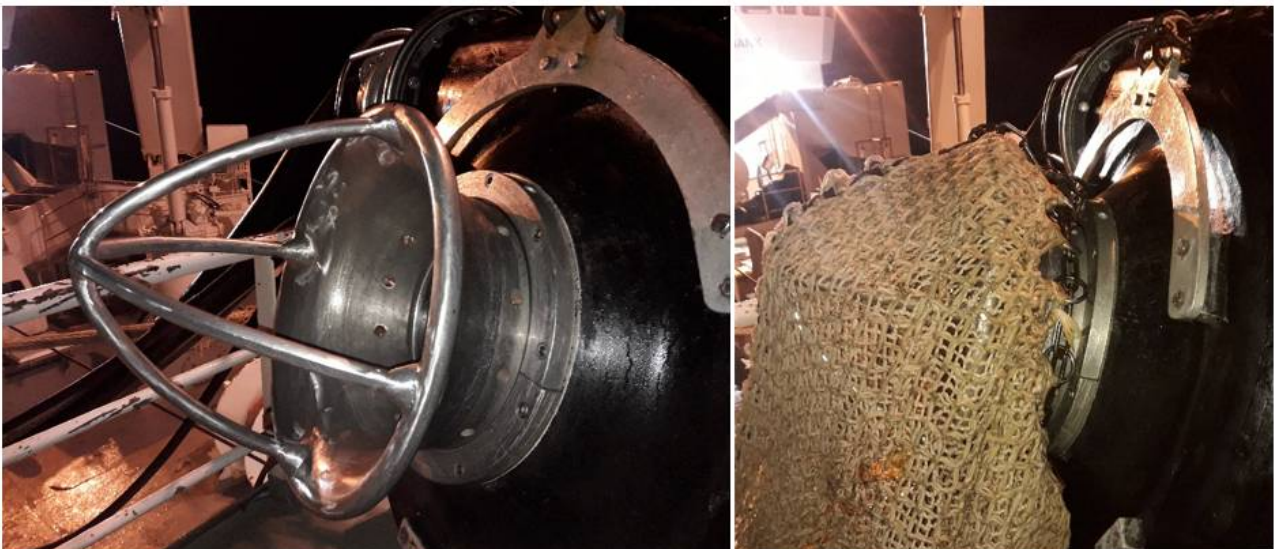
Figure 7.1 - Left: the pump-head funnel; and Right: pump with pump skirt connected [Source: J. Saltskår].

The most commonly used fish pumps by Norwegian fishing vessels are manufactured by Karm, Rapp Hydema and Seaquest. Current practice for coupling a pump-head to a cod-end is to use a chain (thickness 10mm; breaking strength 12 tonnes) wrapped around the cod-end skirt and pump-head funnel, and then locked with a shackle (figure 7.1). As a result, releasing the trawl cod-end from the fish pump on board the vessel can be time consuming, and can risk injury to the crew and damage to equipment. Unforeseen events during the pumping process can mean it takes a long time to empty the trawl cod-end. In the worst case, this can result in the catch losing buoyancy and the trawl cod-end sinking, with several hundred tonnes of fish inside. Such events can be extremely hazardous to the vessel and crew, as the safe working loads of deck equipment and cables can quickly be exceeded. To improve safety, as well as simplify the operation, the development of a quick-release coupling between the cod-end and pump has been proposed. This device should enable the remote release of the pump head from the cod-end skirt and should incorporate an auto-release function to ensure a safe-release when safe working loads are exceeded.

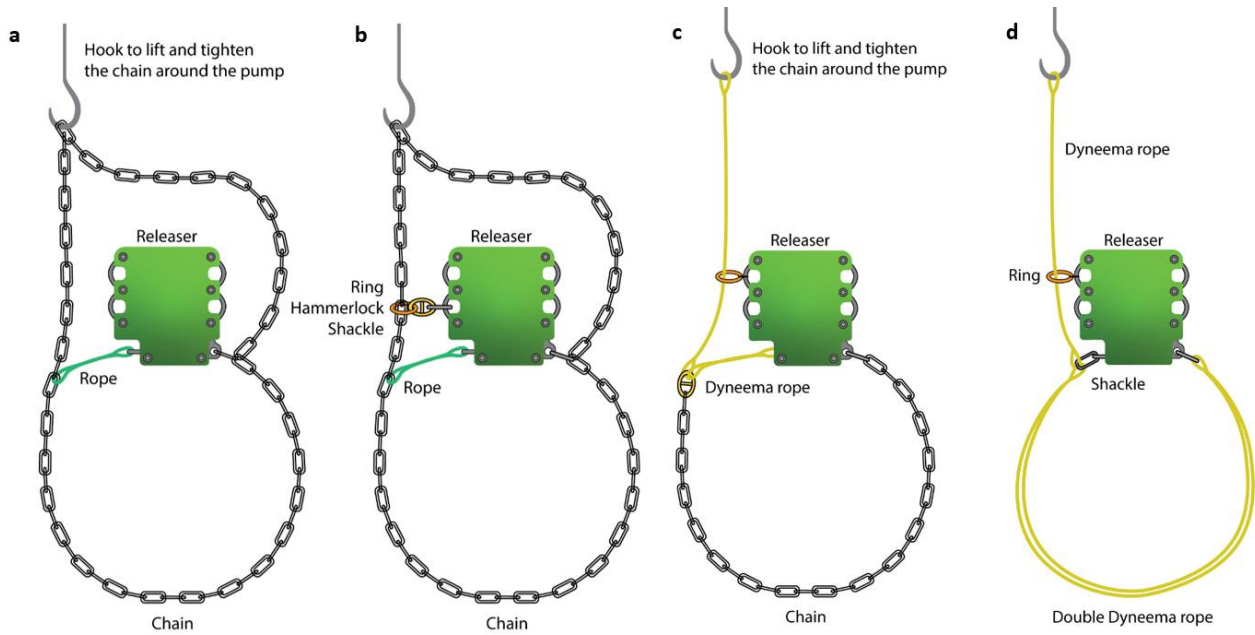
Figure 7.2: Schematic drawings of releaser with various rigs for securing the cod-end skirt to the pump-head. a: rig 1 used in tests A1, A2 & B1; b: rig 1a used in test B2; c: rig 2 used in tests C1 & C2; and d: rig 3 used in test C3.

Test A1: 24th March 2022. The releaser and securing chain were fitted to the pump, without the cod-end skirt attached (figures 7.2 & 7.3a). The assembly was deployed to a maximum depth of 41.1m but failed to release. It was suspected that there was insufficient force on the locking jaw of the releaser to open it.

Test B1: this was the first trial with the cod-end skirt attached to the pump using the releaser and securing line/rig (figure 7.2a, rig 1; & 7.3b). The assembly was deployed to a maximum depth of 46.0m and again released, but the time and depth of release were unknown because the GoPro 7 camera fitted to the pump-head failed to record.

Test C3: In this test, the securing chain was completely replaced with a doubled length of Dynaema twine, with a shackle at one end forming a hard-eye for inserting into the releser jaw (figure 7.2d). It was conducted at the end of a test-haul 02. After the test-haul, the cod-skirt was attached to the pump-head, as would be done during normal fishing operations (see above). The pump-head was deployed to a maximum depth of 41.9m but unfortunately the releser failed to open (table 7.1). When the pump-releser assembly was recovered and examined, it was observed that the releser jaw had not fully opened, with the releser arm partially up. Detailed mechanical examination of the releser unit provided no explanation for this failure, and again it was presumed there was insufficient force to open the releser jaw fully.

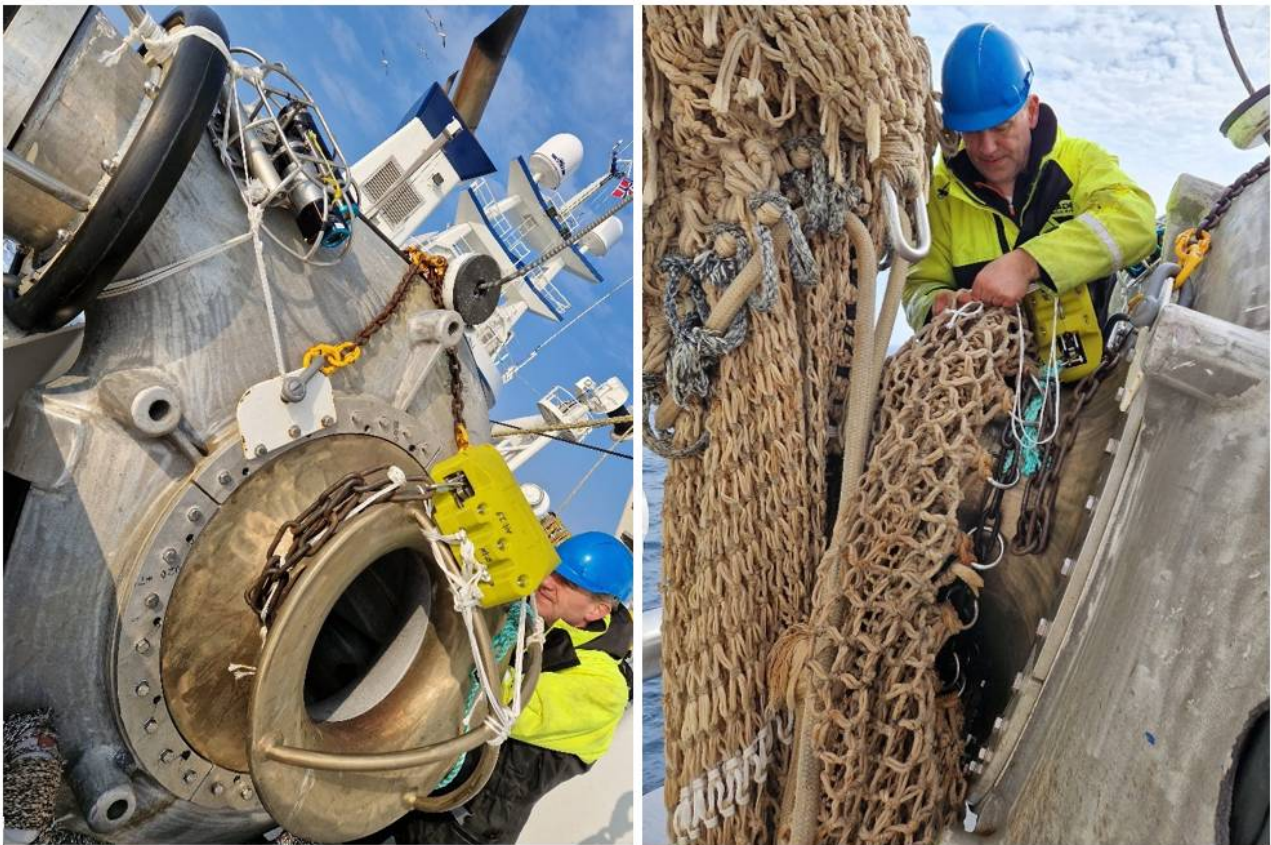
Figure 7.3 – Left: releaser and securing chain (Rig A) attached to pump-head, without the cod-end skirt attached. Camera and depth-sensor array is in a protective steel frame at the top of the image. Right: releaser and securing chain (Rig A) with the cod-end skirt fitted to the pump-head, showing the release jaw side of the releaser.

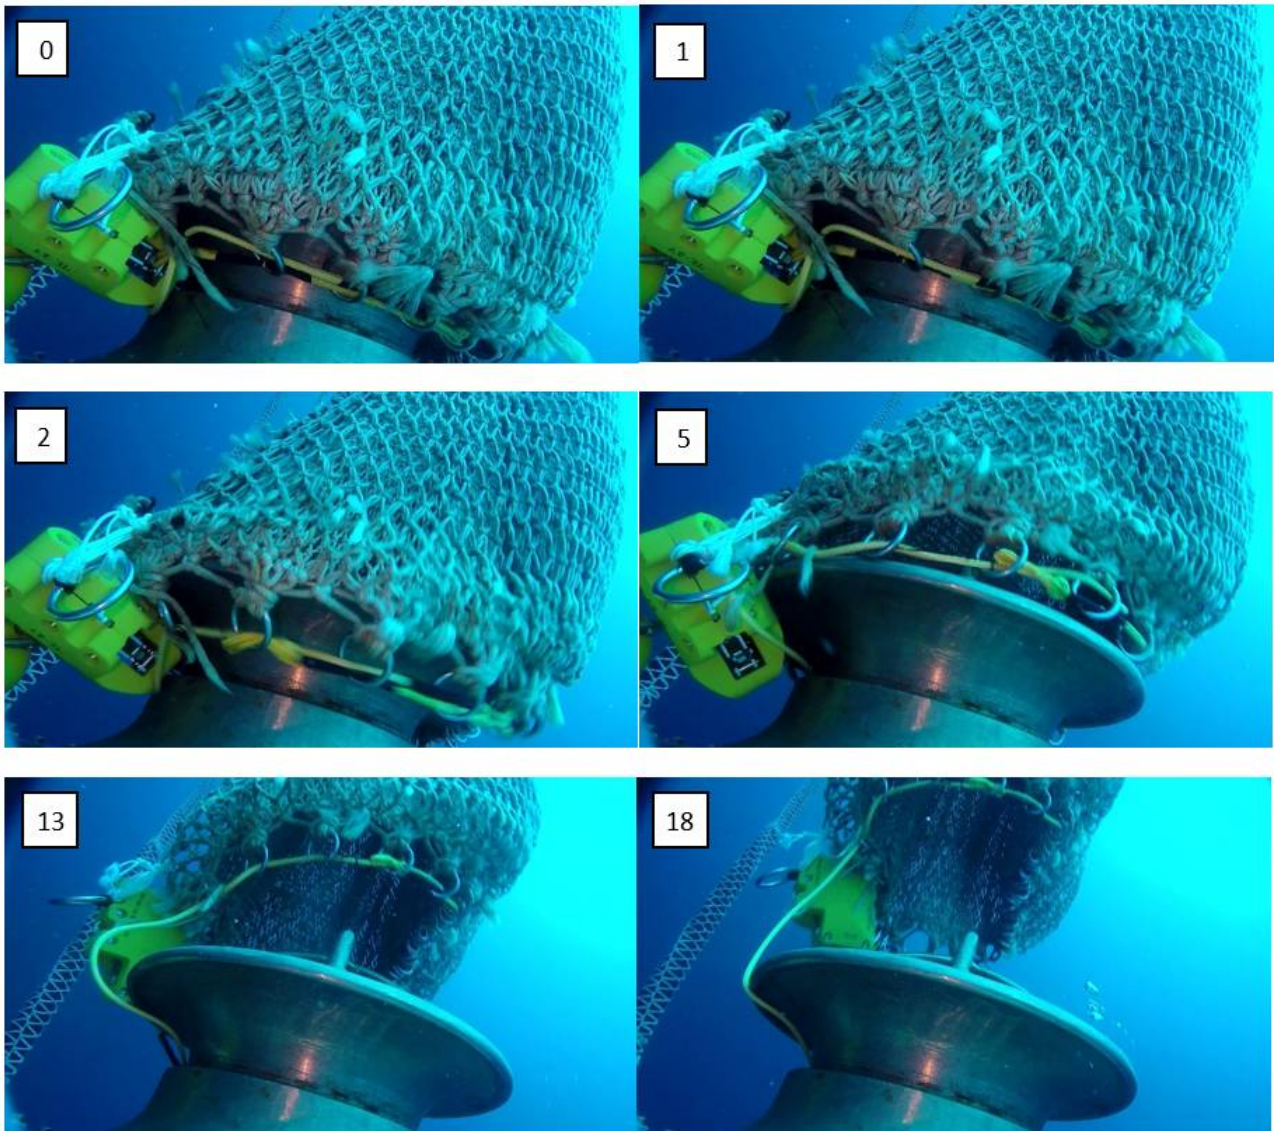
Figure 7.4 – sequence of frames from video (at 24 fps) of the release of the cod-end skirt from the pump head during test C1 (rig 2). Frame 0: just before release; Frame 1: as the releaser jaw opens; Frame 2: securing line leaves the releaser jaw; Frame 5: the cod-end skirt begins to clear the pump-head; Frame 13: ½ sec after release started, the cod-end skirt is mostly clear of the pump-head; and Frame 18: ¾ sec after release started, the cod-end skirt completely clear of the pump-head.

Test C1: 25th March 2022. Changed to releaser #2, because #1 had a poor blue-tooth connection during setup. To enable the end of the securing line that was fixed in the releaser jaw to pass more easily through the rings of the cod-end skirt, the rope with a shackle at the end (figure 7.2b; rig 1a) was replaced with Dynaema twine with a soft eye secured into the releaser jaw (figure 7.2c; rig 2). This appeared to work well on its first test, with the releaser opening at 09:41:29 (20.93m) during its ascent from a maximum depth of 43.0m (table 7.1). Note, the cod-end skirt was clear of the pump-head in <1 second (figure 7.4).

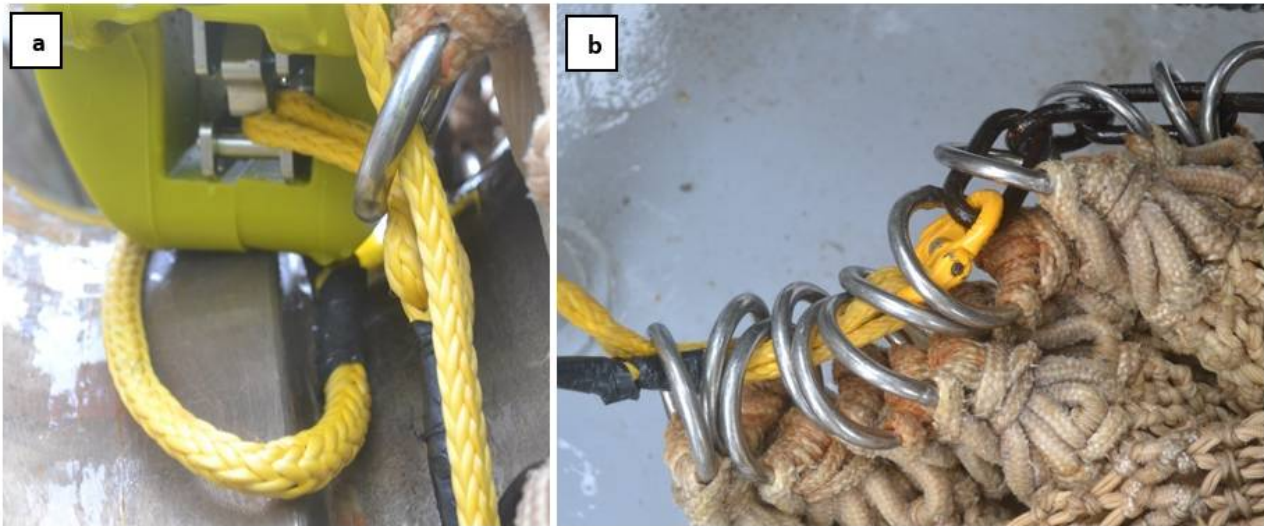
Figure 7.5 – Observations after test C-2 (rig 2); a: the soft eye was only partially released from the releser jaw; and b: the hammerlock linking the Dynaema twine to the securing chain was jammed in the cod-end skirt rings.

Test C2: this was a repeat trial with the same rig as test C1 (rig 2). The pump-head was deployed to a maximum depth of 42.3m but unfortunately the releaser failed to open (table 7.1). When the pump-releaser assembly was recovered and examined, it was observed that the soft eye was partially released from the releaser jaw (figure 7.5a). Moreover, the hammerlock linking the Dynaema twine to the securing chain was jammed in one of the rings around the cod-end skirt (figure 7.5b). In combination, these observations suggest that, because the securing line was not free to pass through the rings, there was insufficient force to fully open the releaser jaw when it was triggered to release. It was also suspected that the soft-eye in the Dynaema may have contributed to this lack of force by being to slip partially out of the releaser jaw.

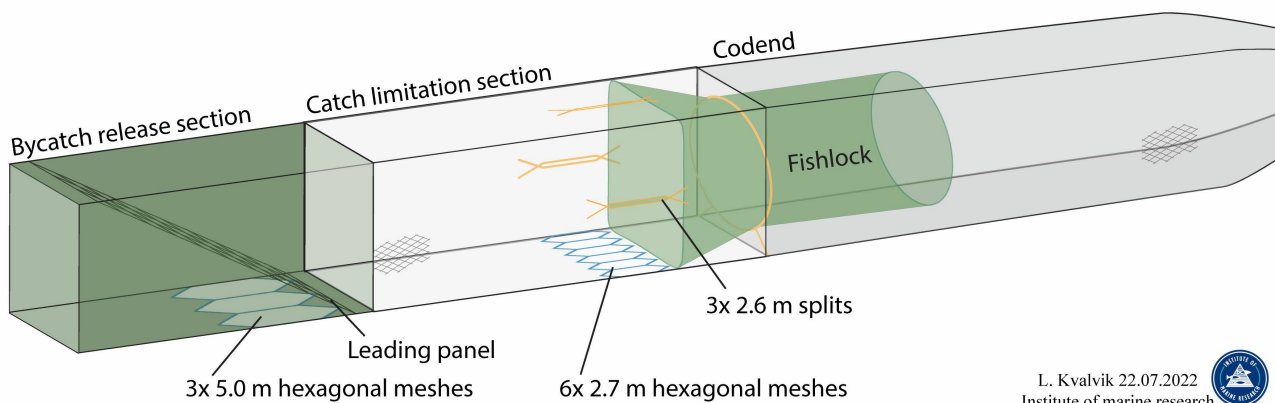
Figure 8.1 - Bycatch Release Section (BRS) was fitted immediately forward of the Fish Release Section (FRS) of the Catch Limitation System (CLS).

The Bycatch Release Section (BRS) was fitted immediately forward of the Fish Release Section (FRS) of the Catch Limitation System (figure 8.1). It consisted of a 12.0m long four-panel cylindrical section of 80mm diamond mesh netting, in the bottom panel of which were cut three 5.0m long hexagonal escape openings (figure 8.2a). Inside the FRS was an 11.2 long diagonal leading panel of 600mm (300 by 300mm) square mesh netting, set at an angle of approximately 16° (figure 8.2a). The BRS was fitted to the trawl during four hauls (table 2.1). Test hauls 1 and 2 were used to make video and trawl sonar observations of the FRS and BRS sections, to ensure they were fitted correctly. Haul 01 was the first behavioural observations with a live catch. Based on these observations modifications were made to the BRS, by cutting away a 1.2 by 2.7 m opening at the top end of the leading panel (figure 8.2b). This version was tested in haul 07.

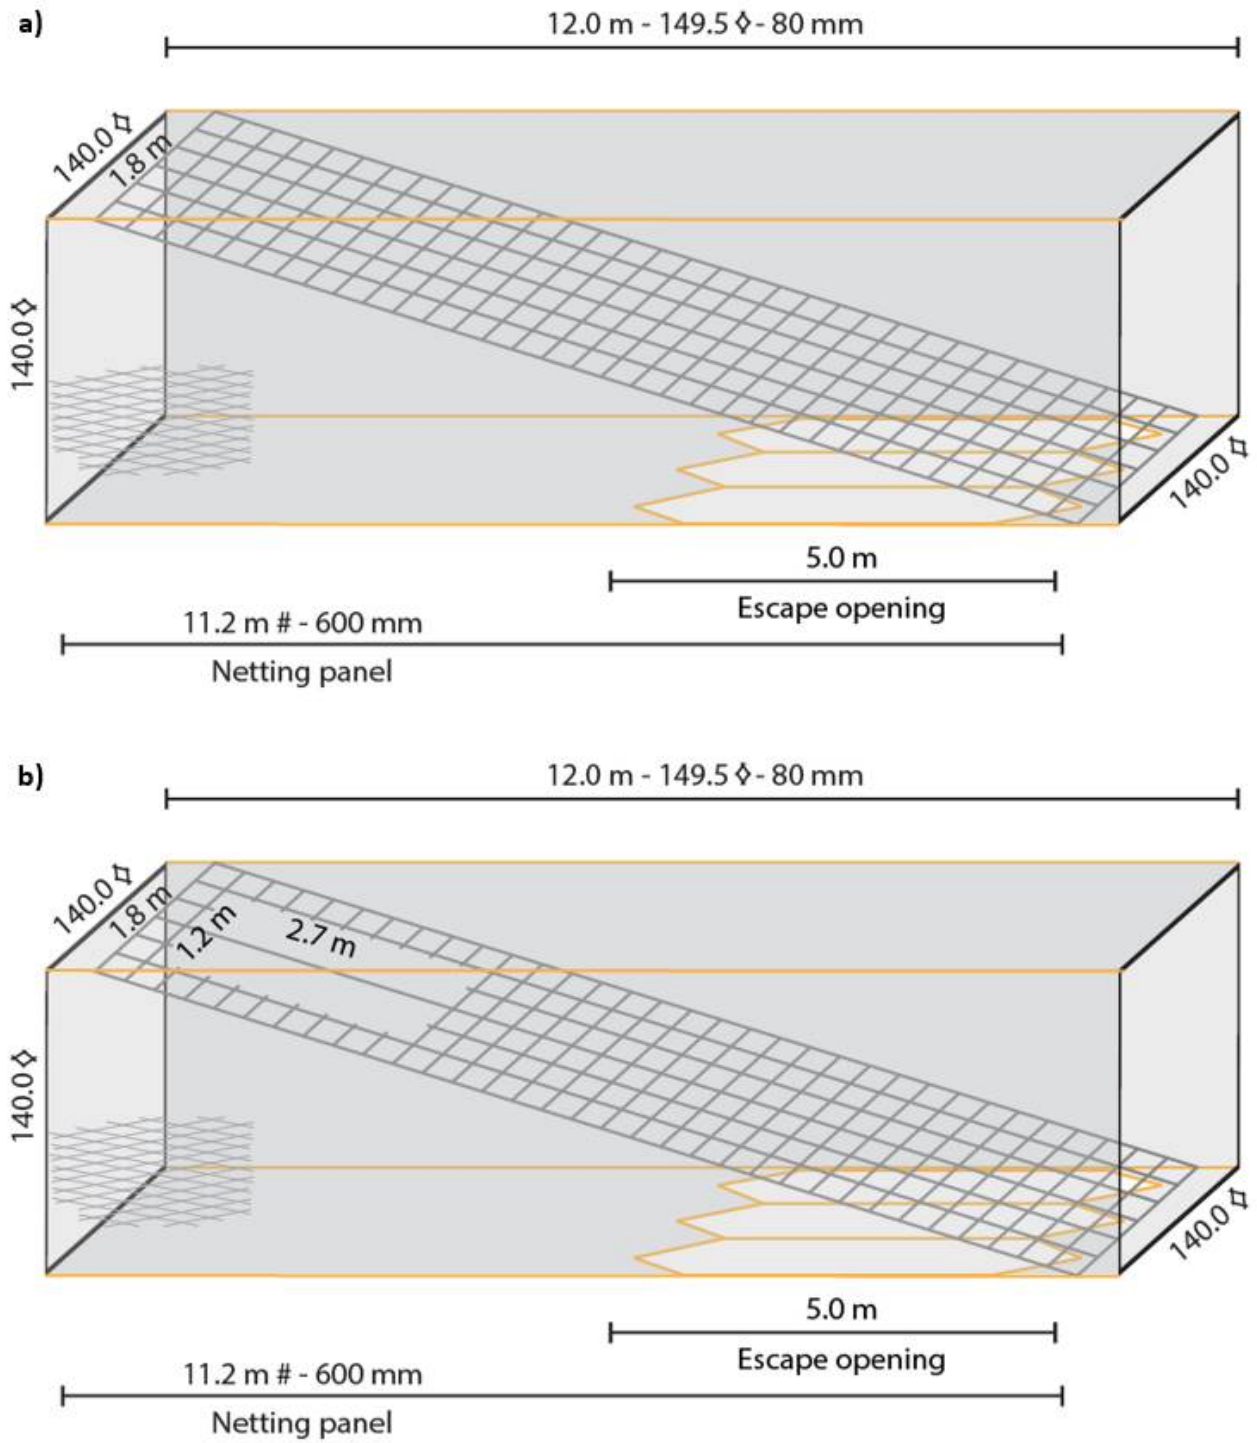
Figure 8.2 – Schematic drawings (not to scale) of the Bycatch Release Section (BRS): a) version 1 used in Test Hauls T1 & T2 and Haul 01; and b) version 2, with a hole cut in the leading panel, used in Haul 07.

Haul 01 demonstrated that a substantial proportion of blue whiting encountering the leading panel in the BRS was exiting via the escape openings (figures 8.4 & 8.5). Although the mesh openings in the leading panel were relatively large (300 by 300mm square), at the shallow angle (~16o) they were presented to the fish approaching the leading panel they would have had a projected vertical opening of only ~63mm. Based on this and the knowledge that blue whiting entering the cod-end tend to accumulate higher up, while the porbeagle observed in cruise 1 swam along the bottom of the cod-end (Breen et al, 2021), it was decided to cut a hole in the upper part of leading panel in an attempt to reduce the excessive loss of blue whiting from the BRS (figure 8.2b).

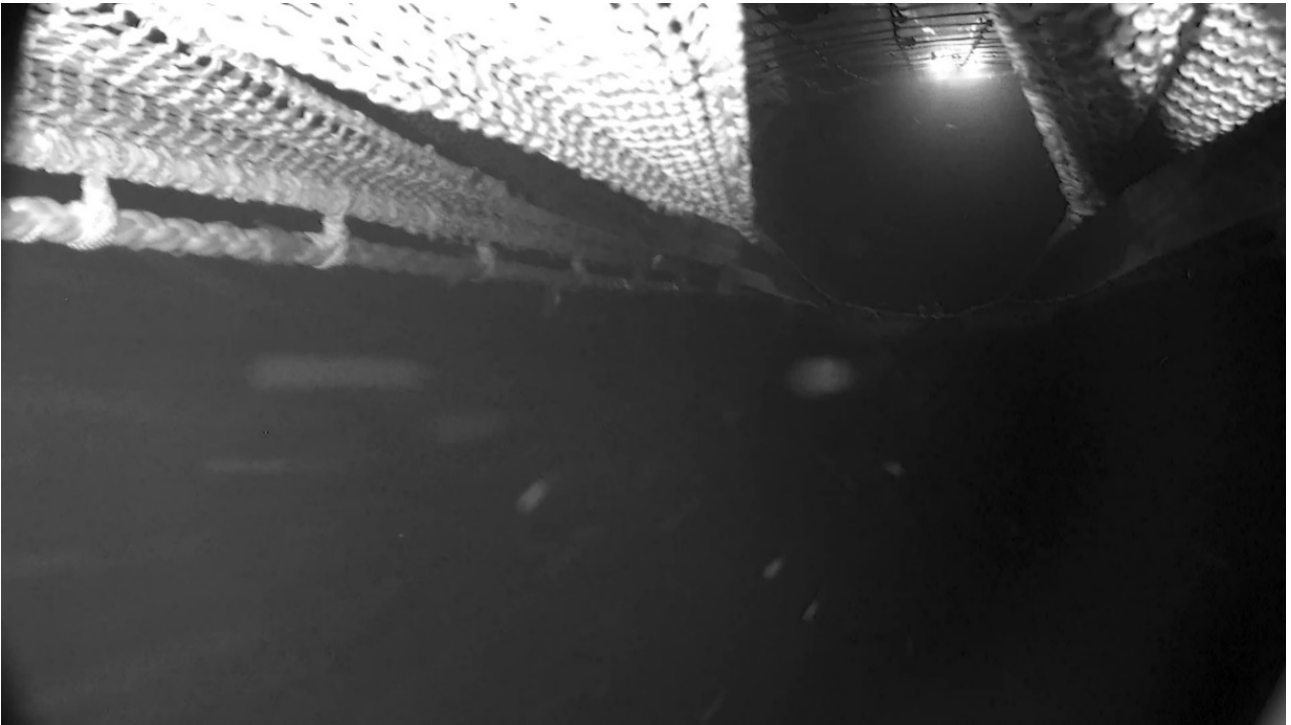
Figure 8.3 – view from camera position 6oF, showing the leading panel visible through the escape openings of the BRS.
