CATCH CONTROL IN THE BLUE WHITING PELAGIC TRAWL FISHERY

Research Cruise Report [2022825]: FV "Vikingbank"

TOKTRAPPORT
No.1 2023

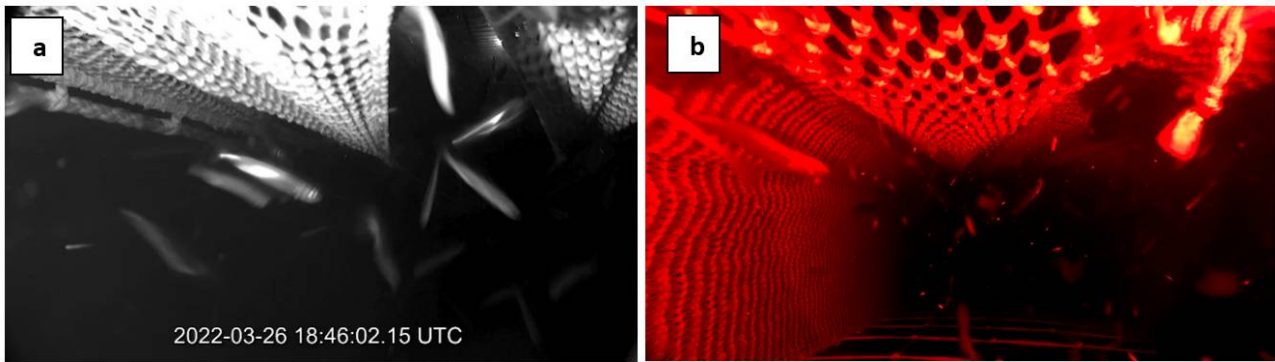
Figure 8.4 – images from video early in haul 01 [18:46:02]: a) position 6oF, below the BRS escape opening, shows a substantial number of blue whiting escaping; while b) position 9iB, inside the BRS aft of the leading panel, shows few blue whiting passing through panel. For comparison, at this same time, escapes from the bottom opening in the FRS were only 7 fish per minute, but it was difficult to differentiate between fish exiting via the BRS and FRS, so this estimate could be less (position 2oF, not shown).

Haul 01 demonstrated that a substantial proportion of blue whiting encountering the leading panel in the BRS was exiting via the escape openings (figures 8.4 & 8.5). Although the mesh openings in the leading panel were relatively large (300 by 300mm square), at the shallow angle (~16o) they were presented to the fish approaching the leading panel they would have had a projected vertical opening of only ~63mm. Based on this and the knowledge that blue whiting entering the cod-end tend to accumulate higher up, while the porbeagle observed in cruise 1 swam along the bottom of the cod-end (Breen et al, 2021), it was decided to cut a hole in the upper part of leading panel in an attempt to reduce the excessive loss of blue whiting from the BRS (figure 8.2b).

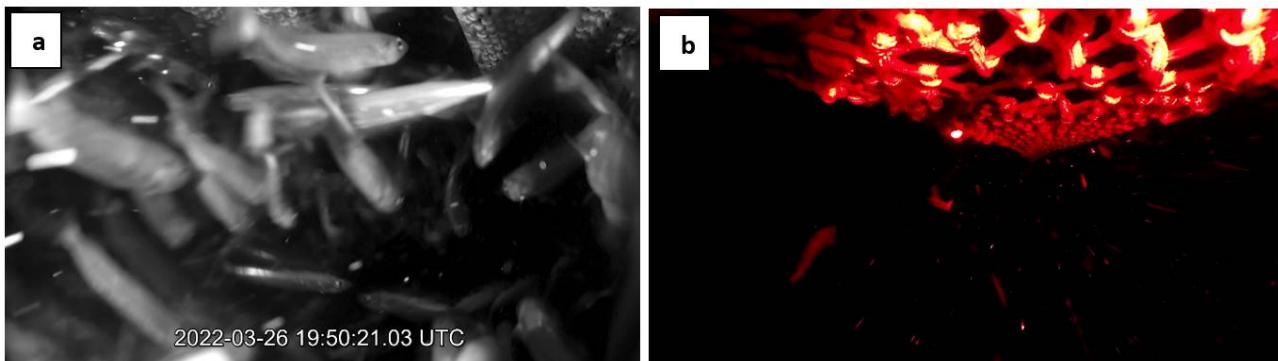
Figure 8.5 – images from video later in haul 01 at higher catch densities [19:50:21]: a) position 6oF, below the BRS escape opening, shows a very substantial number of blue whiting escaping; while b) position 2oF, outside the bottom opening in the FRS, shows fewer blue whiting escapes. For comparison, the escape rate from the bottom opening in the FRS (position 2oF) at this time was approximately 30 fish per minute, but it was difficult to differentiate between fish exiting via the BRS and FRS, so this estimate could be less. Unfortunately, there was no video available inside the BRS at this time, because the camera at position 9iB stop recording at 18:46:10.

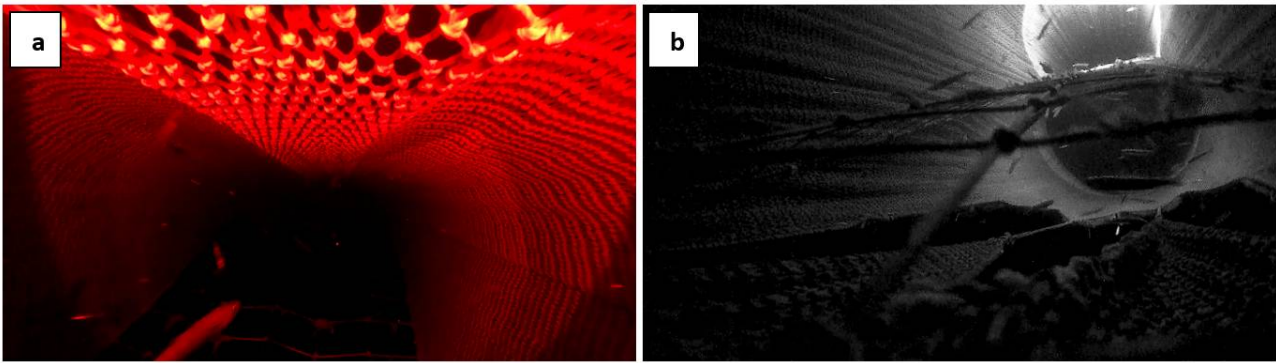
Figure 8.6 - images from video inside the BRS early in haul 07 [03:10:47]: a) position 7iF, looking forward towards hole in leading panel; b) position 6iF (DarkVision camera), looking forward from behind the leading panel, with escape holes in bottom panel visible in the foreground. DarkVision camera operating without its own light during this period.

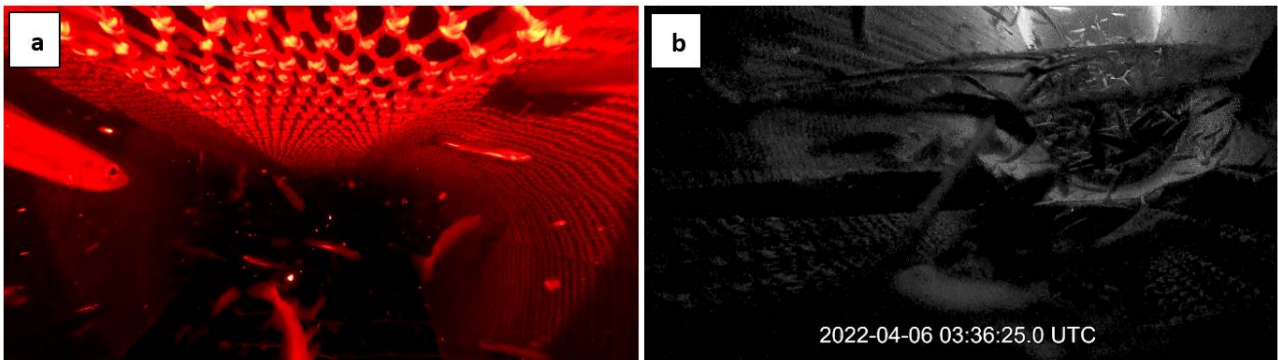
Figure 8.7 - images from video inside the BRS early in haul 07 [03:36:25]: a) position 7iF, hole in leading panel allowing fish through in upper part of BRS; b) position 6iF (DarkVision camera), moderate fish density in front of panel with some fish passing through the lower panel, while a substantial proportion is deflected down and out of the escape openings. DarkVision camera operating without its own light during this period.

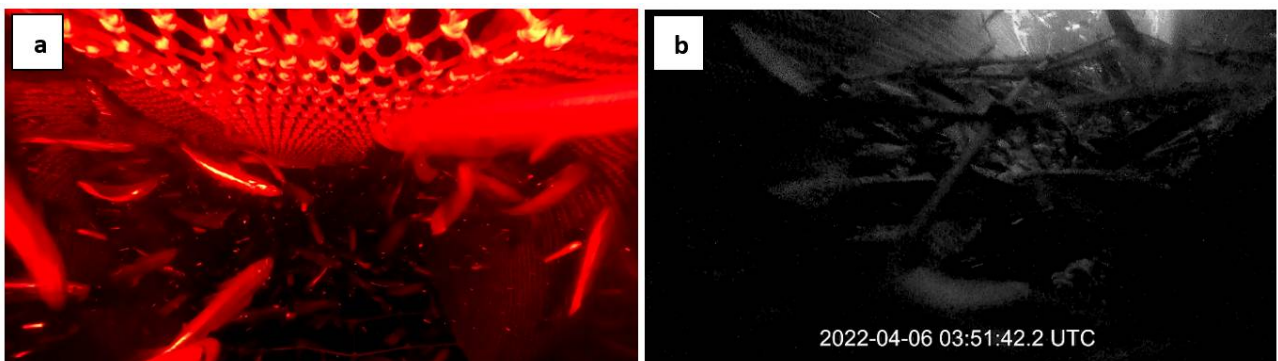
Figure 8.8 - images from video inside the BRS early in haul 07 [03:51:42]: a) position 7iF, hole in leading panel allowing fish through in upper BRS; b) position 6iF, in contrast at higher fish densities the deflection of fish down the leading panel causes a blockage. DarkVision camera operating without its own light during this period.

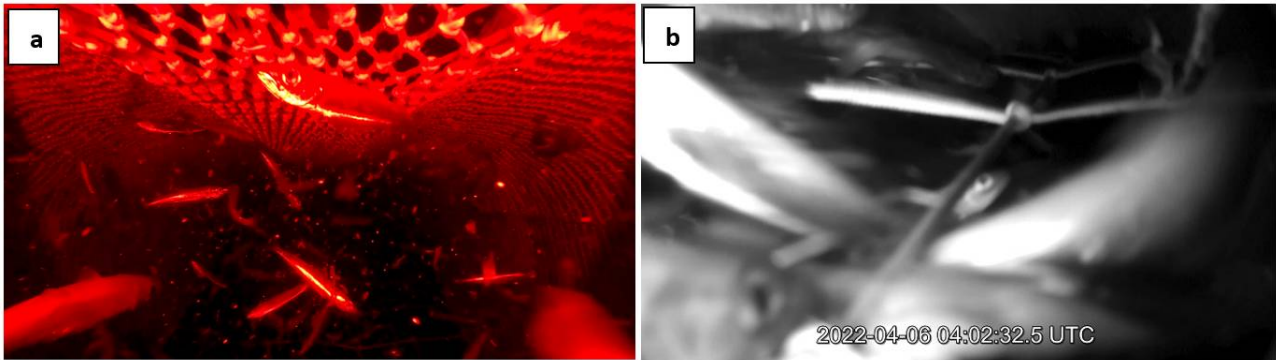
Figure 8.9 - images from video inside the BRS early in haul 07 [04:02:32]: a) position 7iF, hole in leading panel allowing fish through in upper BRS; b) position 6iF, in contrast at higher fish densities the deflection of fish down the leading panel causes a blockage. DarkVision camera operating without its own light during this period.

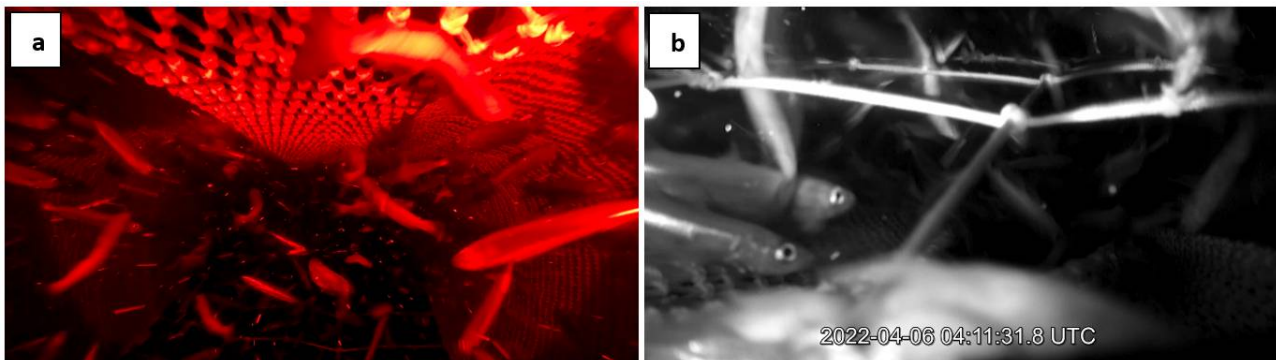
Figure 8.10 - images from video inside the BRS early in haul 07 [04:11:31]: a) position 7iF, hole in leading panel allowing fish through in upper BRS; b) position 6iF, moderately high fish density in front of panel with some fish passing through and frequently contacting the panel, while a substantial proportion is deflected down and out of the escape openings.

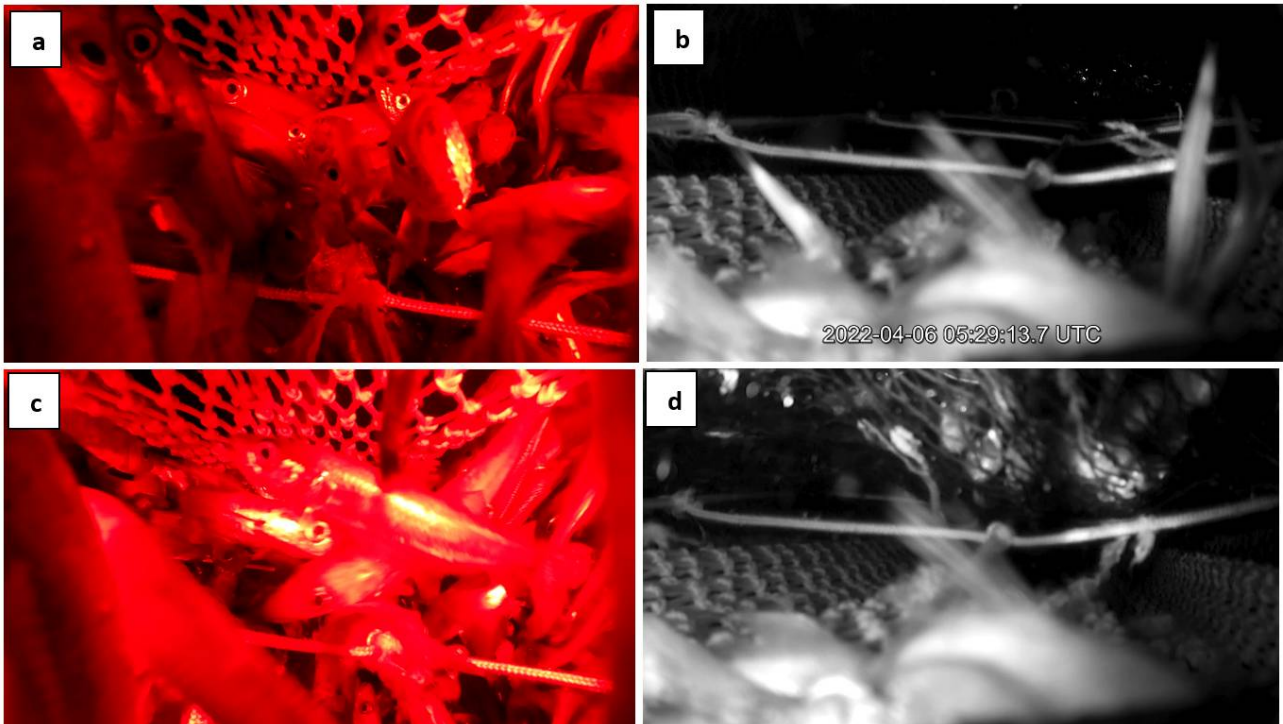
Figure 8.11 - images from video inside the BRS during hauling haul 07 [05:29:13]: a) position 7iF [05:29:13], fish accumulating at top of the leading panel; b) position 6iF [05:29:13], accumulation of fish at the top of the leading panel visible as speckles in the background; c) position 7iF [05:29:21], fish accumulating at top of the leading panel; and d) position 6iF [05:29:21], mass of fish trapped in netting behind the leading panel.

At the end of haul 07, during hauling, there was an unexplained crowding event observed by camera positions 6iF and 7iF (figure 8.11). At 05:29, there was an accumulation of fish ahead of the upper part of the leading panel in the BRS (figure 8.11a & b). At this time there was a reduced water flow in the trawl, and it is assumed that these fish had been ahead of BRS at the end of the fishing tow. Within less than 30 seconds the view at camera position 6iF was obstructed by a mass of fish trapped inside a netting fold. It is unclear what part of the trawl is forming this netting fold, but it is thought unlikely to be the fish lock in the CLS (which did invert during this haul; see section 4) because this was 16m aft of this position, and the fish-lock netting panel has a maximum length of 11.64m. This type of event was not observed in haul 01.

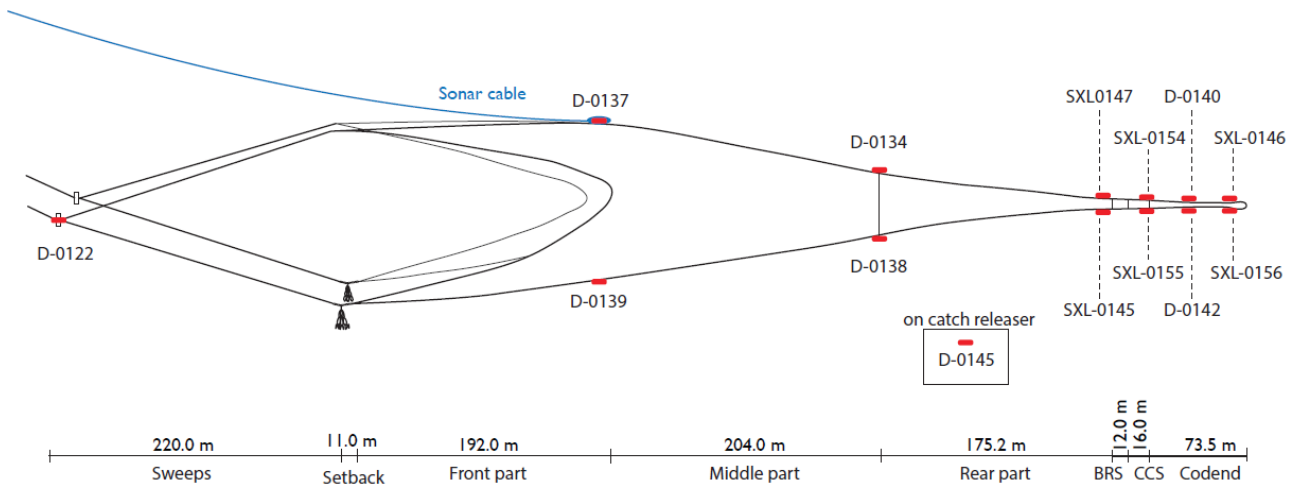
Figure 9.1 - Positions and Identity Code for depth sensors on the trawl. Detailed positions for the cod-end depth sensors are detailed in table 9.1. [Source: Liz Kvalvik].

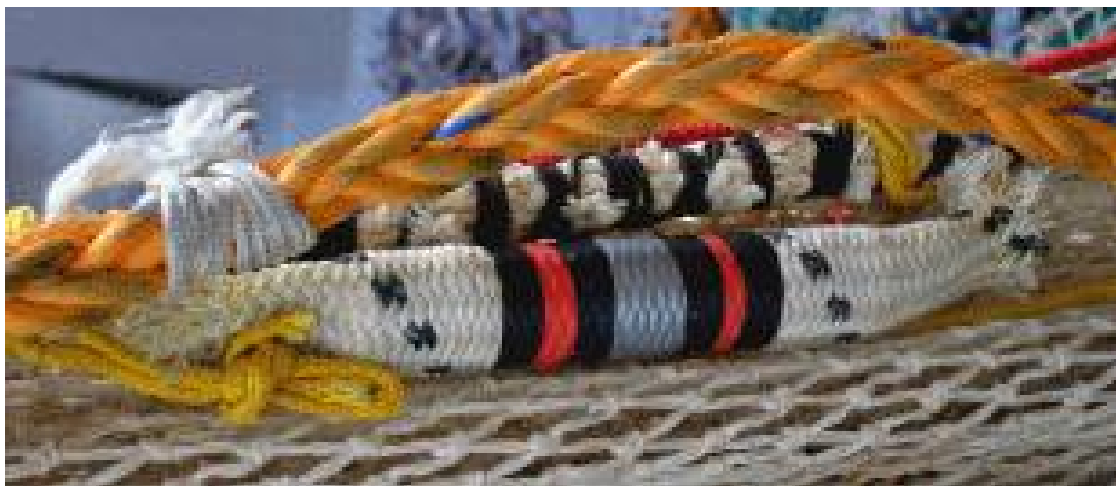
Figure 9.2 – a depth sensor (SXL-0154) in its protective housing and sheath fixed to the top of the FRS.
