1 ***Retrofitting and Rehabilitation of Vernacular housing in Flood Prone Areas in Sri***
2 ***Lanka***

35 This paper presents findings from an investigation into applications to improve the structural
36 resilience and safety of low-rise vernacular masonry homes when subject to extreme flooding.
37 In 2016 and 2017 flooding brought devastation throughout many areas in Sri Lanka. Findings
38 from field investigations to evaluate, characterize, and quantify the extent and nature of
39 structural damage to low rise vernacular masonry houses from these flood events are
40 presented. Low cost solutions were developed to enhance the flexural capacity of masonry
41 walls using reinforced plasters. Single storey homes in rural areas are particularly at risk from
42 rapid flood events, and limited evacuation opportunities require a means of in-situ refuge.
43 Focusing on these risks, a unique retrofitting project, including an elevated refuge area for
44 occupants to escape and shelter during flood events, is also presented. This research will

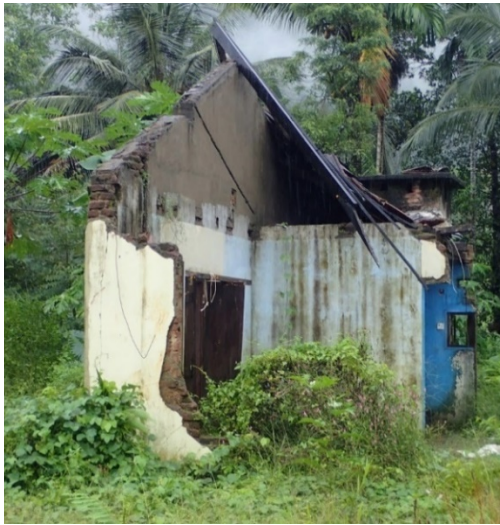
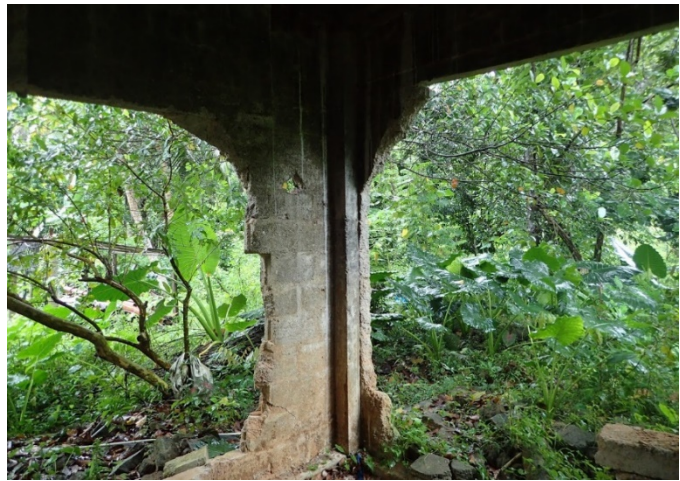
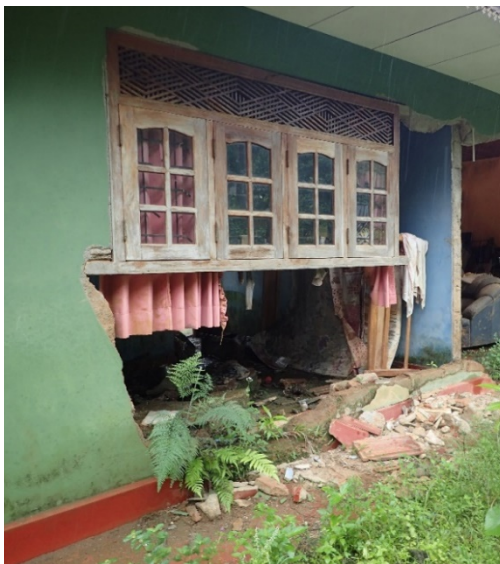
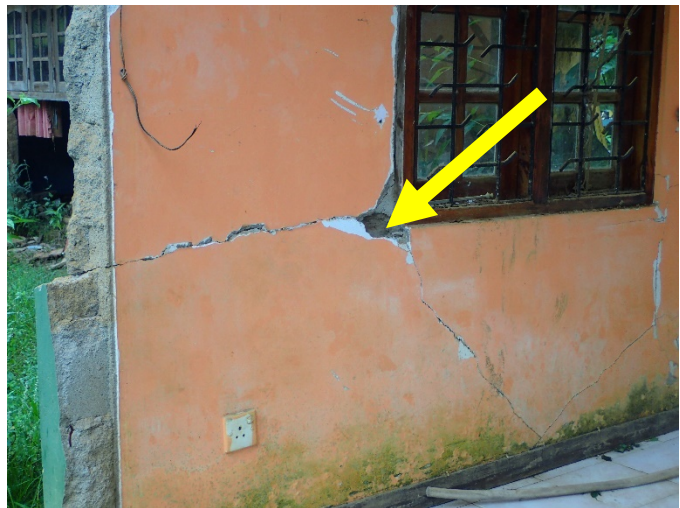
Figure 2. Observed damage to URM.

165 effected regions; together accounting for 95% of reported wall construction. Both types of
166 masonry units are produced through a decentralized and largely unregulated cottage industry.
167 The flood damaged homes display many external walls cracked due to flexural failure parallel to
168 the bed joint, as shown in Figures 2c and d.

a) complete collapse of load bearing URM

b) complete collapse of single leaf infill walls

c) flexural failure parallel to bed joint (note the elevated window height)

d) failed external walls and flexural cracks

367 The need for retrofitting is in response to elevated flooding hazards. The architectural
368 vernacular in many Sri Lankan homes includes low-silled windows (Figure 2c). As a result, the
369 resultant force from hydrostatic pressure will rarely be higher than 0.33 m above the base of an
370 exterior wall. Most homes are built with locally made materials, primarily FCB and CSB that vary
371 greatly throughout the country. As seen in Table 1 and Table 3, the sample units tested
372 exhibited poor compressive and flexural strengths even when dry.

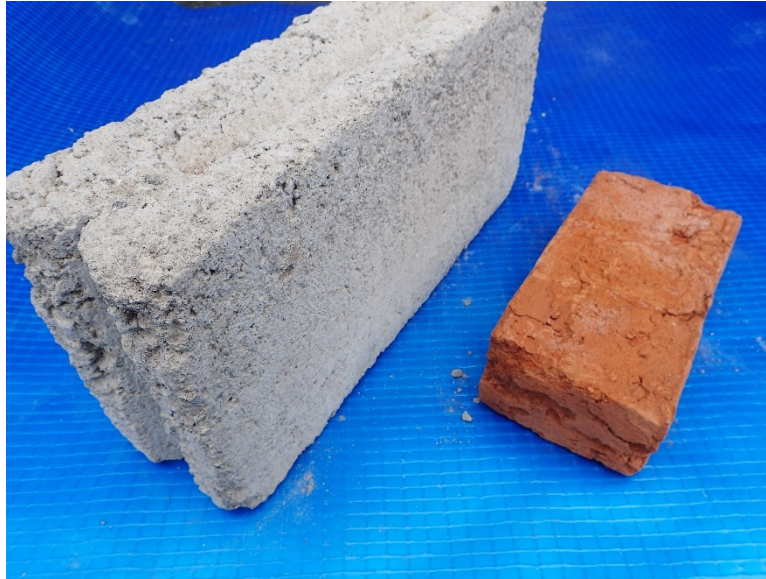
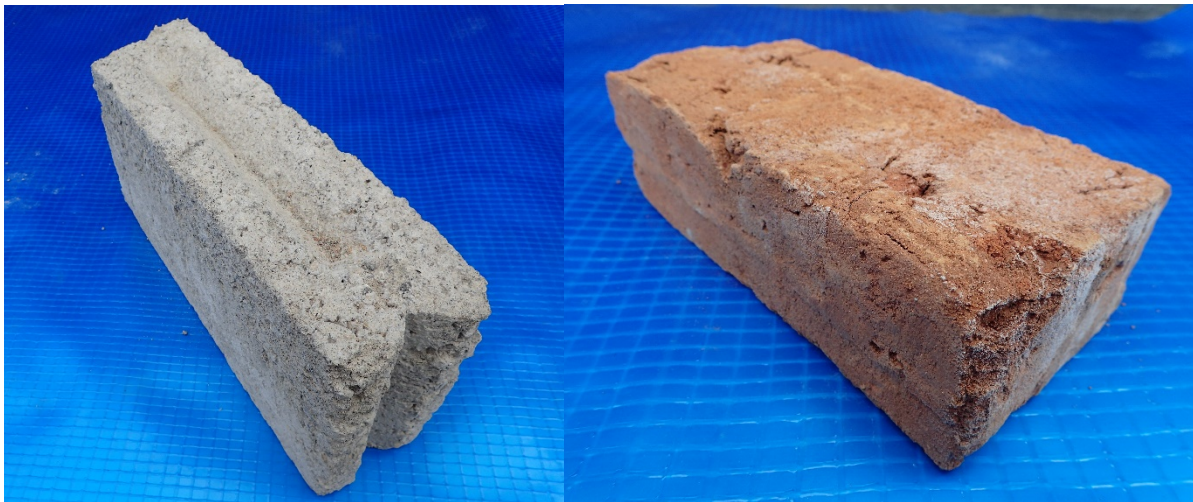
Figure 3. Masonry units used in study.

183 The variation in quality of the FCBs was investigated by testing two separate batches (A and B).
184 The solid fired clay bricks were supplied with nominal dimensions of 220 mm (length) x 105 mm
185 (width) x 65 mm (height). However, the actual dimensions varied, reflecting the small-scale
186 cottage industry; these averaged 188 mm x 93 mm x 54 mm (with a Coefficient of Variation
187 (COV) of 1.4%, 1.5%, and 4.2%, respectively). The CSB were frogged (recessed) on one bed
188 face, and on both vertical edges, and were supplied with nominal dimensions of 400 mm x
189 100 mm x 200 mm. The average dimensions were 337 mm x 92 mm x 166 mm (COV of 0.5%,
190 2.0%, and 3.1%, respectively). Representative samples of CSB and FCB are shown in Figure 3.

Cement sand block (CSB)

Fired clay brick (FCB)

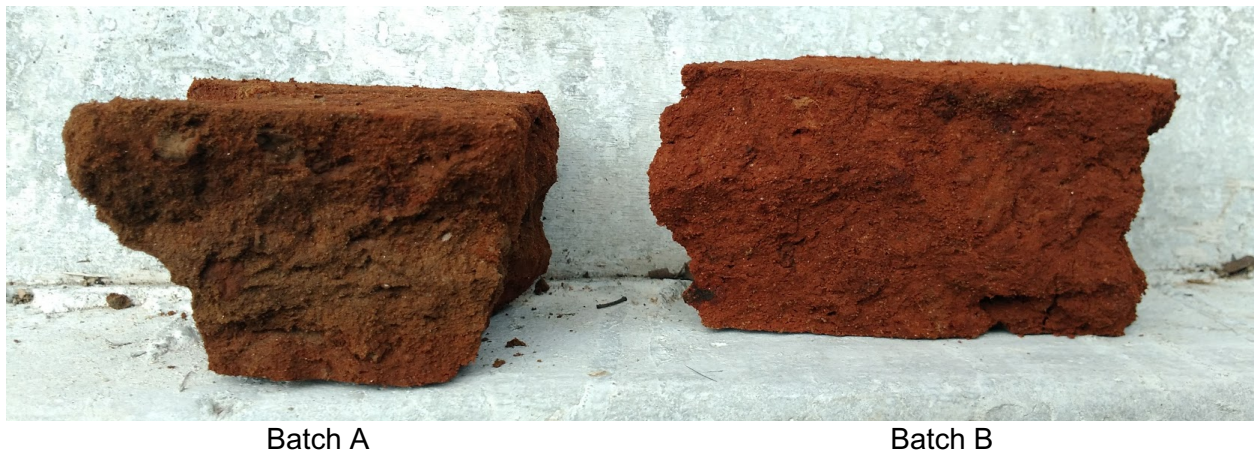
225 Figure 4. Cross sections of fired clay bricks.

219 Batch B FCB presented greater strength but lower density than Batch A, although both batches
220 exhibited similar water absorption values. Figure 4 shows the cross sections of bricks from
221 batches A and B. Batch A maintains a finer texture near the surface with greater variations near
222 the centre of the brick, while Batch B has a fairly uniform texture and colour throughout. This is
223 due to differences in raw soil grading and processing, and manufacturing including inconsistent
224 firing [Maskell et al, 2013].

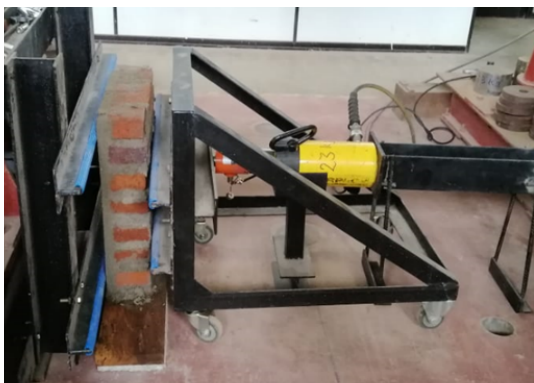
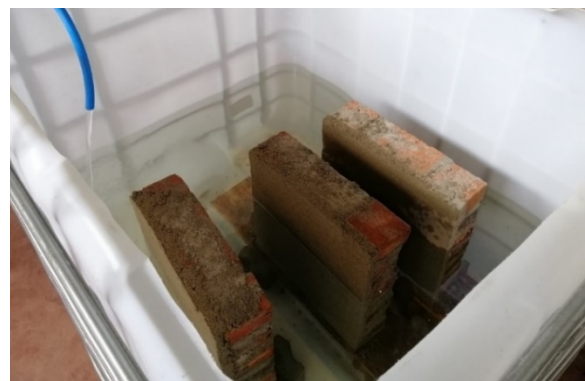
a) Parallel to bed joint flexural test (BE EN 1052-2:2016)

b) 24-hour immersion of panels prior to saturation tests

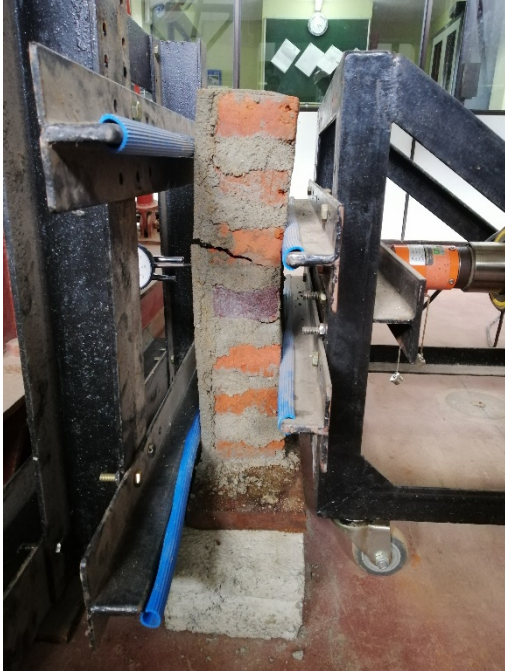
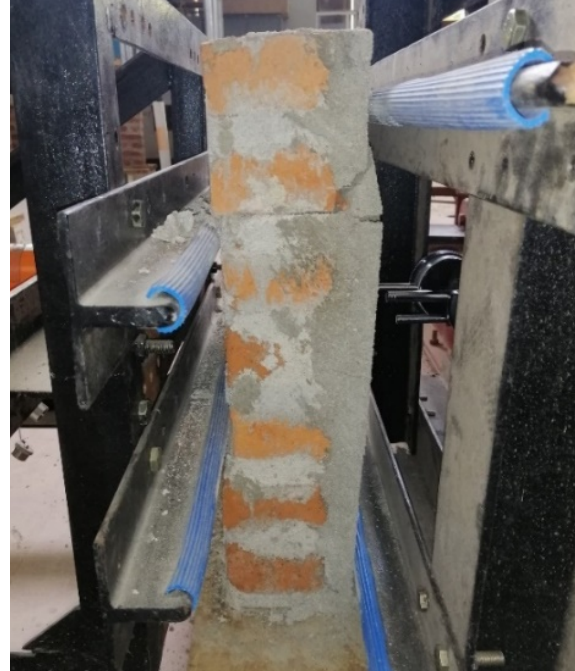
Figure 7 Representative failure modes of flexural tests.

299 Figure 7a shows a typical flexural failure occurring in the constant moment region of the test
 300 with bond fracture occurring at the interface between the mortar and the masonry unit.

a) parallel bed joint flexural test failure of saturated unreinforced plastered wall

b) typical failure in shear zone of geogrid-reinforced wall

301 BS EN 1052-2:2016 is intended to assess flexural strength of wallettes. However, with the
 302 addition of geogrid reinforced mortar, flexural failure is mitigated and the wallettes fail in a shear
 303 mode as seen in Figure 7b. For this reason, wallette capacity is reported in terms of maximum
 304 applied lateral force rather than flexural strength in Table 4 regardless of failure mode.

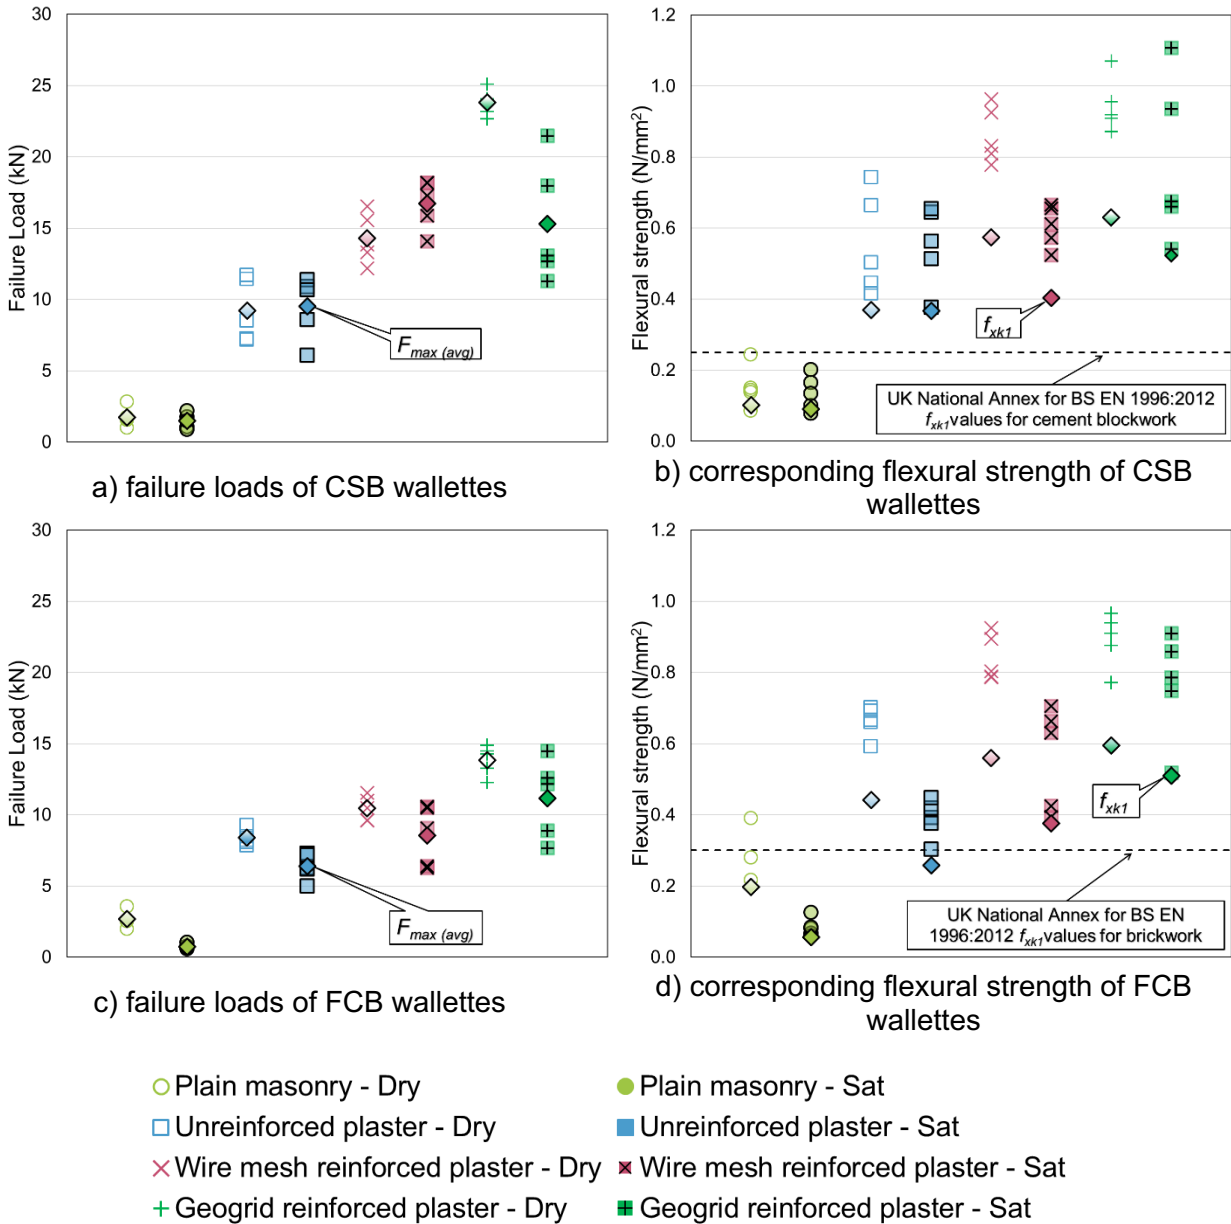
Figure 8. Summary of wallette capacities

311 Figure 8 shows the applied load capacity and calculated flexural strength of the wallettes at
312 failure. The ultimate load, $F_{i,max}$, applied on the wall panel was recorded and subsequently, the
313 flexural strength, f_{xi} , was calculated according to BS EN 1052-2 using Equation 1.

315 Where, L_1 and L_2 are the outer and inner bearing spans, respectively. The width and depth
316 (thickness) of the masonry specimen is represented by b and t_u respectively. For the geogrid-
317 reinforced wallettes, the flexural strength calculated at the point of shear failure. This is
318 therefore a lower-bound indication of the flexural strength of these wallettes. Also shown in
319 Figures 8b and 8d is the relative characteristic flexural strengths (f_{xk1}) which the UK National
320 Annex for BS EN 1996:2012 specifies as a function of total water absorption and mortar grade
321 for clay brickwork; and as a function of unit type, unit compressive strength and mortar grade for
322 concrete block masonry. For the experimental materials, the values for f_{xk1} are 0.25 N/mm² for
323 the CSB and 0.30 N/mm² for the FCB. Neither the un-plastered CSB or FCB meet the
324 prescribed strengths and only obtaining 0.15 N/mm² (COV 38%) and 0.197 N/mm² respectively.

325 However, with the addition of mortar or reinforced mortar, the wallette capacities (and presumed
326 lower bound capacities) are significantly greater than these limits for both dry and saturated
327 conditions by as much as 252% and 209% respectively (for CSB). In each case there is a
328 reduction in capacity for the saturated wallettes compared to their dry counterparts. The failure
329 plane of the dry wallettes was typically along the interface of mortar and masonry unit at the bed
330 joint. Since the block strength is reduced when in the saturated condition (Table 1), some the
331 failures shifted to occurring within the block itself when the wallette is saturated.

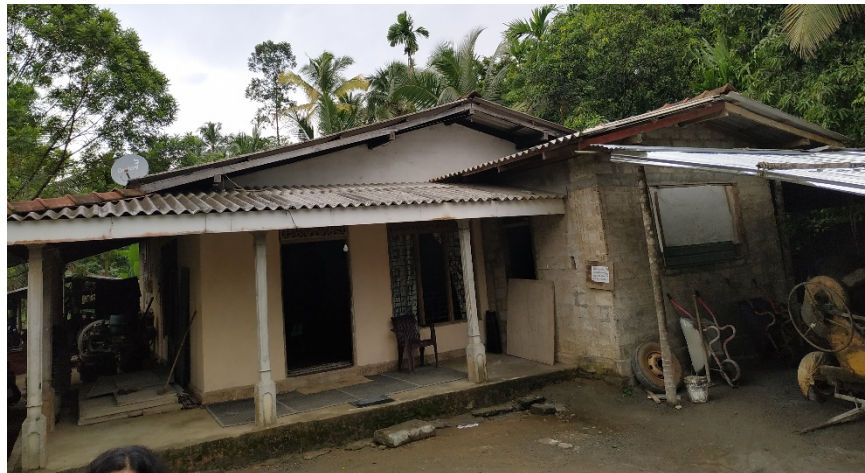
389 The four-bedroom 142 m² (1532 ft.²) house selected, shown in Figure 10, was constructed in
390 year 2000 for a family of six resettled in 1995 due to landslide threat in Heenpadura
391 (Bulathsinghala). The load-bearing masonry walls are rendered mixed masonry construction,
392 with exterior walls made from FCB and inner walls of CSB. The structure is built on a rubble
393 foundation, with no columns, and the single unit gable roof is sheeted in corrugated cement fibre
394 sheeting. The layout of the building is such that there is increased resistance during a flood with
395 respect to the dominant direction of expected flow from the rear to the front of the building
396 (Figure 8a).

a) plan

b) exterior view from “bottom” of plan

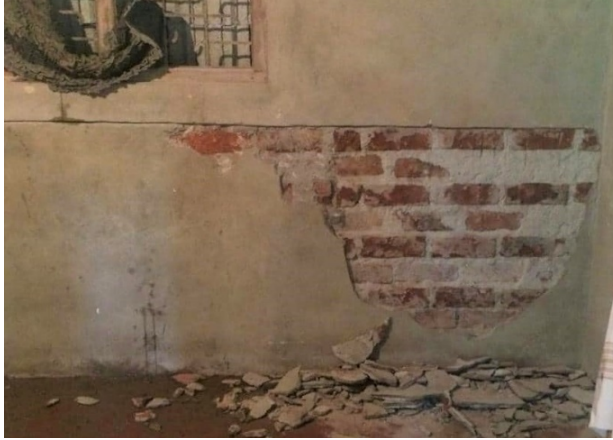
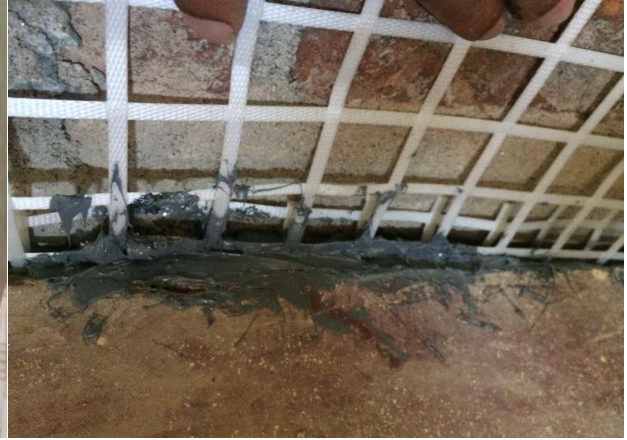
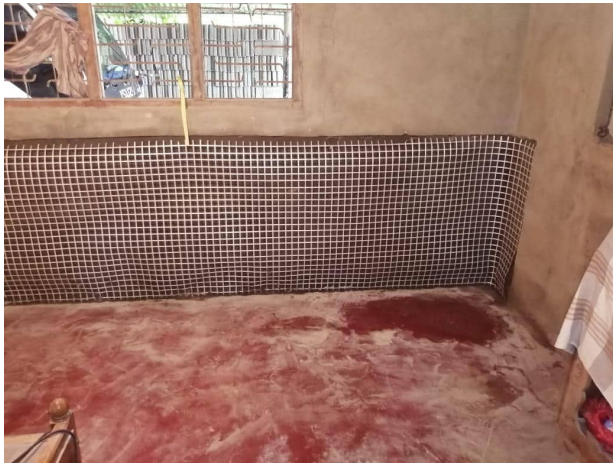
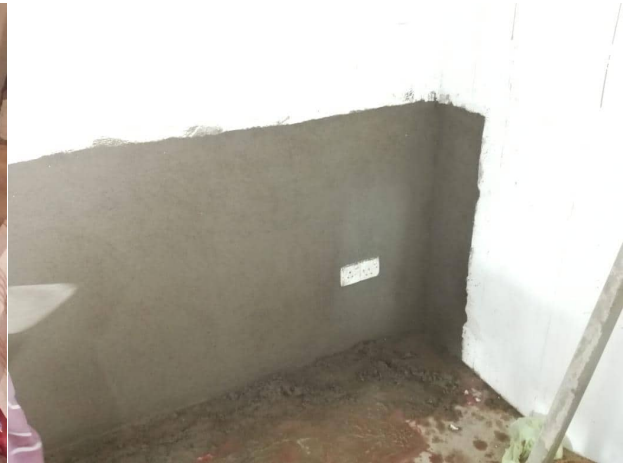
425 The reinforced plaster retrofit was applied to the interior face of all exterior walls and wrapped

426 300 mm along internal partition walls to strengthen the corners (seen in Figures 11c and d).

a) removal of existing plaster

b) epoxy the geogrid in place

c) application of scratch coat and geogrid

d) final retrofit wall; note that the retrofit looks no different than the existing plastered wall shown in part a)

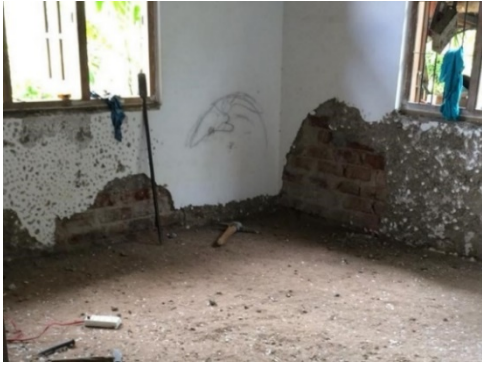
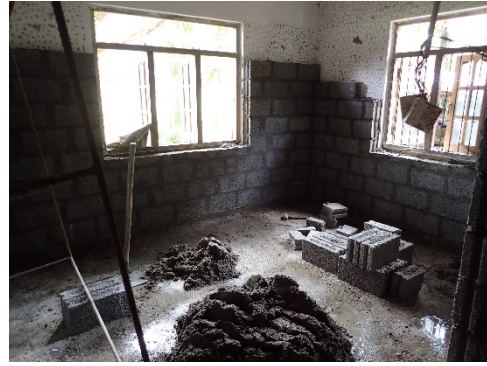
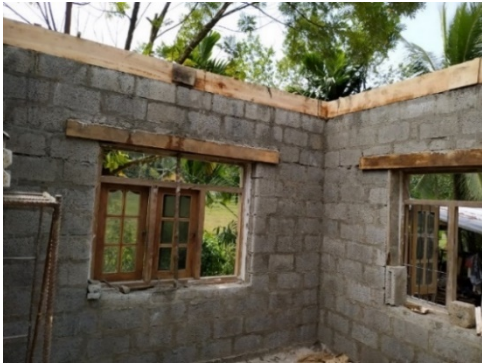
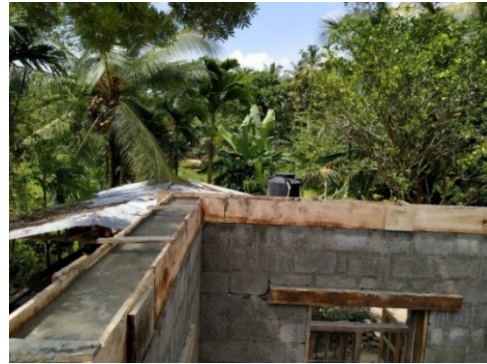
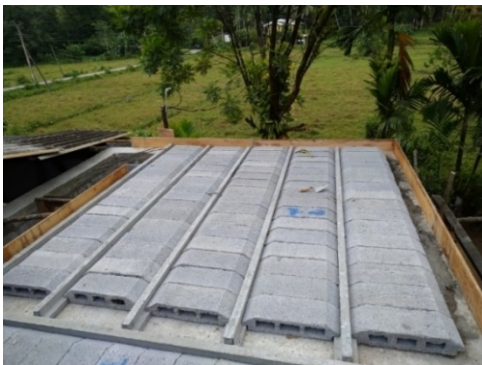
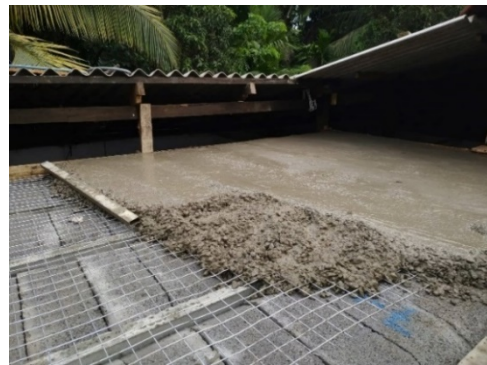
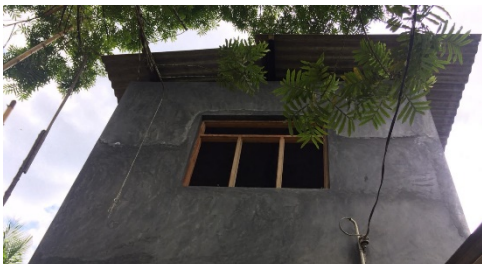
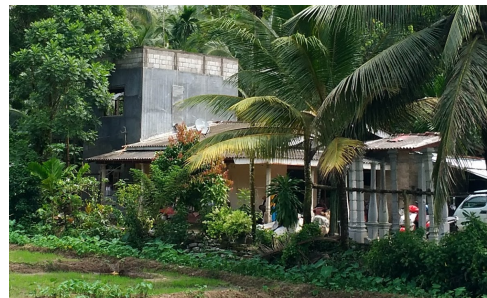
Figure 12. Construction of Refuge Space

a) existing wall and floor plastering removed

b) construction of interior wall

c) ground floor walls with lintel beams added

d) walls capped with reinforced ring beam

e) installation of inverted-T beams and infill

f) casting of screed over reinforced slab system

g) completed first floor with temporary roof

h) view with refuge space

438 Following site investigations, the existing foundation was considered of sufficient size and depth
439 and therefore, the addition of the secondary interior 100 mm CSB wall required no additional
440 ground support. A new 75 mm reinforced concrete slab with a reinforced concrete grade beam
441 provided further support for the existing walls as well as a stable foundation for the new walls.

442 The refuge space was located to minimize overall impact on the existing structure. The upper
443 floor of the refuge space extended through the existing roof and was fitted to reduce chances of
444 water infiltration.
