Assessing the effectiveness of landslide slope stability by analysing structural mitigation measures and community risk perception

Keywords Landslides · Slope stability · Countermeasure · Disaster risk perception · Structural mitigation measures

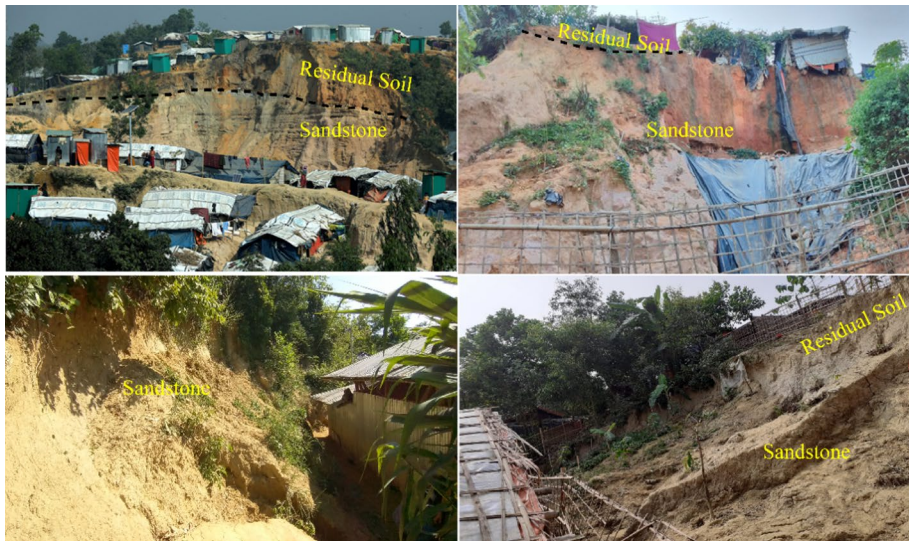
Fig. 2 Landslides in the Kutupalong Rohingya camp

The entire KRC area has been affected by hundreds of landslides from 2017 to the present (Figs. 1 and 2). To characterise them for overall slope stability and reliability analysis, average values of the shear strength parameters and four dominant and representative slope angles (40°, 45°, 50°, and 55°), where most landslides occurred, were considered. The area is also composed of almost monotonous lithology and structural setup. Three different slope stability analysis methods were used: geographic information system (GIS)-based infinite slope stability, limit equilibrium method (LEM), and finite element method (FEM). The factor of safety (FoS) determined using these methods was correlated and described the stability state of the slopes. Reliability or sensitivity analysis also assessed uncertainty in the geotechnical properties of the slope materials. The unstable slopes identified from the comparative analysis were further investigated by incorporating the existing landslide mitigation measures. In this way, the performance of the countermeasures to protect the slope was assessed, and the pitfalls of current measures were evaluated (He et al. 2022; Jiang et al. 2022). The results obtained from different slope stability analysis methods can be used in the future to select and implement proper landslide countermeasures in the KRC area.

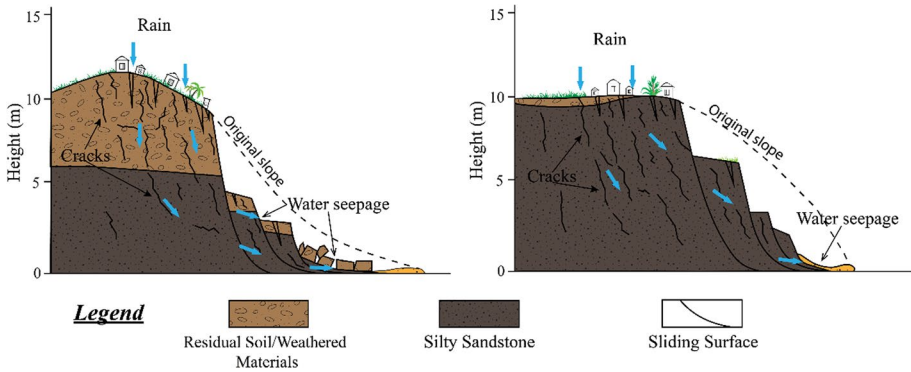
Fig. 3 Schematic geological section of landslides occurring in the KRC area (Kamal et al. 2022b)

Landslide occurs mainly in the residual soil and upper loose, fractured, and partially weathered bedrock of the Pliocene to Pleistocene geological formations (Kamal et al. 2022b). Geological observation of the existing landslide site demonstrates that slide and slump-type slope failures are dominant (Fig. 3). Semicircular sliding plane and well-developed multiple landslide heads were observed where the upper soil has a greater thickness. Otherwise, complex slide and flow-type failure mode is prominent. The landslides in this area are primarily observed in the steep slopes ($> 40^\circ$ slope angle) of natural and anthropogenic reworked origin.

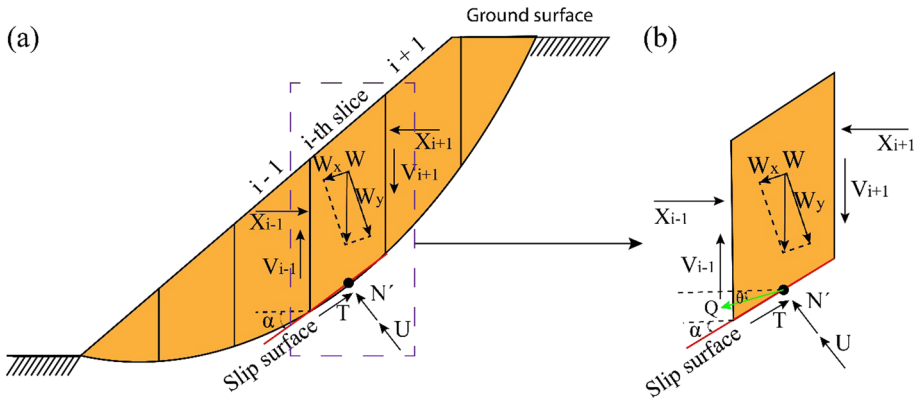
Fig. 5 The 2D stability analysis using Spencer's limit equilibrium method. **a** Forces act on a single slice of a slope, **b** Spencer's method assumption in which interslice forces X_{i-1} , X_{i+1} , V_{i-1} , V_{i+1} are replaced by a single force Q acting at the midpoint of the slice's base

The factor of safety (FoS) for the limit equilibrium method (LEM) was determined by Spencer’s method (Spencer 1967). It satisfies both the moment and force equilibrium and considers parallel interslice forces. In Spencer’s method, the interslice forces (Fig. 5) are substituted by an equivalent resultant force Q inclined by a constant angle of θ .

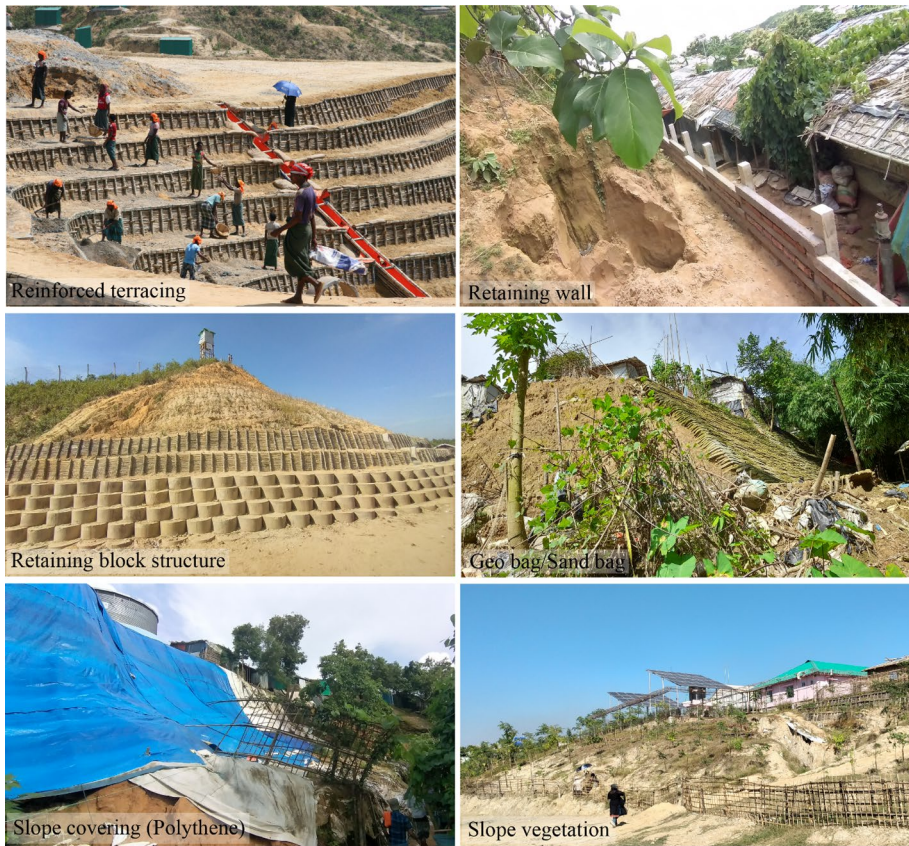
Fig. 6 Different landslide mitigation measures implemented in the KRC area

To protect the critical settlement and makeshift temporary shelters against landslides or slope failures, different mitigation measures were implemented in the Kutupalong Rohingya Camp (KRC). The essential measures of mitigation observed during the fieldwork in March 2022 were the reinforced terrace (benching) slope, concrete retaining wall, reinforced concrete block structure, slope covering by geo/sandbag, and nature-based slope stabilisation using tree plantation (Fig. 6). Immediate measures to prevent rainfall infiltration slope covering with polythene were also implemented in some vulnerable slopes. During fieldwork, it was found that the landslide mitigation measures successfully protected against slope failure. But in the various location, it was observed that the slope failed, although mitigation measures were present. A performance evaluation of the existing landslide mitigation measures was done to investigate the actual cause and pitfall of the slope stabilisation measures. The performance evaluation of the mitigation measures was carried out by the limit equilibrium method. The necessary data, such as retaining wall strength, slope terrace geometry, and geobag strength, were collected during the fieldwork (Supplementary Table S1). The strength of the concrete retaining structures was measured by the Schmidt hammer rebound process, and the geobag strength was measured by laboratory investigation of the filling sand materials.

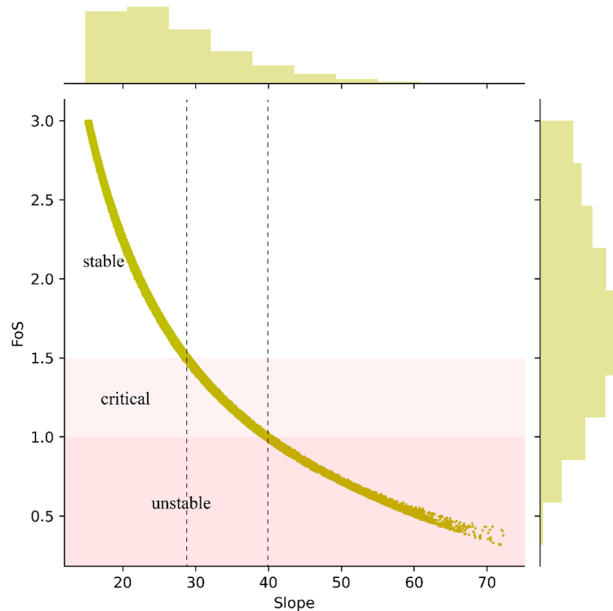
Fig. 8 Correlation of slope angle and factor of safety (FoS) calculated from the enclosed area of Fig. 7b

($FoS > 1.5$). The FoS distribution follows the pattern of elevation and slope. It decreases exponentially with slope angle (Fig. 8). Several authors also reported the exponential decrease of FoS with slope angle (Löfroth et al. 2021). The visual inspection of the model result shows that the unstable slopes are concentrated along the steep slopes. Significant slope destabilisation is observed when the slope angle is higher than 40° and critically stable between 28 and 40° (Figs. 7b, 8). In KRC, the abundance of slope angles more elevated than 40° is much smaller, also reflected in the unstable (< 1) FoS value. Although the unstable slope's abundance is less, critically stable slope abundance is much higher in the KRC area. A qualitative comparison of the previous landslide inventory with the produced instability map agrees with the spatial distribution of the FoS values determined using the infinite slope stability framework. Landslide locations were mainly confined within unstable and critically stable areas. The unstable area suggested by the FoS value is frequently concentrated in camps no 4, 5, 8W, 8E, 10, 13, 17, 18, and 20.

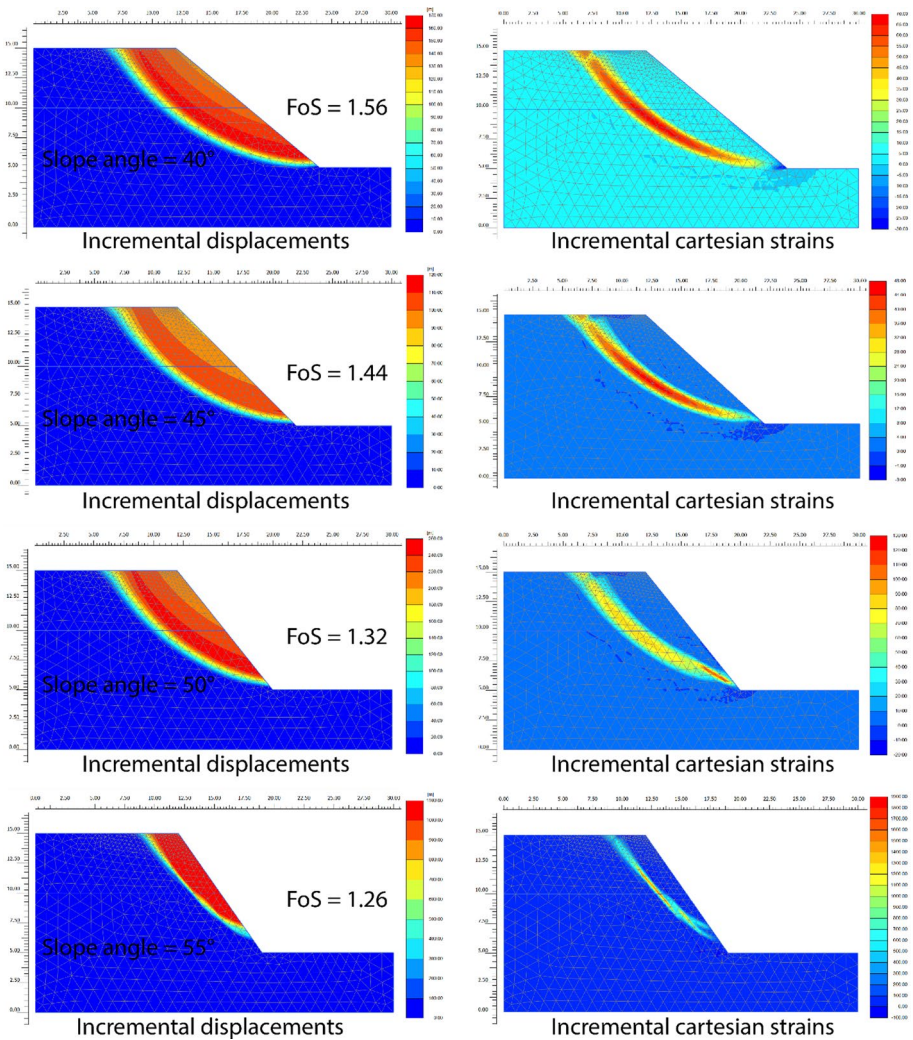
Fig. 10 Safety factor determined for different slope angles under natural conditions without anthropogenic overburden load using the FE method

The distribution of incremental displacement and strain with increasing slope angle is shown in Fig. 10. The FoS value obtained for a 40° slope angle is 1.56 under natural conditions without any stable overburden load. But when an anthropogenic load is applied, the FoS value decreases to 1.28 and 1.12 for 50 and 100 kN/m² loads, respectively. Decreasing trends of FoS with anthropogenic overburden loading occur for all the slope angles and are illustrated for the 45° slope angle in Supplementary Fig. S2. The displacements of slope materials are highest along a narrow semicircular zone which is also attributed to

maximum strain (Fig. 10). These are possible locations of the slip surface during the slope failures. These slip surface configurations are in good agreement with the LEM-derived slip surfaces.

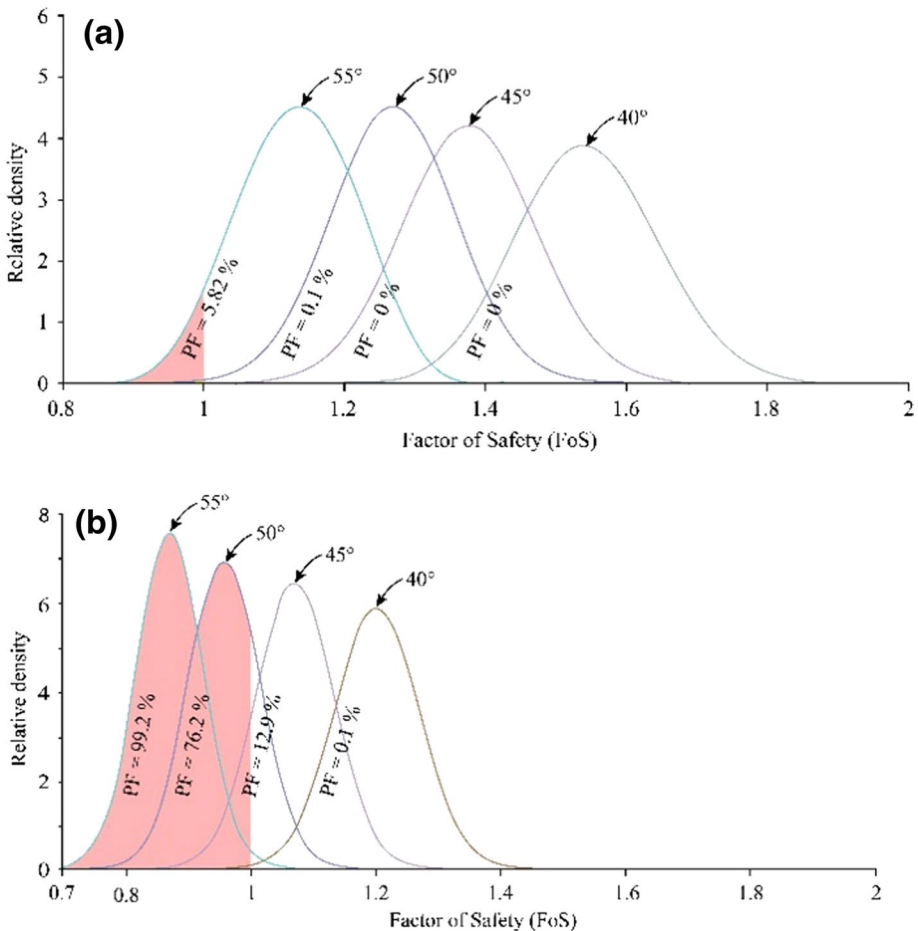
Fig. 11 Results of reliability analysis of slope. **a** Probability of failure (PF) different slope angle under the natural condition without anthropogenic overburden load and **b** with 100 kN/m² overburden load

The reliability of slope stability analysis was carried out to determine the probability of failure (PF) and reliability index (RI) of the particular slope, as shown in Fig. 11 and Supplementary Fig. S3. The distribution of field shear strength parameters (c' , ϕ' , γ) has normal distributions. The factor of safety (FoS) value distribution with variable shear strength parameters also showed normal distribution (Fig. 11). With increasing slope angle, the FoS distribution graph approached the left. The probability of failure (PF) is the area delineated by FoS = 1 line and FoS distribution graph; here, it is indicated by the red shaded area (Fig. 11).

The PF value is null for all slope angles in the case of zero anthropogenic overburden load except 55°, which has a 5.82% failure possibility. Failure probability increases with anthropogenic overburden load. For 100 kN/m² overburden load, >75% PF value is obtained for 50° and 55° slopes. Their FoS are also less than 1; i.e. they are always unstable and susceptible to failure. The reliability index (RI) for each of the cases analysed is also shown in Table 2. It shows that all slopes have positive RI except three with less than 1 FoS value. An RI value of more than three is considered entirely safe for work, and here the majority of positive values are more than three or close to 3. These slopes are safe without protection measures.

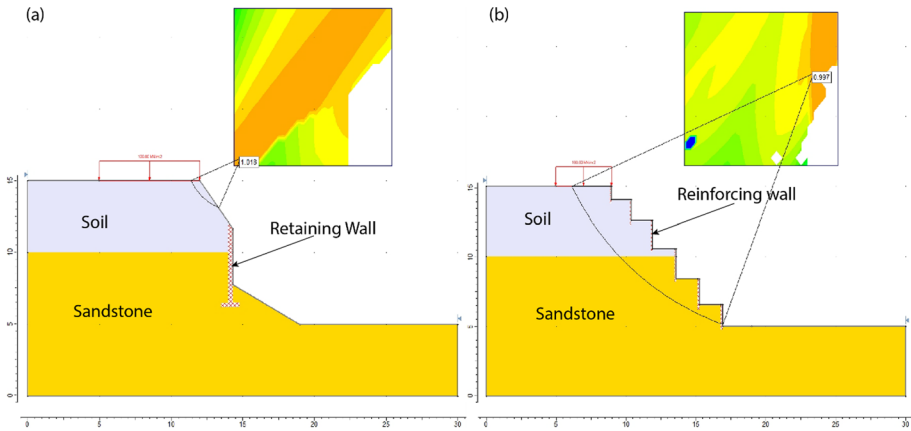
Fig. 13 Safety factor determined for slopes protected against landslide by **a** concrete retaining wall and **b** terrace with the reinforced bamboo wall

The terracing of the slopes with the reinforced bamboo wall increases the factor of safety to a safe limit for 50° and 55° slopes with 100 and 50 kN/m² loading, respectively. Also, the failure probability is significantly low, and the reliability index is close to 3 (Table 2). But for the 55° slope with ≥ 100 kN/m² loading, the slope remains unstable with

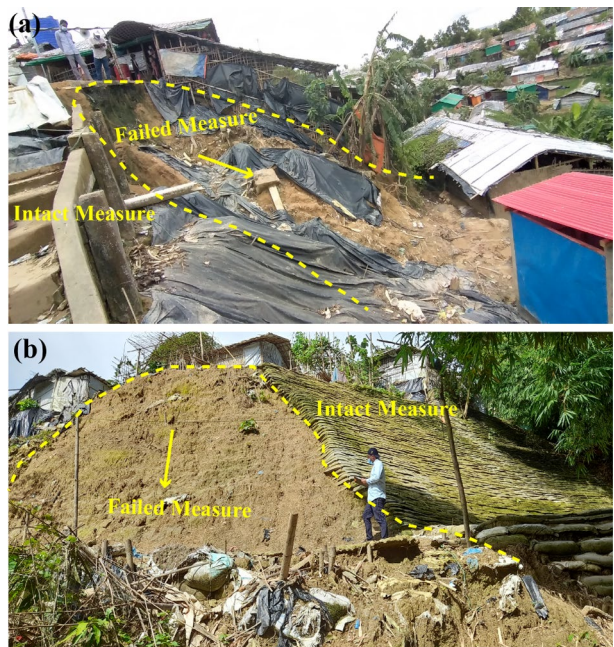
Fig. 14 Examples of landslide mitigation measure failure in the Kutupalong Rohingya camp—**a** retaining wall failure and **b** geo/sandbag cover failure

Implementing slope covering with geo/sandbag (Fig. 14b) protects the slope marginally ($FoS \approx 1$) with a fair share of failure probability for the high slope and loading. For the geo/sandbag-type mitigation measures, it was observed during the fieldwork that the failure of the mitigation measure (geo/sandbag cover) itself causes disaster and fatalities. For example, a 20-year-old woman died in camp 21 (Chakmarkul) in 2021.
