# A full-scale wind turbine blade monitoring campaign: Detection of damage initiation and progression using medium-frequency active vibrations

Mads Anker Fremmelev<sup>1,4</sup>, Purim Ladpli<sup>1</sup>, Esben Orlowitz<sup>2</sup>, Nikolaos Dervilis<sup>3</sup>, Malcolm McGugan<sup>4</sup> and Kim Branner<sup>4</sup>

## Abstract

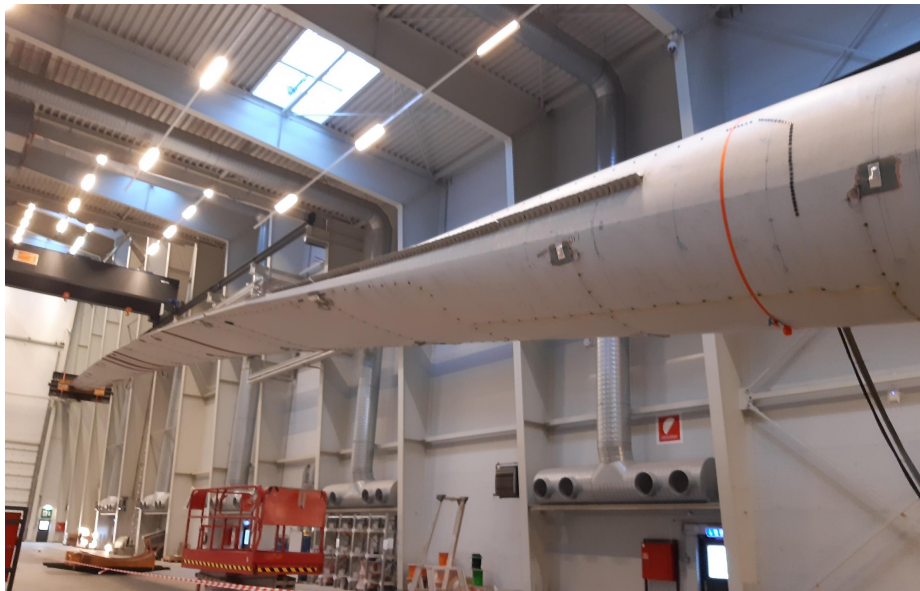
**Figure 1.** Wind turbine blade mounted on a test stand at Siemens Gamesa Blade Test Center in Aalborg, Denmark.

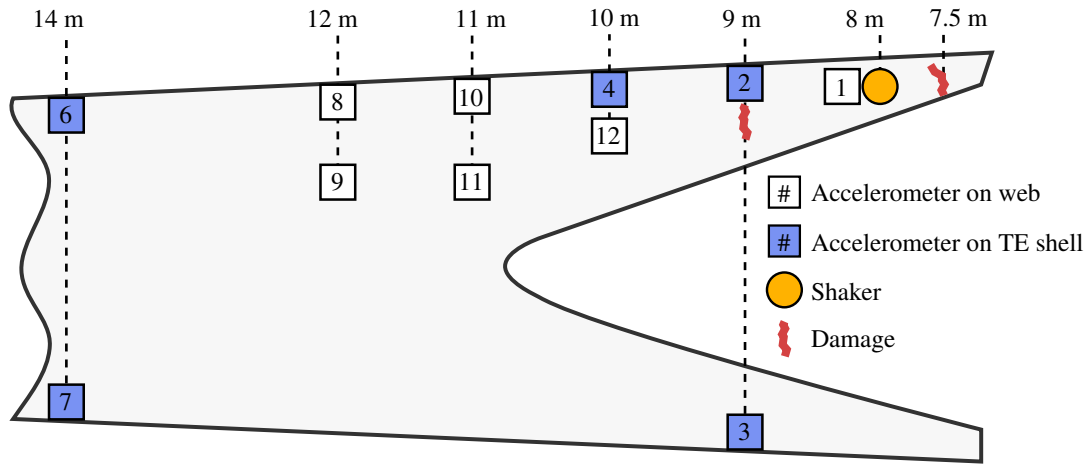
**Figure 8.** Accelerometer channel placement on shear web and shell laminate, viewed from trailing edge side. Sensor channel 5 is used for the force transducer, which is collocated with the vibration shaker. The first shear web damage, shown in Figure 2, is located at 7.5 m, and the second shear web damage, shown in Figure 3 and 4, is located at 9 m.

Placement of the shaker, accelerometers, and damages are sketched in Figure 8. Accelerometers sketched in white were located on the shear web laminate, and accelerometers sketched in blue were located on the TE shell laminate, see Figure 9 for a sketch of the three-dimensional blade view showing the accelerometer locations. The damages and the vibration shaker were placed on the PS side of the shear web. The accelerometers placed on the shear web were also placed towards the PS side, while the accelerometers towards the TE were placed on both the PS and SS side shell laminate. The active vibration input of the electrodynamic vibration shaker and measured output from an accelerometer are plotted in Figure 10. A logarithmic sinusoidal chirp with frequencies between 100 and 3,000 Hz is applied over a time of 12 seconds, with a period of no input at either end of the signal. This frequency range is well above that of the lower-order eigenfrequencies of the blade. White noise and sinusoidal burst signals were also applied, but these signals are not investigated in the present work. The sinusoidal chirp signal is selected for the present study due to its high signal amplitude and wide frequency range. A sampling frequency of 25,600 Hz is used for the accelerometers and for the force transducer. The logarithmic chirp time domain response as a function of time  $t$  is governed by Equation (1) and (2):

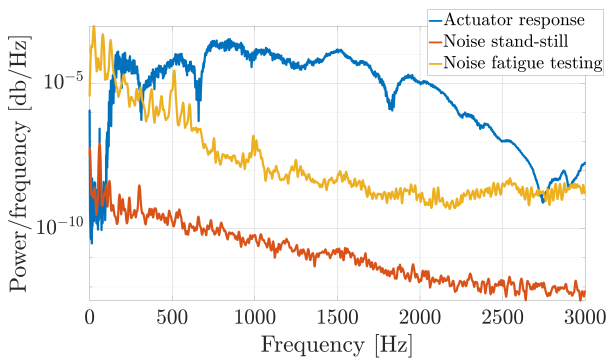
**Figure 11.** Comparison of PSD of chirp signal vs. PSD of noise floor. Based on acceleration measurements of accelerometer 9, see Figure 8.

200 Hz, see Figure 11. For e.g. accelerometers 6 and 7, which are the sensors placed furthest from the vibration shaker in the present work, the measured amplitude of the vibration shaker signal attenuates more. For the mentioned sensors, frequencies below approximately 500 Hz show higher noise amplitudes than the measured shaker signal, whereas for frequencies above approximately 500 Hz, the noise amplitude is lower than the measured shaker signal.

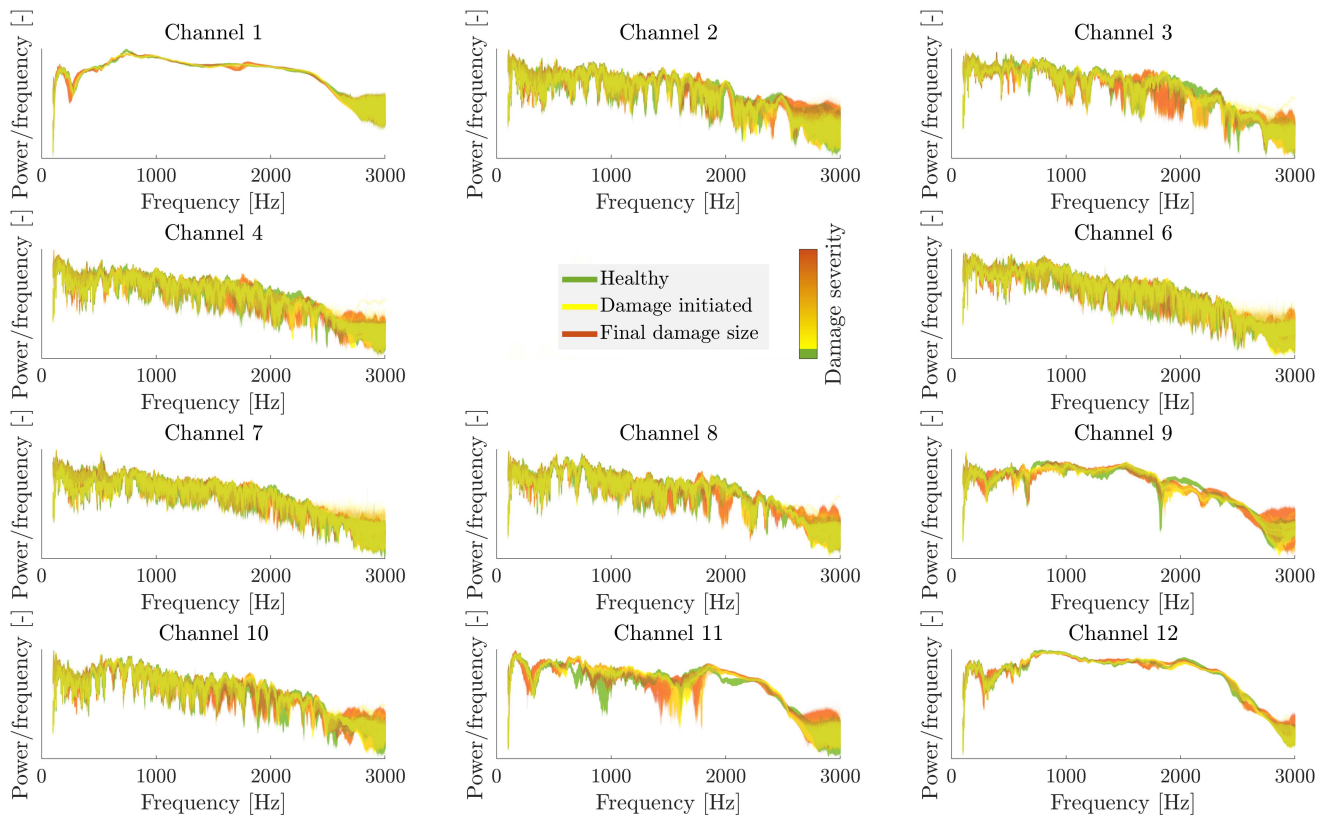
**Figure 13.** PSDs from all accelerometer channels (see Figure 8) resulting from active vibration input, plotted for all observations recorded during testing with the first shear web damage. Observations recorded during the healthy state of the blade are plotted in green, while observations starting after the manual initiation of the damage are plotted on a yellow to red color scale with increasing damage severity. Overlap renders as mixed colors.

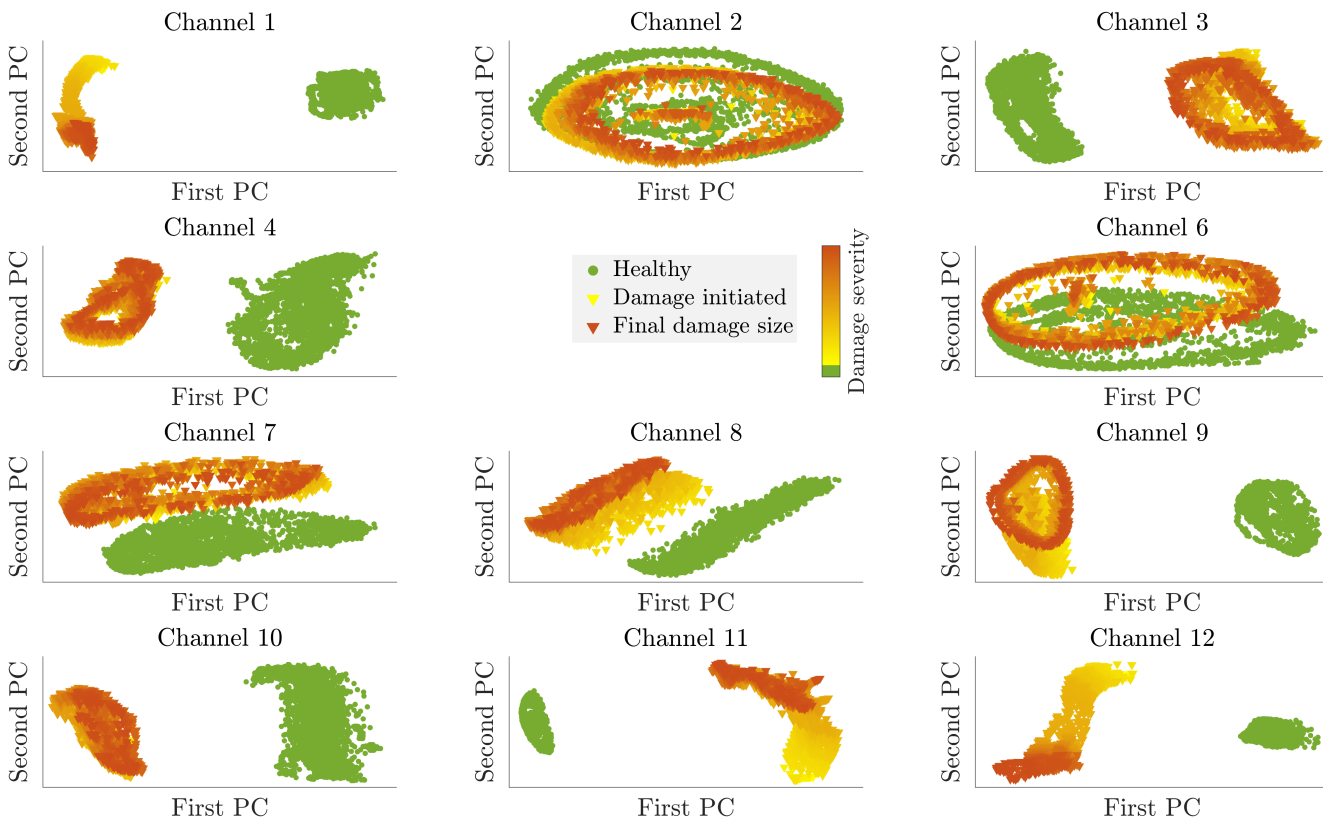
**Figure 14.** First two PCs for the PSD data from all accelerometers, using frequencies between 600 and 2,500 Hz. Healthy observations are plotted in green, while damaged observations are plotted on a color scale from yellow to red with increasing damage severity.

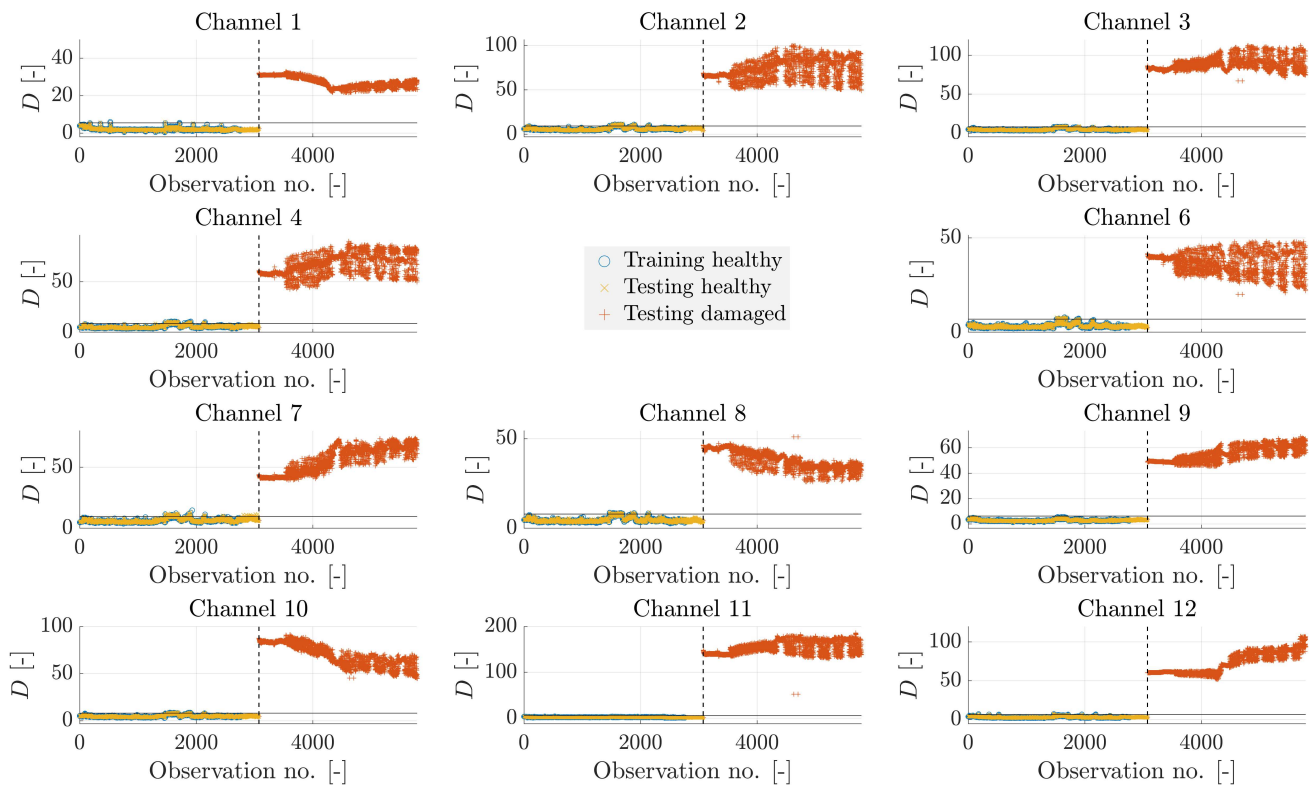
**Figure 16.** Plot of damage index  $D$ , calculated based on the Mahalanobis distance by using PCs explaining 95% of the variance of the original data. The horizontal solid line marks the 99% confidence threshold, allowing for 1% false positives in the training data. The vertical dotted line marks the manual introduction of the first damage.

detection of the shear web damages. Figure 16 shows outlier plots for all accelerometer channels, using data recorded during testing with the shear web damage shown in Figure 2. The Mahalanobis distance, see Equation (7), is used for discordancy testing, and the healthy threshold is calculated with a 99% confidence interval based on every second observation from the first 90% of the healthy data. Generally, for all accelerometer channels, more than 99% of the healthy observations are classified as inliers, while all damaged observations are classified as outliers. A large jump in the damage index  $D$  can be observed after the introduction of the shear web damage, followed by progressive change in the damage index in line with the observed damage progression. However, progression in the damage index is not monotonic for all accelerometer channels, and neither does the damage index increase in magnitude with increasing damage severity for all accelerometer channels. For e.g. channels 7 and 10, the progressions after damage initiation are close to mirror images of each other. For channel 7, the damage index increases monotonically in line with progression of the damage, whereas the damage index decreases monotonically with progression of the damage for channel 10. Whether or not the damage indices increase monotonically with increasing damage severity is believed to be dependent on whether the positions of the corresponding accelerometers are sensitive to the changes in the local vibration response resulting from damage, as well as the number of PCs used as features for outlier detection.

Considering channel 10, the damage index decreases monotonically with increasing damage severity. One

possible explanation for this is the local vibration response of the blade changing towards resembling the vibration response at the healthy baseline, as compared to becoming more different from the vibration response after introduction of the damage. Similar behavior, where the damage index partially decreases with increasing damage severity, can be observed for other accelerometer channels. Since damages in e.g., glass fiber reinforced epoxy do not repair themselves, changes in the damage index over time are indicative of changes in the damage state in form of damage propagation.

Another observation that can be made from the plots of the damage indices is the presence of distinct zones in the observations from the damaged states. For the plot from channel 4 in Figure 16, the observations following initiation of the damage are shown in Figure 17. The observations in the first block marked with dotted blue lines in Figure 17 have little variance, followed by a second block of observations marked with blue dotted lines, where the observations have increased variance. These two types of blocks are repeated throughout the damaged observations. The consecutive observations with little variance were sampled during stand-still of the fatigue test, whereas the consecutive observations with increased variance were sampled while the fatigue test was running. Consequently, the noise from fatigue testing adds variance to the damage index, which may be due to e.g. opening and closing of the crack during fatigue testing. Observations from both the operational states of stand-still and fatigue testing are classified correctly as outliers since both of these operational states were included in the training data.

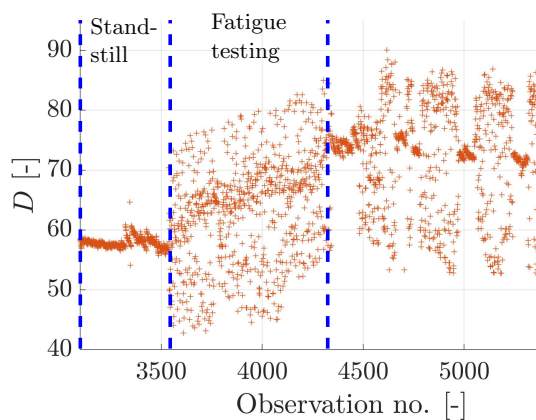
**Figure 17.** Zoomed-in view of damaged observations of channel 4 from Figure 16.

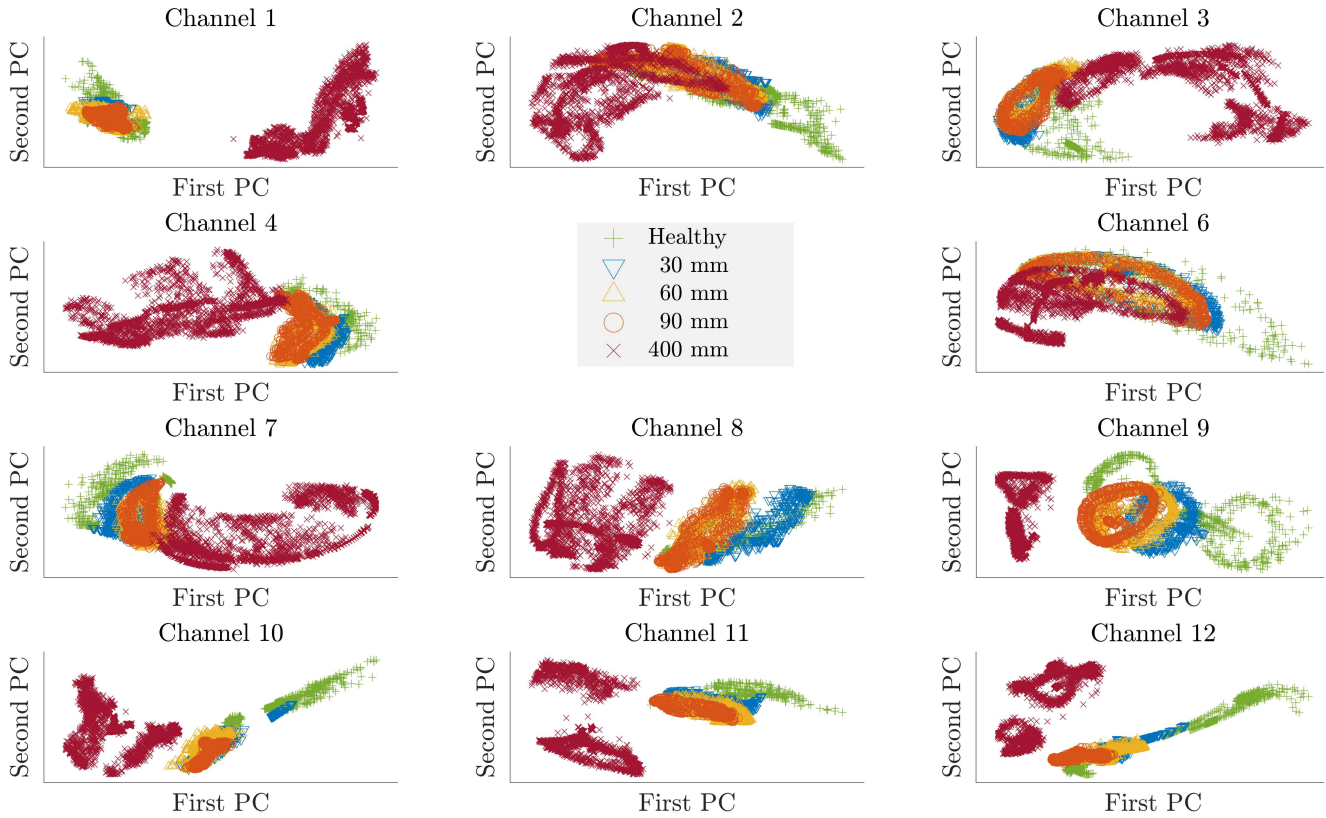
**Figure 18.** First two PCs for the PSD data from all accelerometers, using frequencies between 600 and 2,500 Hz.

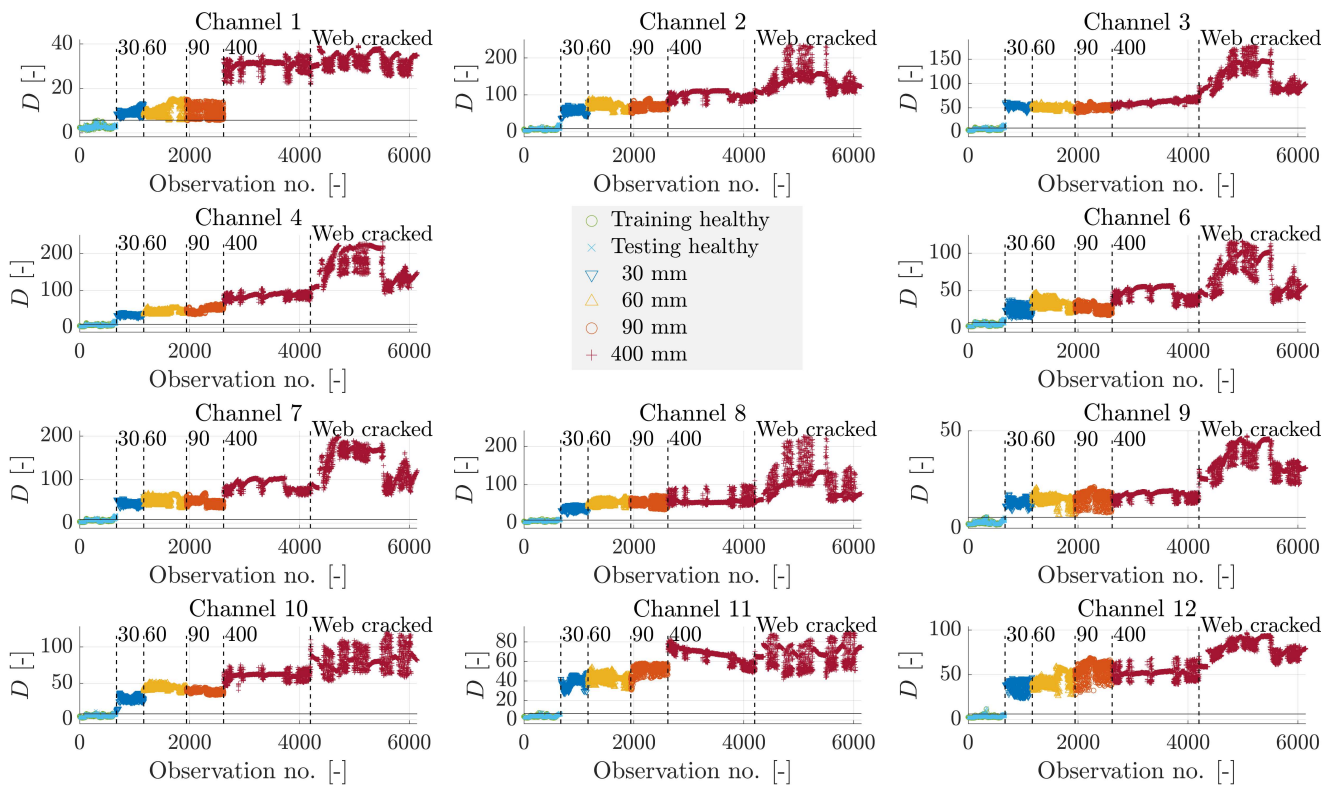
**Figure 20.** Plot of damage index  $D$ , calculated based on the Mahalanobis distance by using PCs explaining 95% of the variance of the original data. The horizontal solid line marks the 99% confidence threshold, allowing for 1% false positives in the training data. The vertical dotted lines mark the manual introduction and manual increase in length of the second damage, including a significant event in fatigue-driven damage propagation (web cracked).
