SYNERGISTIC EXPLOITATION OF GEOINFORMATION METHODS FOR POST-EARTHQUAKE 3D MAPPING OF VRISA TRADITIONAL SETTLEMENT, LESVOS ISLAND, GREECE

KEY WORDS: Post-earthquake 3D mapping, Lesvos earthquake, UAV, Laser Scanning, SfM method

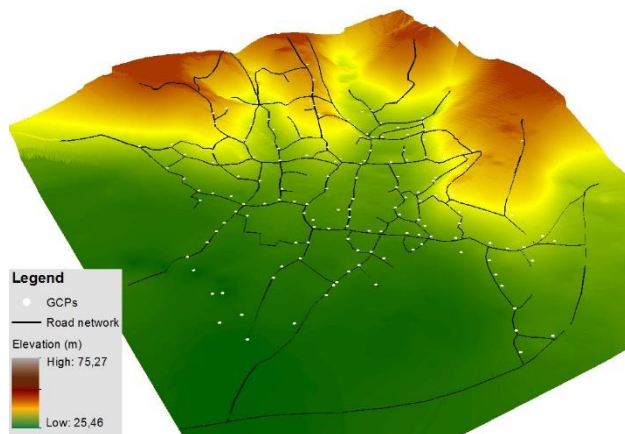
Figure 2. Digital Elevation Model of the study area, derived by kriging interpolation of the 157 RTK elevation measurements.

1. Two Base Stations (BS) were established within the village of Vriza, depending on the base of the greek National Trigonometric Network (NTN) located at the top of the hill named Korona, SW of the settlement of Vriza having coordinates X = 689641.55 Y = 4322030.77 and Altitude = 135.98. Due to the morphology of the settlement, as it is developed on three hills and two flat relatively low altitude surfaces (Figure 2), the two BSs were placed on the

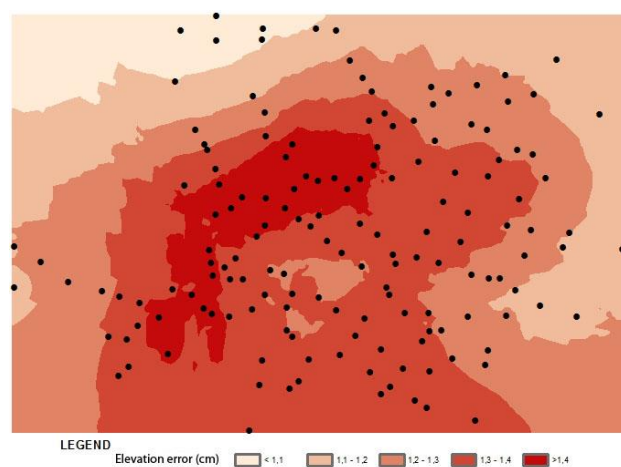
Figure 3. Spatial distribution of the elevation error by the 157 RTK measurements.

One hundred fifty seven (157) GCPs were placed within the Vrisa settlement, having very high accuracy in three dimensions (X, Y, Z), with an RTK rover, the base of which was placed at the one of the two base points, depending on the area where the GCPs were placed, to achieve better reception and a greater number of satellites, with an average horizontal error of 0.8 cm and an average elevation error of 1.3 cm (Figure 3). The GCPs were

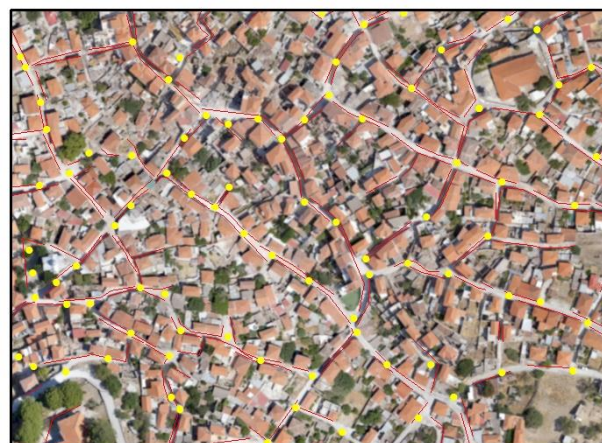
Figure 4. The 240 sections of the terrestrial photograph and the 140 TLS positions campaigns.

More specifically, the Vrisa settlement was divided into 238 road sections where each section included not more than five buildings (Figure 4) and about 20,000 photos were taken covering all the buildings of Vrisa village, taking into serious consideration that the post-earthquake activity was in progress and many aftershocks with magnitude 4 – 5 were frequently occurring.

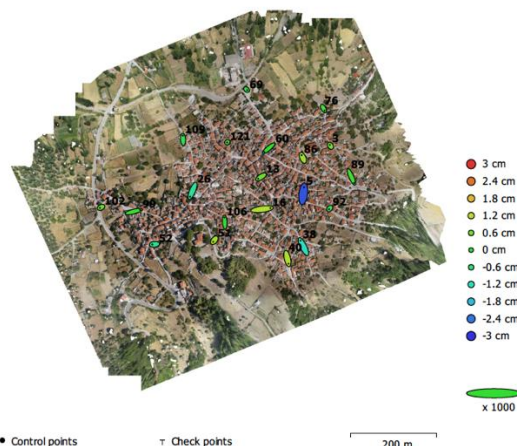
Figure 5. GCP locations and error estimates.

GCP locations and error estimates are depicted in Figure 5. The estimated GCP locations are marked with a dot and Z error is represented by a colored ellipse. Furthermore, X, Y errors are represented by elliptical shapes where the size of the ellipse for the major and minor axes represents the magnitude of X and Y errors respectively. From the geo-registration accuracy achieved, one can conclude that the precision of the geoinformation produced is of satisfactory accuracy for earthquake damage assessment.

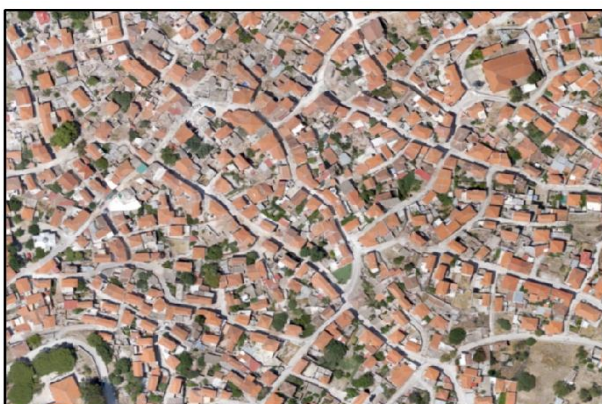
Figure 5. Orthophoto map of 13th June 2017, scale: 1:4.000 illustrating damages of grade 5 e.g. partial and total collapse of buildings.

The Orthophoto map (Figures 5, 6) and DSM (Figure 7) produced by processing the 229 UAS aerial high-resolution images, which were obtained from flights at 160 m altitude, proved to be very efficient in ‘early damage assessment’. Both products, obtained after few hours of processing due to a few photos, capture all the important information and give a clear view of the most damaged areas of the Vrisa settlement, as well as those that were not essentially affected. Collapsed and nearly collapsed buildings can be visually recognized, streets closed by collapsed building stone walls can be clearly seen, and even destroyed chimneys can easily be identified. Based on the EMS-98 (Grünthal, 1998) damage classification on the specific results damages of: i.) Grade 5: destruction e.g. partial and total collapse of buildings and, ii.) Grade 4: very heavy damages e.g. heavy structural failure of roofs and floors can be visually identified giving a quick and accurate assessment of the earthquake devastation. Additionally, the DSM of Vrisa settlement (Figure 7) provides the most effective means to measure building heights and surfaces after the earthquake, giving an estimation of their volume, and the possible extent of their total or partial collapse.

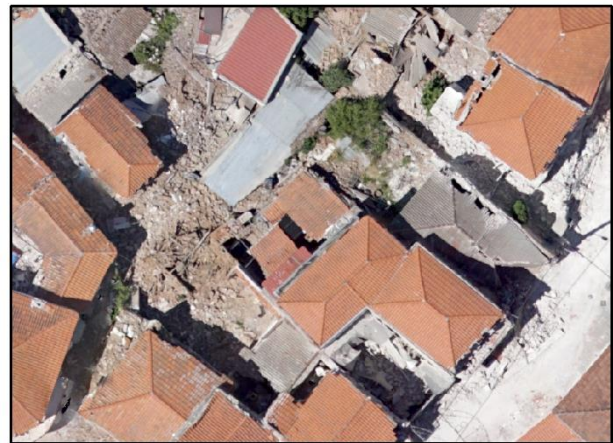
Figure 6. Part of the 13th June 2017 orthophoto map at a scale of 1:500 with damages of grade 4 e.g. heavy structural failure of roofs and floors.

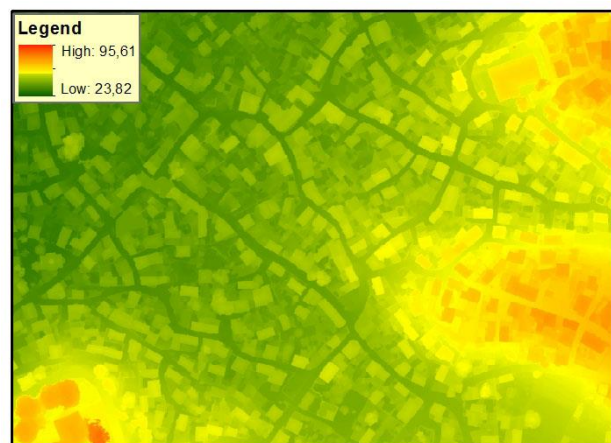
Figure 7. DSM for the 13th of June 2017, scale 1:4.000

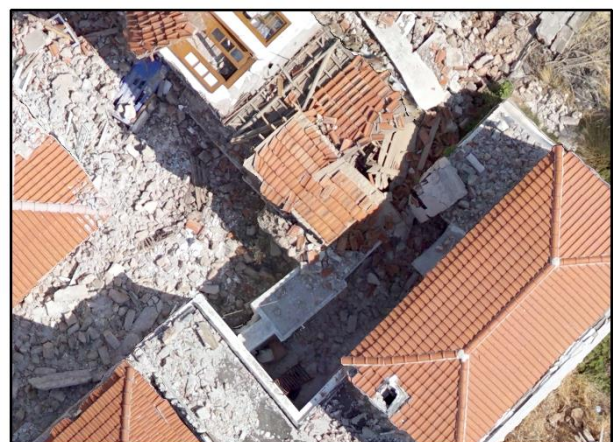
Figure 8. Part of the 25th July 2017 orthophoto map at a scale of 1:200 which clearly shows damages of grade 3, e.g. dislocation and fall of roof tiles, detachment of the roof from the rest of the structure and fall of gables.

The Orthophoto map (Figures 8, 9 and 10) and DSM, produced by processing the 1050 nadir and oblique UAS aerial high-resolution images which flew at 65m altitude, proved to be very effective for creating a 3D model at village scale (date: 25 July 2017). This 3D model (Figure 10) captures many of the building facades and as such it provides accurate information concerning the grade of damage occurred to buildings.

Based on the EMS-98 (Grünthal, 1998) damage classification, on the specific orthophoto map, building damages, can be visually identified i.e. Grade 2: moderate damages e.g. cracks in many walls, detachment of small pieces of places from the walls and partial collapse of chimneys, and Grade 3: substantial to heavy damages e.g. large and extensive cracking of all masonry load-bearing walls, detachment of large pieces of plaster in all load-bearing walls, dislocation and fall of roof tiles, detachment of the roof from the rest of the structure and fall of gables. The results highlight the importance of applying suitable flight planning characteristics e.g. low altitude, more than one oblique cameras on board, in order to achieve more detailed and reliable 3D information (Figures 8 and 9).

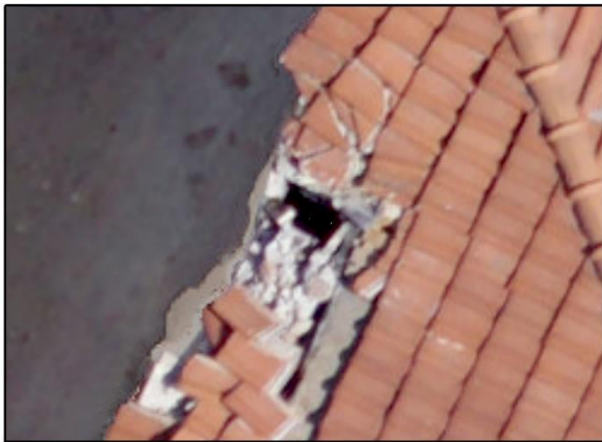
Figure 9. Part of the 25th July 2017 orthophoto map at a scale of 1:40 which clearly shows damages of grade 2 on the top of the buildings, e.g. collapse of a chimney.

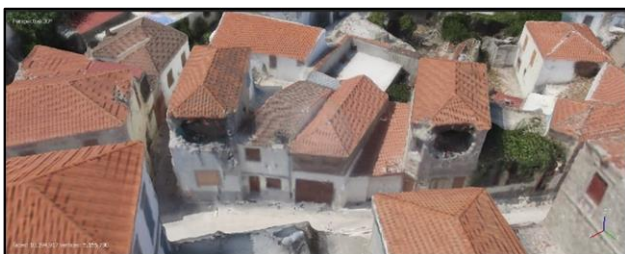
Figure 10. Part of the 25th July 2017 3D model produced by nadir and oblique UAS-derived high-resolution images.

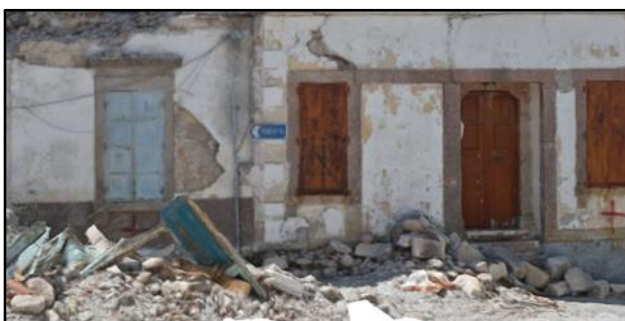
Figure 11. Part of a 3D model produced by terrestrial photogrammetry.

All the 240 3D models (Figure 11) and the 140 point clouds of the 3D laser scanner (Figure 12), created by terrestrial photogrammetry and TLS respectively, provide the most

important 3D information for assessing damages of Grade 1: negligible to slight damages of the buildings. Their very high resolution and accuracy permit identifying hair-line cracks in walls, fall of small pieces of plaster only, falls of loose stones from upper parts of buildings.

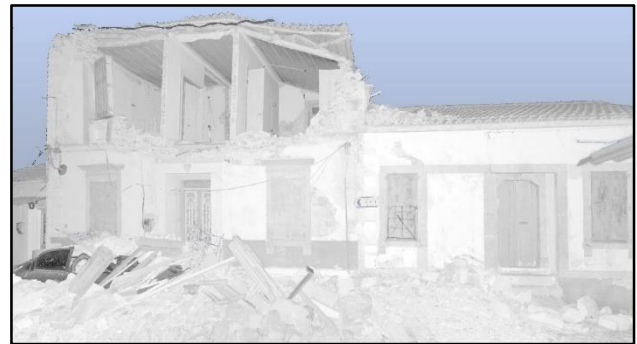
Figure 12. Part of a TLS 3D model with intensity values.
