Seismic Assessment, Repair and Retrofit of Existing Corroded Structures Using UHPC Jacketing

A Dissertation Submitted to the Faculty of Graduate Studies in
Partial Fulfillment of the Requirements for the Degree of Doctor
of Philosophy

Graduate Program in Civil Engineering

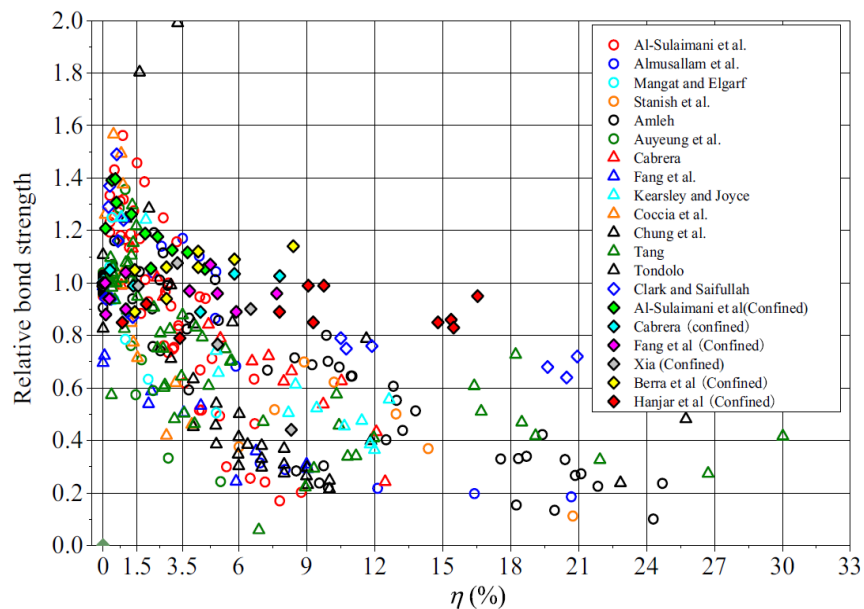
Figure 2-6. Relative Bond Strength with Increasing Degrees of Corrosion (Lin *et al.*, 2019)

Figure 2-6 shows the variation of relative bond strengths as a function of the degree of corrosion quantified by the percentage of bar mass loss (η) (Lin *et al.*, 2019). All filled dots in the Figure refer to confined specimens using stirrups while the rest were unconfined. A general trend could be easily identified for the unconfined specimens, where bond strength increases initially and then decreases dramatically. But a discrepancy is identified in terms of the critical corrosion level (when the relative bond strength drops below 1), ranging between 0.3% and 4.8%. The scatter could be attributed to the different materials used, specimen dimension, corrosion method, current densities, test setup, and loading procedures used (Lin *et al.*, 2019).

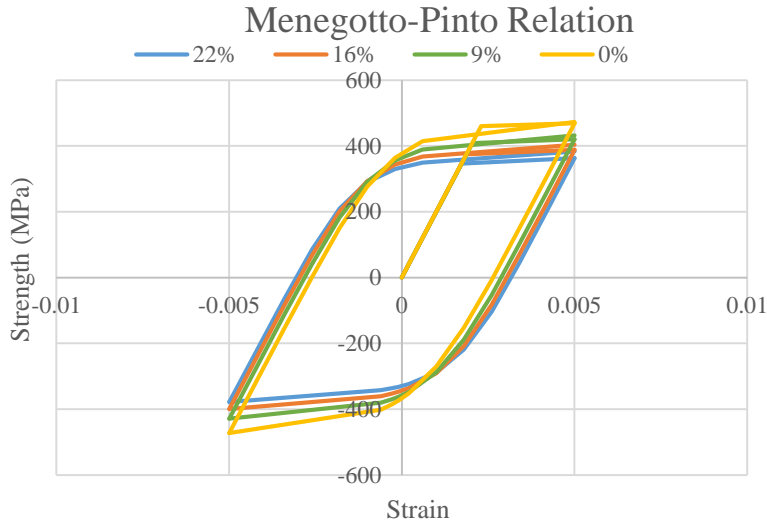
Figure 3-8. Menegotto-Pinto relationship for steel used for modelling Goksu and Ilki's columns

Where, C_1 , C_2 and R are defined by the user. The subscript (o) of strain (ε_o) and stress (σ_o) presents the start point of the hysteretic branch while (r) of strain (ε_r) and stress (σ_r) represents the end point of the branch. Parameter ε is the strain corresponding to the stress σ . Figure 3-8 illustrates the calculated cyclic stress strain response of the reinforcement with these variables, for the onset of unloading occurring at a strain of 0.005.

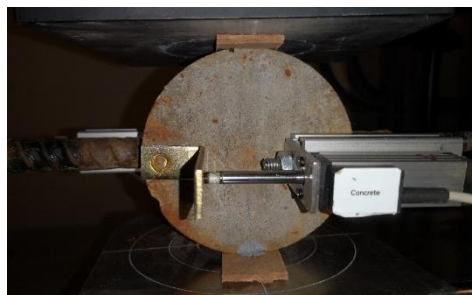
Figure 4-2. Specimen Pre-Cracking Splitting Setup and Instrumentation. Rust stains were caused by oxidation of steel fibers during the curing period and not from accelerated corrosion which followed this stage.

Pre-cracking of specimens was achieved by conducting a standard splitting test on the cylinders using an MTS machine under displacement control. Load was applied while crack widths were continuously monitored with the help of two linear displacement transducers until their width stabilized to the desired value. Note that due to the presence of fibers and the steel bar crossing the crack, cracks were constantly closing after unloading. Thus, several loading cycles were applied in order to finally reach the target residual crack width after unloading. Pre-cracking instrumentation is depicted in Figure 4-2.

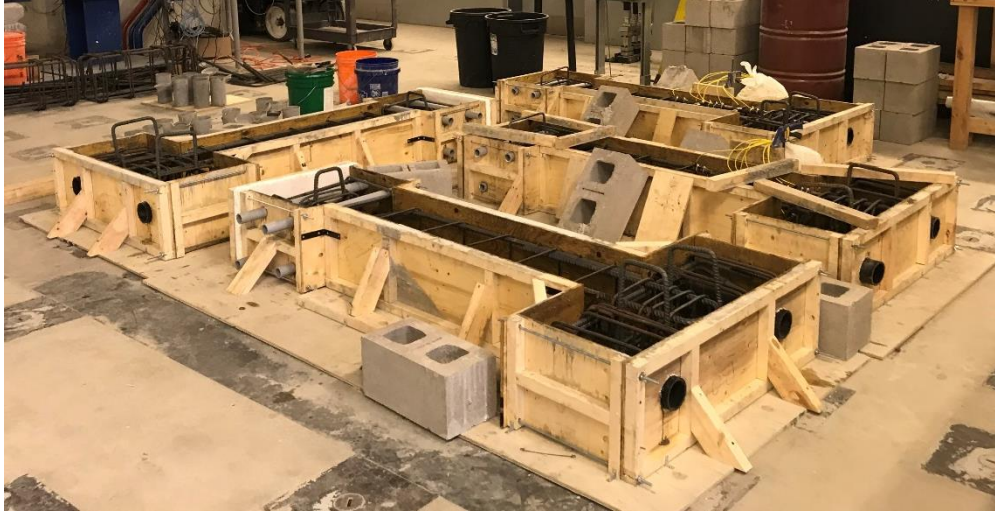
Figure 6-4. Specimens ready for casting

formwork deformation after pouring the concrete. Figure 6-4 shows the state of the specimens awaiting casting.

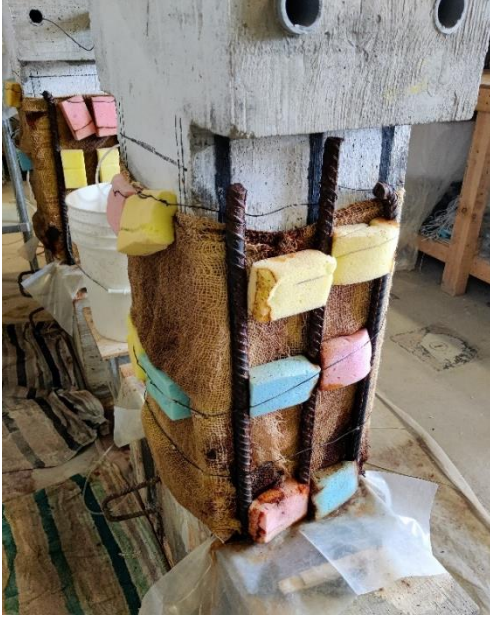
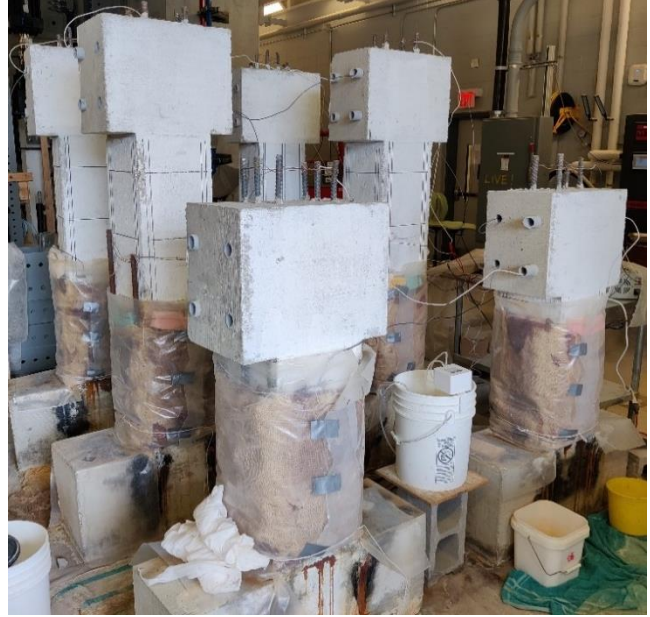
Figure 6-6. Photos from the accelerated corrosion program. Short column with cathode bars shown before covering with second layer of burlap and a plastic sheet (left). All columns are shown during a wetting cycle (right).

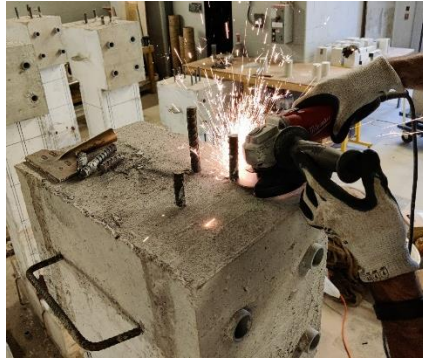
Figure 6-19. Removing extruded bars from the top of the columns.

Prior to load testing the specimens, certain provisions were made in order to render the specimens ready for testing. The accelerated corrosion process required reinforcement to be extruding from the top of the column's cap. These bars were removed using an angle grinder as can be seen in Figure 6-19. Additionally, plastic pipes extruding from the footing (required to accommodate the anchor rods to fix the specimen on the floor) and from the column's cap (for the rods required to attach the lateral actuator on the specimen) were sawn off manually flush with the concrete surface.

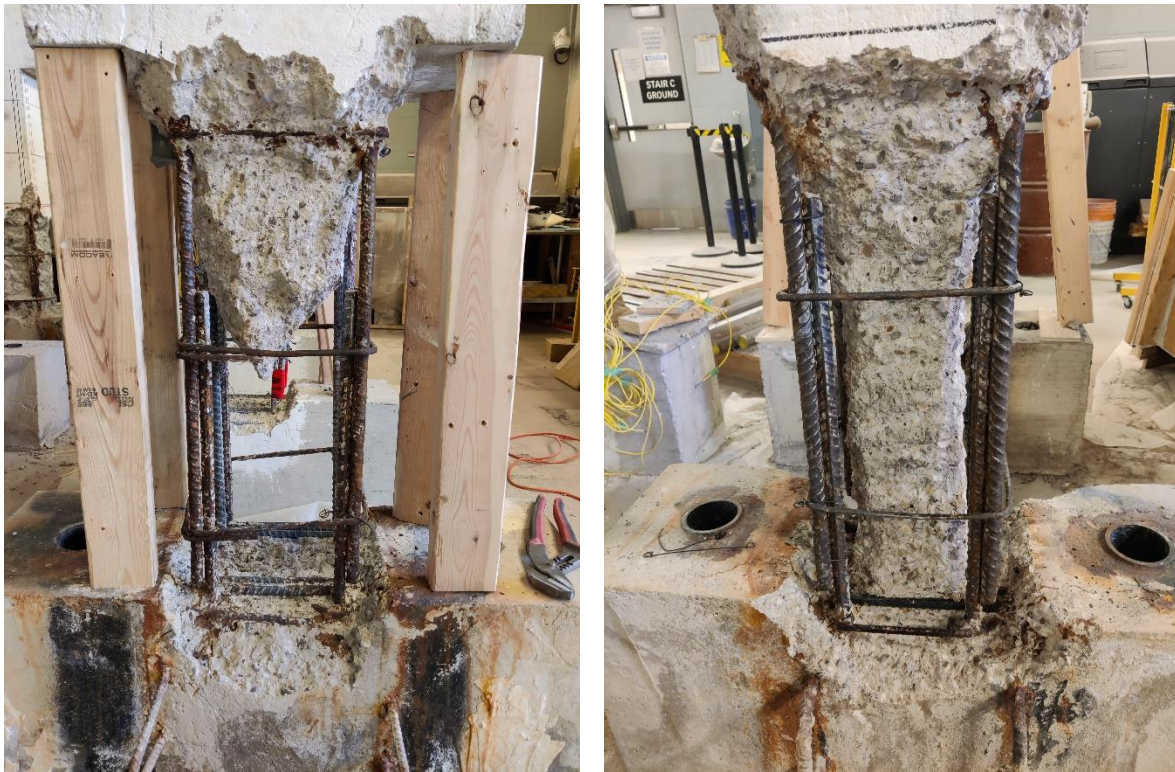
Figure 6-24. Sample of the state of the columns after concrete removal during the repair/strengthening process

The repair work extended into the footing to a depth of 5-10 cm in order to mitigate failure at the column-footing interface. Figures 6-24 show a sample of the repair work.

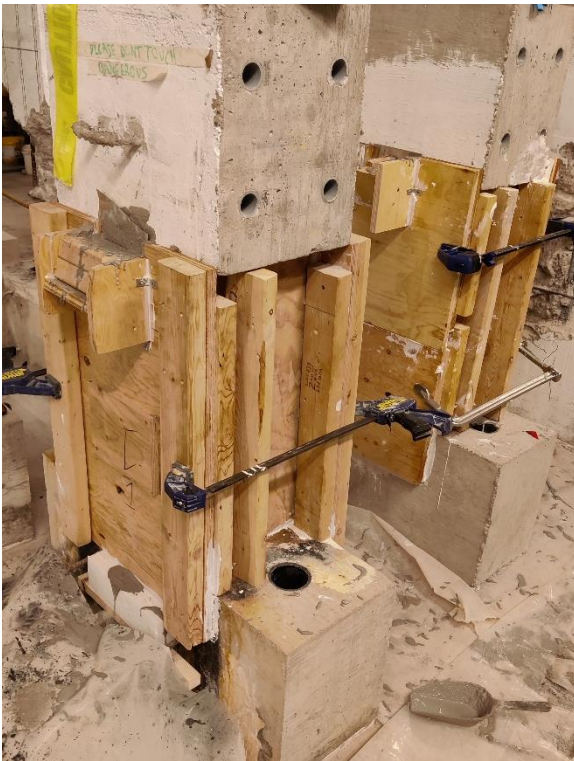
Figure 6-25. Sample of formwork used during the repair/strengthening process

available option. The exposed concrete was then blasted with pressurized air to remove any debris or dust. A special jacketing formwork was designed for the repair work with two slanted openings to facilitate pouring of the UHPC material into the thin layers of the cover over the entire length of the repaired region. Where the length of cover replacement was large, intermediate openings in the formwork were used for pouring at two levels; when the fluid concrete reached the level of the lower opening it was sealed and then pouring was continued from the upper opening. Figure 6-25 shows two formworks in use after casting UHPC.

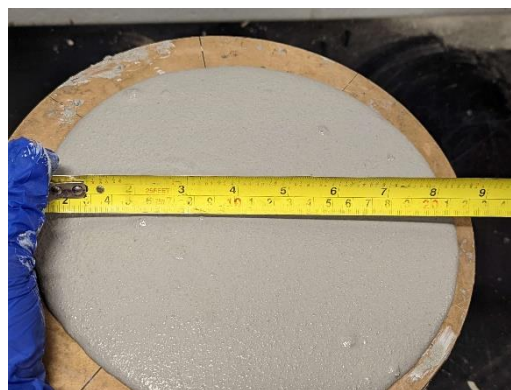
Figure 7-1. UHPC flow test

Concrete was provided by a ready-mix concrete producer with the specifications of having a 21 MPa 28-day compressive strength and a maximum aggregate size of 15mm. UHPC materials were cast in-house. The mix design of the prepackaged material is the same as described in Chapter 4: it consists of mixing 1 unit of mass of dry-mix Densit Inducast TT-5[®] with 0.13 units of water, and 0.066 units of mass of straight steel fibers (2% by volume steel fibers). Straight brass coated Dramix[®] were used having 13mm length and 0.2mm diameter. The material was very flowable with the 2 min spread reaching 210 mm as shown in Figure 7-1.

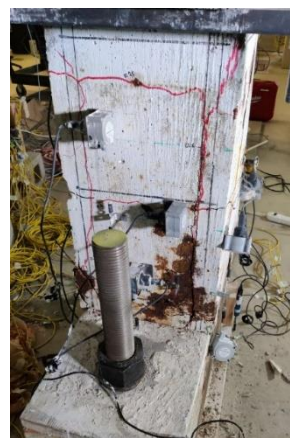
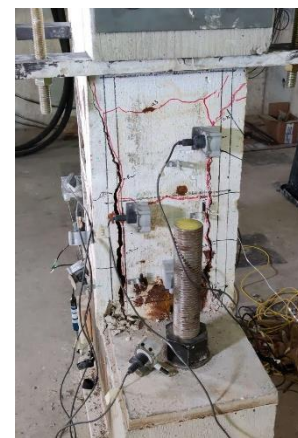
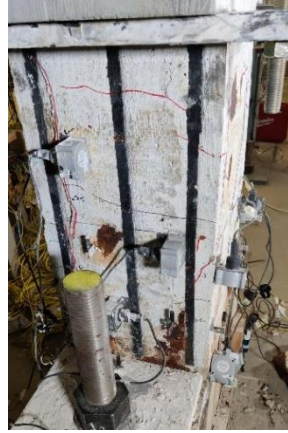
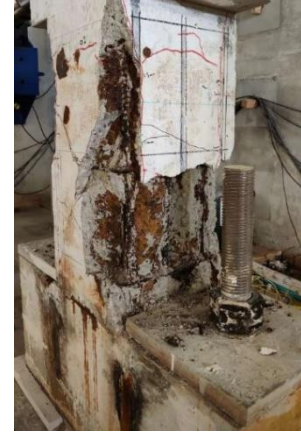
Figure 7-4. Final state of short concrete columns after testing.

Two failure modes were observed in both columns. One column side's failure was dominated by lap-splice (bond) failure, which was observed in the negative drift region of Figure 7-3 (column moving towards the strong wall), where a significant degradation in strength is observed with increasing drift level on one side of the column. The other side of the column experiences a shear failure, which is evident by the pinching of the hysteretic loops and is confirmed by the crack pattern on the column as is observed in Figure 7-4. The side views (left) of both S-25-Cor and S-20-Cor columns show the pre-existing longitudinal cracks caused by corrosion without a significant increase in crack width and that is because shear failure dominated the response when the column was pushed in that direction. Side views (right) on the other hand show significant increase in longitudinal crack width or total cover delamination due to bond failure.

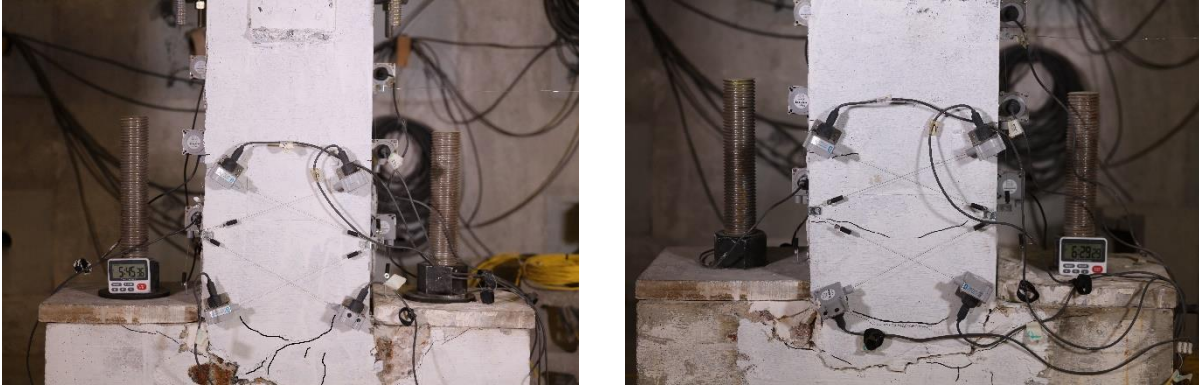
Figure 7-6. Final state of repaired columns after testing. S-20-Rep (left) and S-15-Rep (Right).

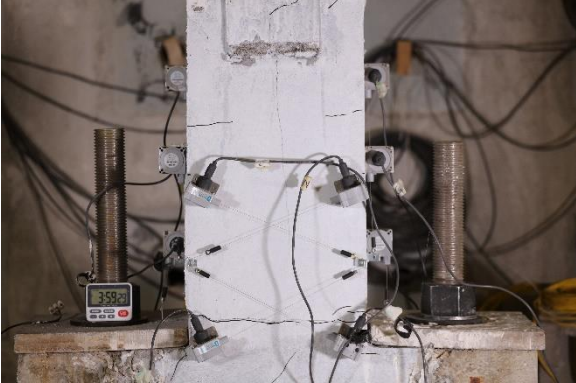
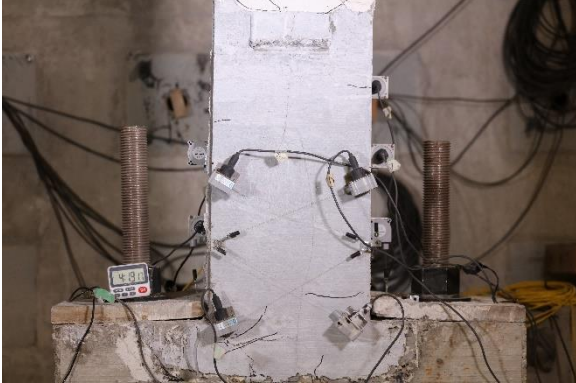
Figure 7-11. Final state of tall repaired and strengthened columns.

Figure 7-11 displays the final state of tall repaired and strengthened columns. Damage in the shear span was limited to hairline cracks whereas the footing experienced all the damage. Especially along the UHPC-Concrete interface.

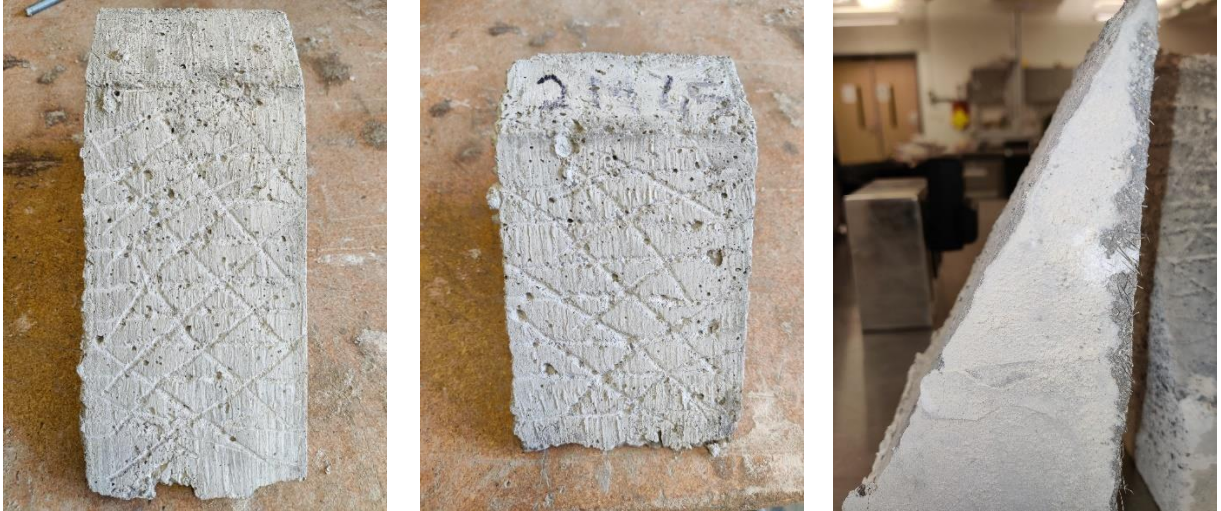
Figure 8-2. Interface surface prior to UHPC addition

To study the interaction at the interface, a series of slanted shear tests were conducted on specially fabricated prismatic specimens, which contained an interface plane at an angle with respect to the longitudinal axis of the prisms. Thus, each prism contained normal concrete in 50% of its volume. After casting normal concrete in the prismatic molds that were open at the top up to midheight, and while the concrete was fresh, the specimens were placed on shelves having three different inclinations to the horizontal plane so as to generate a free surface at an angle with the longitudinal axis. The concrete portions of the specimens were cured for 28 days. The free surface was then roughened with a maximum depth of 2mm as seen in Figure 8-2 and cleaned using pressurized air. Then the molds were filled with UHPC, this time standing on flat ground so that the free surface at the top of the mold would be horizontal and the resulting specimen would be a prism having cross sectional dimensions of 100 mm x 100 mm and a varying height depending on the angle of inclination of the interface. Prior to casting the UHPC, the roughened surfaces of the concrete were sprayed with water so as to increase the bonding strength between the two materials.

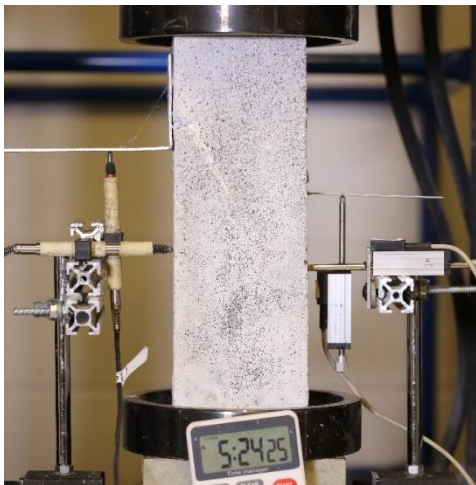
a) Slanted Shear Test

$$\tau = \frac{P}{A} \cos \theta \sin \theta \quad (8-2)$$

Where P is the applied load in KN, A is the cross sectional area of the specimen and theta is the angle between the inclined plane and the horizontal.

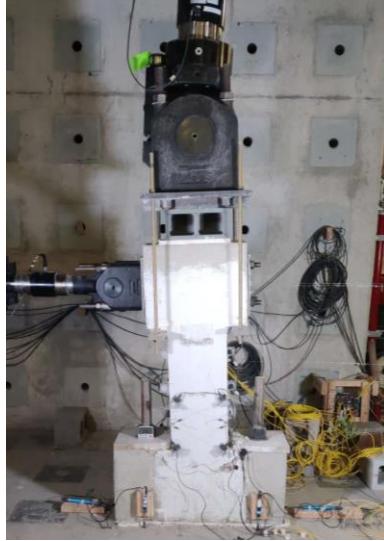
Figure 8-12. Test setup adopted in the experimental program

Resistance curves obtained from the finite element analysis are shown in Figure 8-13 and are compared with the experimental results that were presented in Chapter 7. The lateral resistance loads for both the experimental results and the numerical results were corrected to account for the P- Δ effect contributed by the applied axial load, so as to eliminate the phenomenological lateral degradation owing to second order effects and the lateral load contribution of the axial load. It is noted that second order effects occur both in the simulation and in the experiment, but they are not mutually equivalent. The values of the lateral resistance load calculated with the finite element model were corrected based on Equation 3-12, since the vertical load produces second order moments with respect to the column base, as it follows the top section of the cantilever model during lateral displacement. At the same time, and with the purpose of taking into account the second order effects on the experimentally tested columns, it was determined that the measured lateral resistance ought to be enhanced so as to account for an additional component contributed by the inclined piston which did not stay vertical during testing, but pivoted with respect to its point of attachment at its upper pin, as it followed the lateral displacement at the top of the cantilever specimen, as shown in Figure 8-12. Therefore, the experimental lateral resistance values were corrected according to Equation 8-4.

$$V_{res} = V_{exp} + P \cdot \theta \cdot \cos \theta + P \cdot \sin \theta \quad (8-4)$$

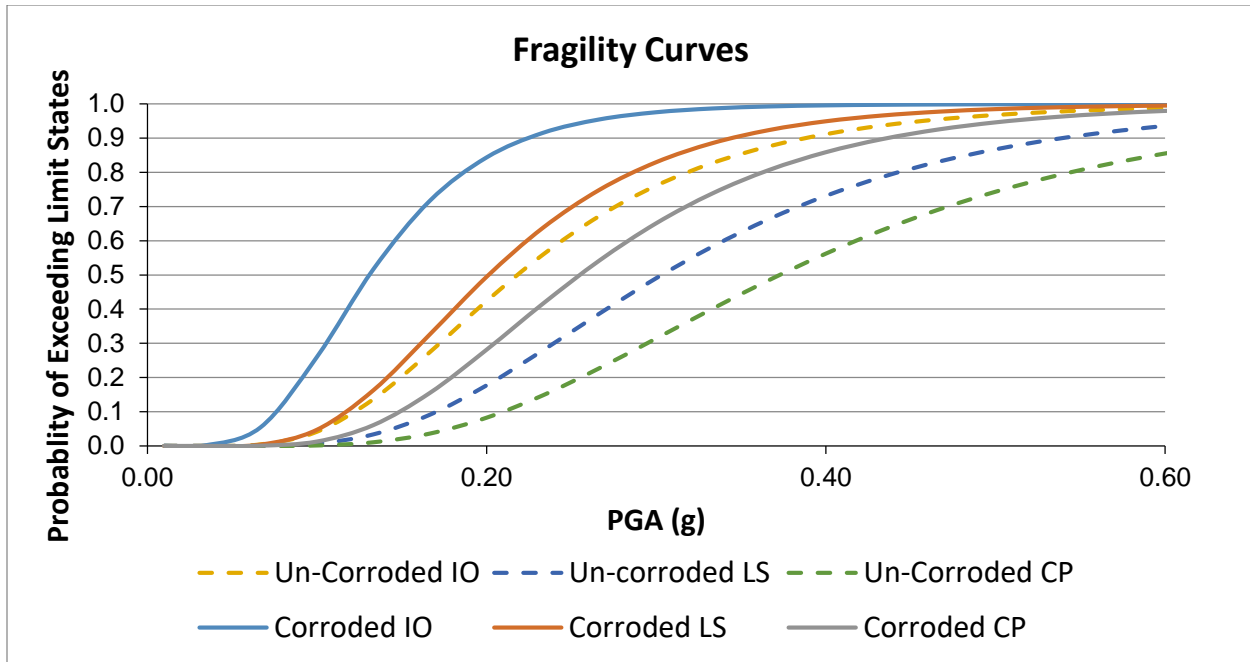
Figure 9-13. Fragility curves for the corroded (straight line) and un-corroded structure (dashed line) at the three limit states.
