Physical Model of Rainwater Along Roadway Filter Strip

PHYSICAL MODEL OF RAINWATER ALONG ROADWAY FILTER STRIP

A thesis submitted in partial fulfillment
of the requirements for the degree

Civil and Environmental Engineering

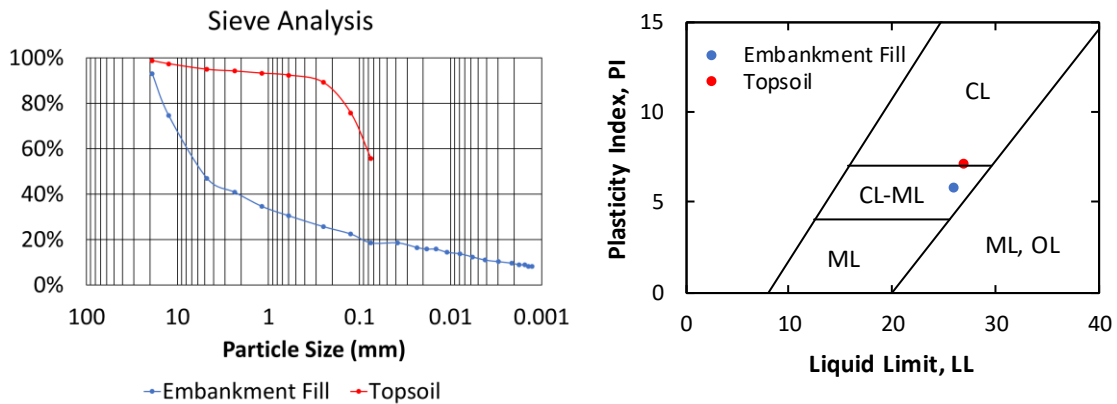
laboratory tests resulted in an AASHTO soil classification of A-4(0), LL = 27, PL = 20, PI = 7, with 9% clay. A summary of the embankment fill and topsoil properties are shown in Fig. 2.

Fig. 2. Embankment fill and topsoil gradations and Atterberg limits.

Tests were performed in a laboratory to determine the embankment material soil classification. Several gradation tests were performed on various samples of the embankment material in accordance with ASTM D2487-17. The LL, PL, PI, and clay fractions were found using ASTM D4318-17 and ASTM D7928-21. The laboratory tests resulted in an AASHTO soil classification of A-2-4(0), LL = 26, PL = 20, PI = 6, with 9% clay.

Tests were performed in a laboratory to determine the soil classification for the topsoil. A gradation test was performed on a sample of the topsoil in accordance with ASTM D2487-17. The LL, PL, and PI were found using ASTM D4318-17. The

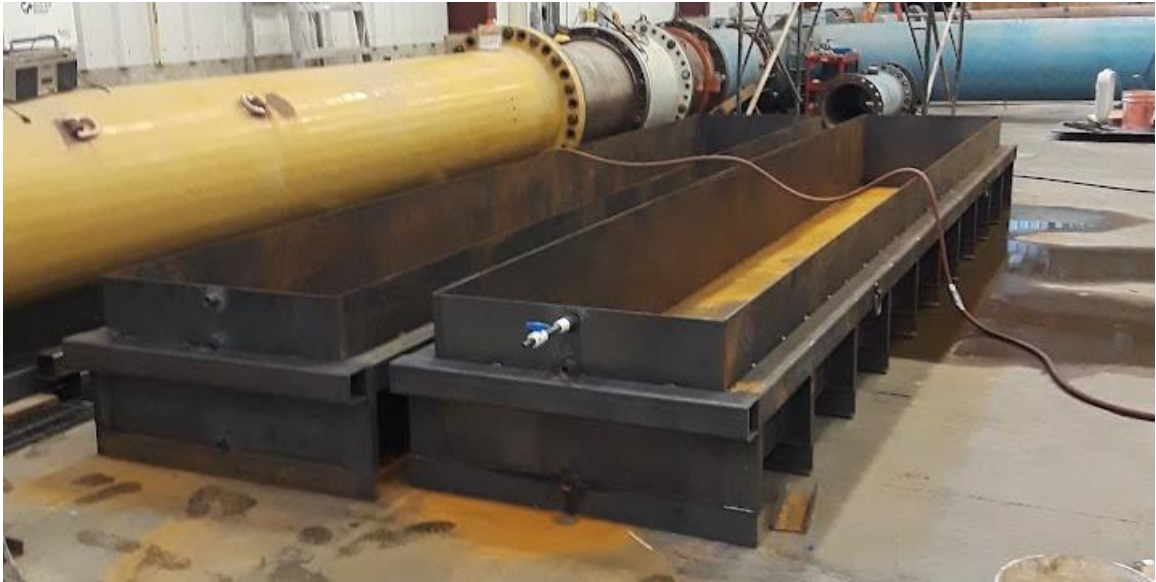
Holes with a $\frac{3}{4}$ -in. diameter were drilled at the toe of the apparatus to provide a place where runoff and infiltration data could be collected. Three holes were drilled to

provide data for surface runoff, infiltration through the topsoil, and infiltration through the entire embankment. This construction process was repeated to construct an additional testing apparatus (Fig. 4).

Fig. 4. Photo of completed apparatuses with installed drain.

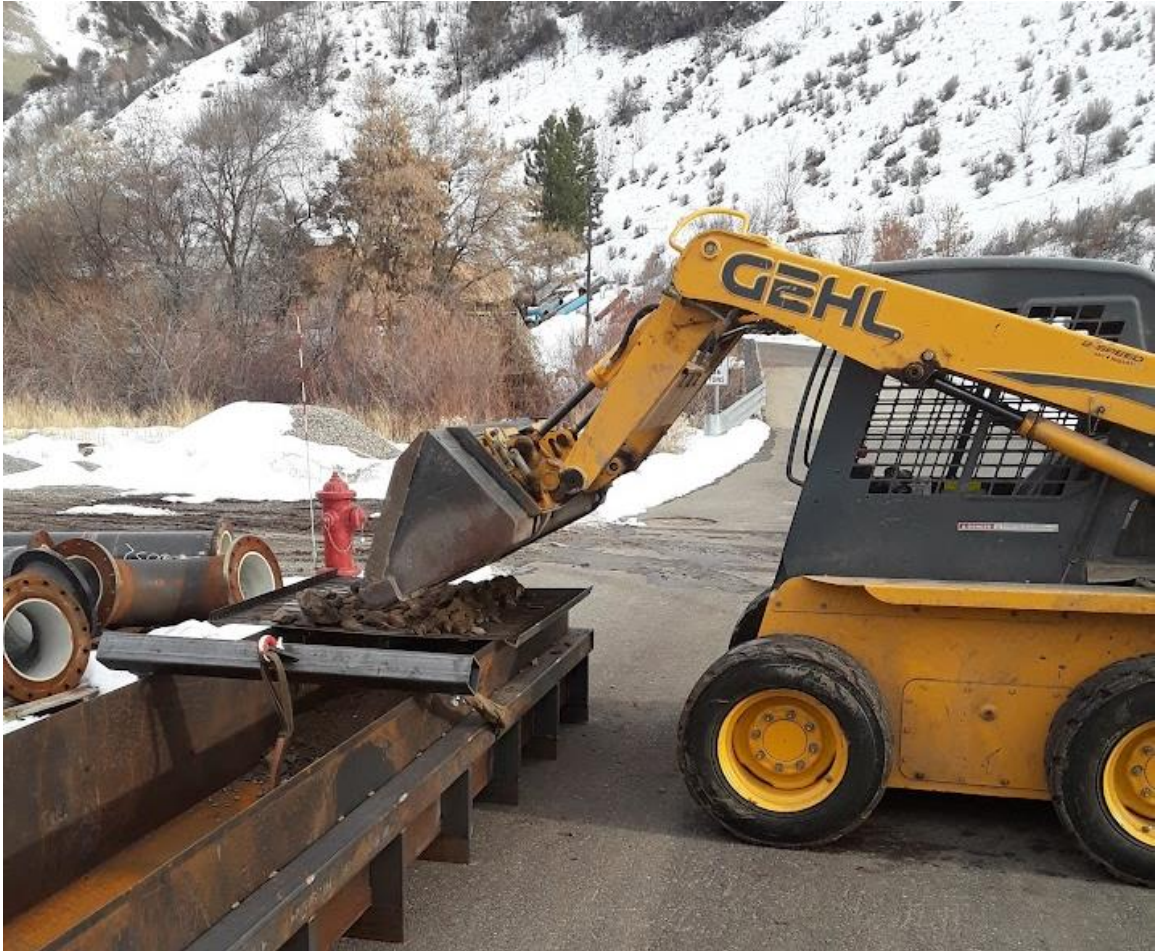
material was discarded. This process was repeated until there was approximated 8 in. of material in the apparatus.

Fig. 7. Sieving material into apparatus.

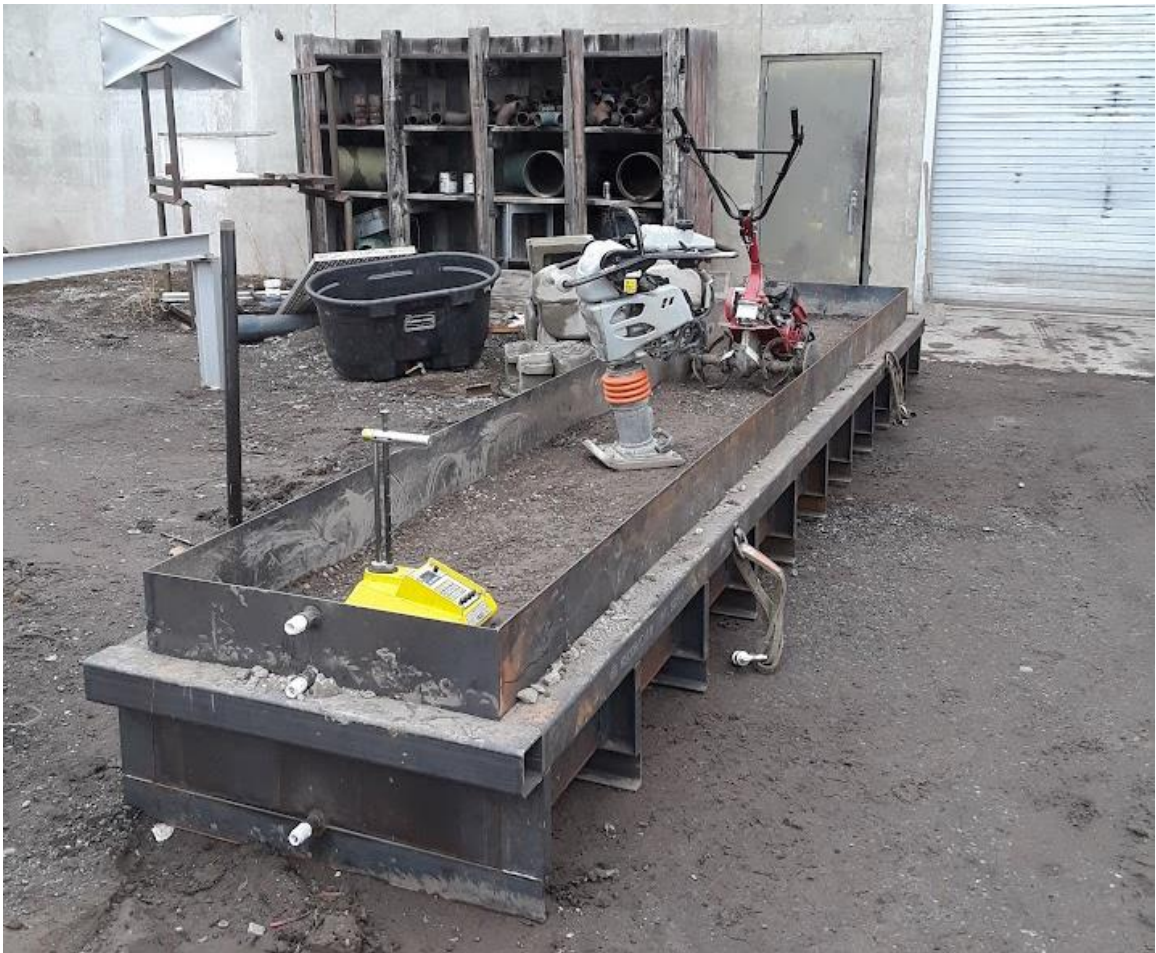
A modified proctor test (ASTM D1557-87) was performed and the results are given in section 3.1. Water was added to the loose 8 in. of soil and mixed using a rotary tiller to reach an optimum water content of 7%. Reaching the desired water content was estimated by feeling how well the soil compacted by hand and then by using engineering judgment. A jumping jack compactor was then used to compact the material to a relative density of 90% of the modified proctor.

A nuclear gauge was calibrated and used in accordance with ASTM D7759-18 and ASTM D6938-17. A surface density measurement was taken in three locations inside the apparatus to determine if the soil was uniformly compacted to a relative density of 90%. The soil surrounding the density measurement was compacted again if the results of the density measurement were too low (Fig. 8). This process was repeated for an additional two layers until the total soil depth was 19 in. Two carry deck cranes were used to lift the apparatus into the supporting frame.

Fig. 8. Compaction and testing of material in apparatus.

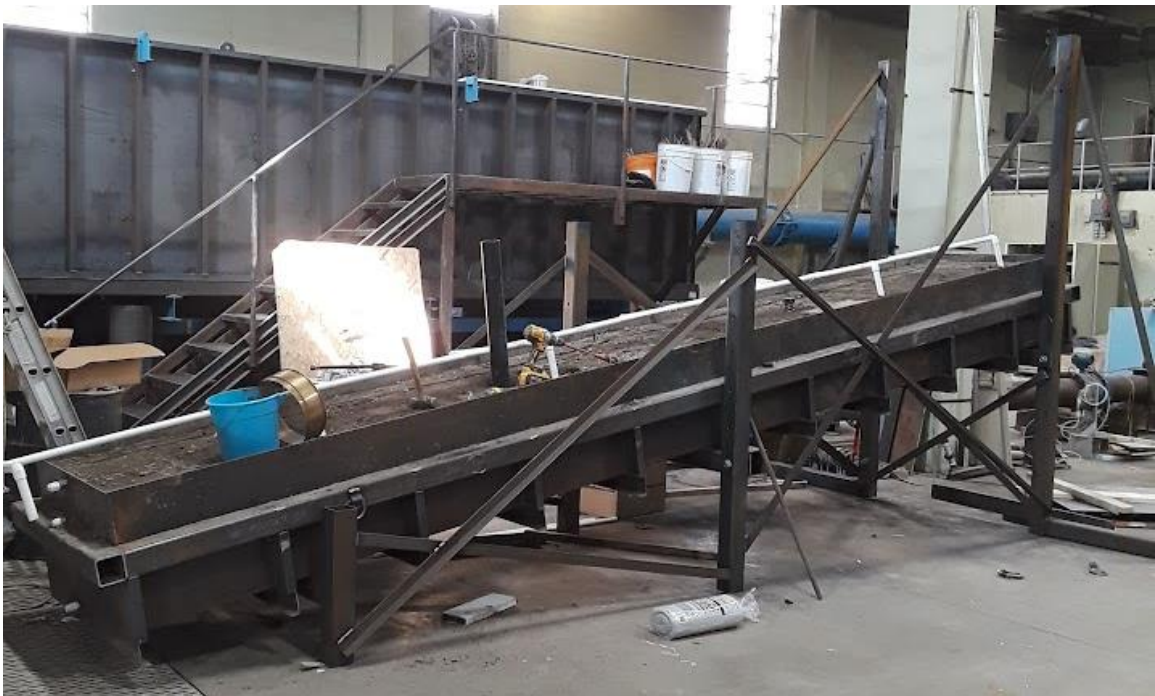
SoilVUE10 soil moisture sensors from Campbell Scientific with six sensor locations were then installed into the embankment fill (Fig. 9). The sensors measured permittivity, temperature, and electrical conductivity to calculate VWC. Special care was taken during the installation process of the sensors so that the sensor coils would not become damaged. A soil auger bit was used on a hand drill to drill a pilot hole. The hole would also be used for the soil sensor to be screwed into place. Due to the amount of gravel in the material, the pilot hole was larger than the soil sensor. The sensor could no longer be screwed in properly. Having voids around the sensor would provide inaccurate infiltration data.

Fig. 9. Apparatus on support structure and installation of soil moisture sensor.

Two soil moisture sensors were initially installed with 6 2/3-ft spacing. After a few tests were performed, another soil sensor was installed to provide more data. The three sensors were now spaced at 5-ft increments. The sensor protruded out of the ground 2 in. so measurements occurred at depths of 2, 6, 10, 14, and 18 in.

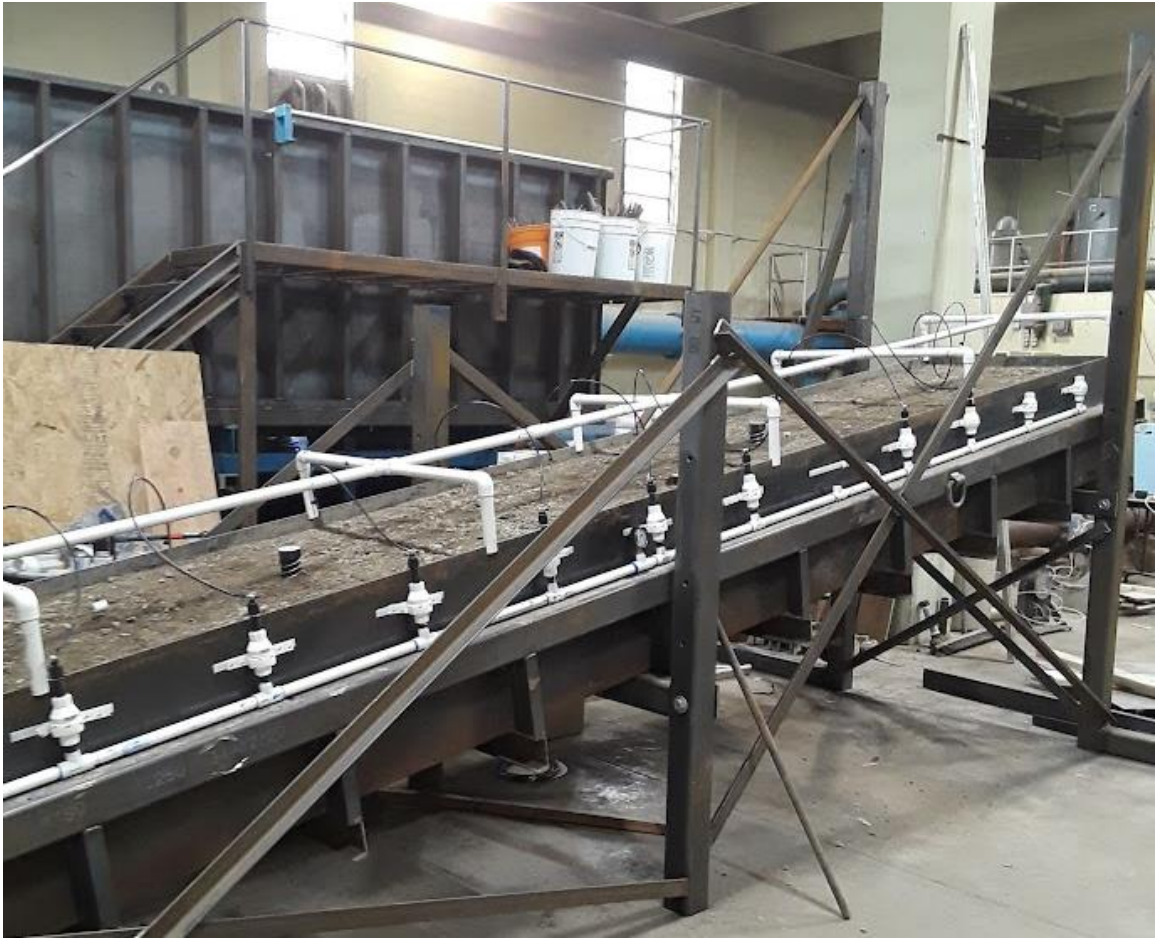
way valves was then connected to a primary pipe which led to the main water supply (Fig. 10). Pressure gauges and a pressure reducer were used because the main water supply had high pressures up to 80 psi. A solenoid valve was attached and programmed to automatically open and close the valve producing 7 seconds of spray every minute.

Fig. 10. Watering system pipe network.

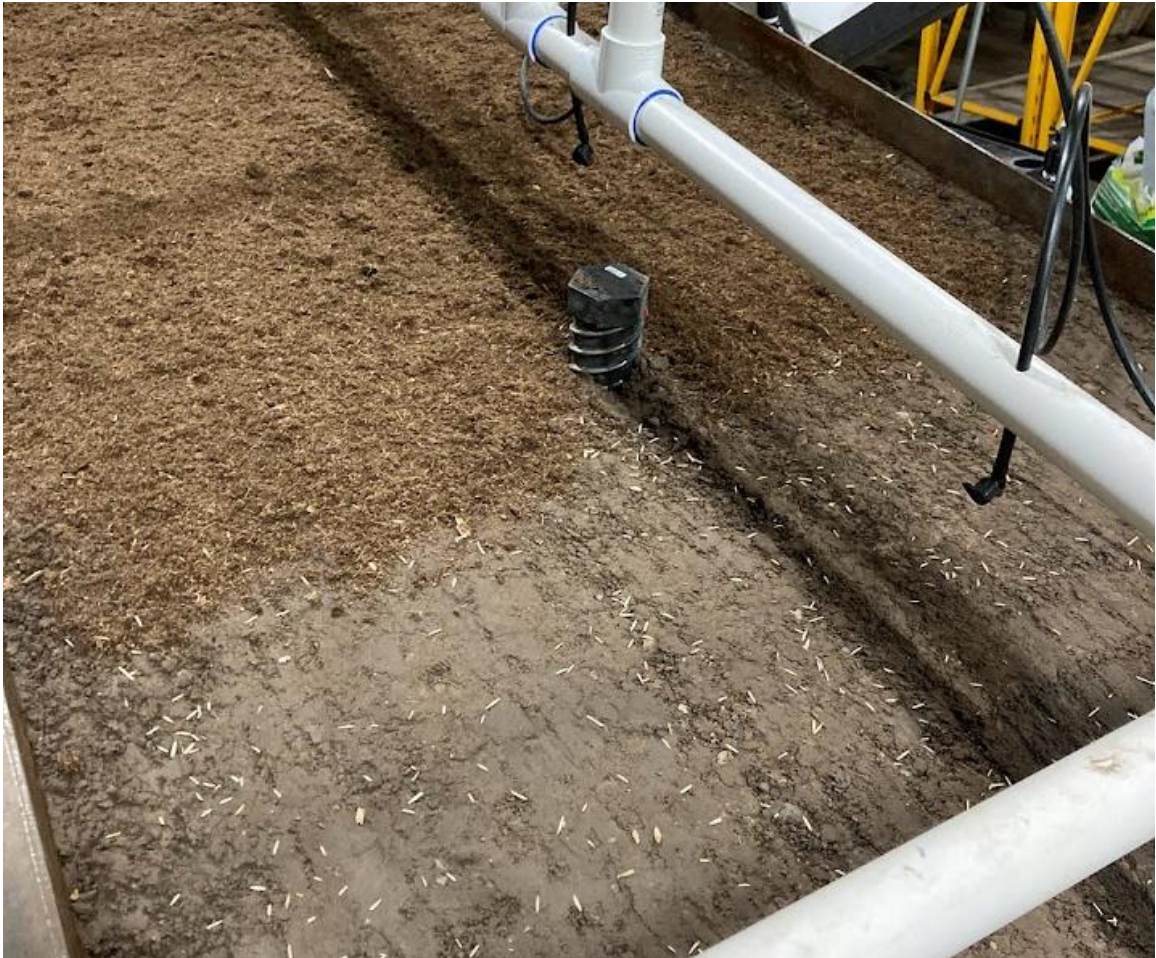
grams/ft² and the seed mix was measured with a digital scale to the appropriate weight. The seed mix was then evenly spread over the surface of the soil. A thin layer of peat moss was then spread over the seed mix to assist in the growth of the vegetation (Fig. 12).

Fig. 12. Application of seed mix and peat moss.

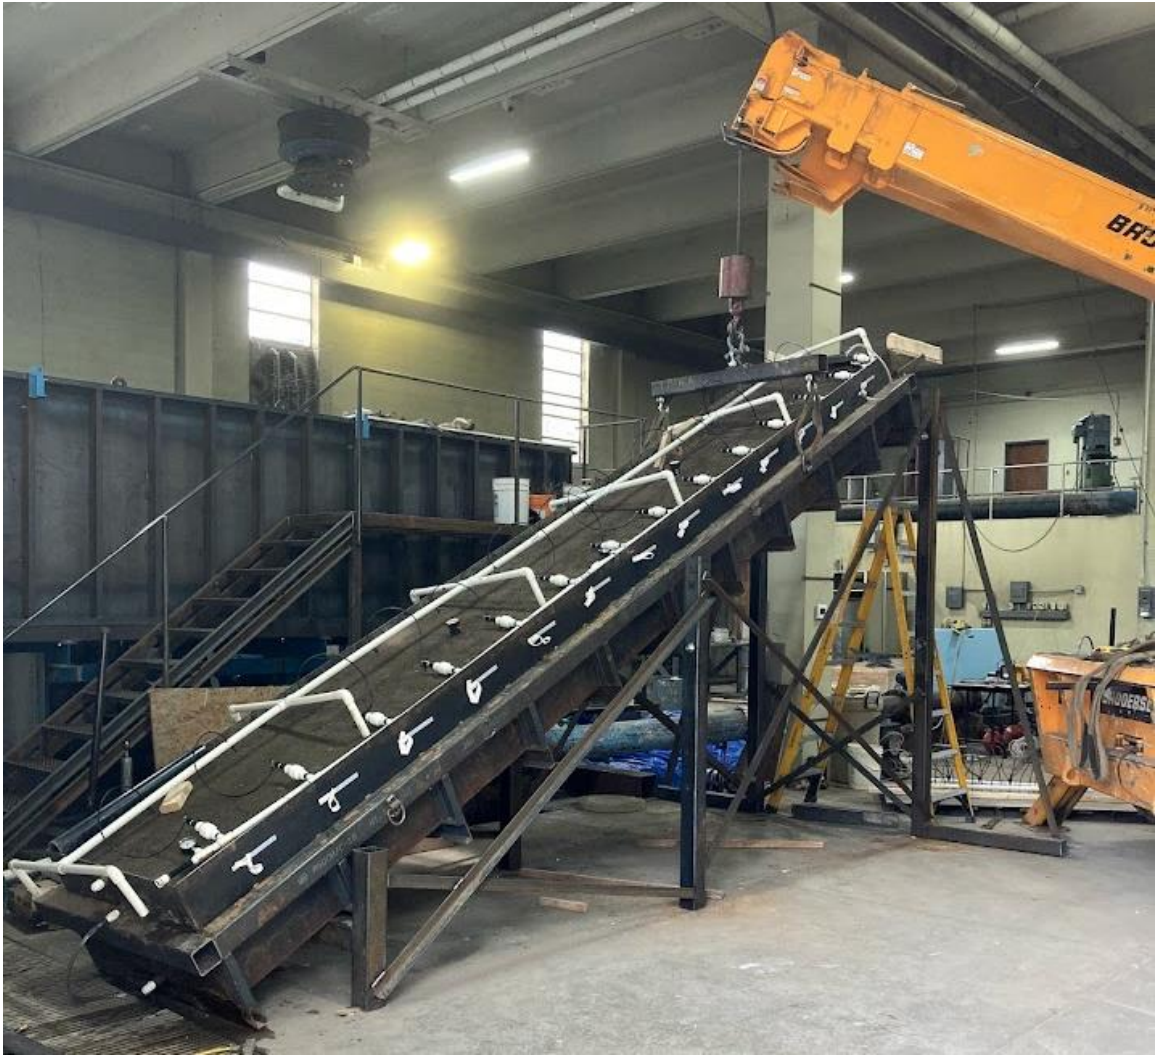
The first step taken prior to performing the next test was setting the testing apparatus to the correct inclinations. One carry deck crane was used to lift half of the testing apparatus (Fig. 13). The two cross beams on the support frame were unbolted, moved to the correct location, and bolted into the support frame legs. The testing apparatus was then carefully lowered onto the cross beams.

Fig. 13. Changing inclination of testing apparatus.

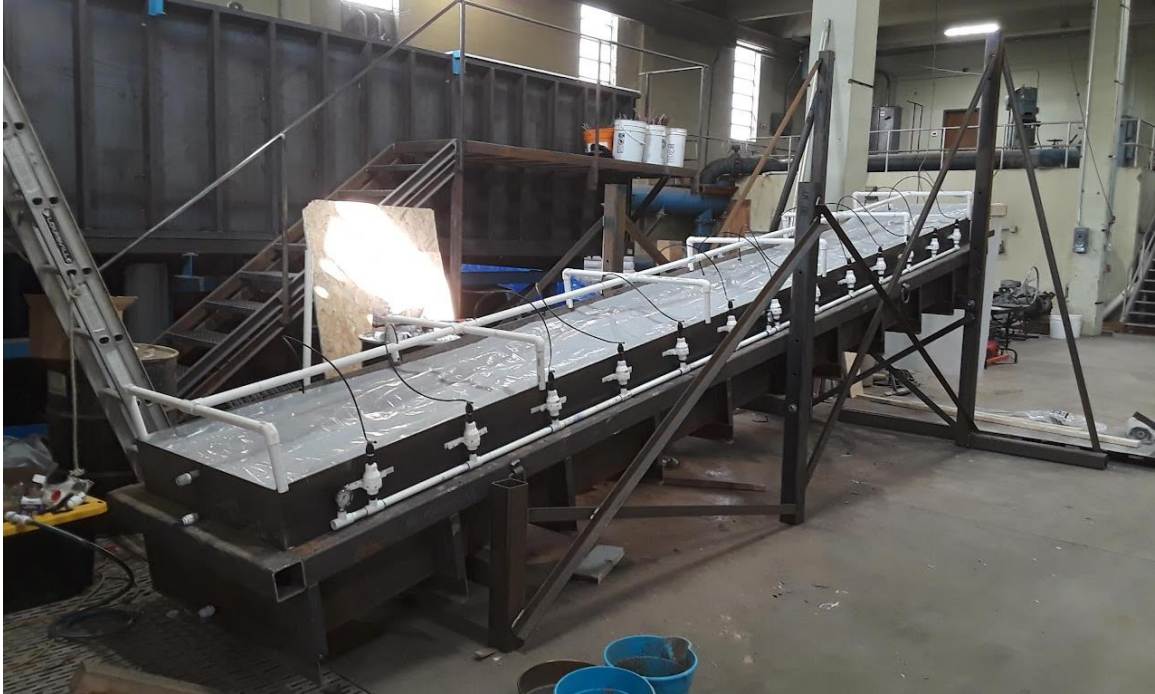
The cables were checked to make sure all connections were tight between the sensors and data logger. Preliminary data collection by the data logger was started to make sure all sensors were reporting data and that the solenoid worked properly. The main water was then connected to the sprinkler system. The testing surface and sheet flow area were then covered with a clear plastic to calibrate the sprinkler system (Fig. 14). Care was taken to make sure water was not added to the surface material during the calibration process. The water supply was then turned on and the calibration process began.

Fig. 14. Calibration of watering system.

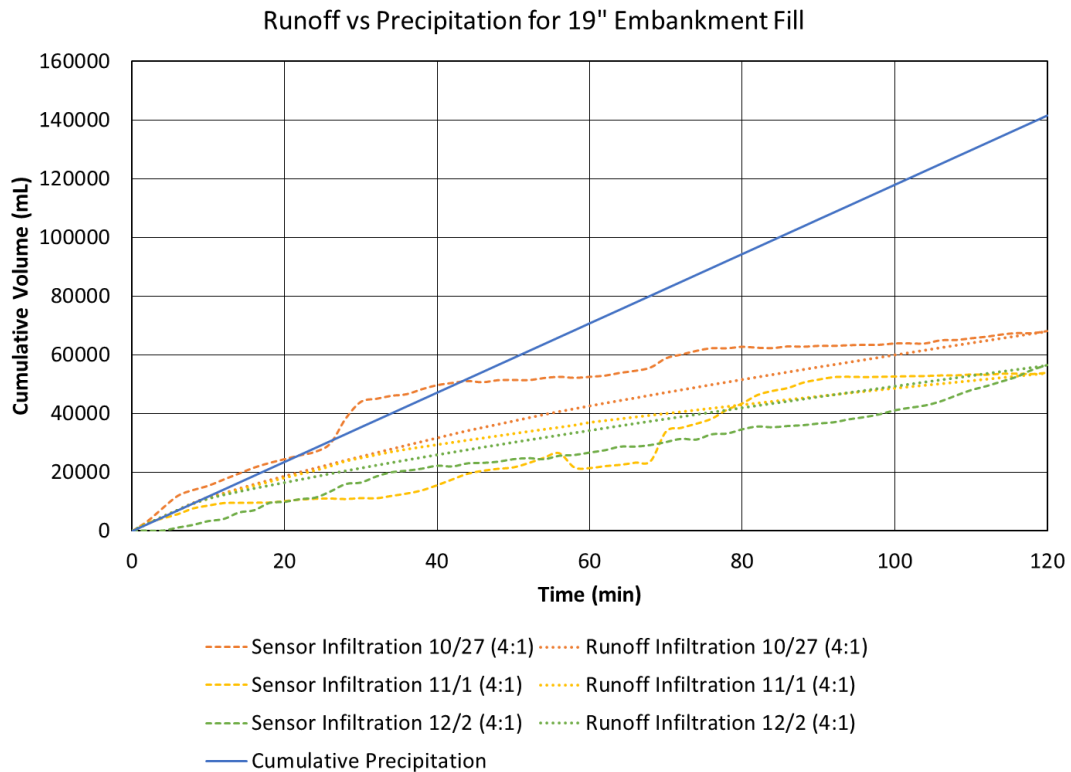
Fig. 18. Cumulative infiltration volumes vs time graph showing cumulative precipitation line, cumulative sensor infiltration, and cumulative runoff infiltration for three tests at a 4:1 slope on 19-in. of embankment fill.

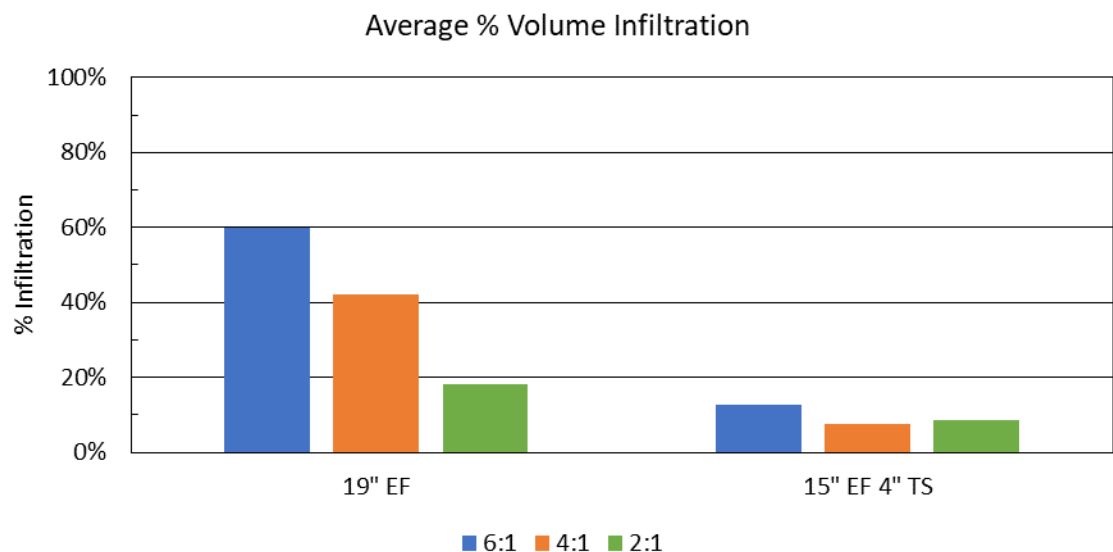
The topsoil configuration resulted in approximately a 70% average decrease in infiltration volume from the base configuration. The experiments were conducted several days apart to allow time for the topsoil to reach an equilibrium VWC. The equilibrium VWC was approximately 5% below the VWC at which the topsoil would stop infiltrating water and the stormwater became runoff. Only 8-13% of the entire storm event was infiltrated with the use of just topsoil. The inclination had very little effect on the amount of infiltration. The addition of the topsoil material was only beneficial for the first rainstorm event. The further storm events resulted in large amounts of runoff.

Fig. 22. Infiltration comparison of embankment fill only and embankment fill with 4 in. of topsoil.

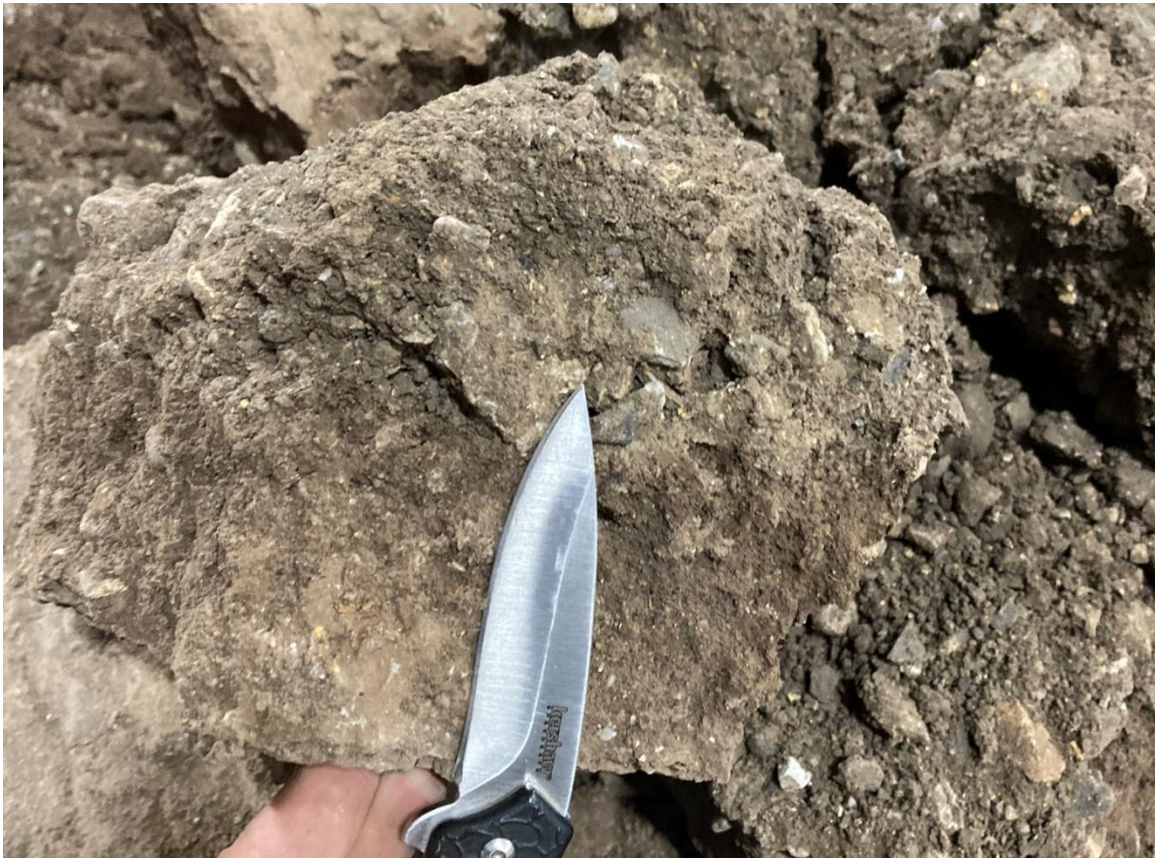
allowed for the topsoil to get into the voids of the loose material. This mixing could be seen when the topsoil was removed at the conclusion of the experiments (Fig. 26). The cohesive topsoil created a bond to the loose embankment material. This mixing allowed for the groundwater to flow through the topsoil and into deeper parts of the embankment material.

Fig. 26. Photo of topsoil and embankment fill bonding.

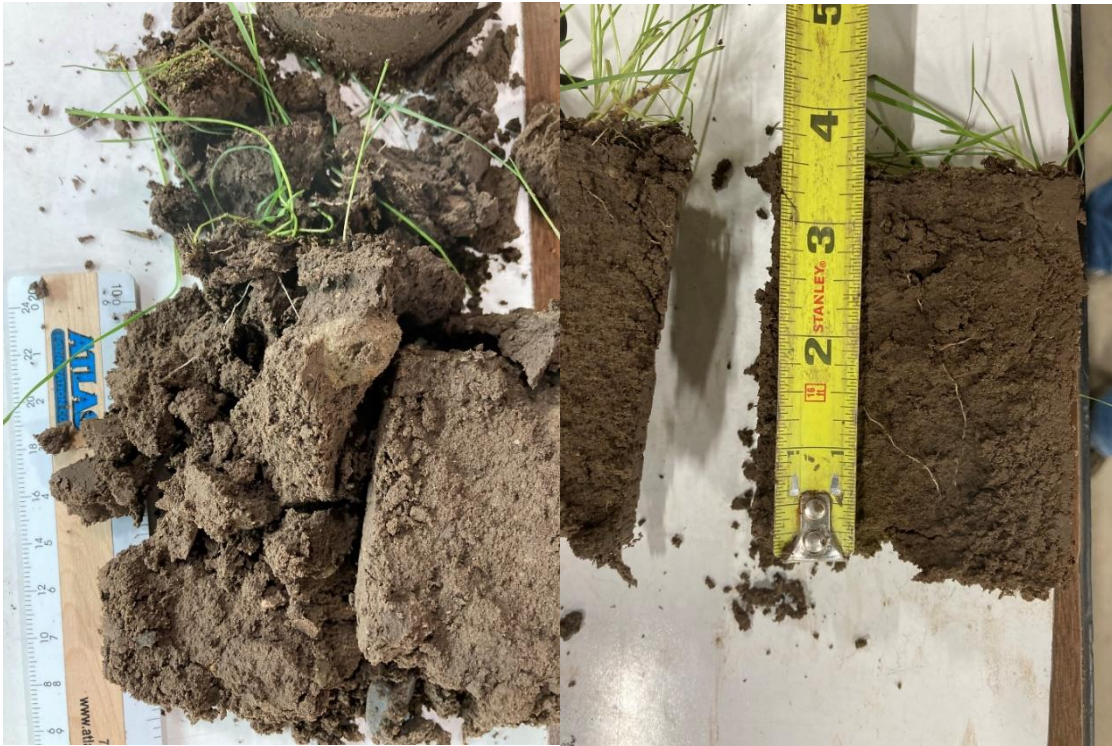
Fig. 29. Root growth through the topsoil before (left) and after (right) testing.

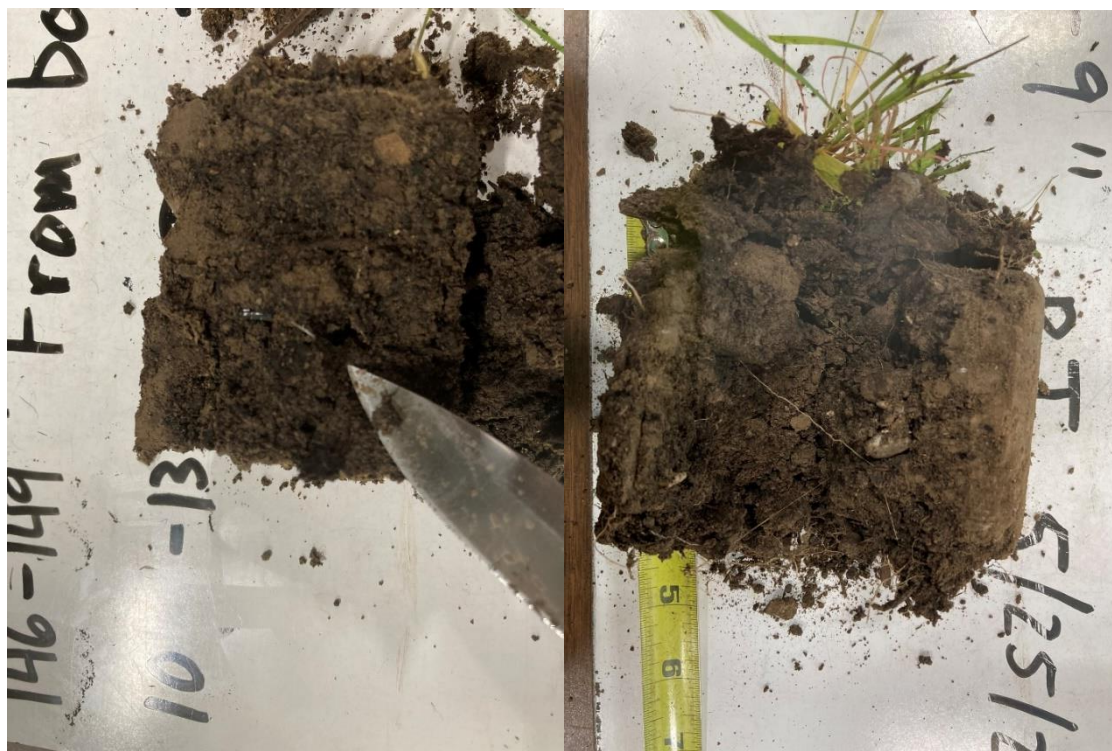
**Fig. 30.** Root growth through the amended topsoil before (left) and after (right) testing.
