## Evaluation of the leakage origin in Abu Baara earthen dam using electrical resistivity tomography, northwestern Syria

W. Al-Fares and J. Asfahani\*

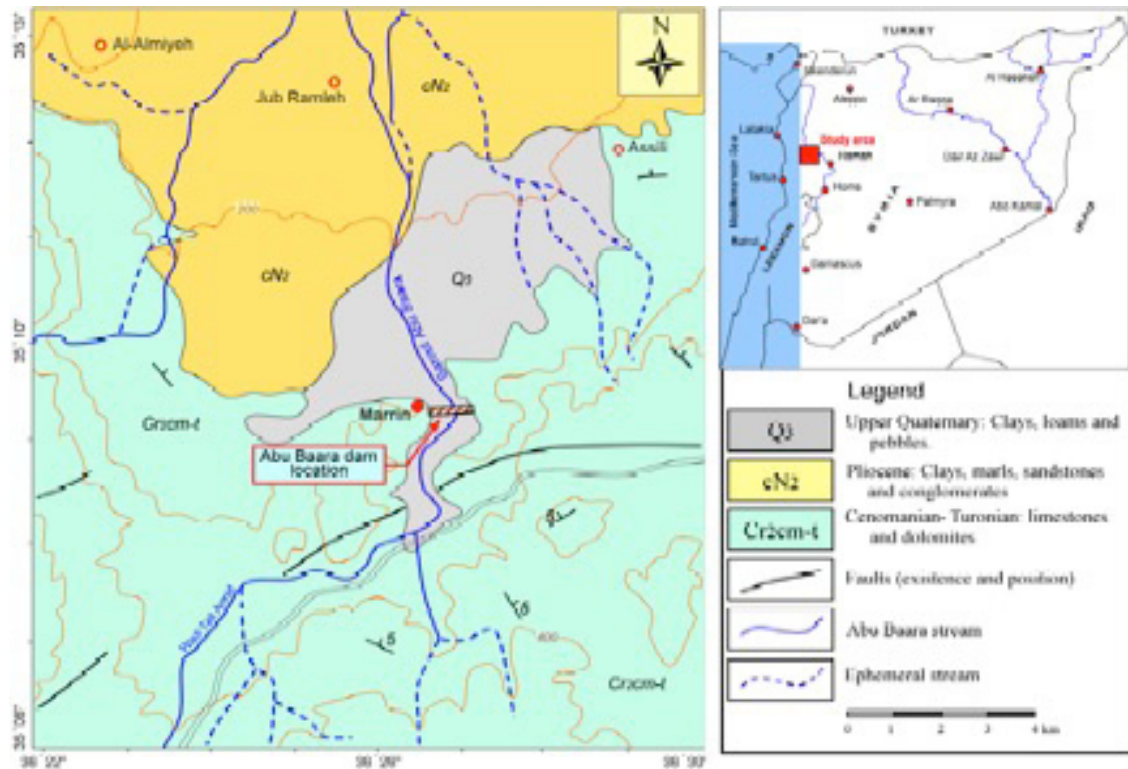
**Figure 1.** Simplified geological map of the study area showing the location of AbuBaara earth dam (modified after Ponikarov, 1963).

Abu Baara dam is situated at the southern margins of Al-Ghab plain depression, 30 km west of Hama city (Figure 1). The depression of Al-Ghab is developed by the effect of the tectonic evolution along the northern parts of the Dead Sea Fault System (DSFS) in the northwestern part of Syria. This depression forms a plain region suitable for agriculture due to the suitable climate conditions, fertile lands and reasonable average rainfall (700 mm/y). The flanks of the depression are clearly limited by faults with series of blocks and scarps (Devyatkin *et al.*, 1997; Brew, 2001; Gomez *et al.*, 2006; Hamade and Tabet, 2013).

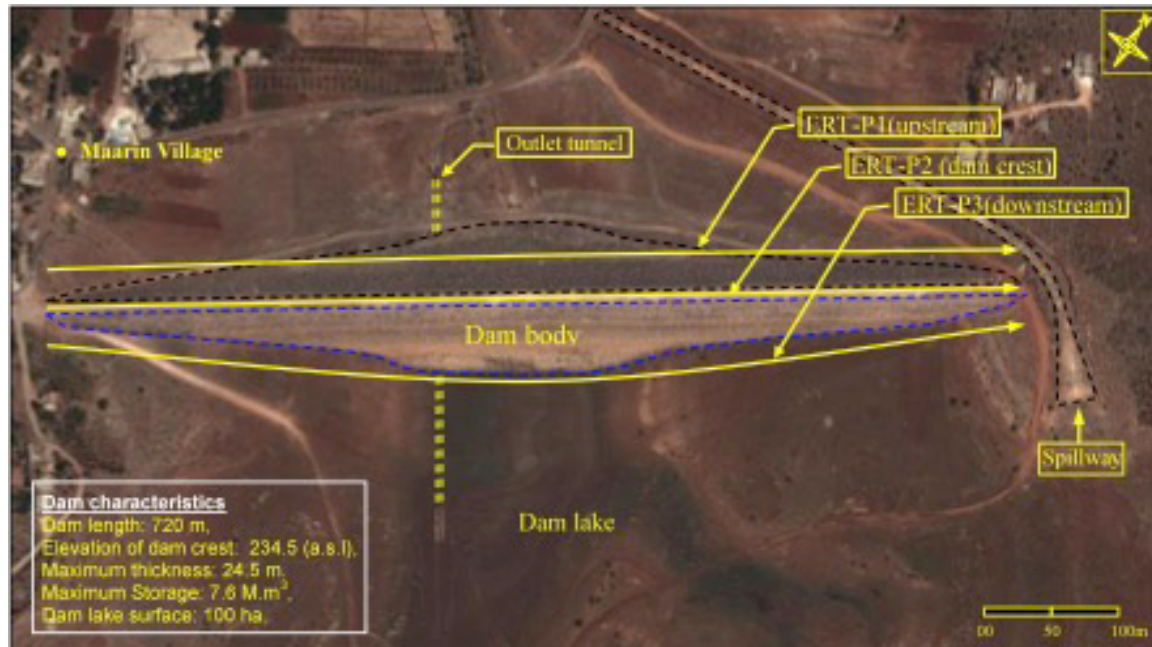
**Figure 2.** Locations of the ERT profiles carried out in Abu Baara earthen dam (Google Earth).

Three ERT profiles of 715m length for each one were executed in Abu Baara dam site (Figure 2): the first one was in upstream side (behind the dam body), the second at the top of the dam's crest and the third in downstream side. These profiles are straight and parallel to the dam body. It is worth mentioning that the field measurements of the ERT profiles were carried out through the summer season where the dam's lake was dry and completely empty of water. Additionally, a topographical survey was also carried out for each profile using a GPS device with UTM projection.

The ERT-P1 profile was carried out in upstream side at a distance of 10m from the dam body (Figure 2). The profile starts from the western edge of the embankment to end up at the eastern edge traversing a distance of 715m. Figure 5. shows the inverted ERT-P1 geoelectrical section, which can be divided into three principal distinguished blocks:

The ERT-P3 is implemented in the downstream side adjacent to the dam body (Figure 2). This profile extends as the other profile along 715m of length with inter-electrode spacing of 5m. A topographic survey was performed for the natural ground surface of the lake along the profile. Figure 9 shows the interpretation of the geolectrical ERT-P3 section, which seems to be structurally similar to the ERT-P1 section. It can be therefore also divided into three main blocks differentiated horizontally:

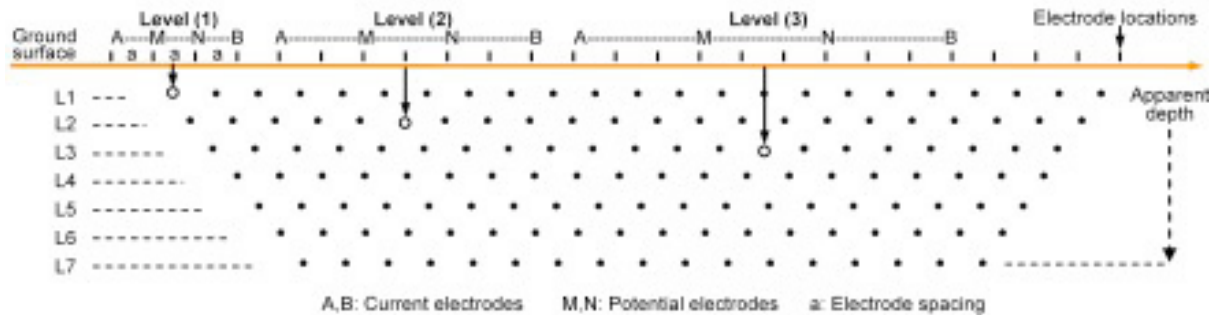
**Figure 3.** Electrical resistivity tomography configuration. Increasing the distances between current electrodes implies a deep penetration depth.

of potential electrodes M and N, as shown in Figure 3. on the ground surface with a current applied through a pair of current electrodes A and B. The apparent resistivity  $\rho_a$  in Ohm.m ( $\Omega.m$ ) is then computed from Ohm's law:

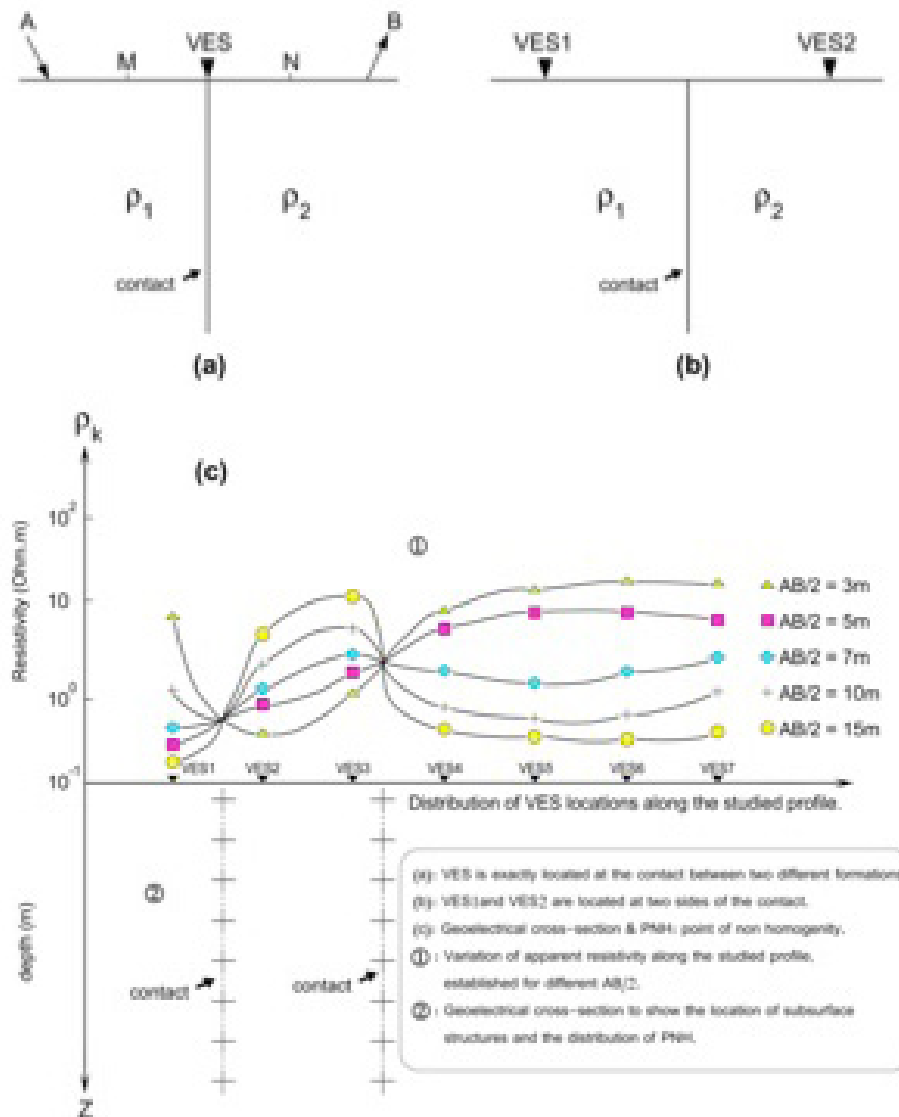
**Figure 4.** Principal of Pichgin and Habibullaev technique (modified after Asfahani, 2011).

The theory behind the Pichgin–Habibullaev technique can be summarized as follows: Suppose two vertical electrical soundings, VES1 and VES2 are performed on either side of a vertical contact. For every given current electrode half-spacing ( $AB/2$ ), all the resistivity profile curves will be intersected at a point located directly over this vertical contact. The locations of the vertical electrical soundings carried out on a given profile are therefore plotted on the abscissa, and the corresponding measured apparent resistivities for each given  $AB/2$  are plotted on the ordinate, as shown in Figure 4.

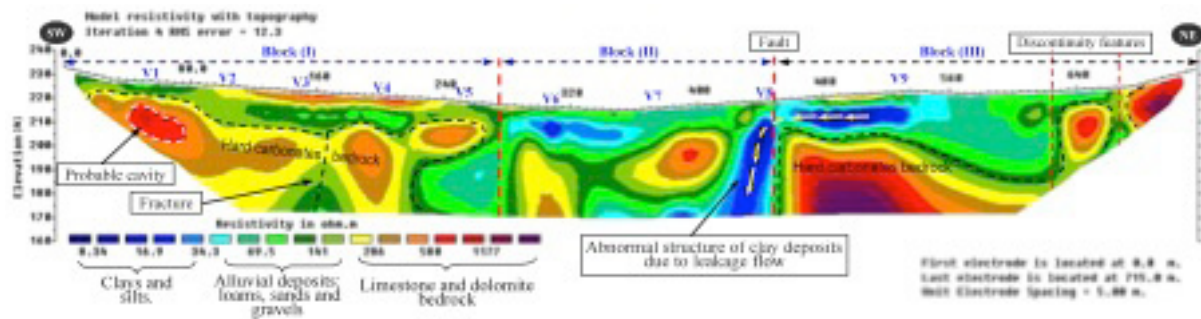
The first block runs from the beginning of the ERT-P1 section to the distance of 280m. This block includes a subsurface layer, of 10m thickness in average, which corresponds to the Quaternary alluvial deposits ( $Q_3$ ), composed of loams, sands and gravels. The electrical resistivity values of these formations are ranging between 50 and  $200\Omega m$ . The alluvial deposits overlay a layer of hard limestone and dolomite Cenomanian-Touronian ( $Cr_2cm-t$ ) rocks. These rocks are characterized by an irregular feature due to fractures and cracks, which makes them heterogeneous chromatically in the geoelectrical section. The limestone and dolomite rocks have resistivity values of more than  $1100\Omega m$ . These rocks constitute the main hard bedrocks of the dam lake. Otherwise, a distinctive resistive anomaly was noticed between the distance interval 60 and 80m of the ERT-P1 section (Figure 5). This anomaly is distinguished by a high electrical resistivity value (up  $1200\Omega m$ ), which most likely could be associated with probable karstic cavity developed within the limestones bedrock. Evidently, the presence of a possible cavity constitutes a suitable potential pathway for water leakage occurrence, especially when the water storage reaches high levels in the lake.

**Figure 5.** Inverted geolectrical section of the ERT-P1 profile carried out behind the dambody (upstream site), V: locations of VES.

section. This zone seems well matched with the course of the main valley behind the dam body. The alluvial deposits are prevailing in this part of profile and filling the valley with exception the existence of two big scattered masses of limestones. The right boundary of this block (at the point 440m) is determined by a vertical hard rocks edge. This almost could be related to the occurrence of a tectonic event such as a fault struck the main valley. Moreover, a distinct anomaly of clay was identified adjacent to the mentioned vertical edge; this abnormal structure may due to a vertical groundwater flow towards the deeper formations. This finding may indicate the existence of hydraulic connection between the shallow and the deep geologic formation. It is obvious that significant leakage most likely occurs through this sector along the tectonic contact zone between the alluvium and the limestones rocks.

The third block extends from the point of 440m to the end of the geolectrical section (Figure 5). The alluvial deposits thickness ranges between 10 to 20m, with resistivity values reach  $150\Omega\text{m}$ . Those deposits overlay the resistive hard limestones bedrock (more than  $1100\Omega\text{m}$ ). A discontinuity features were observed in two locations at the end of the profile (at 630 and 670m), these features are corresponding to fractures in the limestones and dolomites rocks. These discontinuities in the bedrock form additional possible pathways for water leakage from the dam's lake.

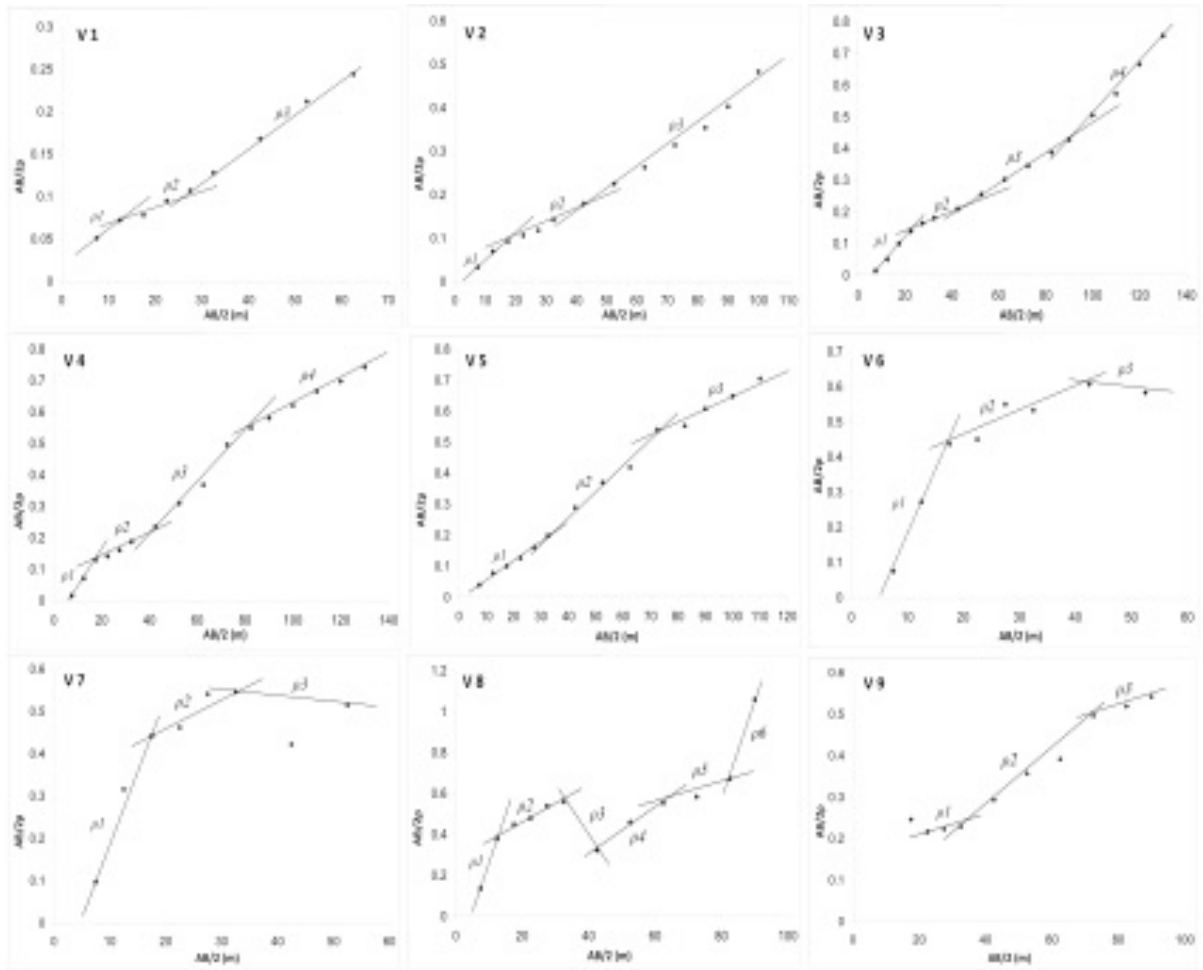
Inverse slope method *ISM* with adapting 1D assumption has been applied in this research for interpreting the nine Schlumberger VES distributed along P1 as shown in Figure 6. True thicknesses and resistivities for the corresponding layers under the study profile P1 have been obtained as shown in Table 1.

The most important remark observed while interpreting those nine VES is the presence of negative slopes, indicating high resistivity values in the studied P1 section. Those high values clearly reflect the hard limestone and dolomite rocks existed in the study region (Ponikarov, 1963). The advantages of applying *ISM* is that it easily distinguishes between the different layers under the study VES. The low resistivity values are attributed to the Quaternary alluvial deposits, while the high ones are attributed to the Cretaceous hard limestone and dolomitic rocks. The *ISM* results obtained confirm well those obtained by the ERT measurements and discussed above, particularly the low and high resistivity distributions.

**Figure 6.** Quantitative 1D interpretation results of nine VES measurements carried out along ERT-P1 profile obtained by ISM.

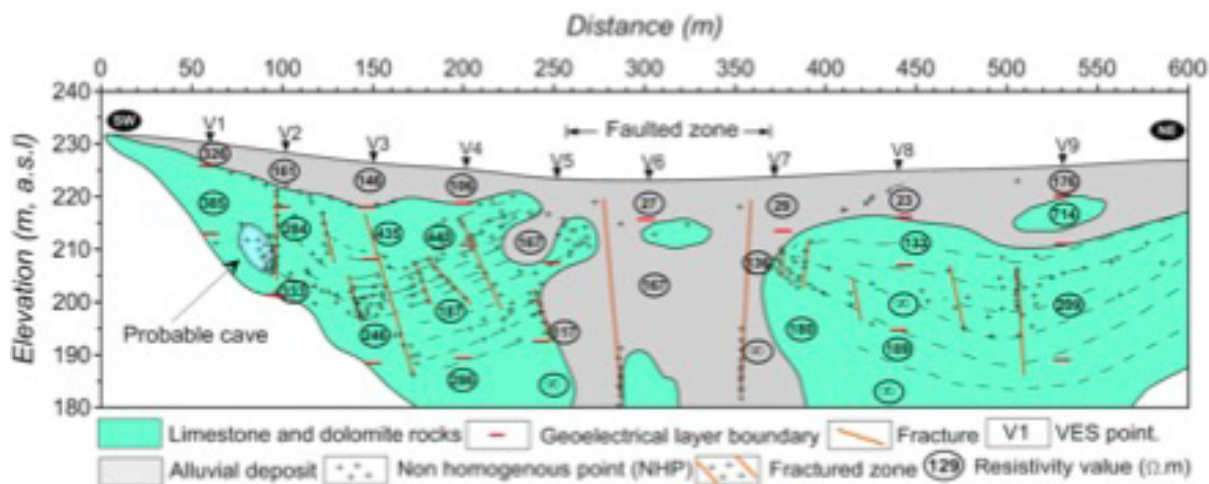
The same nine VES distributed along profile P1 have been interpreted by Pichgin and Habibullaev technique explained above. The geometry distribution of the Non Homogeneous Points (NHP) in the 2D (X-Z) section shown in Figure 7 clearly indicates the presence of three main blocks. The central one of more than 150 m wide could be related to a faulted zone, representing the main alluvial valley. The two other right and left blocks are related to the Cenomanian-Turonian limestone and dolomitic rocks. At a detailed level, the NHP clearly show a basal structure, and the positions of the fractured zones in those two blocks. Their locations are the main leakage points in the study dam under profile P1. It is worth mentioning that the results obtained by interpreting VES data using Pichgin and Habibullaev technique confirm well those obtained by ERT measurements along Profile P1.

**Figure 7.** Quantitative interpretation of VES data carried out along ERT-P1 profile by using Pichgin and Habibullaev technique.

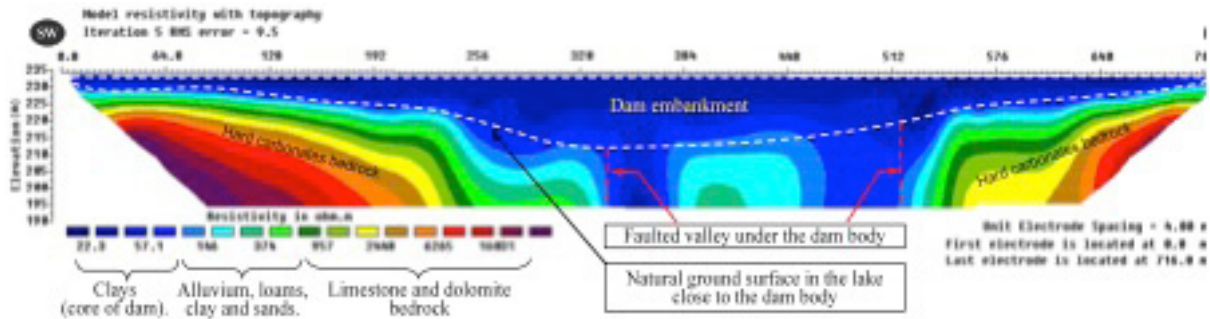
profile (Figure 2). This ERT profile, located on the top of dam body, has been carried out by using an electrical driller to dig holes, 4m apart, in the hard asphaltic layer to facilitate the electrodes plantation. The planted electrodes were wetted with salty water and some clay added to ensure a good contact with the underlying soil and to reduce the noise. This profile has length of 716m and 234.5m above sea level (a.s.l) as a constant topographic elevation. Figure 8 shows the inverted geolectrical section of the ERT-P2 profile, where two main zones can be vertically distinguished; the first zone is directly related to the clayey core of the dam body, marked by clear blue color in Figure 4. The white dotted line represents the lower boundaries of the dam body with the original land surface of the lake. The resistivity values of this zone range between 20 and 50  $\Omega$ m and the thickness increase towards the main valley to reach 25m. The clayey core of the dam seems to be intact and structurally homogeneous and the lower boundaries are clear and distinct especially at the contact with the underlying bedrocks. The second zone of the ERT-P2 section represents the hard limestones and dolomites bedrock. The general structural of this zone is similar to the ERT-P1 structure. It is consisting of two units of massive carbonates rocks separated by the main valley: the first unit extends from the beginning of the geolectrical section until the point 320, while the second starts from the point 512 to the end of the section. Both units are well differentiated and characterized by high resistivity values.

The central part of the second zone extends along the distance between 320 and 512m, this part corresponds to the main valley course

underneath the dam body. It is believed that the absence of hard bedrock at this part of section could be attributed to dissolution processes of the carbonates rocks by the influence of the water flowing stream, or probably related to tectonic activities such as faults leading to the formation of a subsidence faulted structure filled up later by alluvial deposits (Figure 8). The absence of the bedrock under the central part of the dam body could pose problems in future related to the safety and stability of the dam, particularly when the water reaches high levels during the rainy seasons. Many cracks covering the top of the dam were observed during the fieldwork in the asphaltic layer. This seems to be a negative indicator and must be taken into consideration through the implementation of a permanent monitoring program in order to prevent probable failure of the dam. It is consequently believed that most of the vertical leakage occur through this sector at the contact between alluvial deposits and the hard limestones rocks.

**Figure 8.** Inverted geoelectrical section of the ERT-P2 profile carried out at the top of the dam body.

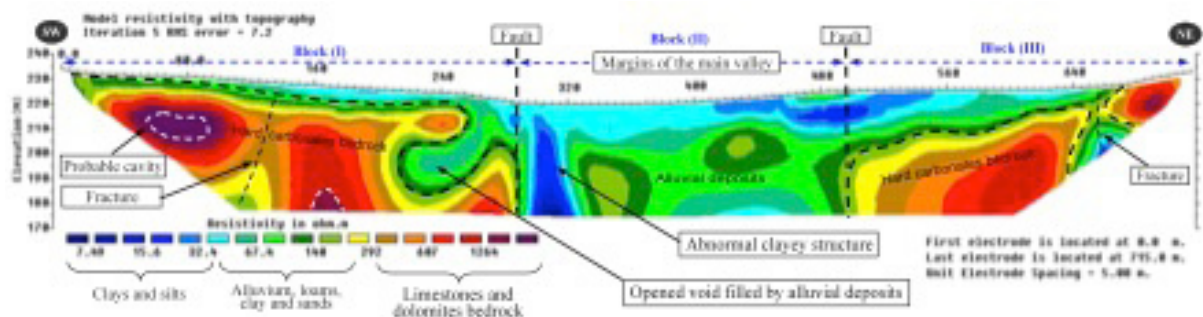
The first and third blocks are interpreted together because they are composed of the same formations. The first block extends from the beginning of the section to a distance of 300m, while the second one starts from 500m to the end of ERT section. The two blocks include a surface layer of alluvial deposits (Q3). The thickness of these deposits ranges between 1 to 5m in the block(I), and reaches 20m at the third block, since it increases towards the main valley. The resistivity values of these deposits vary as mentioned above from 40 to 150Ωm. The alluvial layer covers the bedrock of the hard limestones, which are characterized by high resistivity values (300-1200Ωm), as shown in the geoelectrical section. The bedrocks are dipping about 7° (block I) and 15° (block II) towards the main valley. On the other hand, a resistive anomaly is observed between the interval 60 and 90m of the section, this anomaly has been also observed in the ERT-P1 section. It is characterized by a high electrical resistivity value (1200Ωm), which is most likely related to a karstic cavity within the limestone bedrock. The appearance of this anomaly in the ERT-P1 and ERT-P3 sections at the same location probably indicates

the presence of a subsurface karstic conduit passing under the dam body at this sector. This subsurface conduit certainly constitutes a suitable pathway for the occurrence of intensive leakage from the lake to outside the dam, especially at the high water storage levels.

Another abnormal structure is also observed between the distances 215-280m of the ERT-P3 section. This structure seems as a void or an opened cavity filled with alluvial deposits (40-150Ωm). This void or cavity could be the result of the influence of a tectonic activity followed by erosion and dissolution processes of the limestone and dolomite rocks by the act of water flow effect. Moreover, the discontinuity features identified at the ERT-P1 section are also present in the ERT-P3 section at the same location, these features almost correspond to a fracture extending perpendicular to the dam body within the subsurface carbonate bedrocks. This fracture expands with depth, and it is filled with alluvial and clay deposits of low resistivity (Figure 9). Existence of those fractures constitutes an additional cause of the water leakage from the dam lake.

**Figure 9.** Inverted geoelectrical section of the ERT-P3 profile carried out on the downstream site of the dam body.

The second block is stretching along the distance from 300 to 500m, and forming the central part of ERT-P3 section. The margins of this sector are in concordance with the main valley and they are delineated by two vertical rocky edges. This part of the section is completely composed of alluvial deposits, where their thicknesses reach more than 50m. Moreover, an abnormal structure of clay, located between 300-320m, is observed at the left edge of this block. This structure represents additional evidence of the presence of a vertical water leakage between the surface and the deep formation. This block is structurally considered as the most significant part of the profile, where many structural anomalies are localized and identified. The filtration and the leakage processes are mostly occurring through this sector. The table (2) globalizes the resistivity values for the different subsurface detected structures obtained from the inversed ERT sections.

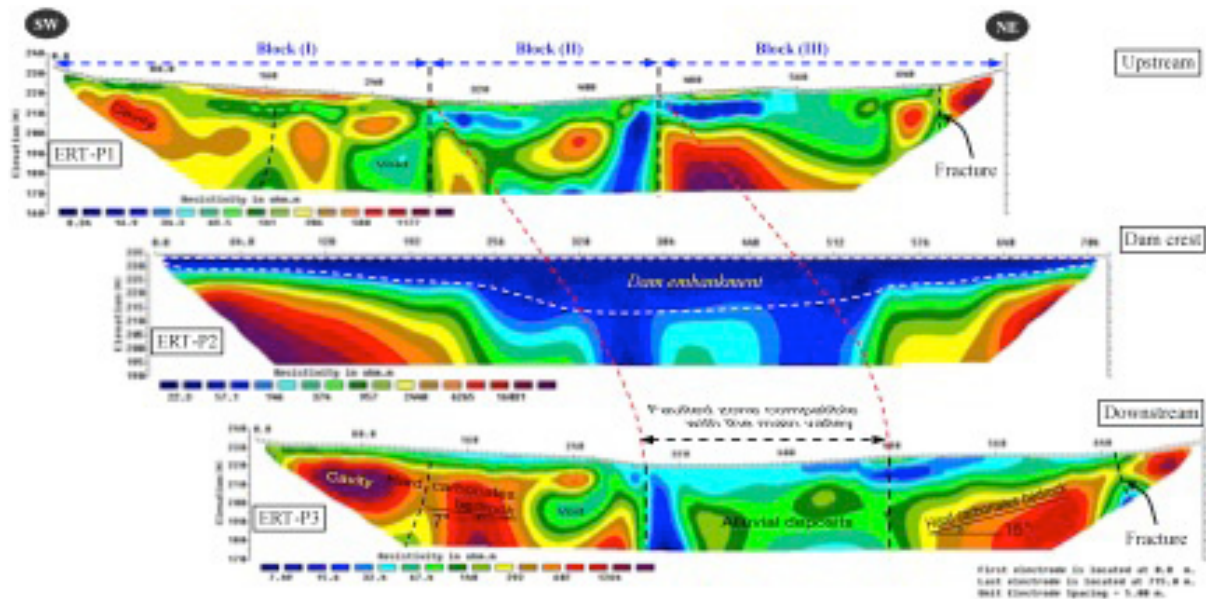
A global structural comparison between the geoelectrical ERT sections of the three profiles illustrated in Figure 10. The general structure of these sections seems to be similar and they are composed of three distinct structural blocks. A remarkable faulted zone can be traced within the interval 300 to 500m of the ERT sections. This zone is compatible with the main valley. Moreover, a karstic cavity located at the beginning of the ERT sections can be observed as well as the presence of discontinuity features at the end of the sections. It is worth mentioning, that many field observations have been noted during the implementation of the field measurements, which point to the role of the tectonic activity and other karstic features in the leakage processes. Figure 11 shows some of these features, where small sinkhole of more than 50 cm of diameter and a large fracture extended for more than 200m parallel to the dam lake margin are observed in many places throughout the lake and behind the dam body.

**Figure 10.** Comparison between the general structure of the inverted geoelectrical ERT profiles carried out in upstream, dam crest and downstream of Abu Baara dam body.

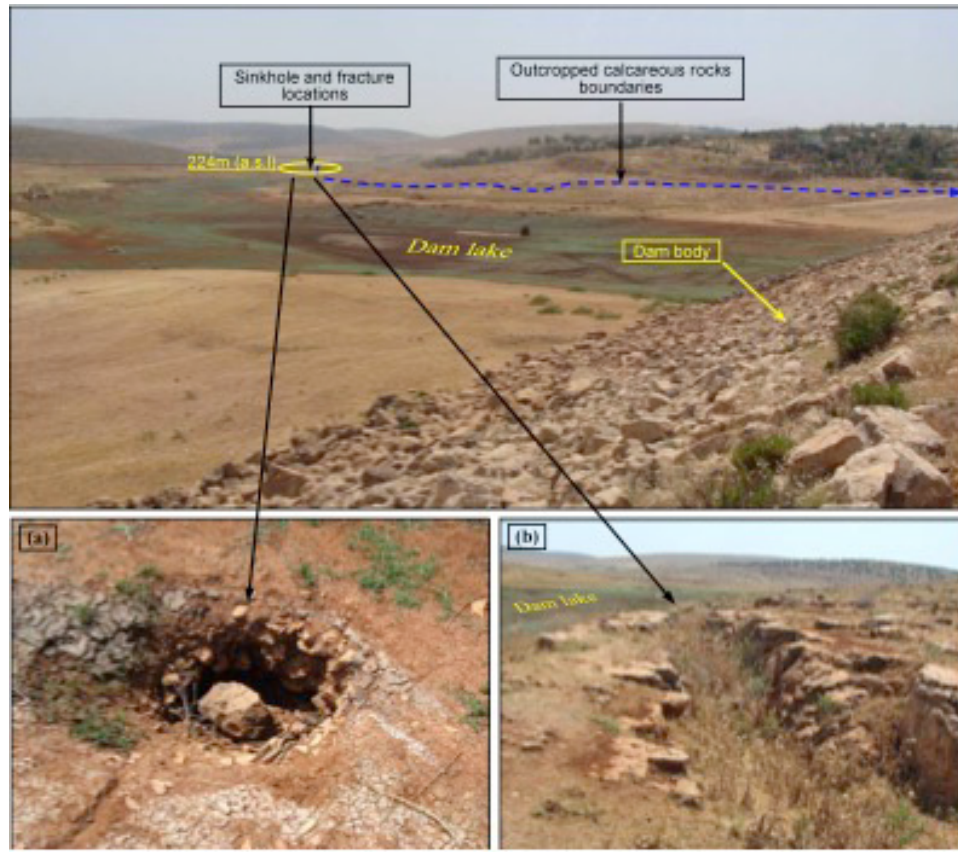
**Figure 11.** Locations of some leakage features observed at the right bank of Abu Baara dam lake, (a): one of the sinkholes which is located nearby the limestone and dolomite rocks boundary (more than 50cm of diameter), (b): a large fracture of 2-3 depth extends for more than 200m in parallel with the dam lake margin.
