## CASE STUDY FOR UAS-ASSISTED BRIDGE INSPECTIONS

E.T. Bartczak\*, M. Bassier and M. Vergauwen

Department of Civil Engineering,  
Faculty of Engineering Technology,  
Geomatics Research Group, KU Leuven,  
Gebroeders De Smetstraat 1, B-9000 Gent, Belgium  
erkkitobias.bartczak@kuleuven.be  
Commision II, WG II/8

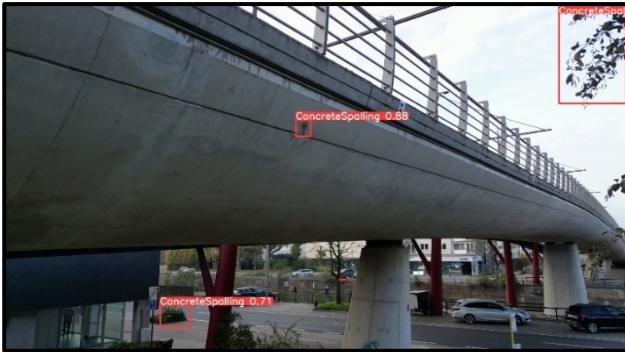
**Figure 2:** Prediction results with bounding boxes (red) of the YOLOv8 concrete spalling model. The result includes one true positive and two false positive predictions.

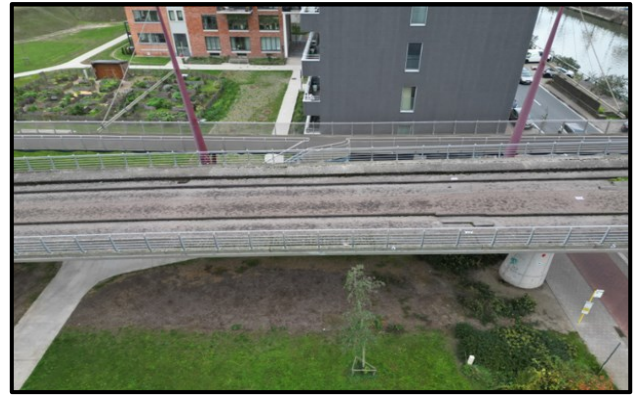
**Figure 6:** Gaardeniersbrug, Ghent, Belgium. Typical UAS Image of the initial photogrammetric flight.

To validate the proposed framework, we conduct a bridge inspection using a DJI Mini 3 Pro on a decommissioned concrete box girder bridge (Fig. 6). The Gaardeniersbrug was specially chosen because it can be easily reached, has no flight restrictions and several documented visual damages. The inspected bridge section is about 100 m long and included two pillars and the abutment. The focus on this case studies lies within the feasibility of the flight, the accuracy of the photogrammetric bridge model, the damage detection procedure and the evaluation of the accuracy of the image-based measurements.
