# Ensuring the Authenticity of the Conservation and Reuse of Modern Industrial Heritage Architecture: A Case Study of the Large Machine Factory, China

**Abstract:** The Large Machine Factory (LMF) was built in the complex historical context of the late Qing Dynasty (1840–1912). Its space and construction faithfully record the architectural and cultural fusion between Chinese and western traditions and mark the beginning of modern architectural techniques in China. Through historical data and empirical studies, the historical background and architectural characteristics of the LMF were analyzed, and interventions aimed at ensuring authenticity were established. The cultural significance and results of construction were considered two crucial elements in terms of outstanding characteristics. Comprehensive inspection and assessment strategies were discussed, with minimal intervention and interpretation principles. Preventive reinforcement of the foundation, complementary reinforcement of the main structures, restoration of the historic façade and environment, and adaptive spatial interventions were found to be effective ways to ensure authenticity. The principles of minimal intervent

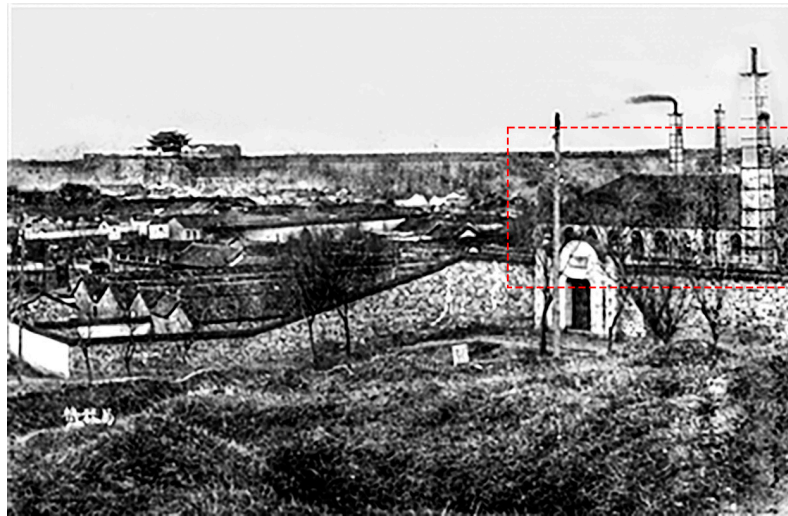
**Figure 5.** The Jinling Machinery Bureau and the LMF in 1889. Modified from [38].

The Jinling Machinery Bureau was built during the self-strengthening movement and was a specific product of the idea of Chinese essence and Western utility. The fusion of Chinese and western cultures was inevitable during planning and construction. In 1865, Li Hongzhang, then governor of Jiangsu and Jiangxi, considered the spatial needs of modern military–industrial production based on four standards [31]: (1) convenient water and land transportation to meet equipment and coal supply requirements; (2) a position close to residential areas to facilitate worker commutes; (3) the inconveniences of building in an urban area in order to prevent experiments and threats to security; and (4) the need for additional sites for later expansion. The final site was chosen outside the Zhonghua Gate in Nanjing, along the Qinhuai River (Figure 4) [33]. In 1886, Li reported to the Guangxu Emperor on the expansion project of the Jinling Machinery Bureau, writing that “the additional factory buildings were built with foreign solid wood, and all the construction technologies followed foreign modes” [34]. European engineers designed these buildings, and the construction and mechanical installation were completed by Chinese workers [30]. British engineer G. Bracegirdle designed and supervised the construction of the LMF, which was completed in 1887 [35,36]. Located on the west side of the Jinling Machinery Bureau, the LMF was the second plant built in the area and the largest one at the time (Figure 5).

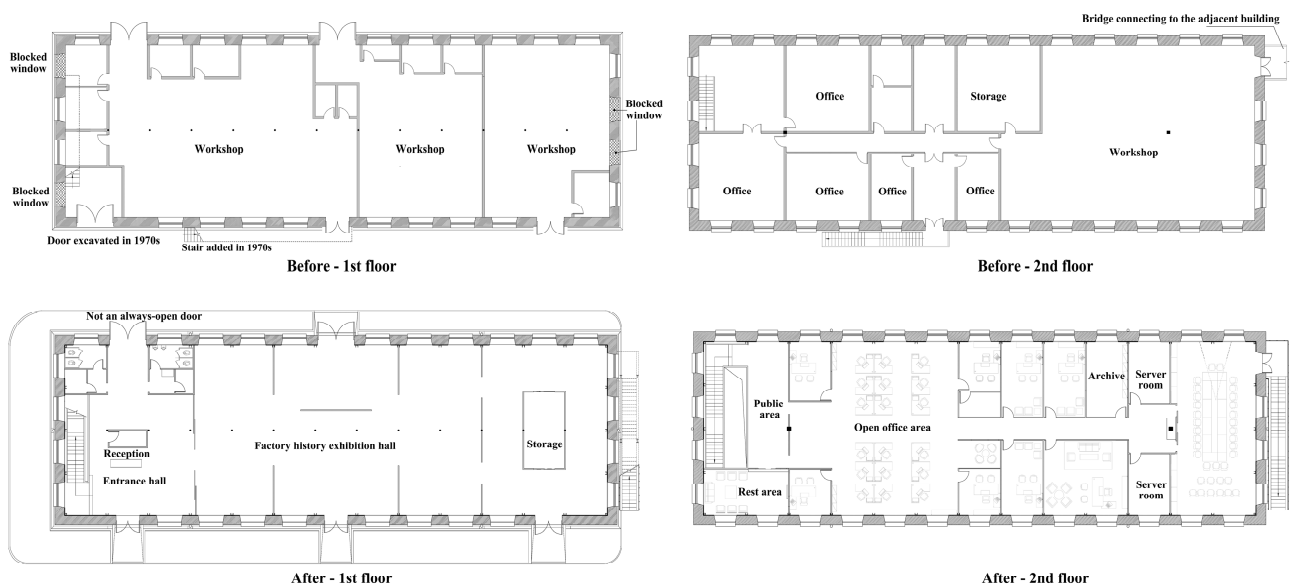
To reuse the LMF, the openness of its functions must be strengthened and its historical characteristics must be retained so that the public can have an intuitive experience. Focusing on fully presenting the historic interior structure, the repurposing of the LMF was based on the strategy of preserving its large spaces to reflect the large scale of the original industrial production hall. The new functions were designed to make the most of the space and redefine it in the process. Therefore, the specific functional layout is as follows: The first floor was kept intact as an exhibition center of the Jinling Machinery Bureau to display the heritage materials, including architectural drawings, historical documents, images, and media, for the interpretation of the historical, cultural, social, economic, and technological value of this entity. The interior staircase was reconstructed in its original position. The steel staircase added to the south side in the 1970s is an unauthorized part

of the building, which does not contribute to the esthetics of the building façade and obscures the historical features of this Qing Dynasty building. It was also not functionally necessary and was therefore removed. As the original evacuation exit, the connecting corridor on the east side of the second floor has been abandoned, but a new outdoor evacuation staircase is justified in its original position. In contrast with the openness of the first floor, the second floor is designed as a relatively quiet and private space for research and office management. The only two original wooden columns in the interior are used as anchor points for spatial separation, highlighting their contribution to the continuity of the roof structure and their monumental role in space repurposing. The three-stage layout of the public area, group office, and private office maximizes the structural characteristics of the roof truss with simple and lightweight glass partition walls (Figure 17). The entire reuse design achieved adaptability, recognizability, and reversibility of the new elements with a light intervention. Modern, lightweight, and transparent materials such as glass and metal, and simple geometric forms and bright colors were used to contrast with historical forms to emphasize the dialogue between the historical and the contemporary (Figure 18).

**Figure 17.** The comparison of plans before and after repurposing. Pictures by X.X.

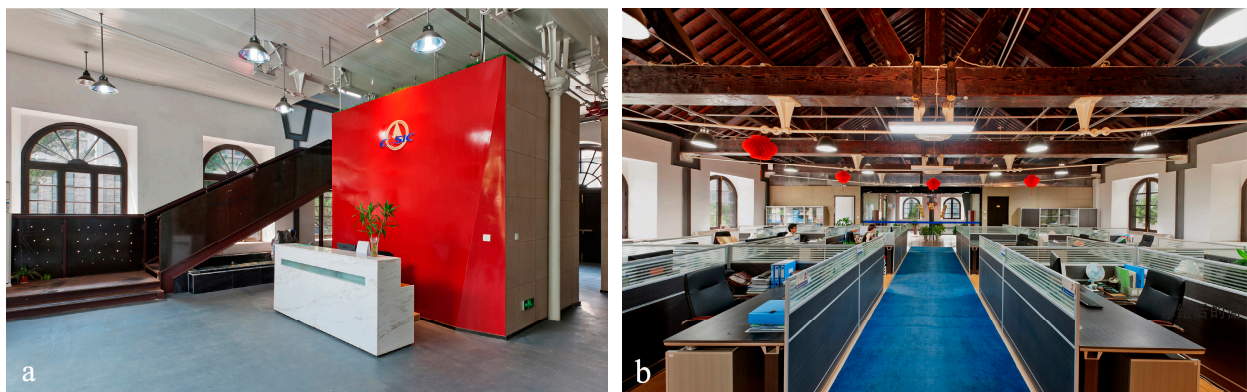
**Figure 18.** Interior space of the first floor (a) and second (b) floors after renovation. Pictures by Y.W.

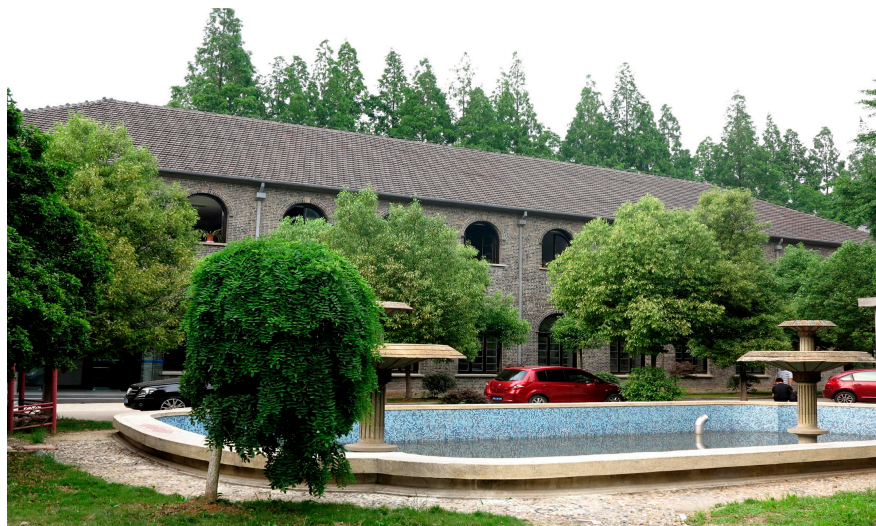
**Figure 19.** The surroundings after restoration. Pictures by Y.W.

cance within the overall historic environment. From the surroundings of the building, the pool built at the same time as the LMF has a traditional Chinese flower-style outline, while two European-style cylindrical fountains were built inside. They all reflect the characteristics of the mixture of Chinese and western cultures. These landscapes have been preserved intact and restored without changing their original shape and function (Figure 19).
