# Effects of soil properties and geomorphic parameters on the breach mechanisms of landslide dams and prediction of peak discharge

Guan, S, Shi, Z, Zheng, H, Shen, D, Hanley, KJ, Yang, J & Xia, C 2023, 'Effects of soil properties and geomorphic parameters on the breach mechanisms of landslide dams and prediction of peak discharge', *Acta geotechnica*. <https://doi.org/10.1007/s11440-023-01908-2>

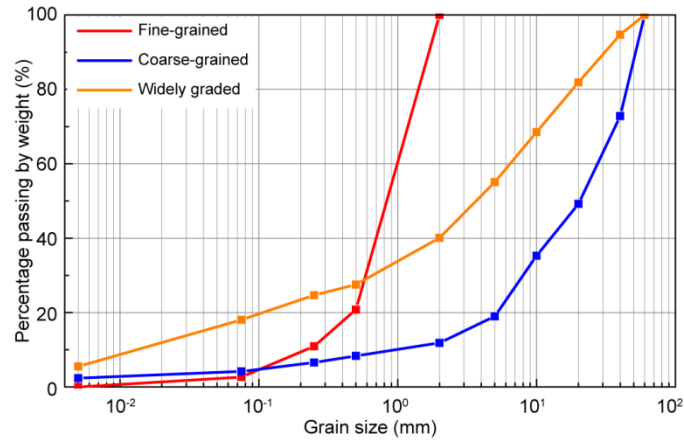
121 Fig. 2. Grading curves of debris material in tested dams.

112 As shown in Fig. 2, grain distributions of the model dams were derived from  
113 landslide dams in the field. Three debris compositions termed widely graded,  
114 fine-grained, and coarse-grained were obtained based on the Tangjiashan, Hsiaolin  
115 and Xiaogangjian landslide dams, respectively [5, 20]. The definition of debris types  
116 was based on the dam material which is inconsistent with the standard engineering

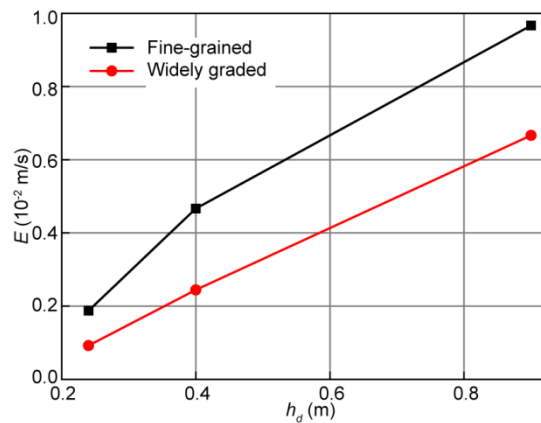
398  
 399 Fig. 11. Mean erosion rate  $E$  of fine-grained and widely graded dams in the  
 400 development stage versus the dam height  $h_d$ .

391 and much of the lake volume was released during breaching (Fig. 9). Furthermore, the  
 392 mean erosion rates  $E$  of the fine-grained dams in the breach development stage were  
 393 higher than those of widely graded dams (Fig. 11). The peak outflow rate for the  
 394 fine-grained dam in test F2 was 56.7 L/s, matching the values for the dams in tests F4  
 395 and F5 (59.1 L/s and 52.5 L/s) due to the same lake volumes (Table 2). The outflow  
 396 rates were smaller than the inflow rates in tests C1–C3 because coarse-grained dams  
 397 remained stable.

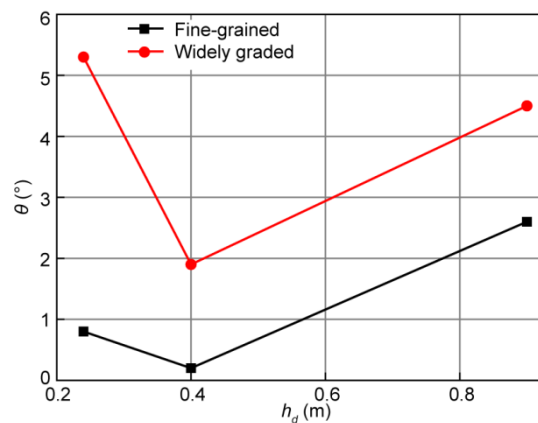
590 Fig. 16. Relationship between the dam height  $h_d$  and slope angle  $\theta$  of the residual dam  
591 in tests F1–F3 and W1–W3. Regardless of the dam height, the slope angles of  
592 fine-grained dams are smaller than those of widely graded dams.

582 The slope angle  $\theta$  of residual dams in the stream direction decreases first with  
 583 dam height and then increases (Fig. 16). This is because the lake shape coefficients of  
 584 the dams with heights of 0.40 m were higher than those of the other dams (Table 2).  
 585 In addition, the slope angle and deposition thickness of residual dams composed of  
 586 fine-grained debris are smaller than those of widely graded dams (Figs. 9 and 16). The  
 587 potential breach risk caused by residual dams composed of widely graded debris is  
 588 larger, although their peak outflow rates during breach are smaller.

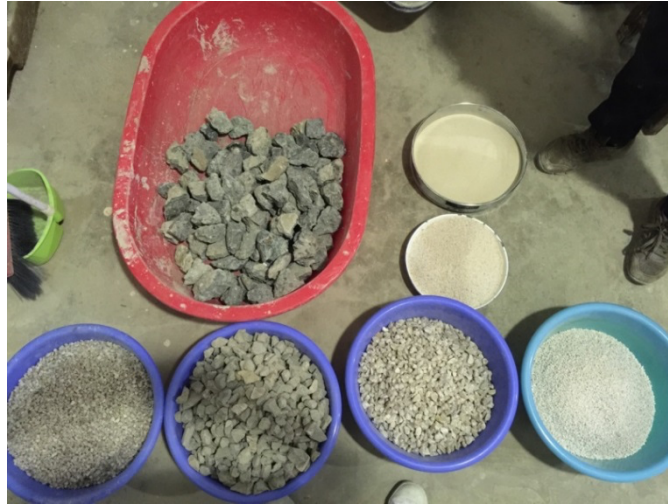
Fig. S1. Experimental dam debris in various components
