ANALYSIS AND DEFINITION OF RESTORATION STRATEGIES WITH H-BIM APPLICATIONS. THE CASE STUDY OF VITTORIO GIORGINI'S "CASA ESAGONO" IN BARATTI, ITALY

Keywords: Casa Esagono; Conservation; H-Bim; Modern Architecture; Vittorio Giorgini; Wooden architecture.

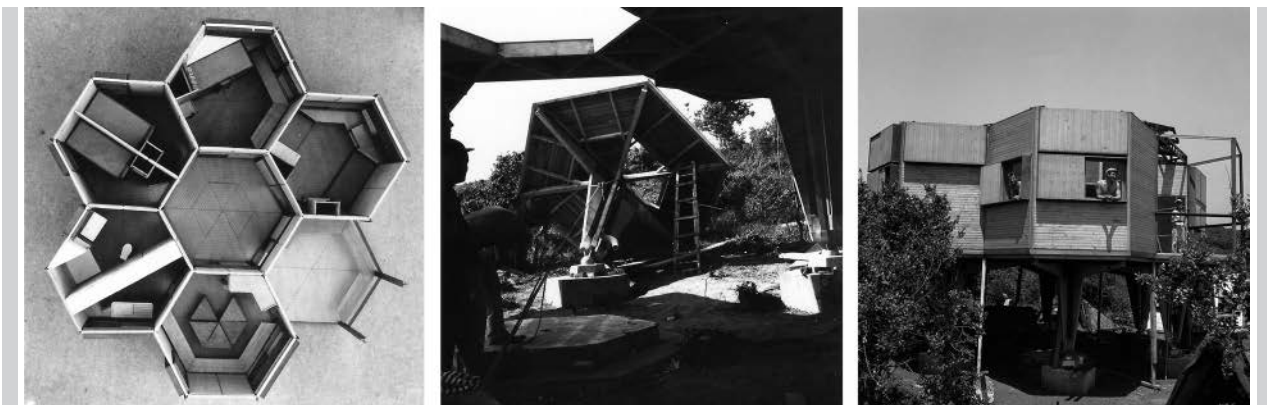
Figure 1. (left) The model of Casa Esagono and (center and right) the house under construction [source: B.A.Co Vittorio Giorgini Archive]

Giorgini is familiar with the MERO component created by engineer Max Mengerhausen, and with the connecting joints designed by Konrad Wachsmann for the US Air Force. He ponders the hexagonal model of Buckminster Fuller's Dymaxion House of 1929 and is aware of the design path of some of the most innovative architects, engineers and artists of the time, such as Frank Lloyd Wright and Le Corbusier. The prefabricated modular elements of the Casa Esagono arrive on-site ready for installation (Fig. 1).

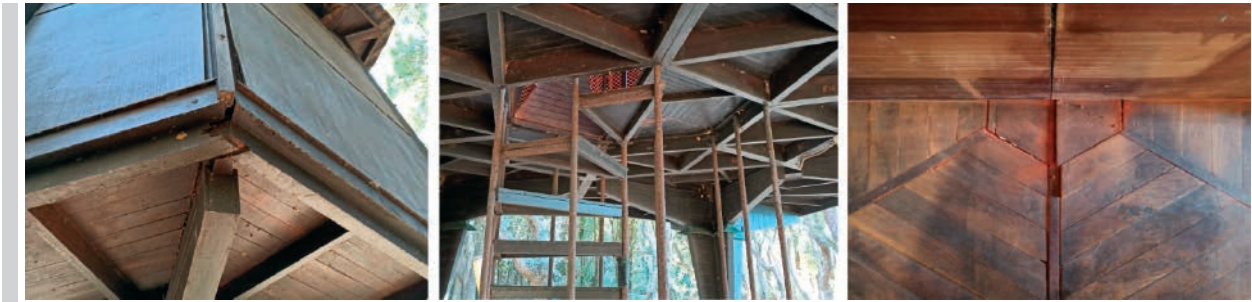
Figure 3.
Loosening of slab joint, stair's structure corrosion, flooring and wall cladding deformations [source: photo by S. Landi]

The cladding intervention in the 1990s, beyond making the house look very differently than in the historical photos, makes it impossible to verify the state of conservation of the perimeter walls, which should be assessed after the removal of the plywood panels. From what could be observed, the two main problems with the house structure are the loosening of several joints at the main floor slab perimeter, where some past temporary repairs are visible, and the advanced state of corrosion of the stairs structure and the floor slabs bolted joints, due to the exposure to the coastal environment. The joints between the plinth and the pillar, instead, are in good condition thanks to the protective paint layers applied. As for the interior, Casa Esagono is almost bare of most of its original furnishings. The interior cladding shows chromatic alteration, stains and deformations of varying degrees caused by humidity, which in some cases have led to cracks. The ceilings show dark stains due to water infiltration. The floorings, near some of the structural joints, shows deformations and rotting due to incoming moisture caused by the same loosening of the joints. Over the years, some degraded parts have been replaced, in particular, wall panels, some doors and windows (Fig. 3).
