# The Role of Lichens, Mosses, and Vascular Plants in the Biodeterioration of Historic Buildings: A Review

**Citation:** Cozzolino, A.; Adamo, P.; Bonanomi, G.; Motti, R. The Role of Lichens, Mosses, and Vascular Plants in the Biodeterioration of Historic Buildings: A Review. *Plants* **2022**, *11*, 3429. <https://doi.org/10.3390/plants11243429>

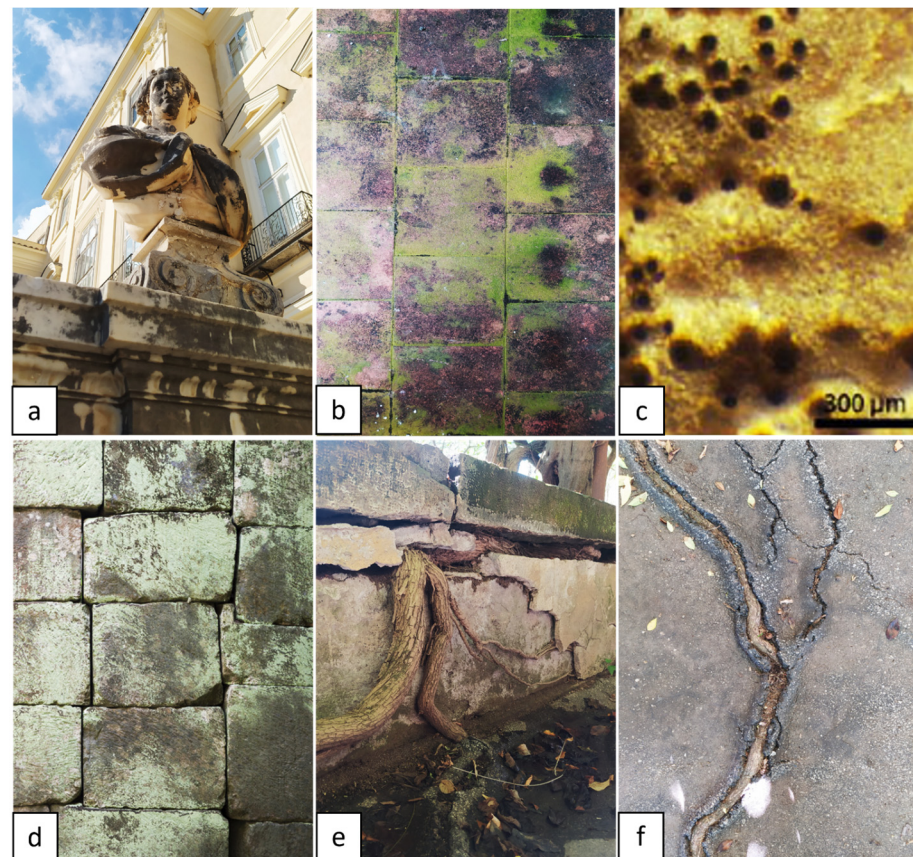
**Figure 1.** Increasing damage caused by colonizing organisms: (a) black crust caused by heterotrophic bacteria (Royal Palace of Portici, Naples, Italy); (b) green patina caused by cyanobacteria (Royal Palace of Portici, Naples, Italy); (c) bio-pitting caused by lichens [25]; (d) discoloring caused by mosses (Royal Palace of Portici, Naples, Italy); (e) cracks in the wall caused by vascular plants (Botanical Garden of Portici, Naples, Italy); and (f) cracks in the pavement caused by vascular plants (Botanical Garden of Portici, Naples, Italy). Pictures by Alessia Cozzolino.

Hence, pioneer microorganisms and plants (both therophyta and hemicryptophyta) are always present in the colonization process and can cause minimal damage, with them being replaced later by more harmful plants such as small shrubs or trees (Figure 1).

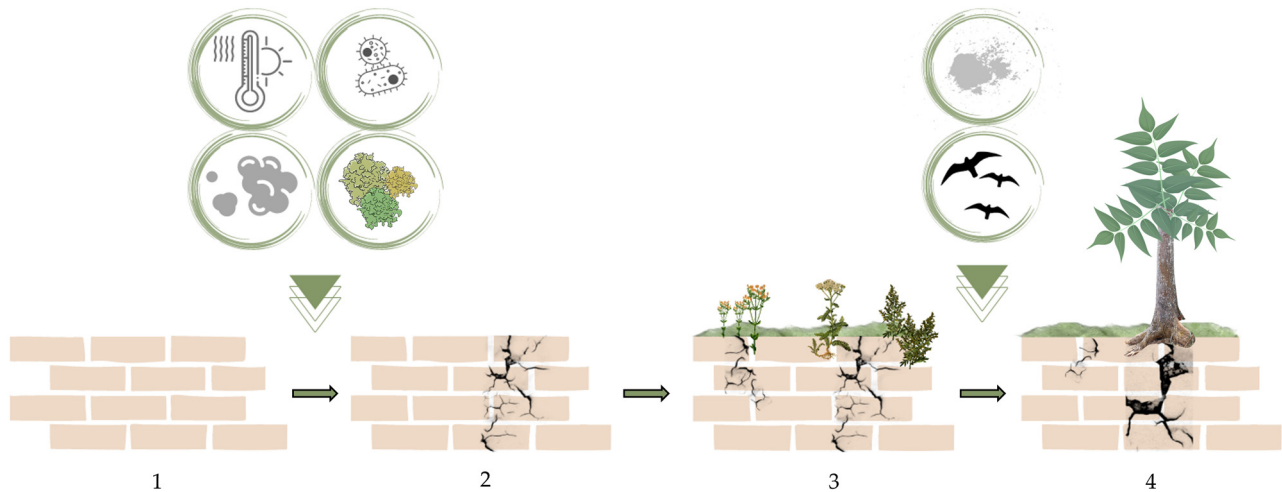
**Figure 2.** Wall colonization stages: abiotic and biotic factors cause a fracture (1,2) in which a thin layer of soil accumulates creating the necessary conditions for herbaceous plants to thrive (3). Subsequently, colonization by arboreal plants (4) occurs due to the presence of a large layer of soil and other elements accumulated in the fracture that have grown in size over time.

*Parietaria diffusa*) which in turn form a favorable substrate for other higher plants through their detritus, atmospheric dust, bird excrement, and human wastes (Figure 2). The second mode of colonization can occur where there are horizontal surfaces and there is good water availability, so the pioneer organisms can be mosses that trap atmospheric dust leading to the formation of substrates necessary for the germination of seeds of vascular plants (Figure 3).

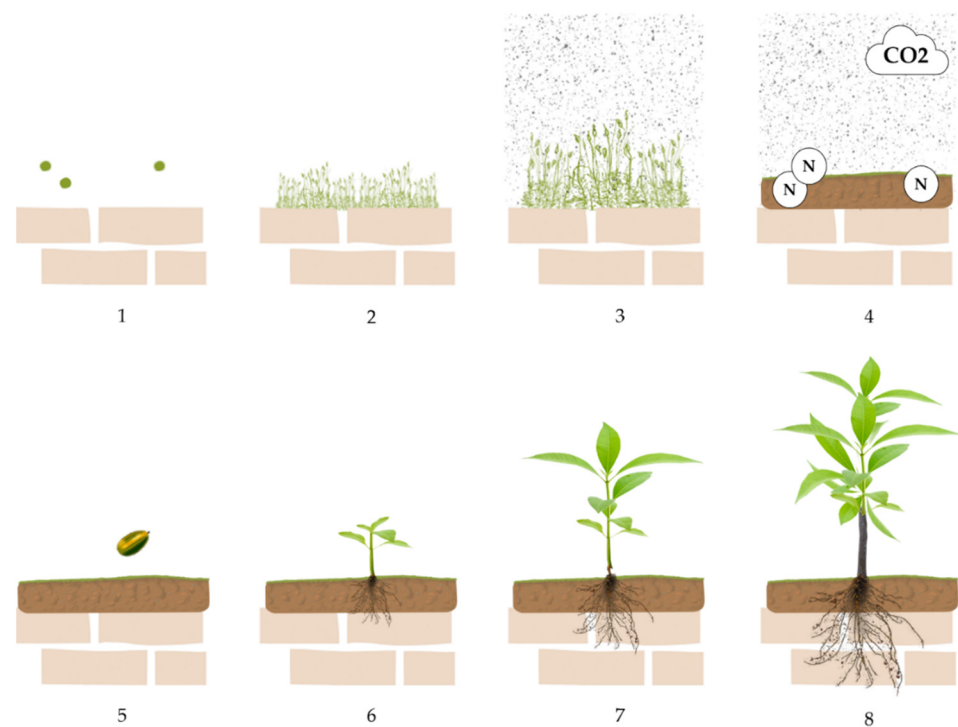
**Figure 3.** Wall colonization stages with pioneering moss: moss spores fall on porous stone and develop (1,2). The storage of atmospheric dust leads to the creation of substrates (3,4) that can host a seed of an herbaceous plant (5). The plant grows (6,7) and damages the wall with the expansion of the root system (8).

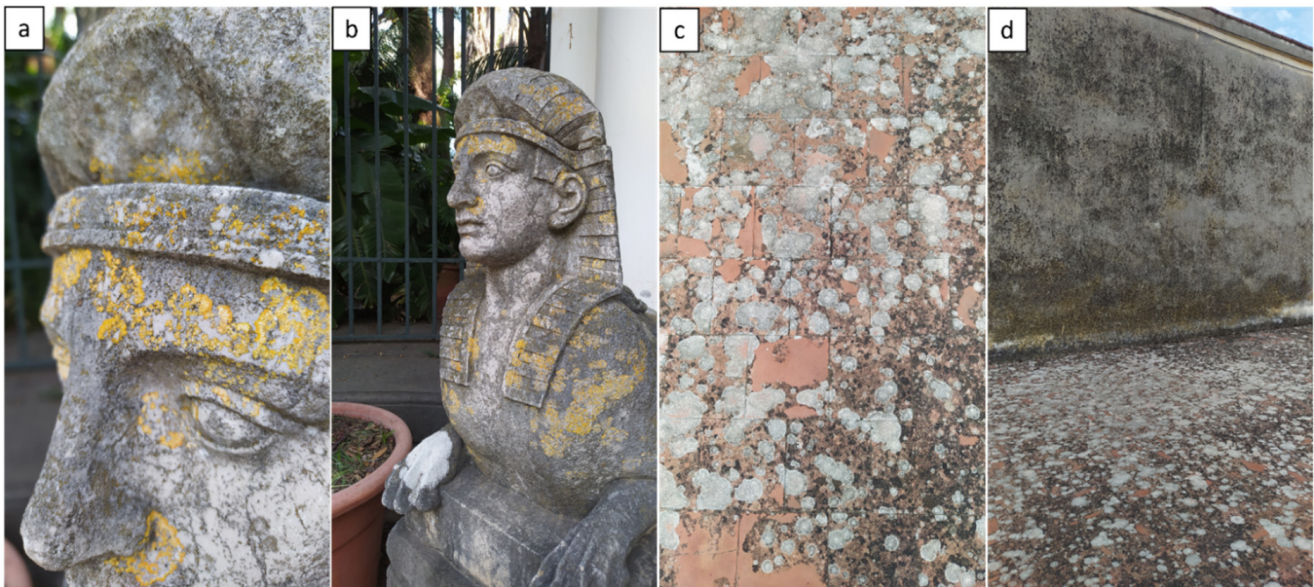
**Figure 4.** Lichens on statues representing sphinxes at the Botanical Garden of Portici (Naples, Italy) (a,b); and lichens on the roof of the Royal Palace of Portici (Naples, Italy) (c,d). Pictures by Alessia Cozzolino.

The succession of communities of living organisms growing on stone artifacts generally begins with the development of lichen flora depending on organic contamination caused by moisture and wind on the stone over time [21]. Lichens occupy environments normally hostile to many other forms of life, perhaps due to their resistance to desiccation and extreme temperatures, to longevity, and to their ability to store nutrients from the surrounding environment (Figure 4) [26].

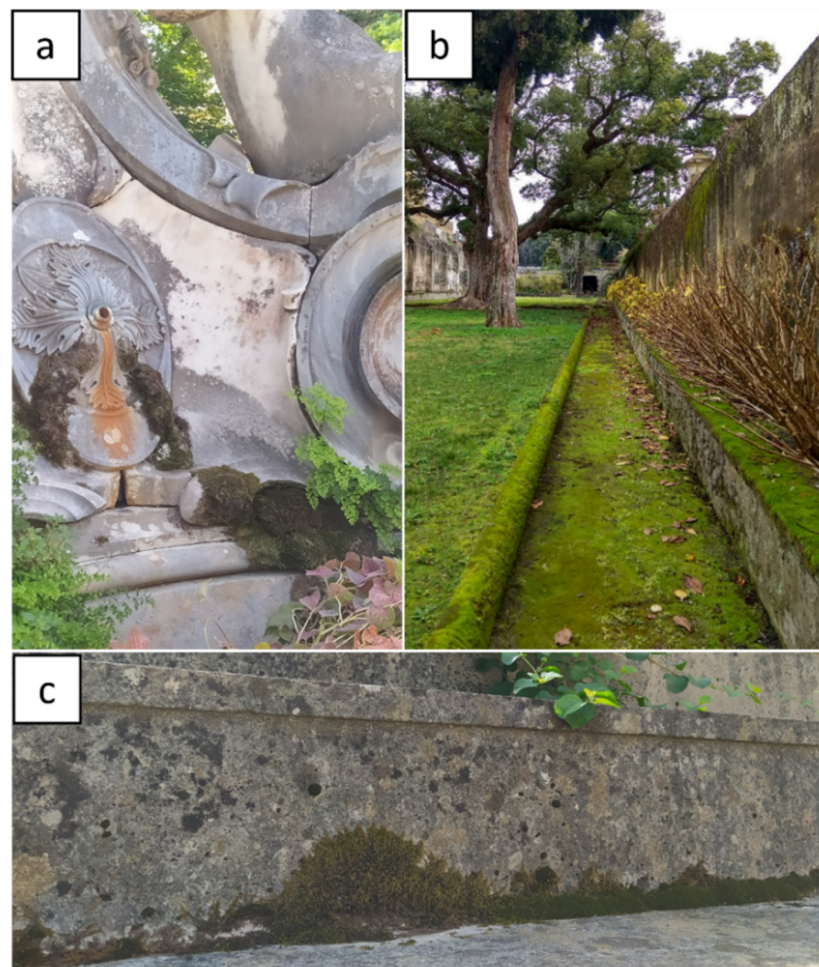
**Figure 5.** Mosses in the Botanical Garden of Portici (Naples, Italy): (a) “Fontana della Vittoria”; (b) the Secret Garden; and (c) steps. Pictures by Alessia Cozzolino.

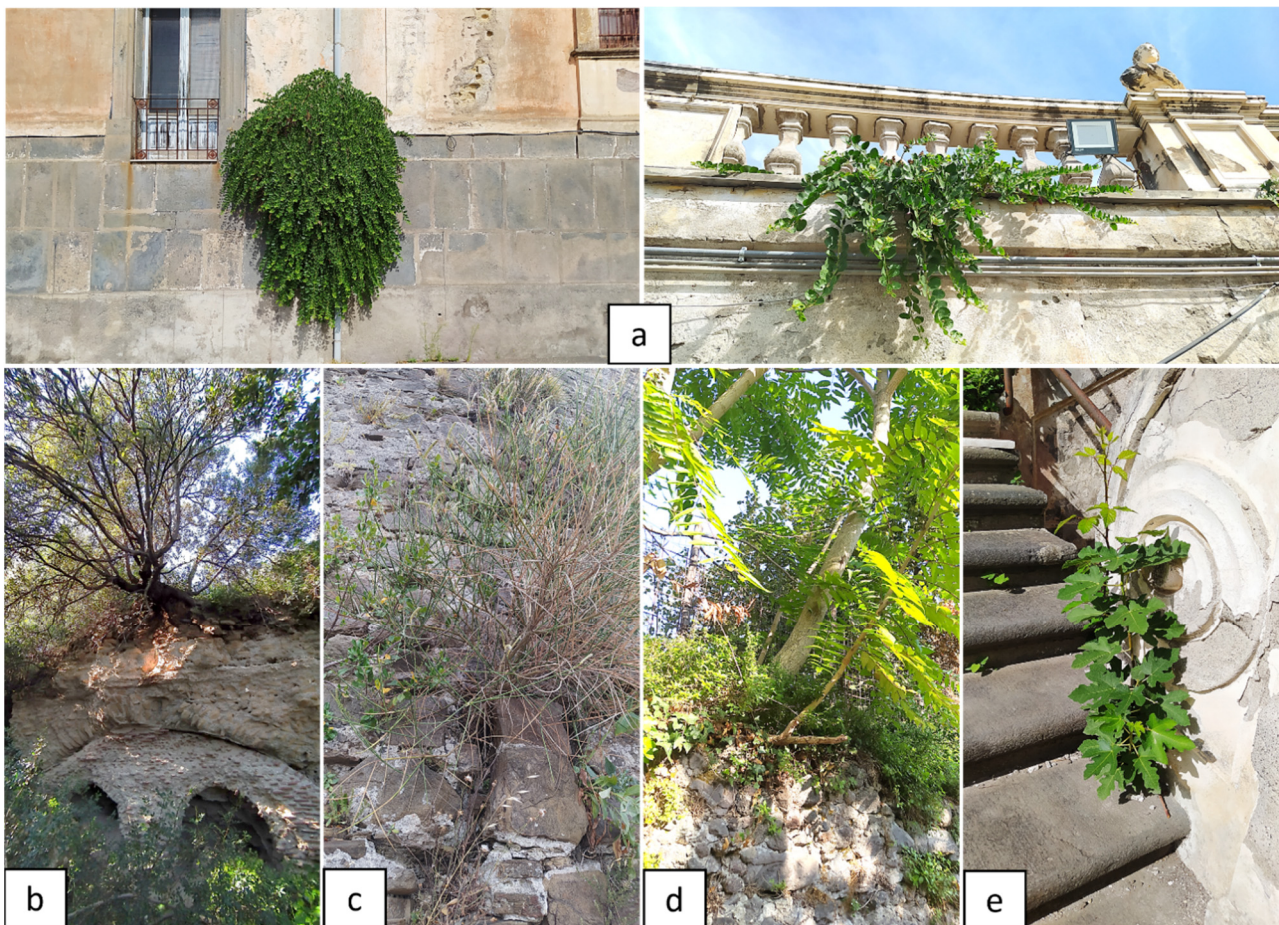
**Figure 6.** Harmful biodeteriogens species: (a) *Capparis orientalis* (Royal Palace of Portici, Naples, Italy); (b) *Pistacia lentiscus* (Archaeological Park of Pausilypon, Naples, Italy); (c) *Spartium junceum* (Agropoli Castle, Salerno, Italy); (d) *Ailanthus altissima* (Somma Vesuviana, Naples, Italy); (e) *Ficus carica* (Royal Palace of Portici, Naples, Italy). Pictures by Alessia Cozzolino.

Generally, the phanerophytes have the highest impact with an average HI of 7, since their shape and characteristics make them more harmful. Then, there are the therophytes (1.1), geophytes (3.1), chamaephytes (4.3), and the hemicryptophytes (4.3) [3]. According to several authors, the most common trees and shrubs with the higher HI among the species are *Ailanthus altissima* (HI 10), *Celtis australis* (HI 10), *Ficus carica* (HI 10), *Capparis orientalis* (HI 10), *Quercus ilex* (HI 9), *Cytisus infestus* (HI 8), *Spartium junceum* (HI 8), *Sambucus nigra* (HI 8), *Pistacia lentiscus* (HI 8), etc. (Figure 6) [3,8,36,37].

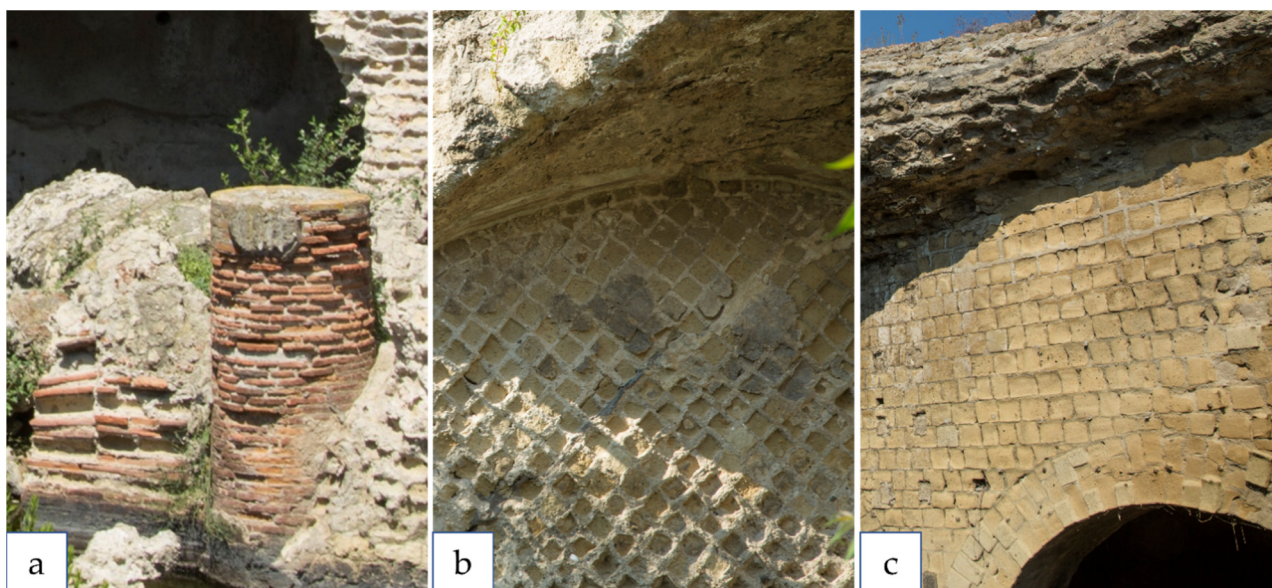
**Figure 7.** Common substrates found in the PFAP: (a) Opus latericium, (b) Opus reticulatum, (c) and yellow tuff. Pictures by Alessia Cozzolino.
