# Characterization and Geotechnical Investigations of a Riverbank Failure in Florence, Italy, UNESCO World Heritage Site

**Abstract:** On May 25, 2016, an artificial riverbank of the Arno River collapsed just upstream from the famous Ponte Vecchio bridge in the city of Florence, Italy, a UNESCO World Heritage Site. An analysis of the failure was performed to identify the damage condition of the involved structures, to define the causes of the failure, and preserve the site. This study was based on borehole integration and geotechnical characterization, terrestrial laser scanner (TLS) and digital photogrammetry (DP), bathymetric and geophysical surveys, riverbank stability analysis, and wall seismic vibrations assessment. The TLS survey results were used to characterize the three-dimensional (3D) wall deformations pattern, the landslide geometry, and to define the involved volumes. The riverbank stability analysis demonstrates that the lower safety factor was obtained in the case of complete saturation of filling materials and low river level in accordance with the major cause of collapse being attributed to the loss of water from subterranean pipes. DOI: 10.1061/(ASCE)GT.1943-5606

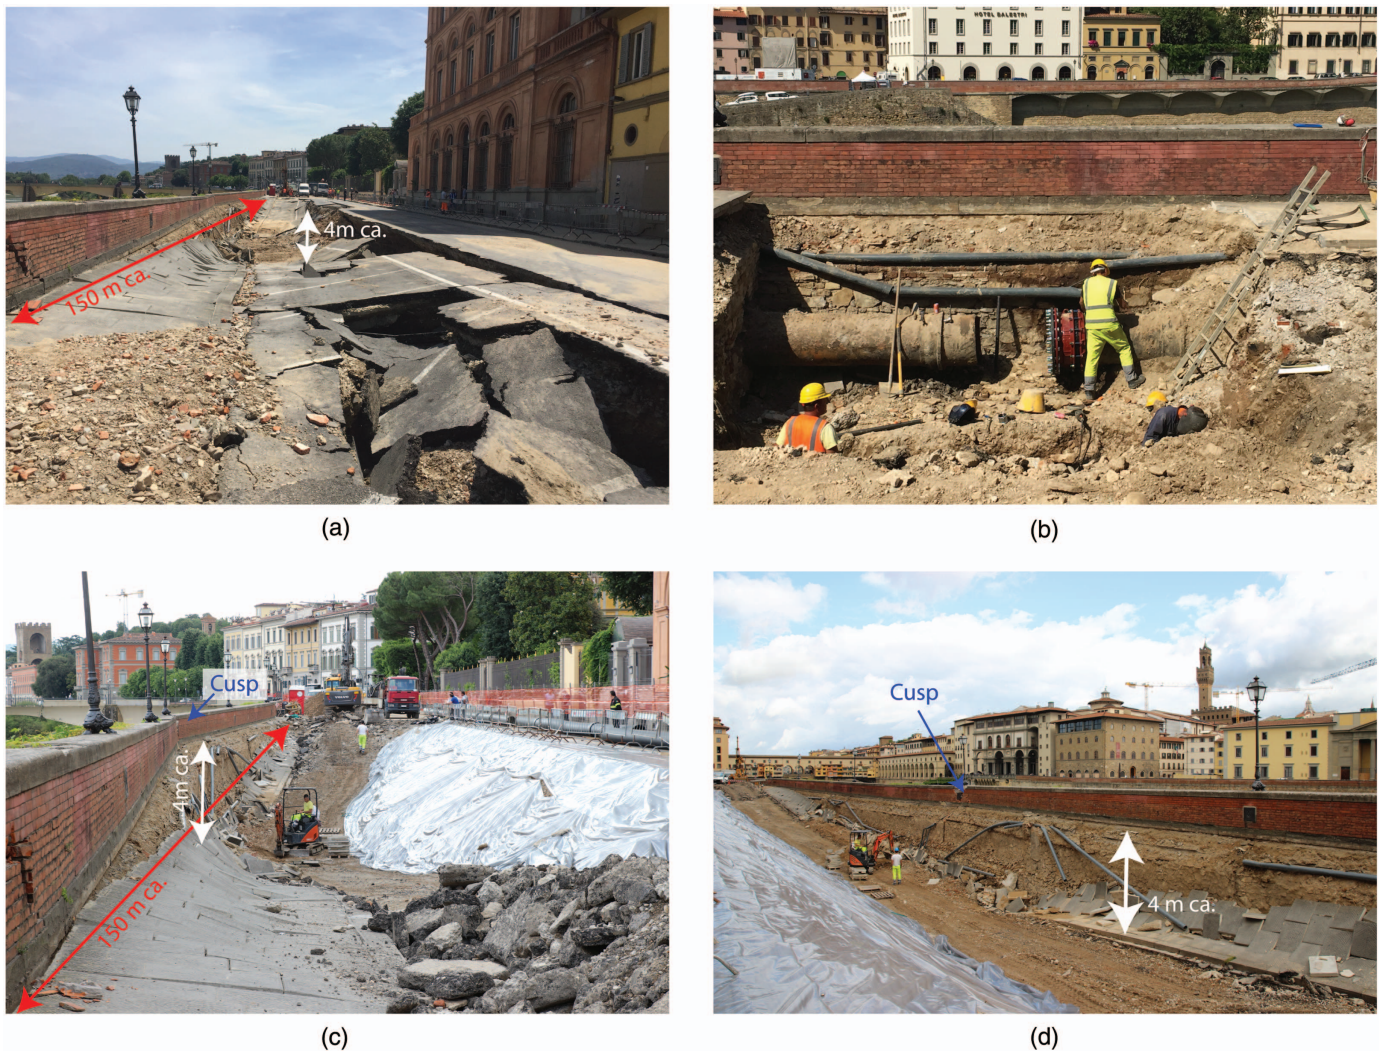
**Fig. 4.** (Color) Photos show (a) roadway and moved retaining wall immediately after removal of vehicles stuck inside landslide; (b) repair of big pipeline affected from catastrophic failure; and (c and d) construction site setup stage (notice large tarps for temporary protection). (Images by M. Nocentini.)

(1) the construction of a pipeline bypass in correspondence with the broken one [Fig. 4(b)]; and (2) the subsoil investigation and characterization for the design of the reconstruction project in the area. Since the event could naturally extend even to the nearby areas, thereby increasing the damage to the heritage site and endangering the lives of workers involved in the construction sites, the Earth Science Department of the University of Florence was mobilized in coordination with the city authorities on the morning of May 25, 2016, to monitor the stability of the entire area. Therefore, an integrated monitoring system was installed to detect any real-time deformation of the masonry embankment wall in the collapsed area and the buildings in the surrounding area. The monitoring system was composed of the following devices/equipment (Fig. 5): (1) one robotic total station (RTS) with 18 targets; (2) one ground-based interferometric synthetic aperture radar (GB-InSAR); (3) one high performance long-range (3D) terrestrial laser scanner (TLS); (4) nine biaxial tiltmeters; (5) four crackmeters; and (6) three seismic ground motion stations.

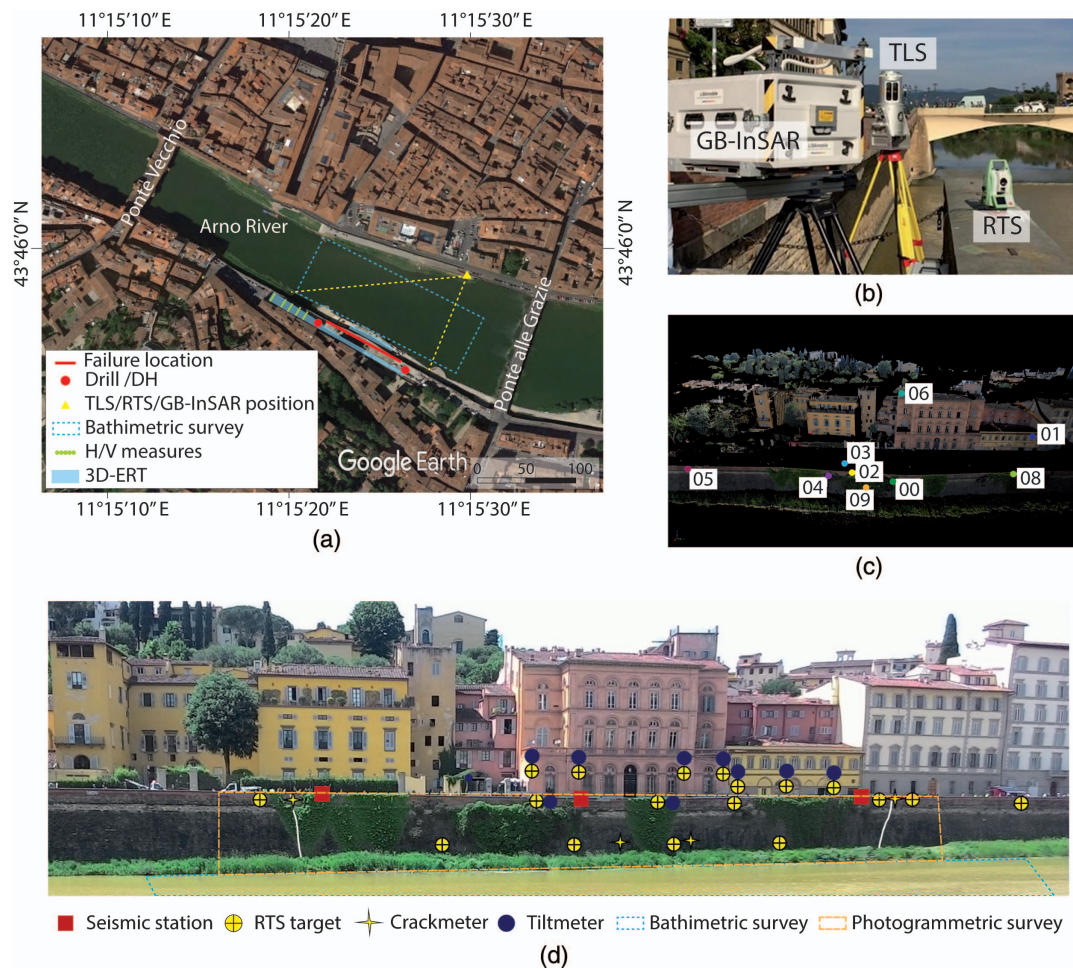
**Fig. 5.** (Color) (a) Satellite image of study area with location of techniques employed to characterize Lungarno Torrigiani landslide: boreholes and downholes (red dots), TLS point of acquisition (yellow triangle), bathymetric survey extent of riverbed (blue dashed line), single-station seismic noise (H/V measures, green dots), and 3D electrical resistivity tomographies (3D-ERT) (map data © 2020 Google); (b) picture of GB-InSAR, TLS, and RTS positioning (image by L. Lombardi); (c) GB-InSAR targeted points over a colored point cloud of whole area obtained with TLS; and (d) front view of landslide area delimited by outermost fractures trace (white lines) with location of RTS targeted points, tiltmeters, crackmeters, and seismic stations (image by L. Lombardi).

The following methods were integrated to characterize the failure (Fig. 5): boreholes and geotechnical laboratory tests (Morelli et al. 2010, 2017; Bicocchi et al. 2019), TLS (Gigli et al. 2012) of

To reconstruct the lithological sequence and define the geotechnical characteristics of the materials involved in the failure, two exploratory boreholes were initiated until reaching a depth of 25 m (Fig. 5). The boreholes have highlighted a three-layer stratigraphy constituted by the following starting from the ground level; (1) filling materials, (2) alluvial deposits, and (3) shales with marls and argillaceous marls (Sillano Formation). The thicknesses of filling material and alluvial deposits are different in two boreholes. The filling material has a thickness ranging from 7.5 to 8.0 m, while the alluvial deposits have a thickness ranging from 2.0 to 4.0 m. Below the alluvial deposits, the Sillano Formation can be seen until the bottom of the borehole. Twenty samples were collected and analyzed from several boreholes and open pits excavated in the

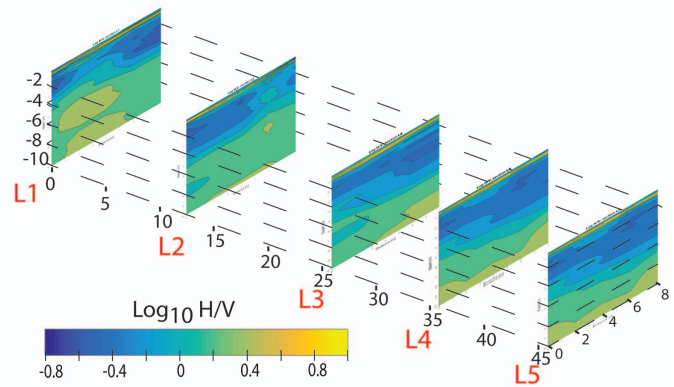
**Fig. 7.** (Color) (a) 2D horizontal view of ERT survey carried out on street and riverside of wall during October 3, 2017, satellite image (map data © 2020 Google); and (b) H/V contour maps perpendicular to embankment wall.

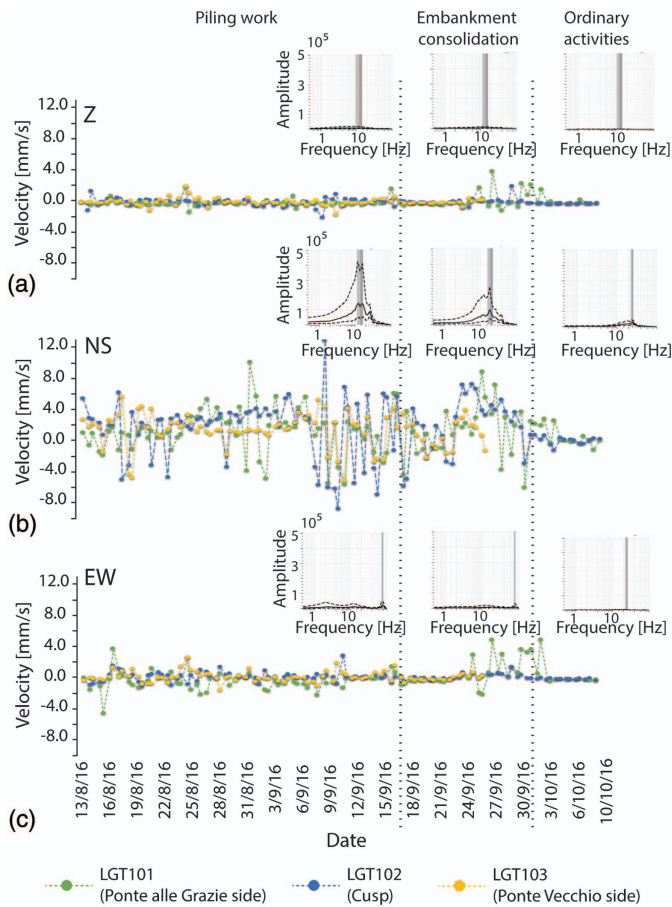
**Fig. 11.** (Color) Peak component particle velocity every 12 h and signal spectral analysis of three components: (a) Z; (b) NS; and (c) EW of each station (LGT101: green, LGT102 blue, and LGT103 yellow). Black dotted lines separate three time intervals corresponding to three different types of work: piling work, embankment consolidation, and ordinary activities. (Adapted from Pazzi et al. 2017a.)

The SN array consists of three high-gain triaxial velocimeters located in the three structurally more fragile and fractured areas: LGT101 near the hinge on the side of Ponte alle Grazie, LGT102 near the cusp, and LGT103 near the hinge on the side of Ponte Vecchio (Fig. 5). The vibration monitoring ran at 200 Hz from August 14 to October 10, 2016, and the whole period can be divided into three intervals according to the different kinds of works: (1) piling work; (2) parapet breakdown, excavation, embankment arrangement, and Arno River side foot wall consolidation; and (3) backfill and restoration of the original condition via standard construction activities.
