Appalachian Student Research Forum

2023 ASRF Schedule

### Preliminary site assessment for ground monitoring of a complex landslide along I-40 in Roane County, Tennessee

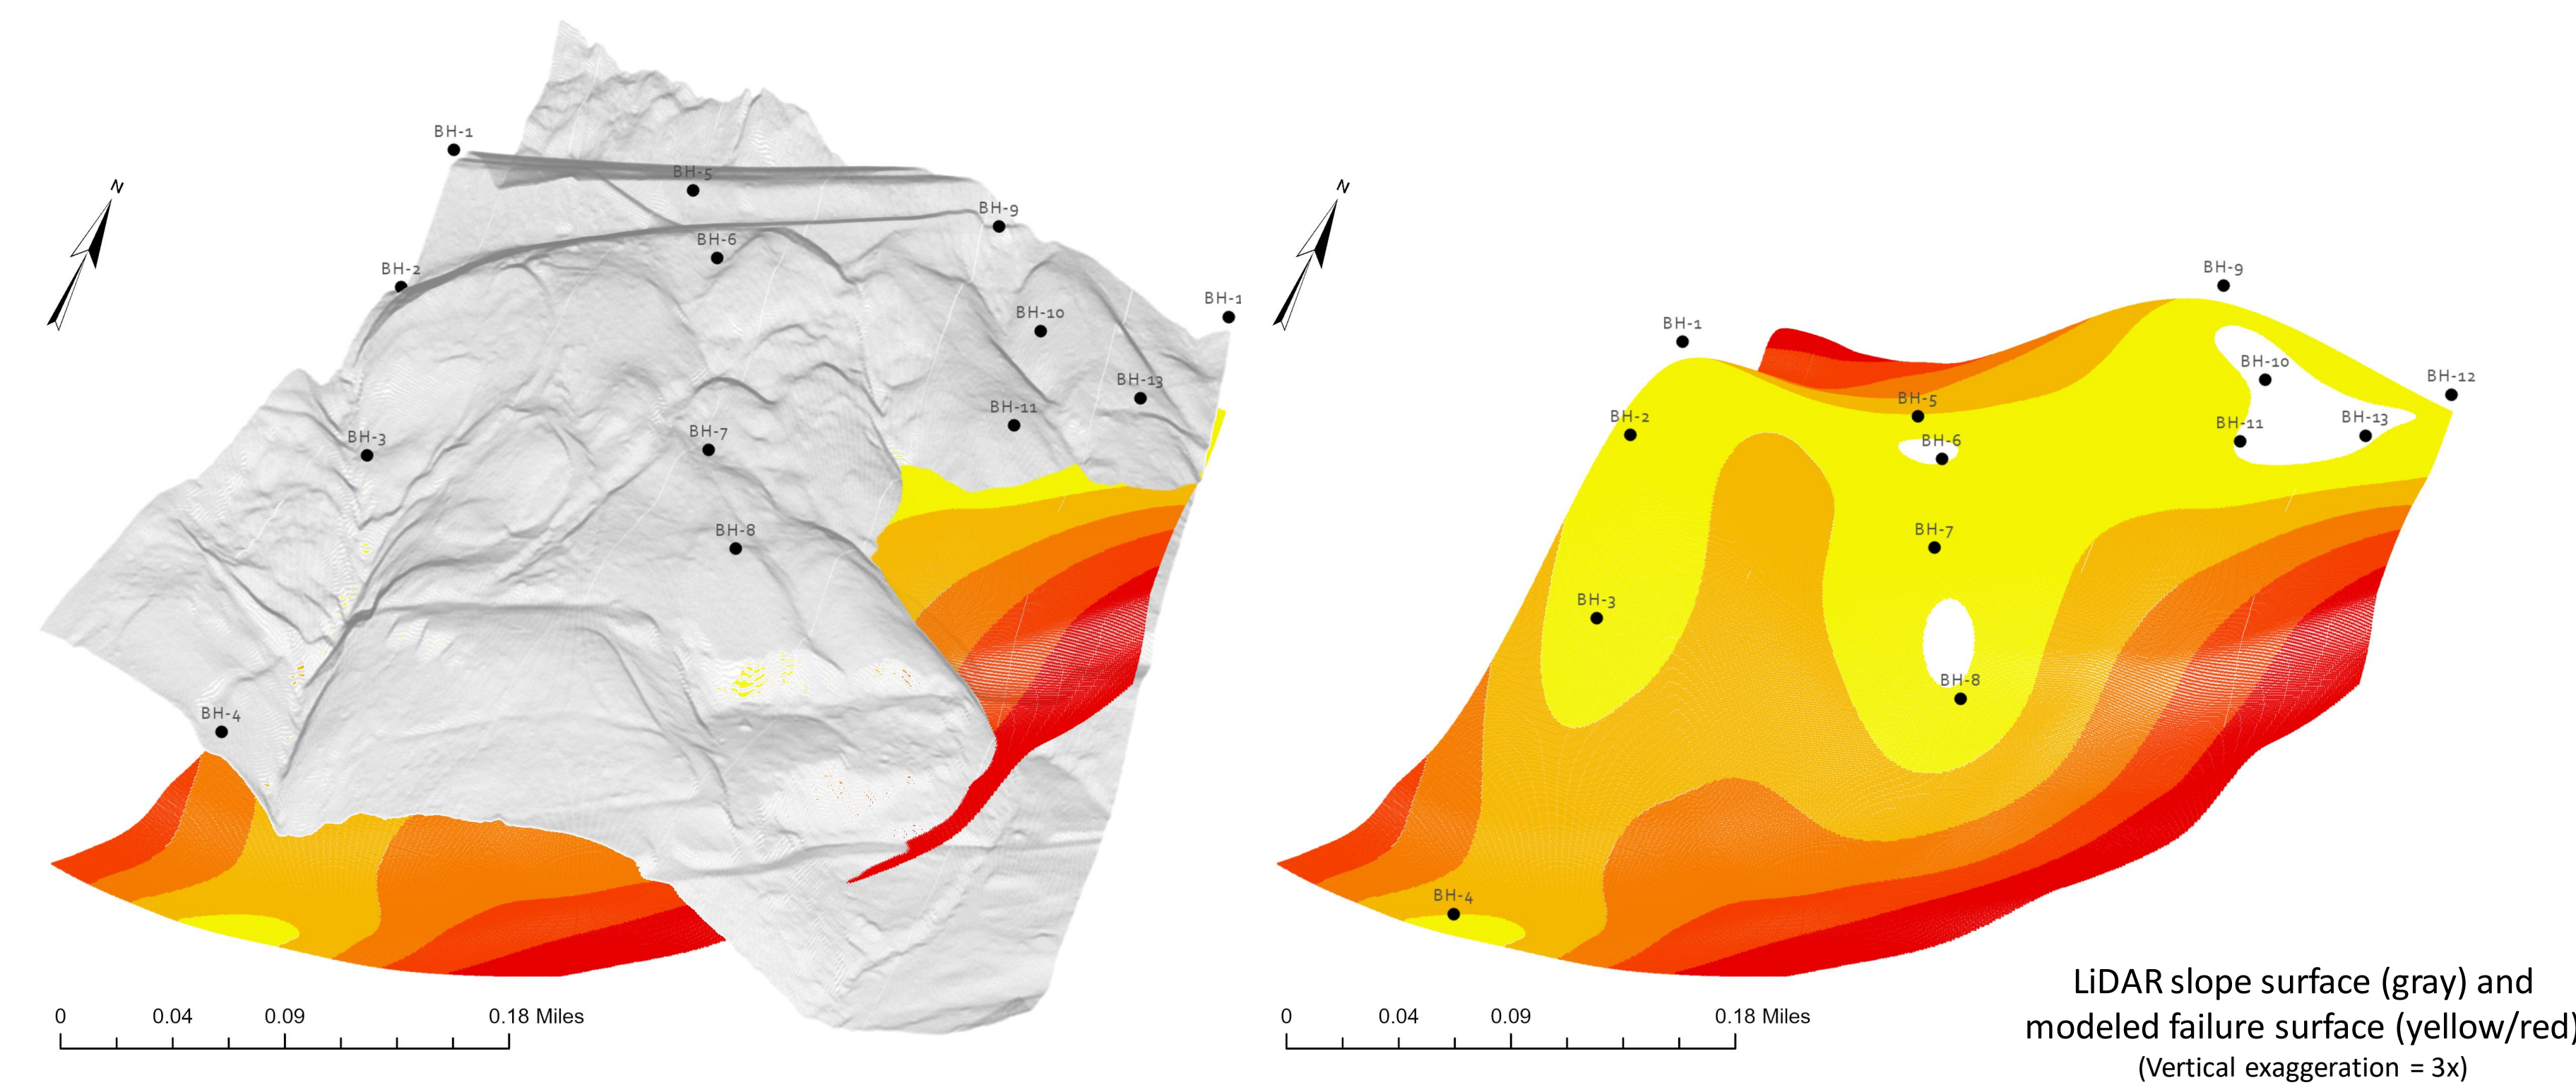
Figure 6. 3D point layers extracted from state LiDAR elevation raster overlaid on an estimated landslide failure surface point cloud based on kriging results. These show an irregular failure surface with shallow sliding in the east and deep failure in the western landslide area. The symbology shows kriging error results: low standard error of prediction = yellow and high standard error = red.

Based on observed depth of movement for each inclinometer, an estimated failure surface was created using Ordinary Kriging (Figure 5). When visualized in 3D with the failure surface overlaid with LiDAR elevation of the ground surface for visual interpretation (Figure 6), the landslide failure surface appears higher in the east (8 to 40 ft), while the side slip surface was deeper on the west side (75-122 feet). The irregular surface suggests a composite landslide with shallow translational and deep rotational components.

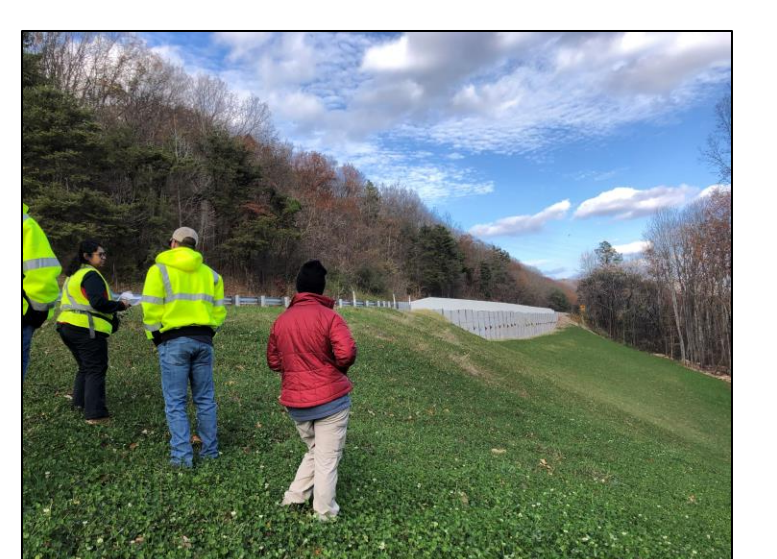
Figure 10. Field work on site.

- Two landslide masses were inferred: deep-seated western rotational landslide with moderate slippage, failure surface at 75 to 122 ft depth.
- Shallower but more mobile slide with recent motion, 8 to 41 ft.
- Greatest threat to I-40 appears to be from the western deep slide.
- 3 borehole locations were selected in upslope, mid-slope, and lower slope positions of the western slide mass for TDR monitoring (Figure 9).
- Feasibility tests for early warning system with TDR will improve safety (Figure 10) and maintenance (Figure 11) along I-40.

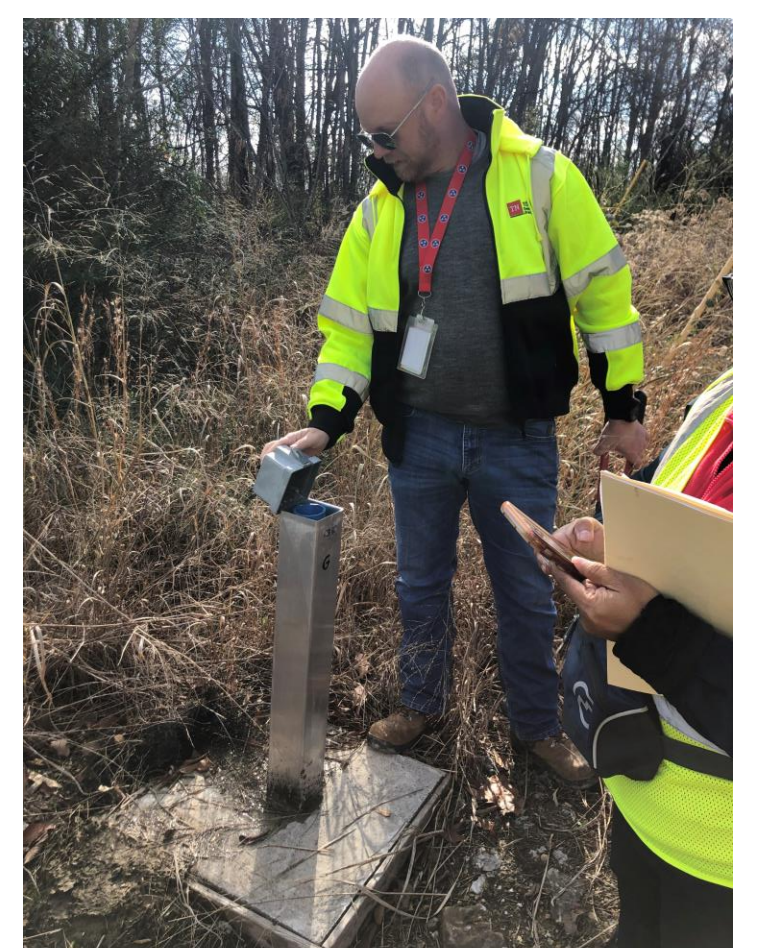
Figure 11. borehole inclinometer.
