# Looking Twice: Identifying and Understanding the Character Defining Features of Historic Fire Stations

**Identifying and understanding the character defining  
features of historic fire stations**

A THESIS PRESENTED TO THE GRADUATE  
SCHOOL OF ROGER WILLIAMS UNIVERSITY

May 2015

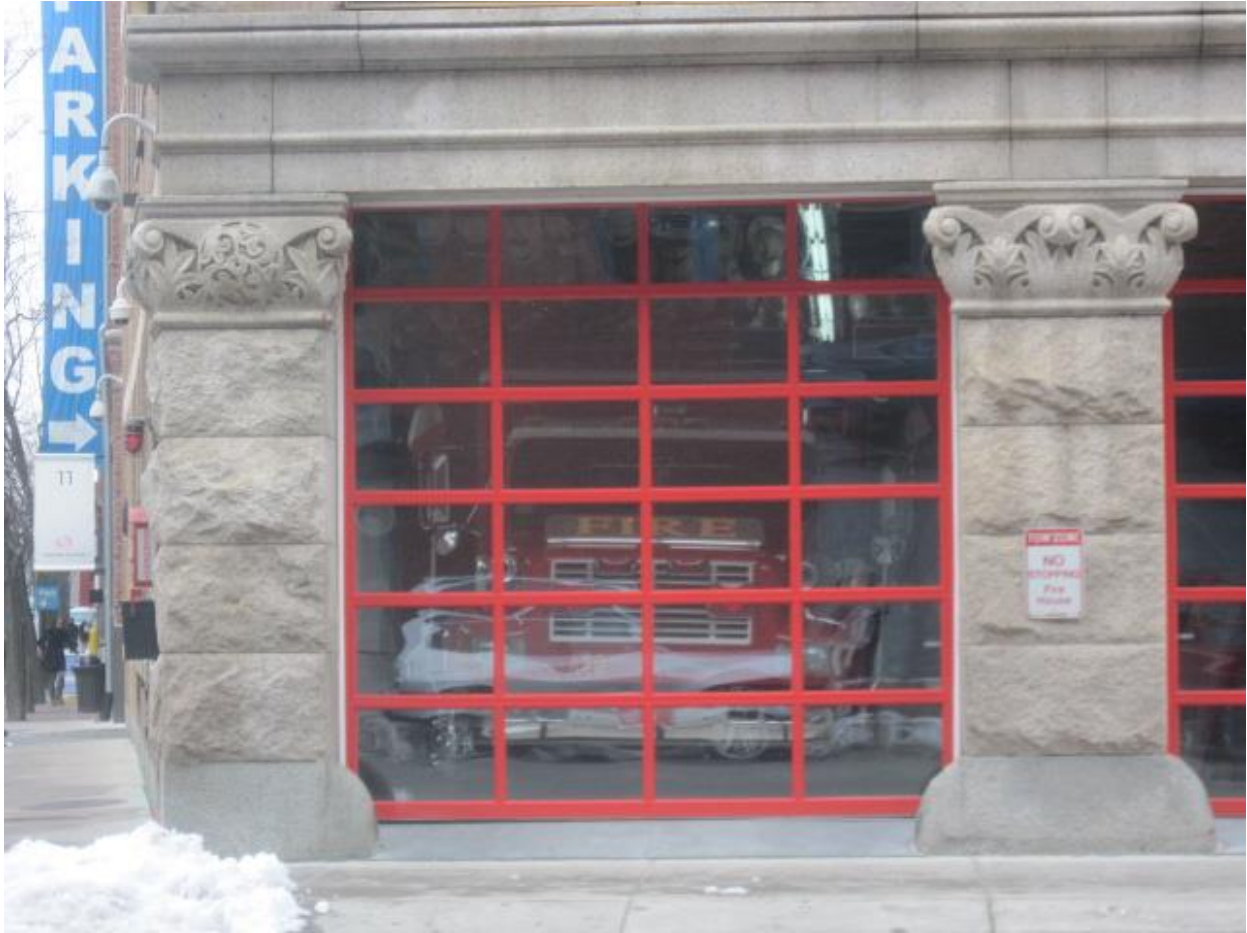
Photograph 6: Door Openings

The Congress Street façade of the building on the first floor has two apparatus door openings. (Appendix 7, Photograph 6) The second story on the Congress Street façade of the

The granite on the piers has a rough finish compared to the granite coursing which has a smooth finish. The brick is a yellow brick. The variety of material is in tune with the Romanesque style of the building. (Appendix 7, Photograph 6)

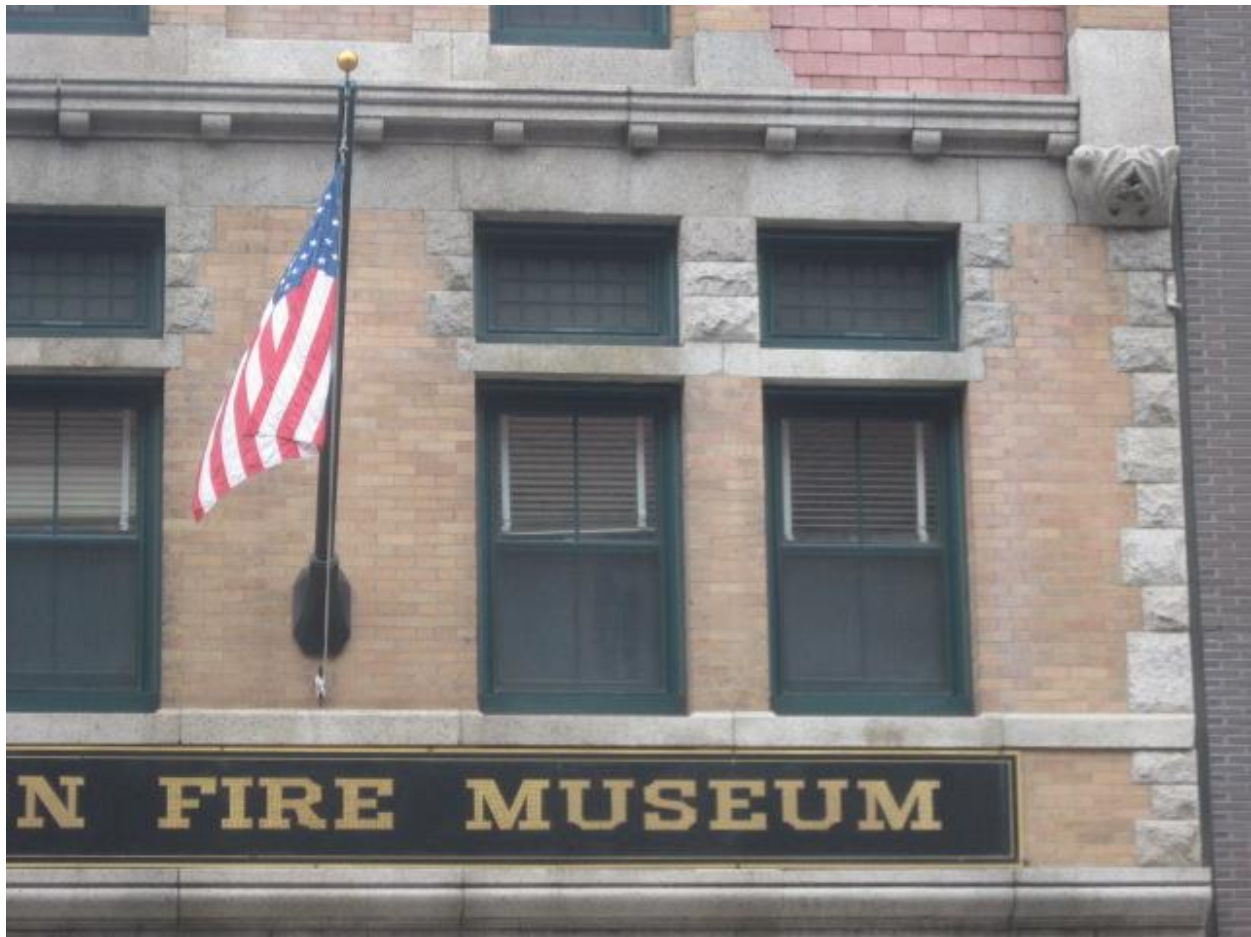
Photograph 7: Window Openings – Front, Second Floor

building has two sets of paired windows. Each window has a two-over-two sash with twelve small framed transom window above. (Appendix 7, Photograph 7) These windows are located directly above the garage doors on the first floor. The third floor façade has a set of three openings. On either side is an eight-over-eight sash window with a bricked in opening in the middle. (Appendix 7, Photograph 8) The exposed side of the building has a series of two-over-two sash windows on the first floor. The second story has two-over-two sash windows with transoms above. There is one eight-over-eight sash window on the third floor. (Appendix 7, Photograph 9 & 10) The back of the building has a series of blocked off windows and block glass windows. There is a door in the back of the building. On the side façade, near the front of the building is the main, pedestrian sized, door. The windows on the side of the building do not have a distinct pattern however, the windows on the first floor are directly below, and inline, with the windows on the second floor.

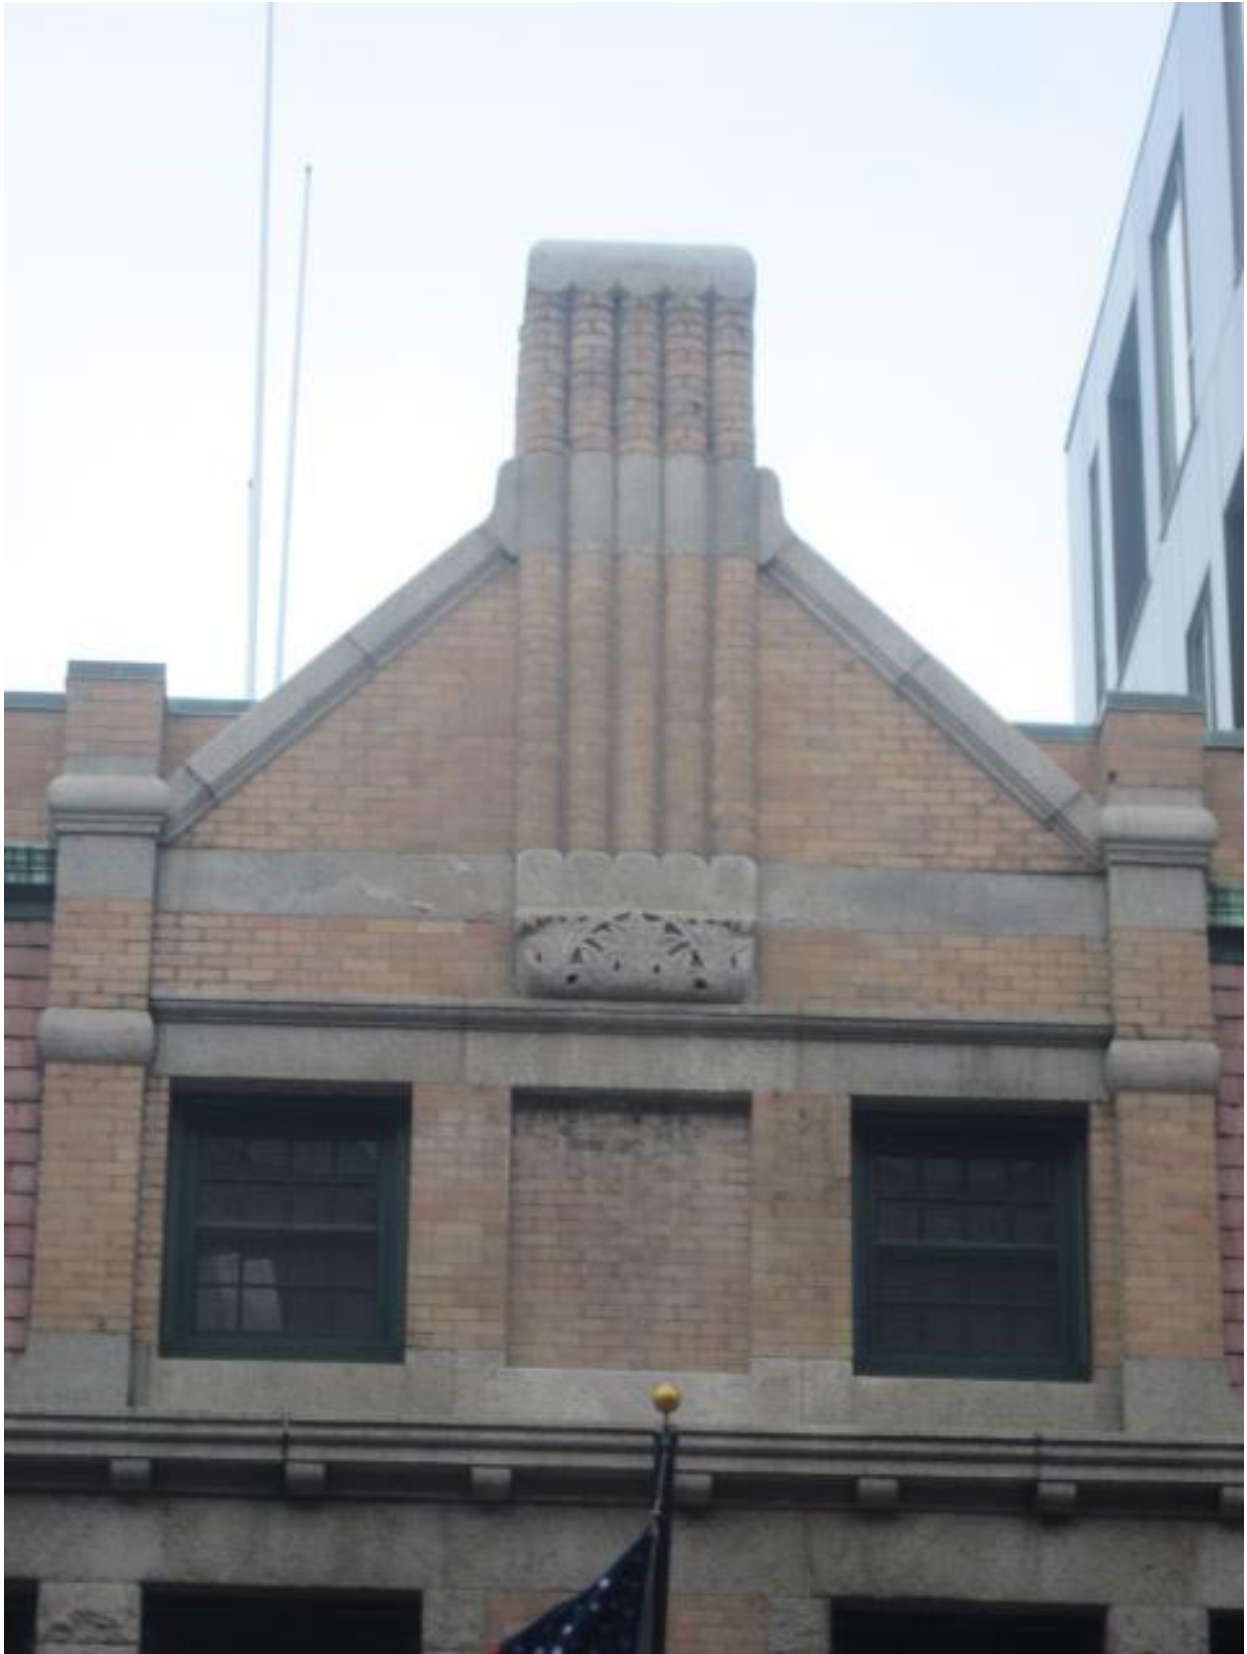
Photograph 8: Window Openings – Front, Third Floor

There are piers on the sides of the façade third story. A faux roof, with chimney, is located in the center of third story as well. (Appendix 7, Photograph 8)

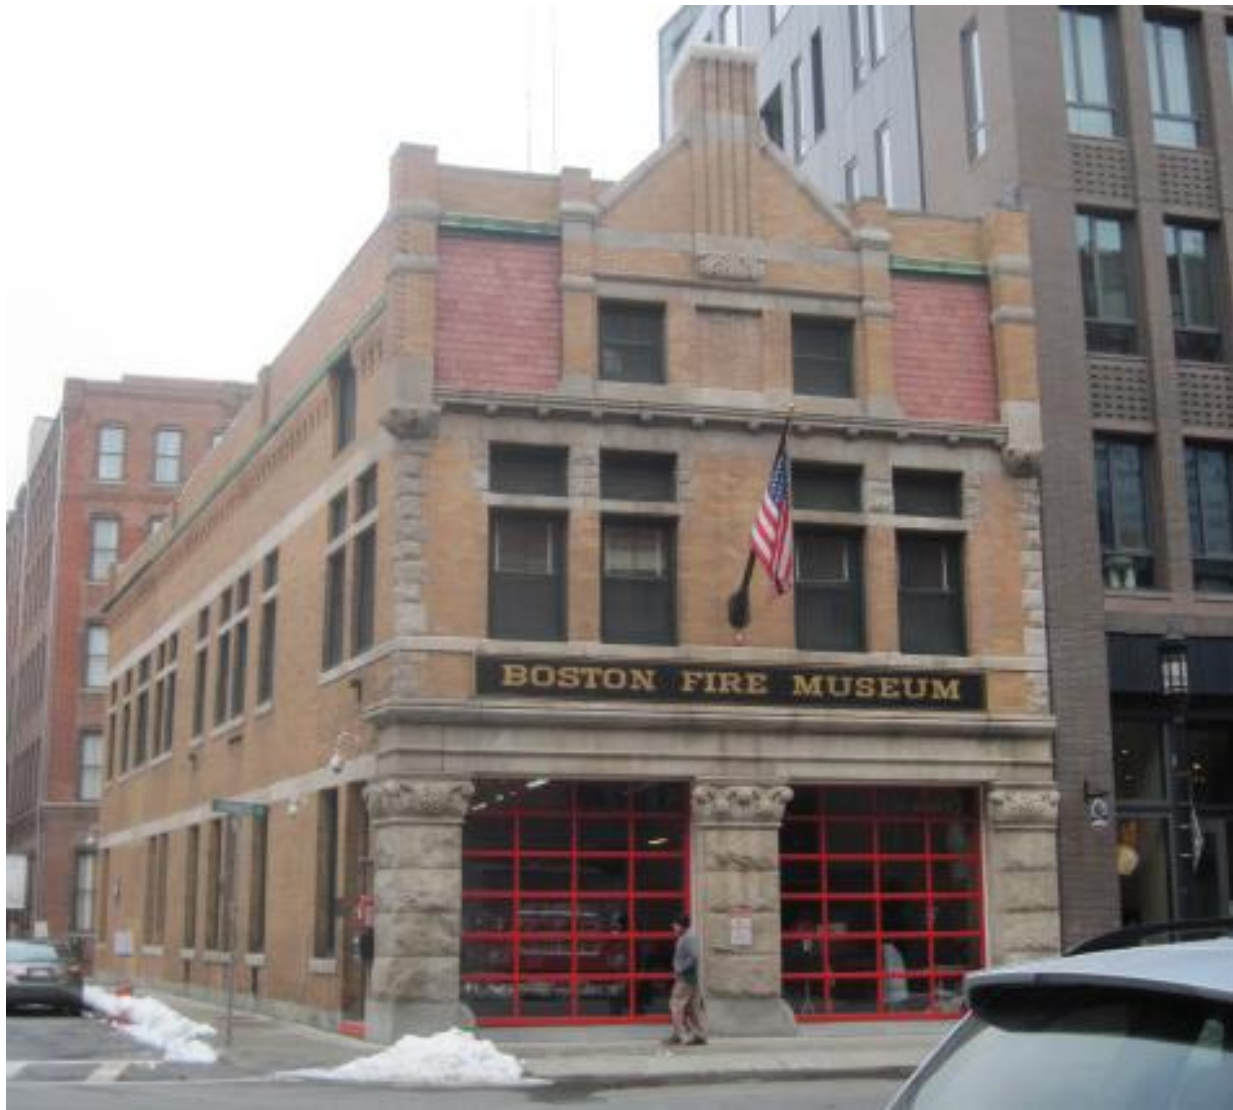
Photograph 11; - Trim and Secondary Features – Piers

The first floor façade has three, granite Romanesque piers that are topped with a granite cornice. (Appendix 7, Photograph 11) The second story façade has granite quoins. There is also granite trim around the transom windows on the second story. (Appendix 7, Photograph 12) The granite trim proceeds to wrap around the side of the building. There is a slate-clad faux roof on the third story. (Appendix 7, Photograph 13)

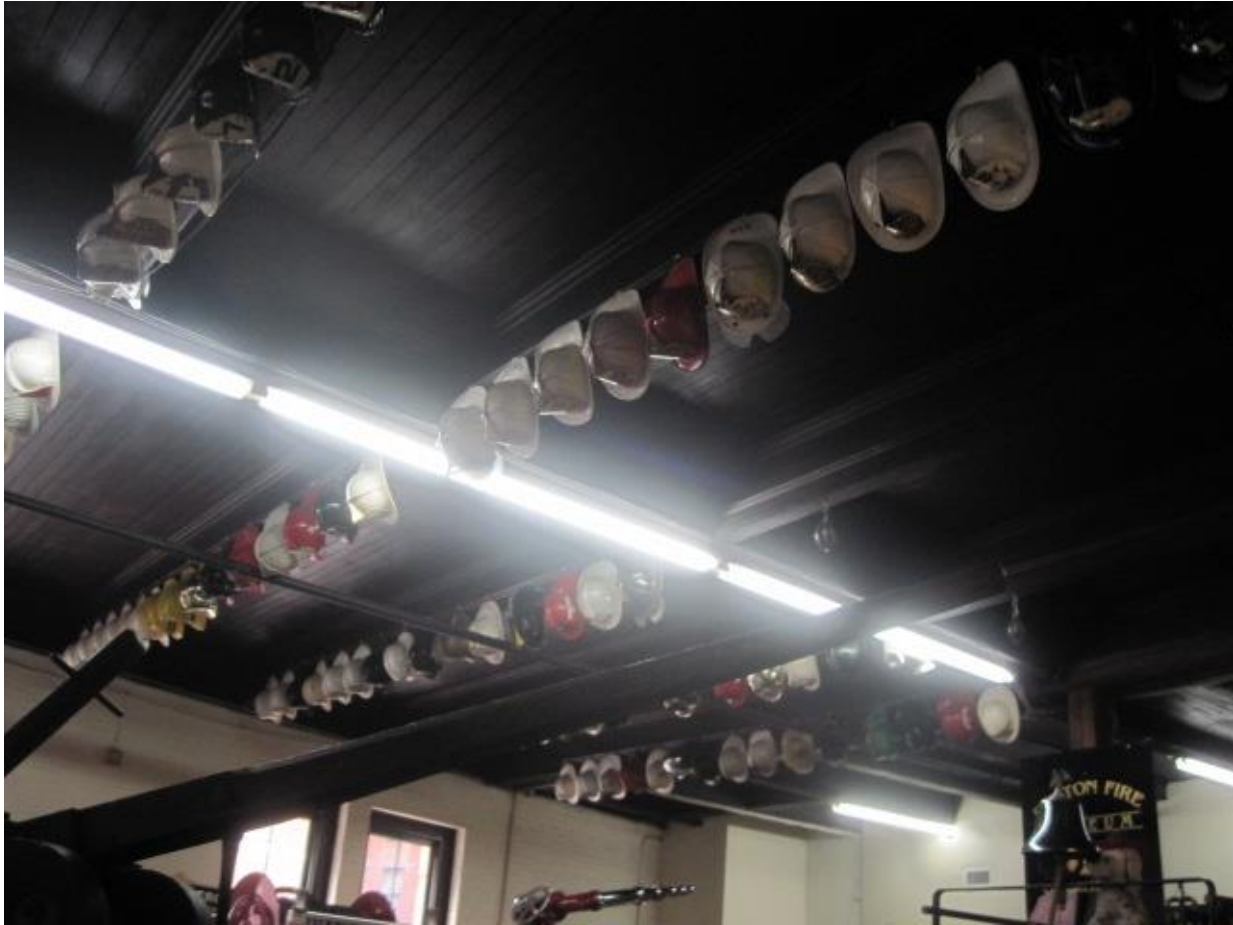
Photograph 14: Craft Details

There are exposed wooden beams on the first floor. The third floor also has an exposed structural system that holds up the second story, which is unique to the building. (Appendix 7, Photograph 14)

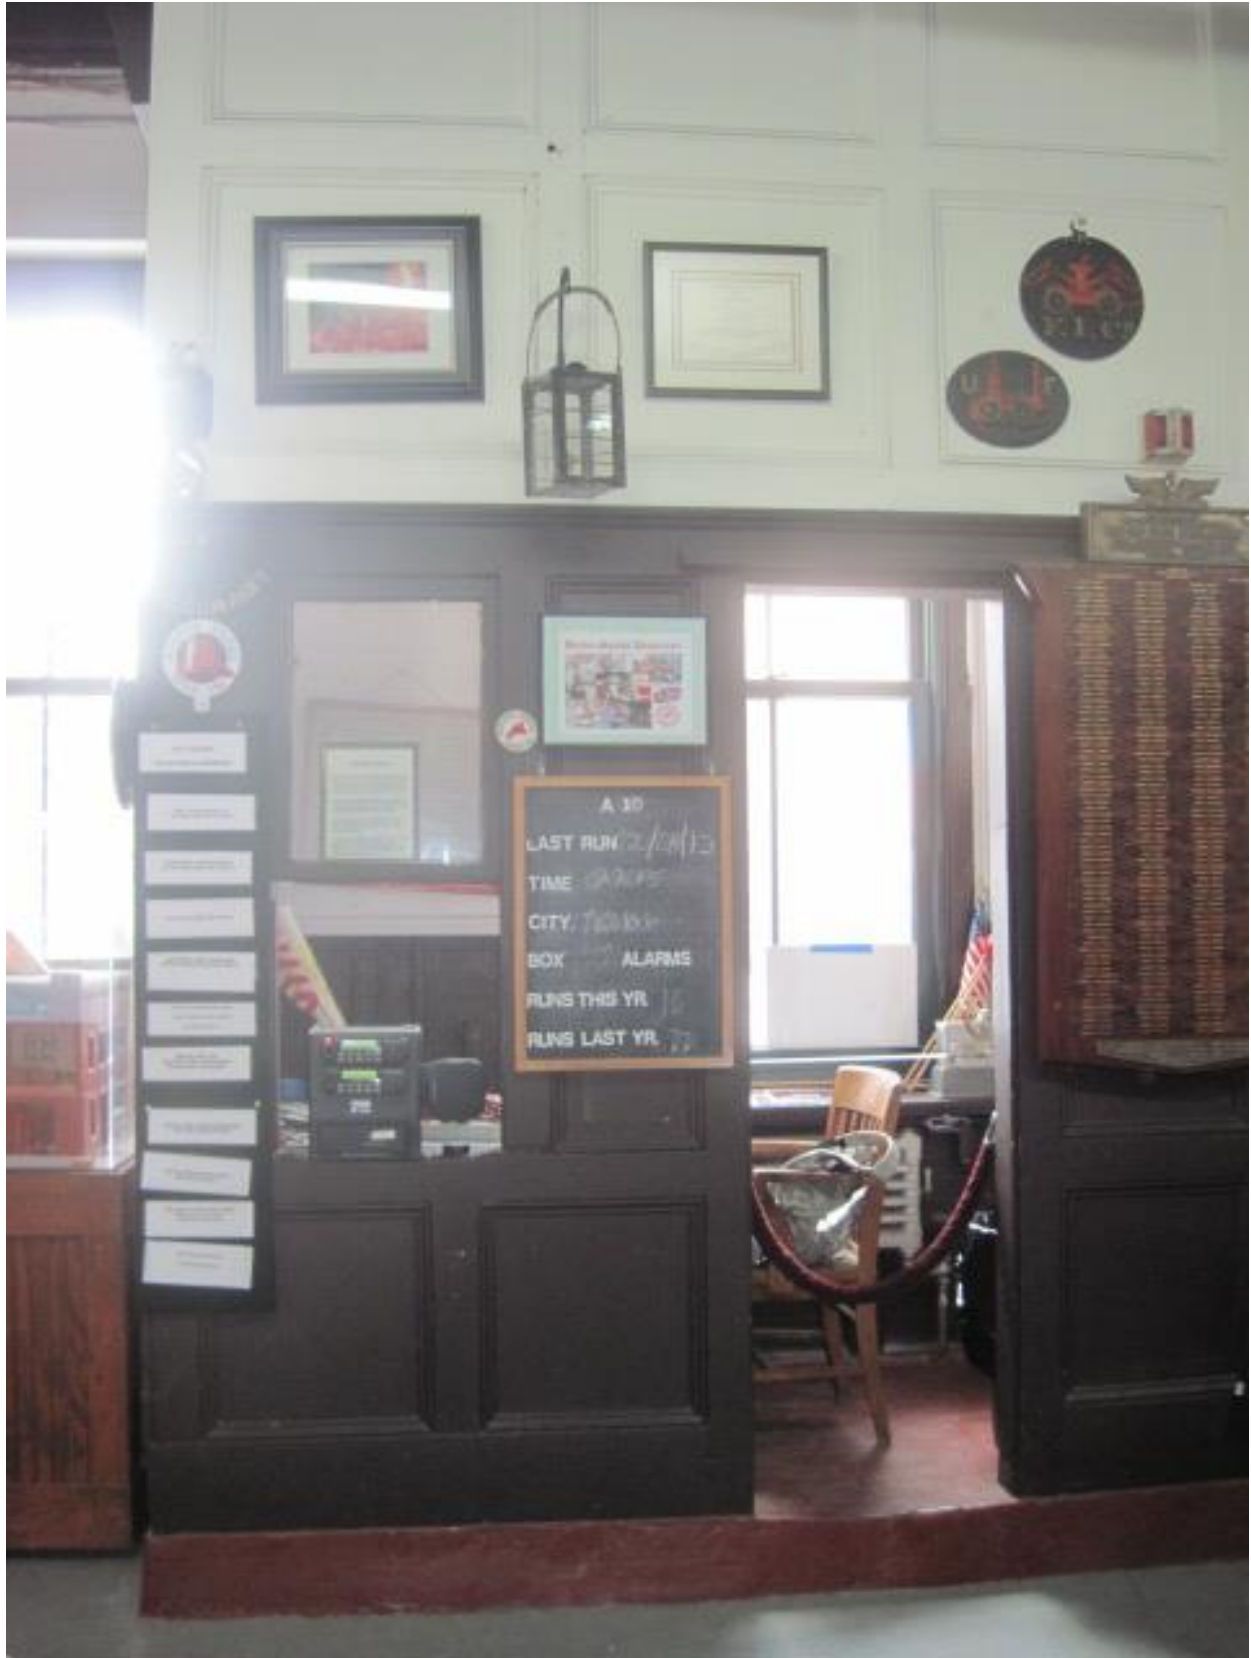
Photograph 16: Individual Spaces

(watch room) is a small raised room surrounded by windows. This room was used by fire fighters to log incoming calls and activities, take reports from the public and receive alarms (Appendix 7, Photograph 16) The second floor has a sitting room, with wood panels; this room would have probably been used solely by the firefighters. There is a large open room which was the bunk room. Since the fire station was also used as living quarters, especially in this one where men would work six days on one day off, the bunk room was a major space within the fire station. There are also two smaller rooms in the back of the station which would have been officers' rooms. These rooms are character defining features because their existence shows the separation and rank within the fire station.

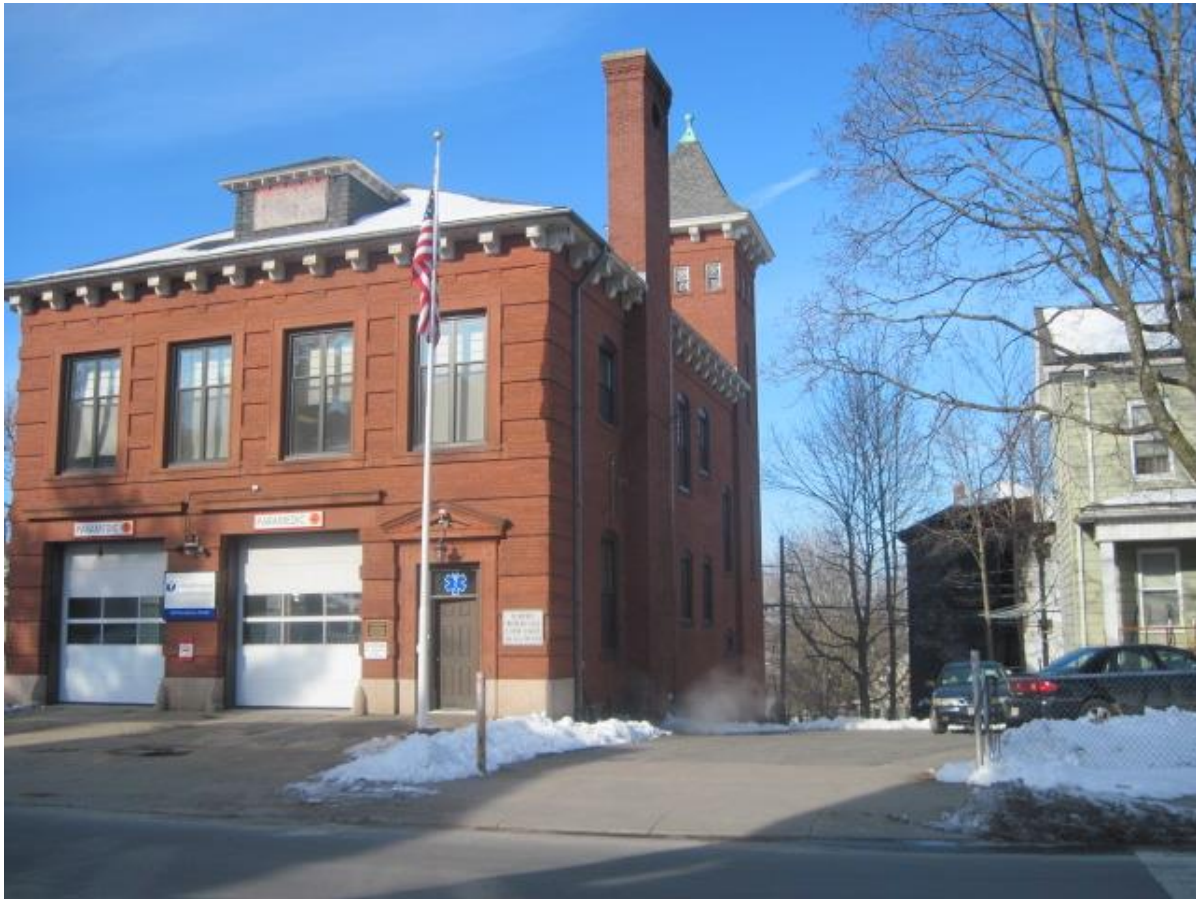
Photograph 17: – Shape

The general shape of the building is simple. The fire station is a two story rectangular building with a square tower on the north side of the building near the back. There is also a chimney on the north side of the building. (Appendix 8, Photograph 17)

The building has a shallow-pitched hipped roof with a single dormer in the front. The roof does not dominate the building façade. (Appendix 8, Photograph 17)

The first floor east façade has two garage doors and one pedestrian door. (Appendix 8, Photograph 17) The door has a surround with projecting circles within the pediment. (Appendix 8, Photograph 18) The second story east façade has a series of four, eight-over-two sash windows. (Appendix 8, Photograph 19) There is a boarded up window in the dormer. The south side, first floor has five, four-over-one sash windows. The second story has a series of small four-over-four sash as well as one four-over-one sash. (Appendix 8, Photograph 20) There are also bricked in window openings at the basement level. (Appendix 8, Photograph 21) The west façade has one, four-over-one sash on the first floor, and a smaller two-over-two sash on the top. (Appendix 8, Photograph 22) There is also a bricked in opening on the basement level.

The major projection on building is the tower, which is square with narrow windows on the first and second levels, and small windows along the top. The top of the tower has a steep, hipped roof. Another projection is the chimney which is on the north wall near the front of the building. (Appendix 8, Photograph 17) There is also a small cupola on top of the roof on the back part of the building. (Appendix 8, Photograph 20)

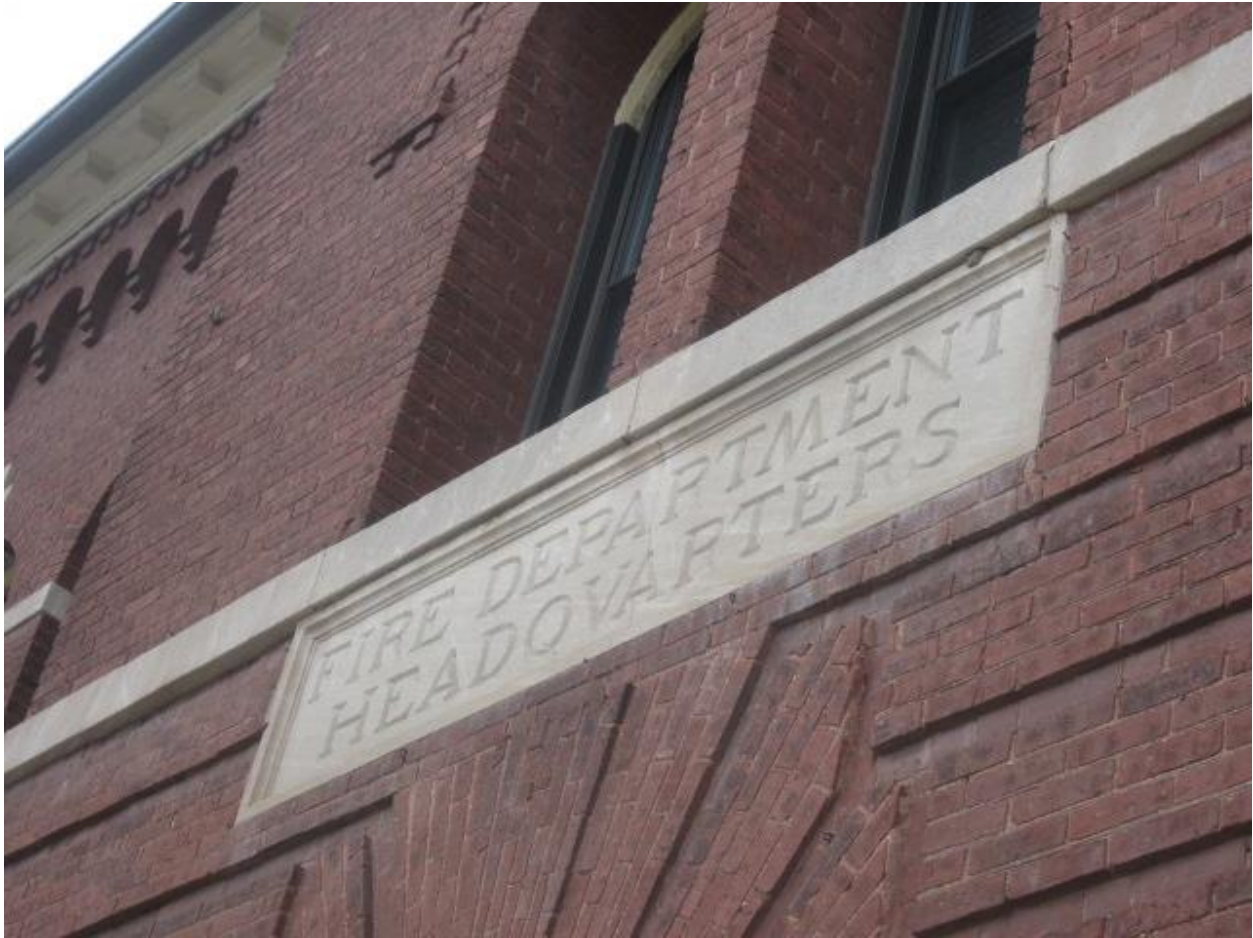
Photograph 66: Trim and Secondary Features – Inscription

The tower has three decorative features to it. One is above the door where there is an inscription that reads "Fire Department Headquarters." This inscription is a character defining feature of the building as it relates to the function of the building. (Appendix 11, Photograph 67) The second decorative feature is an engraving which reads "1899," which is the year the station was built. (Appendix 11, Photograph 68) This engraving is a character defining feature of the

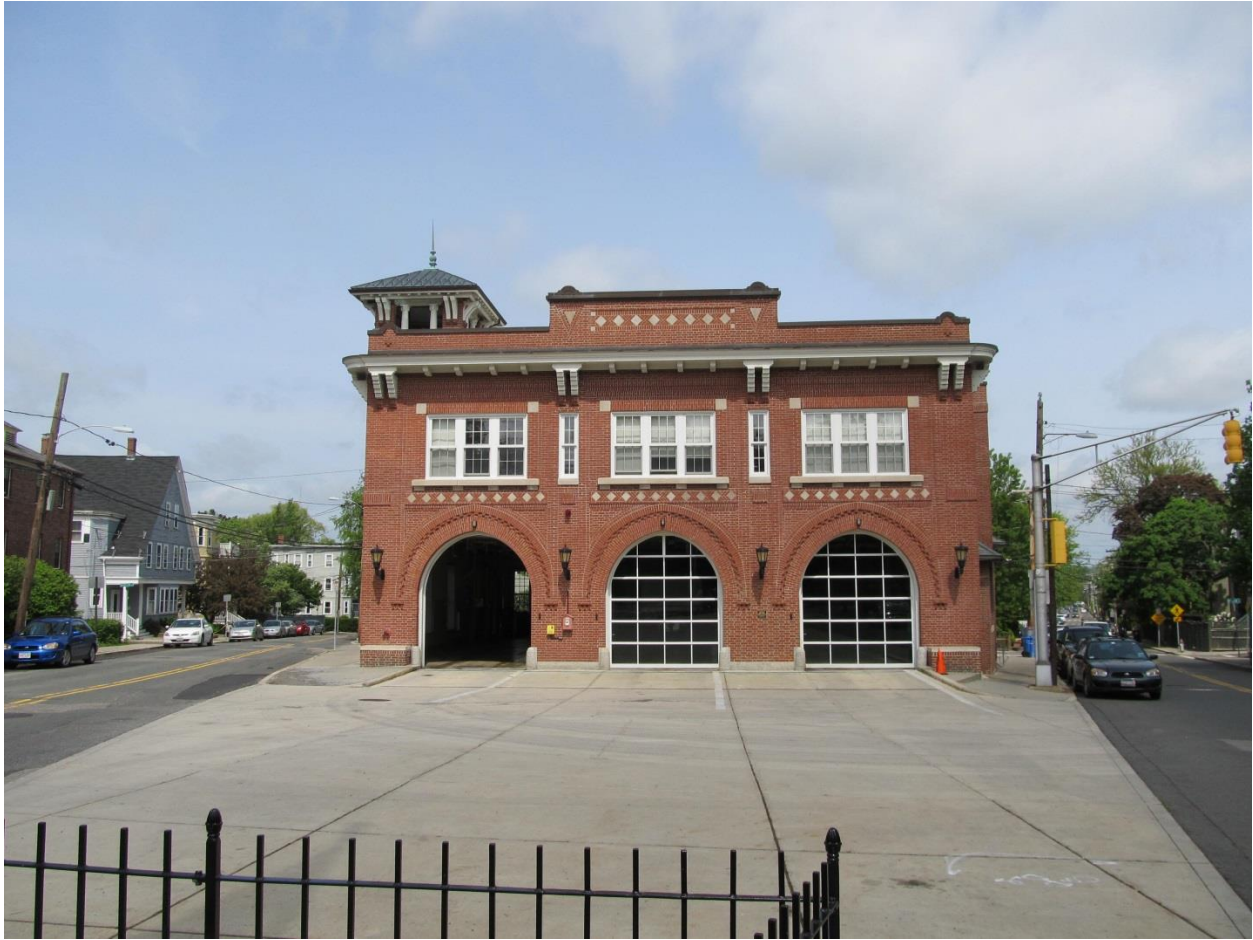
Photograph 70: Shape

The fire station is a two story, rectangular structure with four projections, one of which is a four story tower. The overall shape of the building is a character defining feature. (Appendix 12, Photograph 71)

The main structure of the building has a flat roof with a parapet. The parapet has decorative stone work in the brick work and has decorative molding along the top. The roof of the tower is a shallow pitched hipped roof. The flat roof and the parapet, along with the roof of the tower, are character defining features. (Appendix 12, Photograph 71)

The station sits on the back edge of a triangular lot. The building fills up the majority of the wide end of the triangular lot with the narrower end as part of the drive way and side walk. The location of the station, at the center of the intersection, allows the station to be the center point of the area. (Appendix 12, Photograph 71)

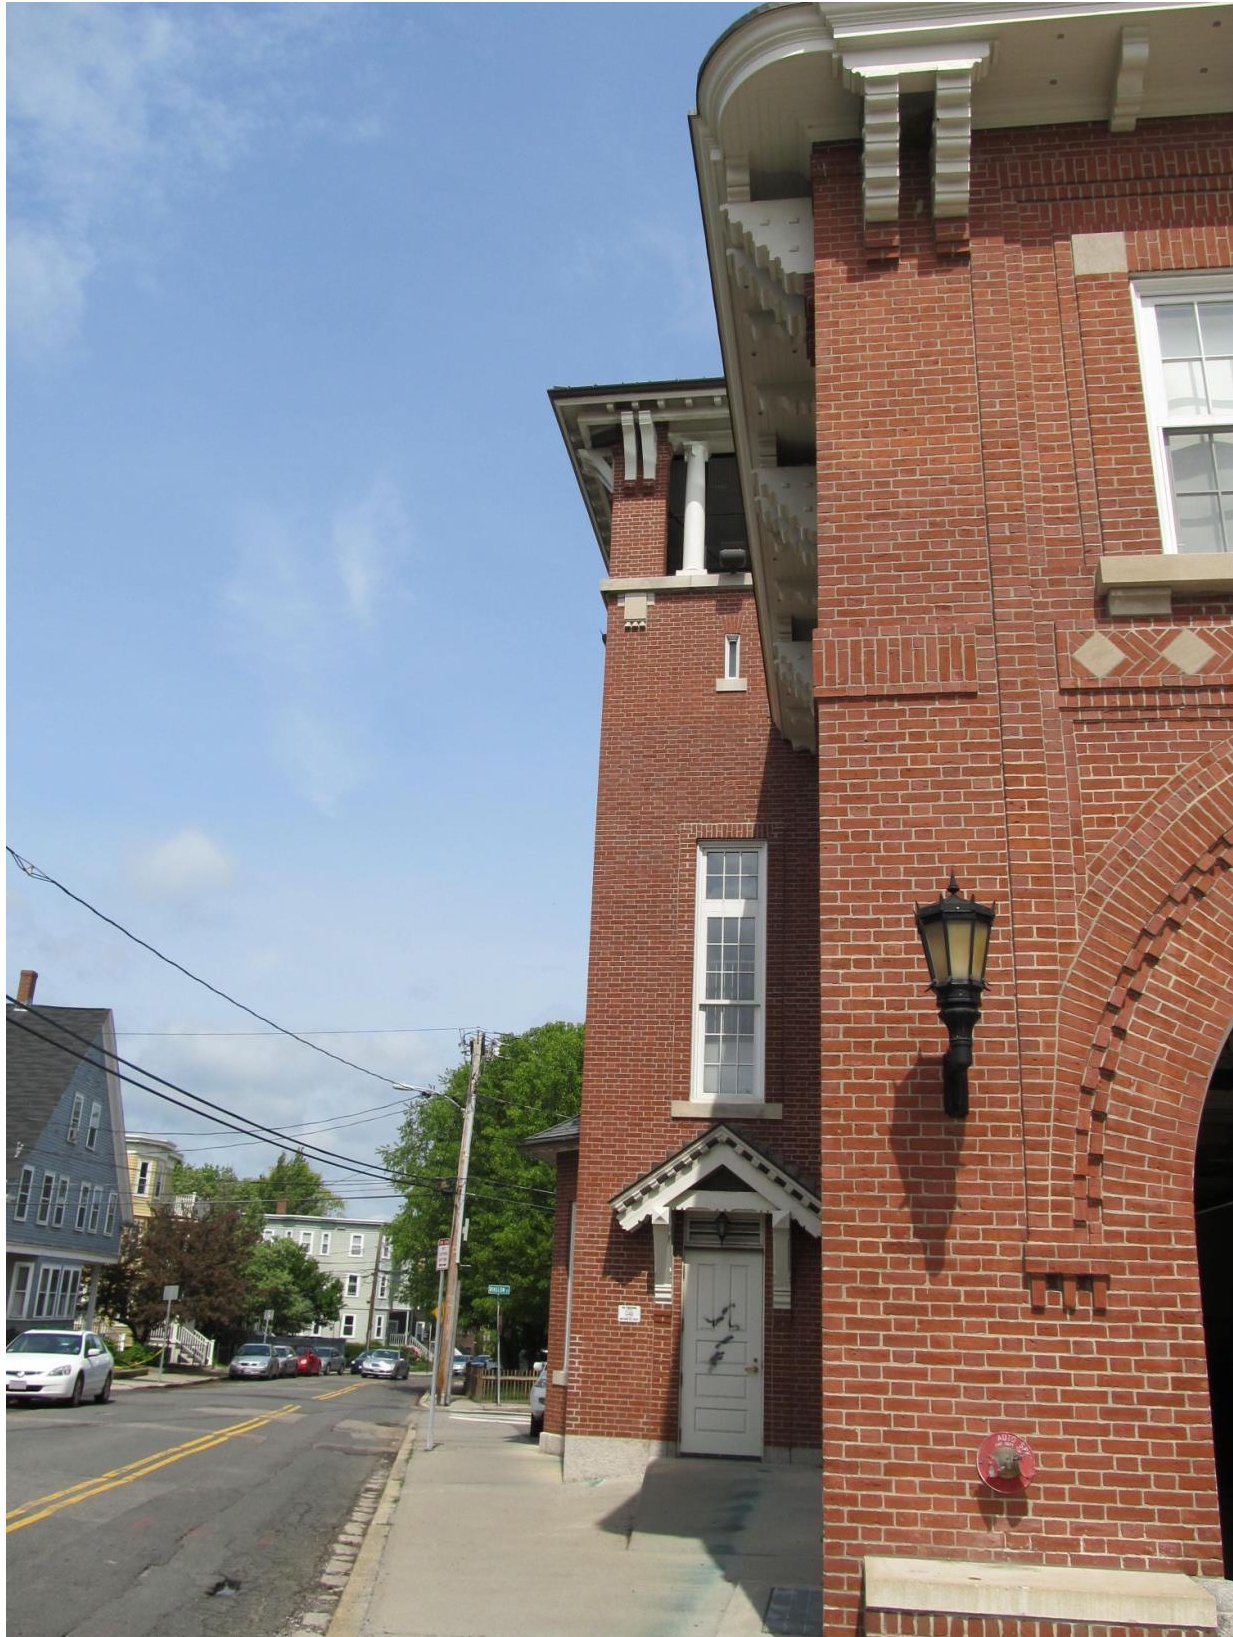
Photograph 71: Openings

they relate to the function of the building. The arrangement of the doors also contributes to the building's character by adding symmetry to the façade. Directly above each apparatus door is a set of three six-over-six sash windows. These windows balance the second floor façade with the first floor façade. In between the set of three windows are two narrow four-over-four windows. These windows add to the balance between the second floor windows, as well as the second and first floors. (Appendix 12, Photograph 71) There is a pedestrian door on the main façade of the tower. (Appendix 12, Photograph 72) This opening, as a main entrance for pedestrians, is a character defining feature. The majority of the windows are either twelve-over-twelve, or nine-over-nine sash windows. These windows are character defining features. The tower has a narrow, six-over-nine-over-twelve window. These large windows add to the linear aspect of the tower and are therefore character defining features. The top of the tower is an open area. (Appendix 12, Photograph 72) This open area is a character defining feature.

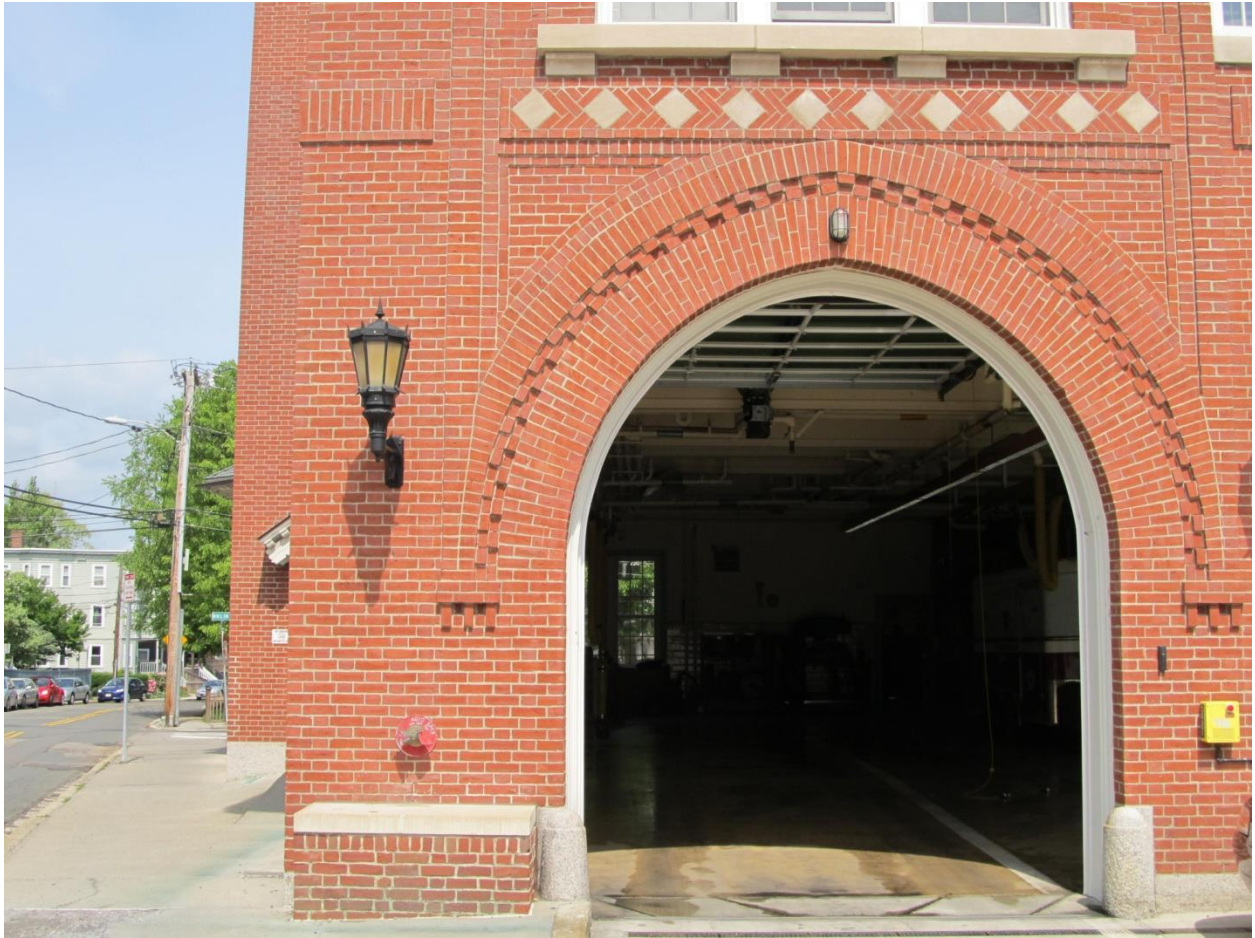
Photograph 73: Trim and Secondary Features

The three apparatus doors are outlined with a decorative brick arch. This brick work is a character defining feature because it adds to the apparatus doors, which are also character defining features. (Appendix 12, Photograph 74) The windows on the main façade are outlined

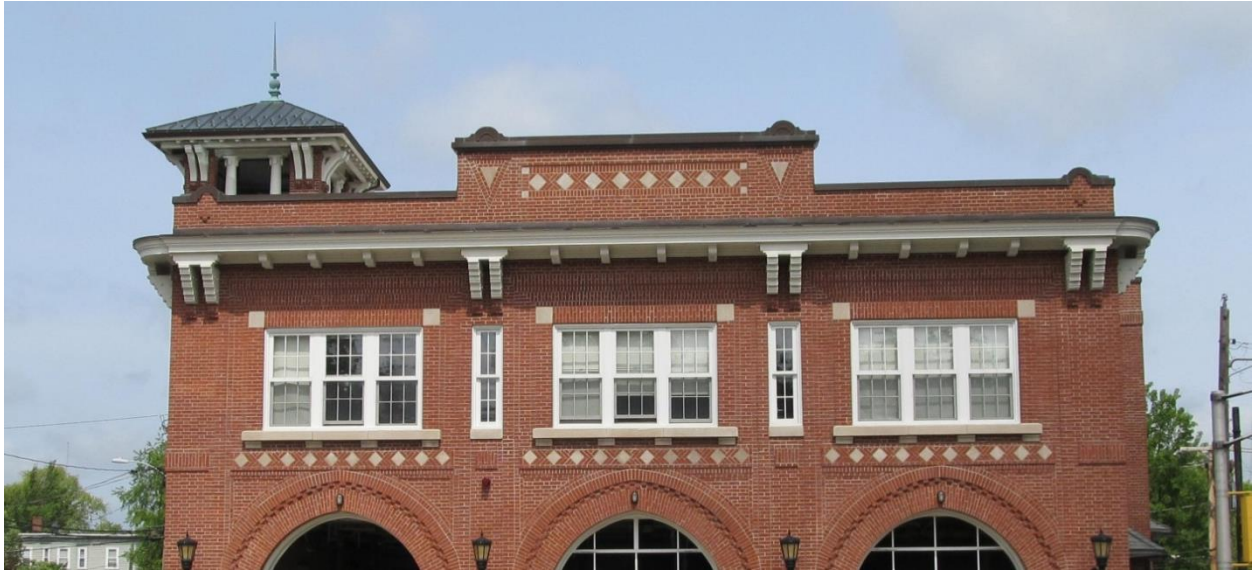
Photograph 74: Trim and Secondary Features

with decorative stone and brick work. This trim adds to the character of the building by accenting the windows, which are character defining features. The decorative stone and brick work around the set of three windows is mimicked along the center of the parapet, which adds character to the parapet. (Appendix 12, Photograph 75)

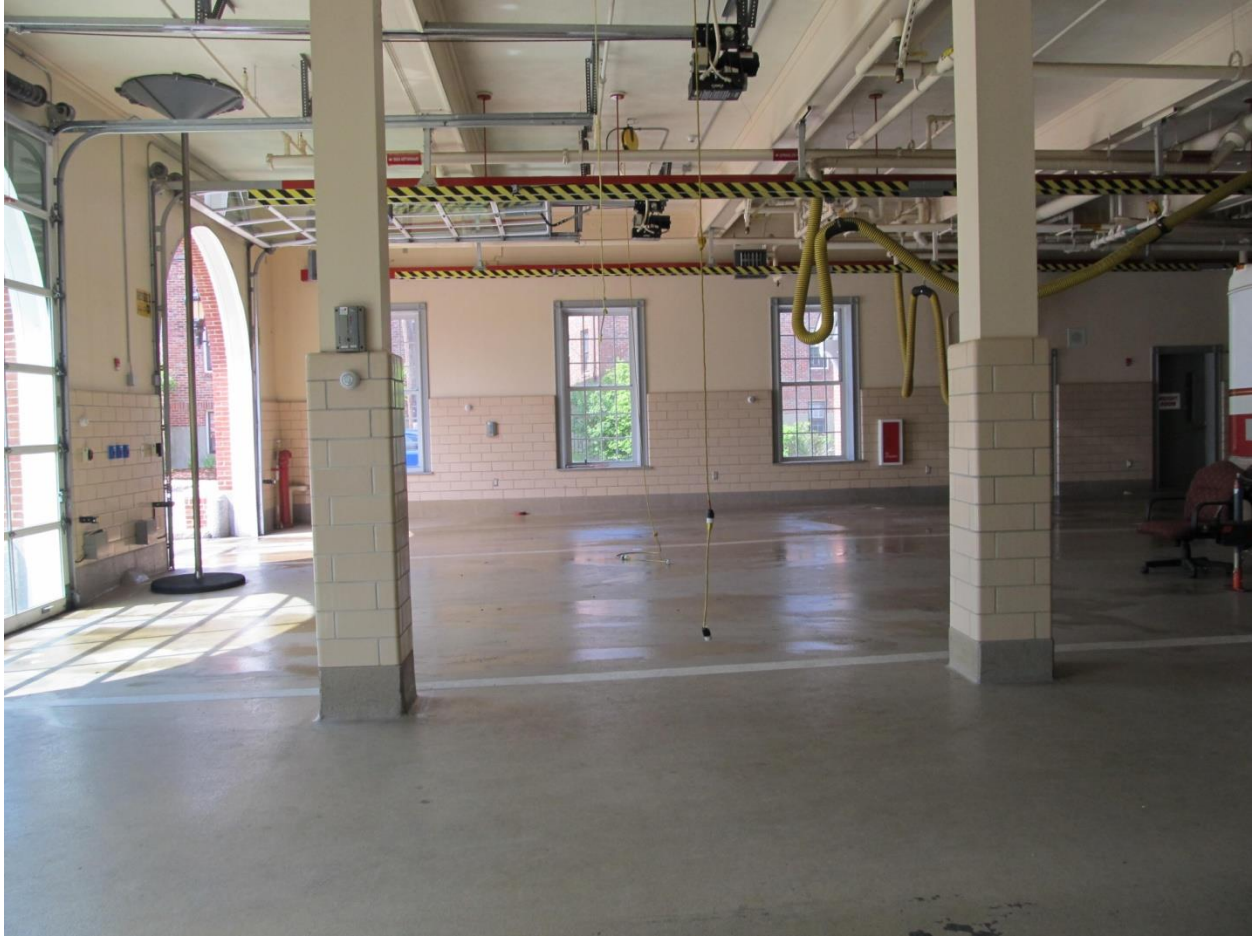
Photograph 76: Individual Spaces

The brick is red with a smooth texture. The brick is connected with a light mortar. The decorative stone work along with the painted wood brackets and cornice is similar in color to the mortar. The mixture of these materials adds to the character of the building. (Appendix 12, Photograph 76) The parapet is topped with copper, which protects the brick and has a similar color to the brick. The copper is a character defining feature.
