Computer vision and thermal monitoring of HMPE fibre rope condition during CBOS testing

Shaun Falconer^{*,a}, Ellen Nordgård-Hansen^b, Geir Grasmo^a

^a Department of Engineering Sciences, University of Agder, Grimstad NO 4876, Norway

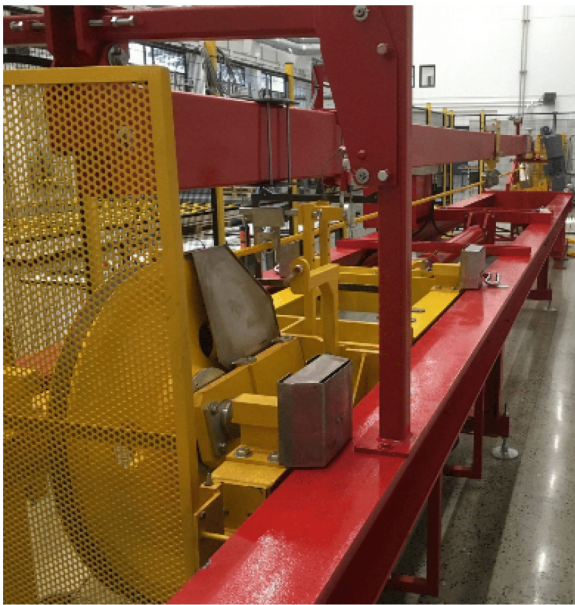
Fig. 1. CBOS test machine as located the MIL, Norway. View is from just behind the test sheave with the driving sheave visible at the far end of the test frame.

The condition monitoring set-up and feature selection were evaluated on ropes during CBOS testing. The test machine used was installed by DEP Engineering at the Mechatronics Innovation Lab (MIL) in Grimstad, Norway, see Fig. 1. The machine is capable of testing both steel and fibre ropes between 20 and 30 mm diameters and can deliver a maximum line pull of 150 kN. The tension is kept constant by a hydraulic cylinder that extends as the test progresses to compensate for creep. The test and driving sheaves have diameters of 0.8 m and 1.0 m respectively. The test sheave is made from 42CrNiMo4 steel and has a U-profile.

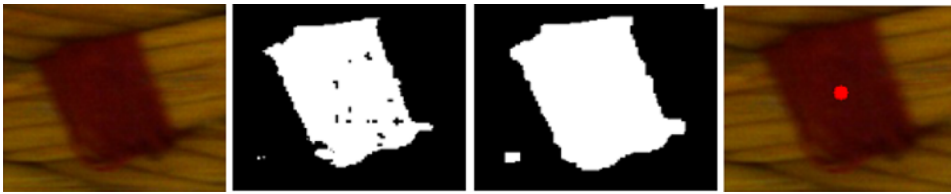
Fig. 4. Different stages and effects of morphological operations applied to the image to detect a specific colour for length measurements: (a) original image, (b) binary image created, (c) dilation operation applied and (d) final processed image with centre point of marker visible after contouring operation.

The local length of each subsection is calculated by locating the different coloured markers sewn into the rope. The image is converted to HSV colour scaling for ease of detecting colours at varying levels of brightness. A specific colour is selected using this colour regime ("red" in the case of the operations shown in Fig. 4). This scale is modified in the algorithm to detect the other colours coinciding with the other zones of interest on the rope. A binary image is created, where the sections of the image that coincide with the colour mask are converted to white. A dilation operation is performed to fill in the gaps in the colour mask and the marker centre points are found using a contouring operation. The Euclidean distance between centre points of both markers is then calculated. The operations are summarised in Fig. 4.

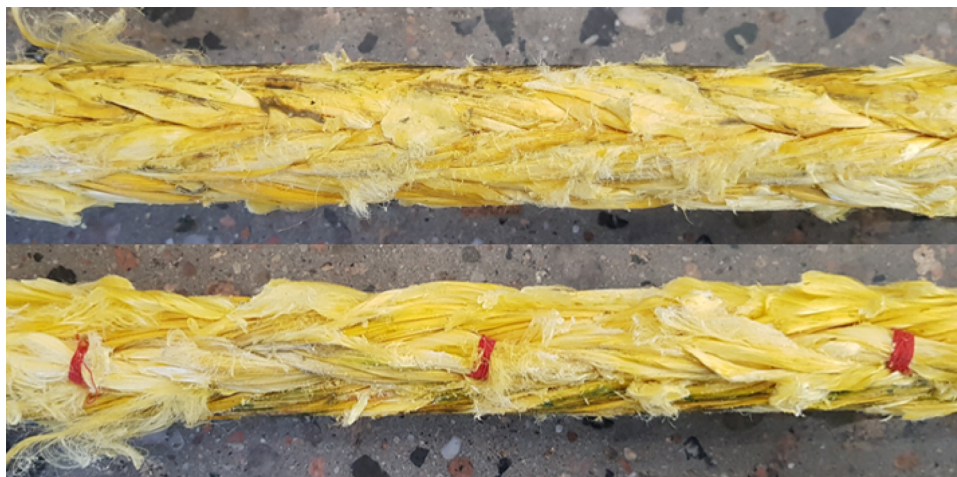
Fig. 8. Compression damage (top) and extruded loops (bottom).

Fig. 8 shows images of the typical state of the rope after each testing phase and removal from the CBOS machine. The top image is an example of the surface compression damage done to the rope through contact with the sheave. The bottom image is the other side of the rope that did not get in contact with the sheave. From this view, the ruptured strands and extruded loops are visible. These become more apparent as the rope degrades during the test.

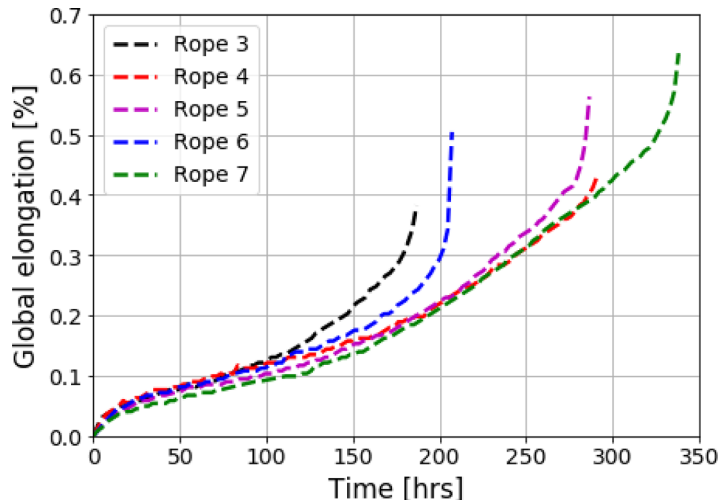
Fig. 9. Global elongation of the ropes after bedding in.

It is noted that Ropes 3 and 6 failed due to degradation in the splice that was partly running over the larger driving sheave. The other ropes all failed at the test sheave as intended. Note that the global elongation in all cases is below 1%, which is in accordance with the manufacturer's rope specification.

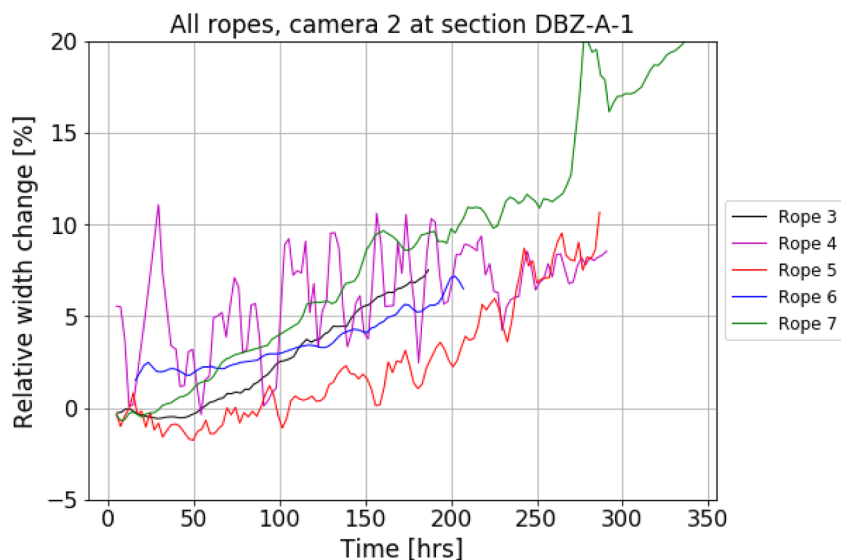
Fig. 12. Percentage change in width from camera 2, perpendicular to sheave axis, at position DBZ-A-1 for all ropes.

The % change in relative width measurements are based on the changes from the original width of each respective subsection. Fig. 12 shows the relative change in width at DBZ-A-1 subsection across all five ropes against time from after the initial bedding in phase until rupture. It also shows that the smallest total relative width changes, when comparing initial and just-before-rupture values, occurred in Ropes 3 and 6, which ran for shortest duration. Substantial varying measurements compared to the other ropes were also observed for this subsection in Rope 4. Camera 2 coincides with viewing from above the rope directly along the sheave axis. Views from the other cameras showed the same tendency of increased width as a function of time, but to a lesser degree.

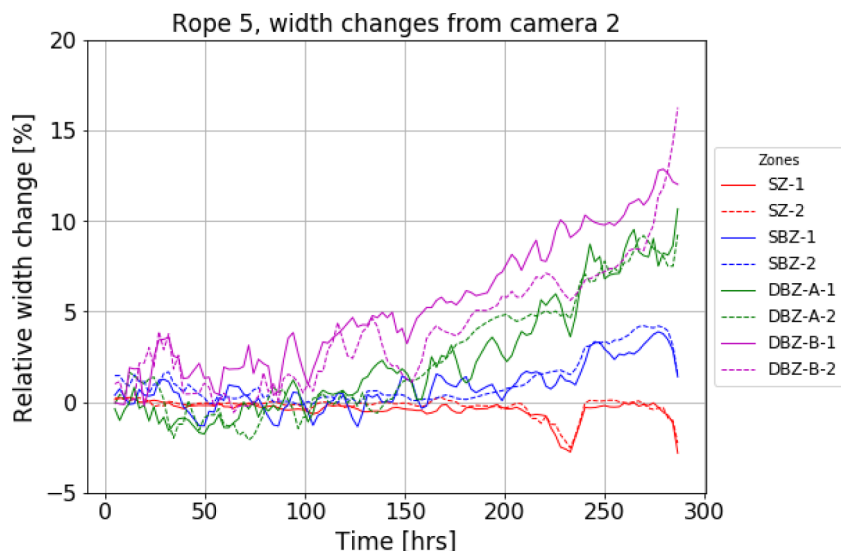
Fig. 13. Percentage change in width from camera 2 for all zones in Rope 5.

Examples of relative width change from camera 2 across all sections with respect to time are shown in Figs. 13 and 14 for Ropes 5 and 7 respectively. The other ropes showed a similar separation between SZ and SBZ showing minor changes, and DBZ sections showing increasing width measurements with the progression of testing. In the SZ section in both examples there is slightly reduced width due to rope elongation.

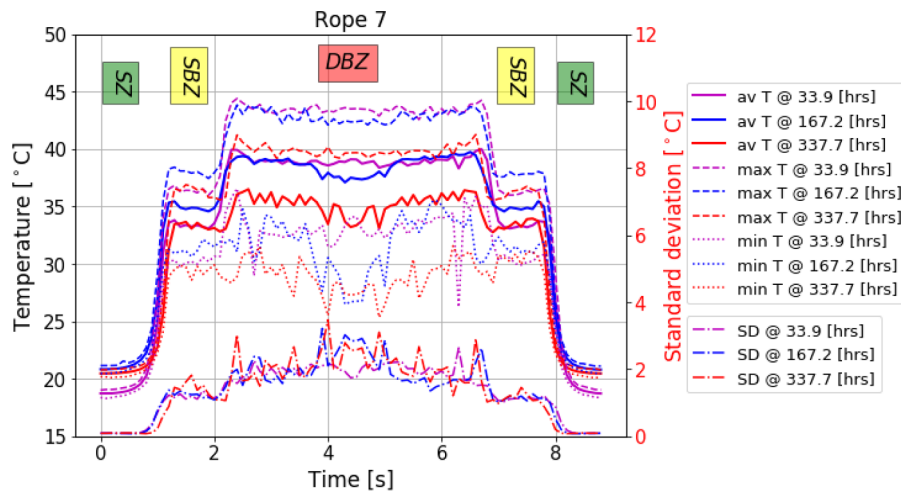
Fig. 16. Rope 7 average, maximum, minimum and standard deviation temperature measurements along the rope for one cycle with respect to the associated test time.

After increasing from the beginning of the test, the average temperature in the DBZ section is shown to decrease as the rope heads toward rupture. This also coincides with lower maximum and minimum temperature at the DBZ section at the more advanced recording times during testing.
