## Improving the reliability of visual inspections conducted by environmental health and safety professionals, on a hyperscale data centre construction site

Alex A. Schouten  
*Technological University Dublin*

Victor Hrymak  
*Technological University Dublin, victor.hrymak@tudublin.ie*

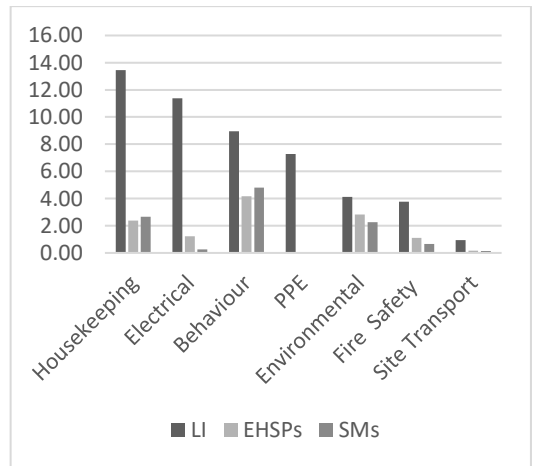
Fig. 2 Mean N hazards observed by construct

A further noteworthy finding is the differences in the number of site hazards observed when categorised into constructs as seen in Fig 2, below. This bar chart demonstrates not only the variability in the number of hazards observed between the lead investigator, EHSPs and site managers, but also the type of hazards observed.
