Maglehøj – preservation of birch bark in a passage grave with evidence of forced entry in prehistory

ABSTRACT

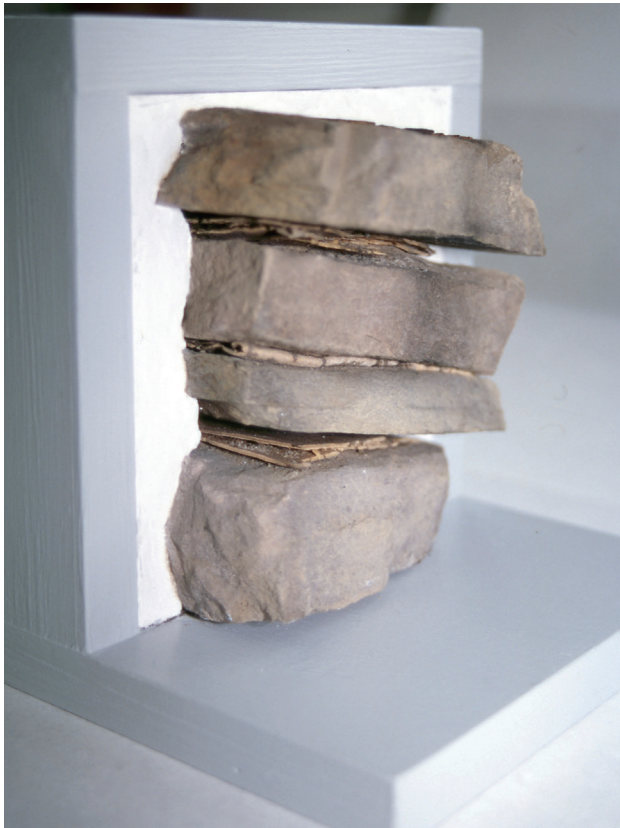
Figure 1. During the investigation at Maglehøj in 1996, five dry-walling slabs with preserved birch bark in between were extracted and fixed as a block for museum storage (Photo: T. Dehn).

- 1) to record the birch bark in the passage grave's dry-walling,
- 2) to extract a block sample containing birch bark in collaboration with the National Museum of Denmark for storage in the museum's storage facilities (Figure 1),
- 3) to attempt to establish the significance of the monument's construction for the preservation of the bark and
- 4) to attempt to find an explanation for the un-

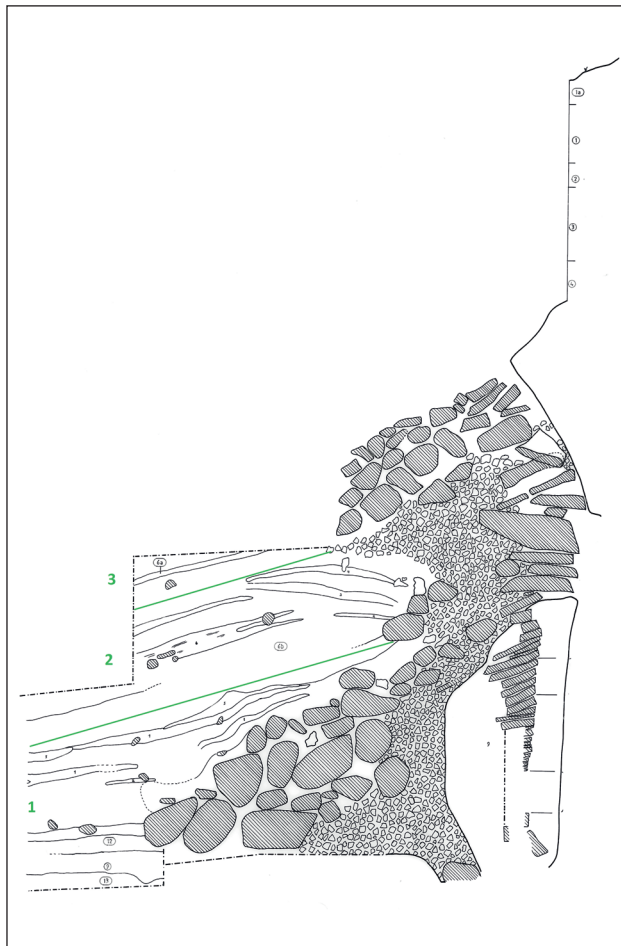
Figure 2. Maglehøj 1996. Section showing the intact construction of the mound outside the southwestern end of the chamber. Immediately adjacent to the orthostat and intermediary layer lies a packing of crushed flint, held in place by a structure of stones and mound fill. It is evident that the latter was added in three operations (1-3) (Drawing: T. Dehn, L. Holten and M. Nissen).

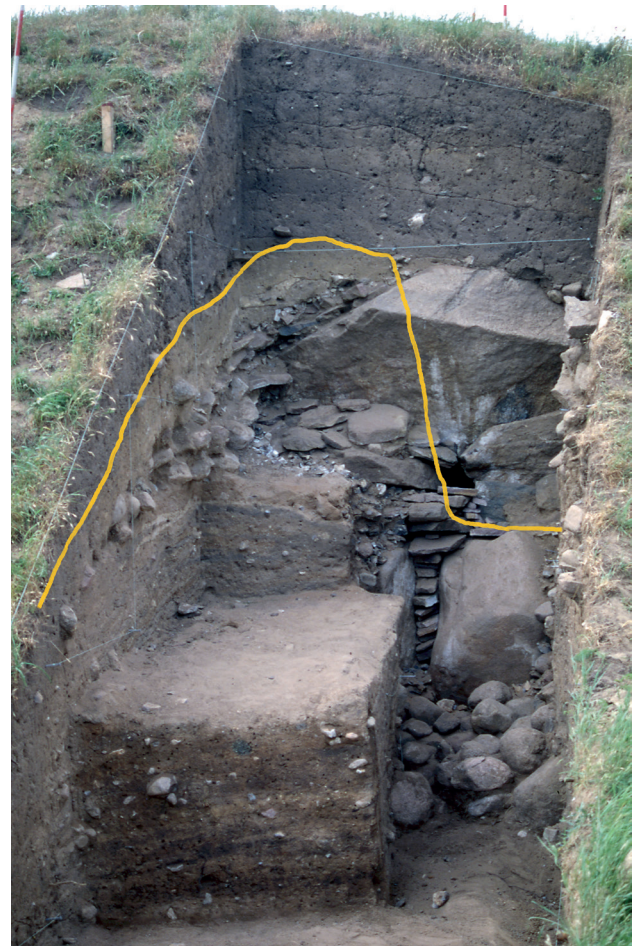
Figure 3. The excavation trench at Maglehøj in 1996 and the southwestern gable of the chamber. The area below the yellow line is the intact structure of the passage grave. The area above the line was altered later in prehistory, probably during the Late Neolithic (Photo and drawing: T. Dehn).

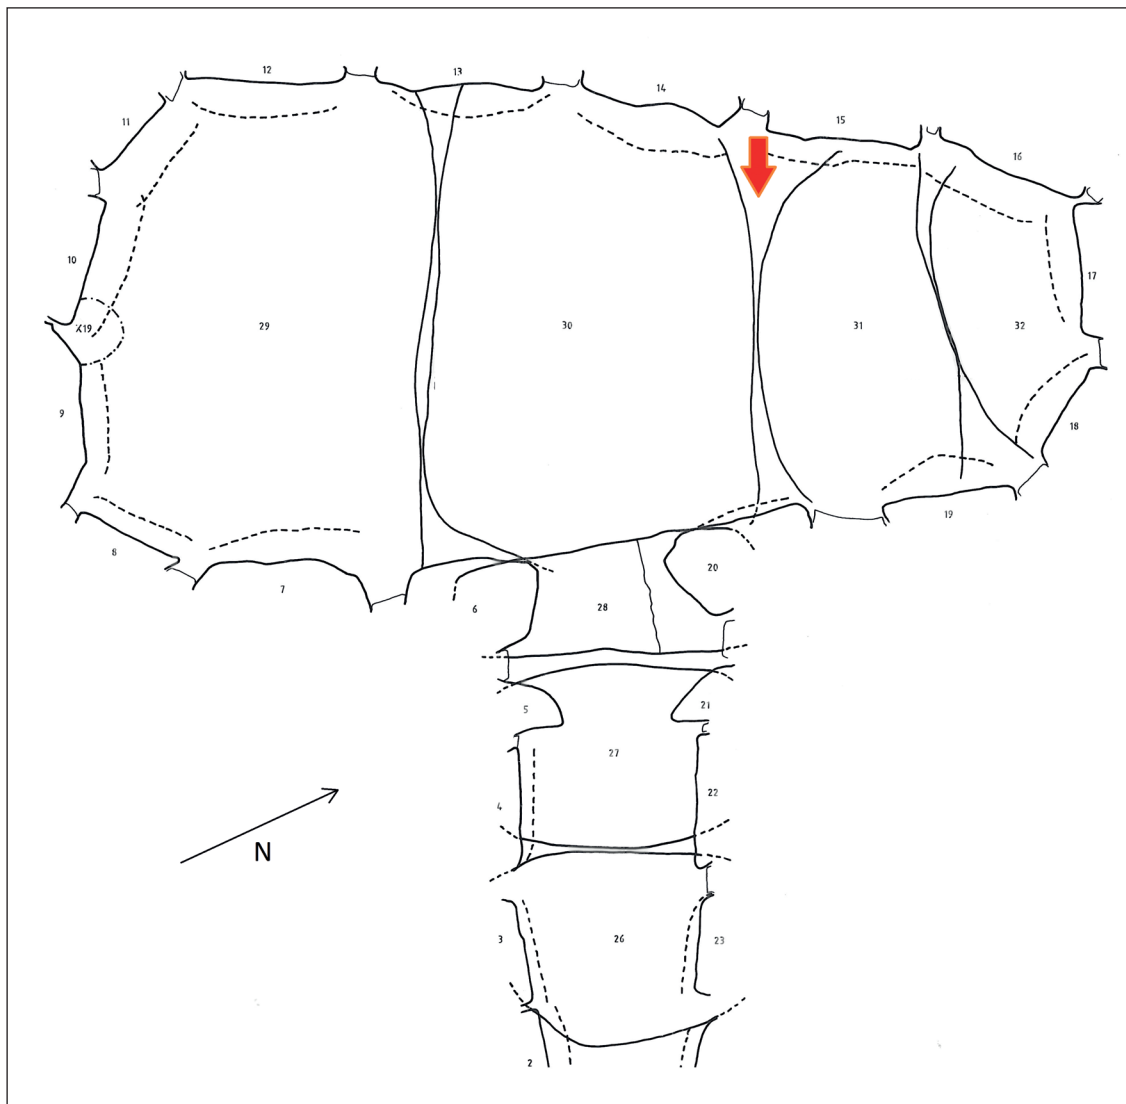
Figure 4. Ground plan of the Maglehøj passage grave. The red arrow marks where the chamber was entered between the capstones when the monument was opened in 1823. The chamber is 5.6 m long (Drawing: L. Holten and M. Nissen).

The chamber's ground plan is stated as being oval, but broader at the southeastern end. The chamber is 5.6 m long and 2.5 m wide in the middle. Within this oval room there is a 15-16 cm

high raised platform on the floor, 3 m long and almost 1.3 m wide in the middle, and of the same oval form as the chamber's ground plan. This is laid with small, loose beach pebbles, and around the edge stand some 'roundish, not very large boulders', which extend 'a few inches' above the floor. Over the chamber are three large capstones and a lesser one. This arrangement of the chamber floor is quite unusual. Normally, chamber floors are covered to varying degrees by cobblestones or flagstones, to which can be added various examples with clay, sand and fire-shattered flint (Ebbesen 2011, 276-278). The situation on the chamber floor can vary considerably when initially described. It has often been disturbed in conjunction with the discovery of the passage grave and perhaps the first steps in

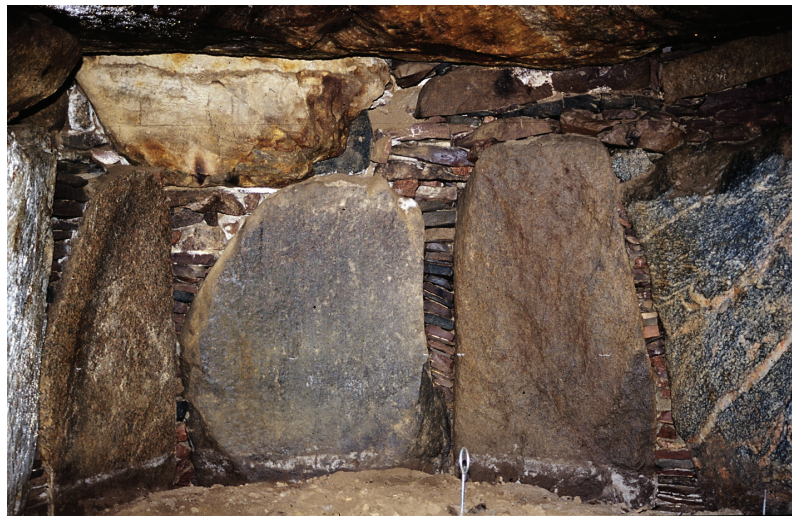
Figure 5. The southwestern gable of the chamber in Maglehøj seen from the inside. The flagstone set on edge associated with the secondary closure is the light stone in the upper left (Photo: T. Dehn).

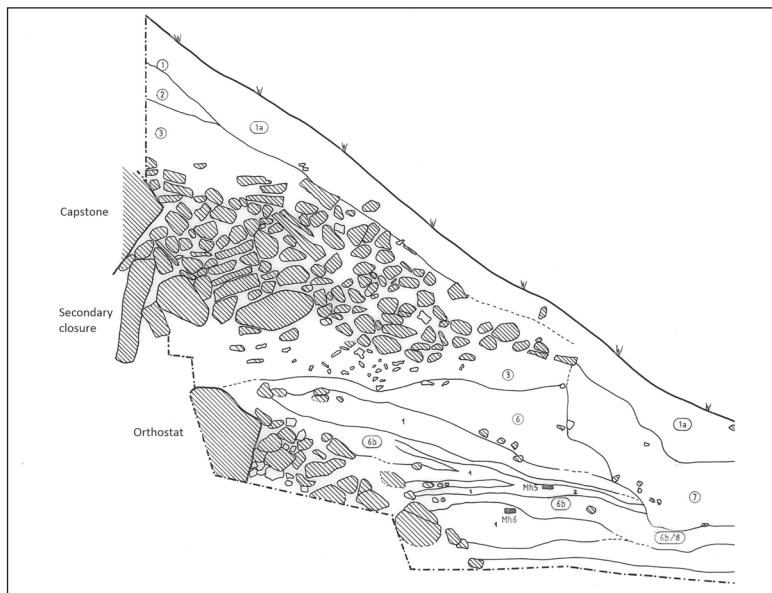
Figure 6. Section showing the intrusion into the intact Maglehøj passage grave. To the left is the edge of one of the chamber's capstones and below this the flagstone set on edge associated with the secondary closure. Outside these is the back-filled pit from the intrusion (layer 3) (Drawing: L. Holten and M. Nissen).

verse of one of the vertical slabs between the orthostats and capstones was visible in the excavation trench which exposed the rear of one gable. It was clear that the mound construction in the part behind this slab was not the original. Instead of meticulous sealing with flint packing and clearly stratified mound fill, in this area there was unstructured fill containing topsoil mixed with stones of all sizes. This was interpreted as backfill in a large pit dug behind the uppermost part of the chamber's gable (Figure 6). In this backfilling, some of the material has penetrated the poorly sealed rebuilding of the gap between orthostats and capstones, where access was gained to the chamber, which is why Lars Rosted noticed a heap of soil here. Subsequent settlement of material in the backfilled pit resulted in the 'depressed' mound surface that was described in the 1820s.

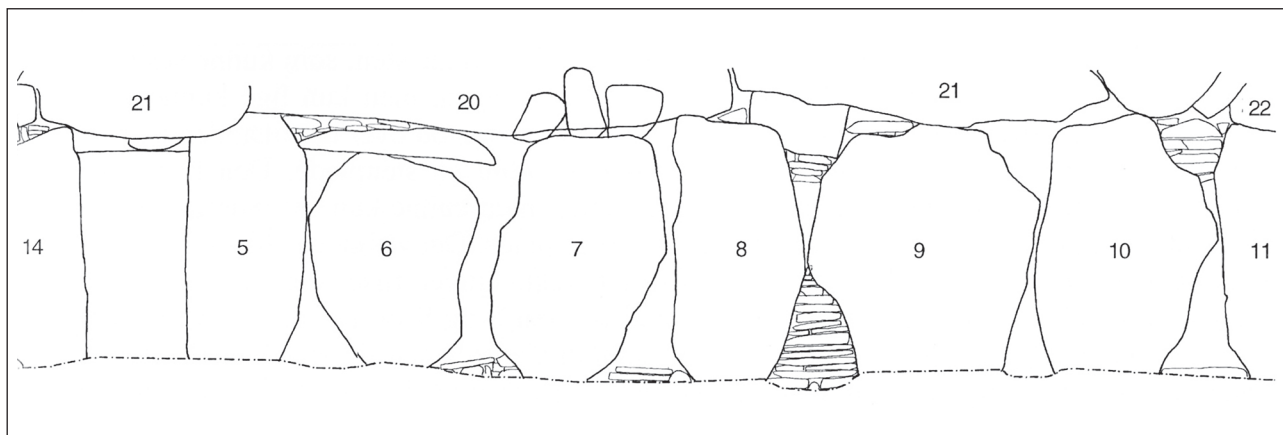
Figure 7. The chamber of the Bigum passage grave was also broken into later in prehistory. On this elevation showing part of the chamber three slabs set on edge cover the gap between orthostat 7 and capstone 20 externally. To the right of this is another slab set on edge between orthostat 8 and 9 (Drawing: T. Dehn).

One example is the Bigum passage grave. Already on being opened in 1914, it was realised that a large gable stone at one end of the chamber leaned outwards and that the dry-walling was missing on both sides. During a restoration in 1990, a trench was dug into the mound behind the leaning orthostat, and it could be seen that the gable stone had been tilted further outwards so there was access between the upper surface of the gable stone

and the capstone (Dehn, Hansen and Kaul 2000, 235-254). The gable stone was subsequently not completely returned to its original position, so the horizontal gap between the gable stone and capstone had been closed with large, rectangular slabs set on edge (Figure 7). It was also apparent that the kerbstone ring had been rebuilt at least twice. During the investigation in 1914, it became evident that the passage lacked capstones. Instead, a Late Bronze Age urn grave stood on one of the orthostats and a stone bearing rock art lay in front of the entrance to the passage. The chamber had two clearly distinct burial layers: The lower layer contained skeletal remains and amber artefacts, while the upper layer had contents that included flint daggers and a bell beaker, indicating that extensive alterations took place in both the Late Neolithic and the Bronze Age.

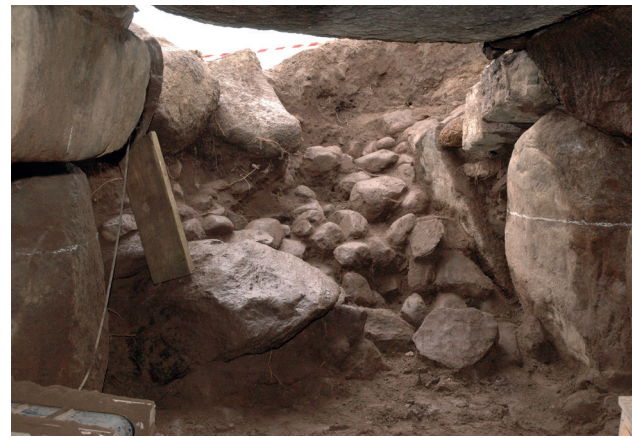
Figure 8. The chamber in Stuehøj lacks an orthostat on one gable. This has been replaced by a heap of stones, which includes larger packing stones and a partially toppled orthostat, seen on the lower left of the picture, where the upper part of the stone heap has been removed (Photo: T. Dehn).

A third example is evident in the passage grave of Stuehøj near Ølstykke in northern Zealand². This was opened in 1834 by the landowner, who found flint daggers, urns and bronze artefacts, among other things, in the chamber. For many years, the chamber's capstones lay exposed at the base of a large pit, and in 2006 a restoration was initiated. One end of the chamber consisted of a large pile of fieldstones, which was found to represent secondary closure of the chamber after a large orthostat in the gable had been completely removed to give access (Figure 8). A stone socket, together with remains of dry-walling, showed that an orthostat had once stood there (Figure 9).

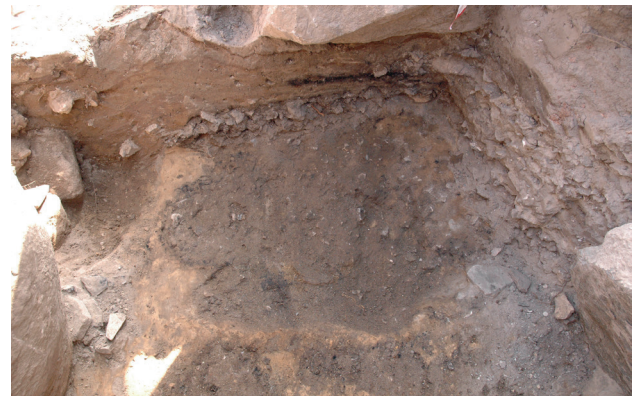
Figure 9. The pit dug down to reach the subsequently removed orthostat lay under the stone heap at the gable of Stuehøj's chamber. Remains of dry-walling can just be glimpsed on the left, and the base of the flint packing which has formed part of the structure around the orthostat is visible behind the pit. To the right, this packing is preserved to a greater height. The actual stone socket has a charcoal-rich fill containing a quantity of crushed flint from the packing outside the stone. Immediately above the preserved base of the flint packing is a 5-10-cm-thick charcoal-rich layer. There is therefore much to suggest that fire was used to make the large stone brittle and ease the process of its removal (Photo: T. Dehn).

The stone socket contained flint which had been part of the packing behind the orthostat that was removed from the chamber. The flint had fallen into the gap left when the stone was pulled outwards. The earthen fill that has also fallen into the gap had a high charcoal content, and in the area behind the stone socket there was a 5-10 cm thick layer of charcoal (Figure 9). A likely explanation for this is that fire was used to make the stone brittle so it could more easily be broken into pieces and removed.

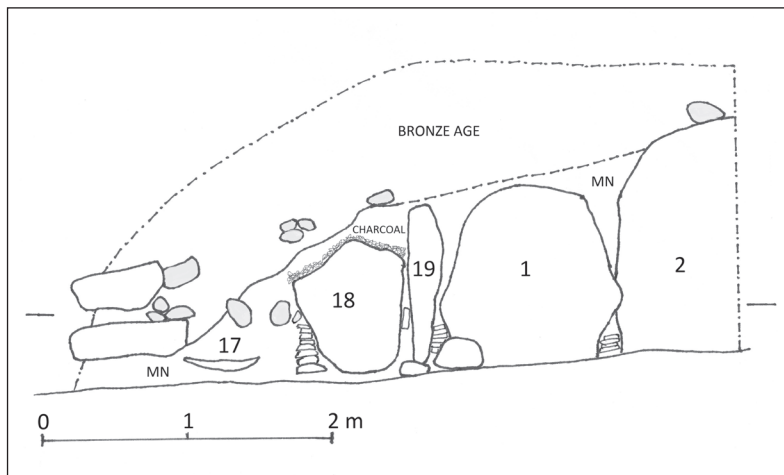
Figure 10. In the Holmhøj passage grave, the outermost part of the passage was reduced in height during alterations to the mound. On this elevation, stones 1, 2 and 19 are still seen in situ, while stone 17 has been removed, although its base remains in a 'rotten' state. The upper part of stone 18 has been hacked off after being rendered brittle by fire. The two horizontal stones on the left form part of the altered kerbstone construction (Drawing: S.I. Hansen and T. Dehn).

absent. During a restoration in 1887, the orthostats at one side of the passage were broken up to enable a completely new passage to be built which provided better access for visitors. One of the aims of another restoration in 2021 was to remove the latter and, as far as possible, re-establish the original passage. During this process, the preserved side of the passage again became visible (Figure 10).

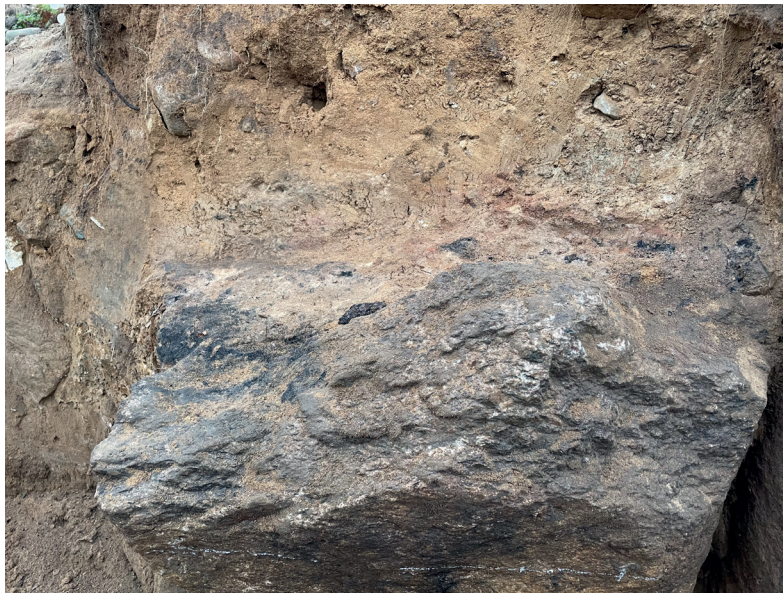
Figure 11. The penultimate orthostat in Holmhøj's passage (no. 18 on Fig. 10) has been reduced in height by hacking away its upper part. Large quantities of charcoal and red-burnt mound fill show that a fire has been lit outside the stone to aid the process (Photo: T. Dehn).

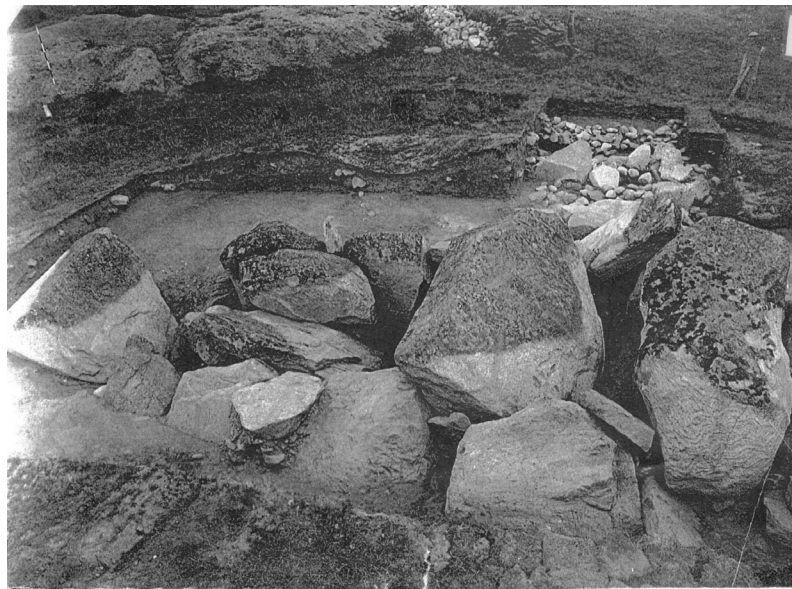
Figure 12. The collapsed and exposed chamber of the Tustrup passage grave in 1954, prior to investigation and restoration. Even back then, the possibility was considered that the collapsed end of the chamber on the left of the picture was caused by an intrusion later in prehistory (after Eriksen, Dehn and Hansen in press).

As a final example of a possible intrusion into a chamber, mention can be made of the passage grave in the megalithic complex at Tustrup on Djursland. In both 1887 and 1891 this was described as a passage grave in a collapsed state, and it was excavated and restored in 1954 (Eriksen, Dehn and Hansen in press). The orthostat in one gable and a broken capstone together provides a basis for an interpretation that an intrusion into the chamber took place in prehistory. The gable orthostat is tipped outwards and lies at an angle of at least 45 degrees. The capstone is broken into two parts, which lie directly beside the orthostat on the floor of the chamber (Figure 12). It seems

likely that the breaking of the capstone was caused by the gable orthostat being toppled. Extensive preparatory work was required prior to toppling the large orthostat outwards, as it was necessary to dig a pit measuring *c.* 2 x 2 x 2 m from the surface of the mound, part of which had to be cut through some of the solid stone packing which encloses the entire construction.

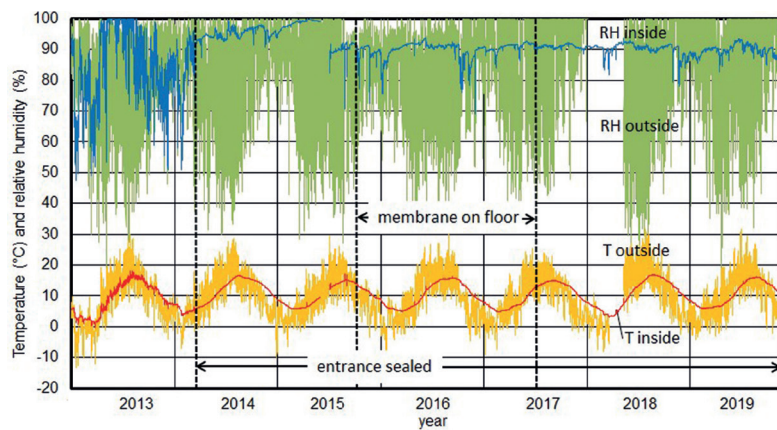
Figure 13. Measurements of temperature and relative humidity inside and outside the Maglehøj chamber in the period 2013-19.

During the first year of the investigation the passage leading into the chamber was open, while in the subsequent 5 years it was closed with a sealed door. Temperature and relative humidity were measured both inside and out with the aid of electronic sensors attached to a central data logger (Figure 13). The measurements showed that the internal temperature follows the average external temperature with a delay of about a month. The annual fluctuations in temperature are damped inside the chamber so the maximum lies some degrees lower and the minimum some degrees higher than the corresponding averages for the external temperature. This is due to the thermal inertia constituted by both the stones and earthen fill, as well as the earth below the floor. There is only a marginal difference in the fluctuation from summer to winter between the open and the closed passage. The thermal stability is far from adequate to level out annual variations

The closing of the chamber had a much greater influence on air humidity than on temperature. In the open chamber, air humidity varies between 50 % and 100 % RH according to the season and external climate. There are frequent episodes with condensation on the internal surfaces in the period between April and September. This is because the external air during this period is warmer than the chamber and contains a relatively large amount of water vapour. When this warm, damp air meets the cold surface of the stones, the water vapour condenses. In the closed chamber, the relative humidity is high and constant, around 90 % RH all-year round. Even so, condensation is a rare occurrence. This is because the temperature of the air is almost the same as the surface temperature of the stones. Even though the relative air humidity is high, the dewpoint is rarely exceeded. The closed situation has presumably prevailed during most of the monument's existence up until the opening of the chamber two centuries ago. There has therefore been a stable, damp climate *without condensation* for much longer than a variable climate with alternating periods of desiccation and condensation (Figure 14).

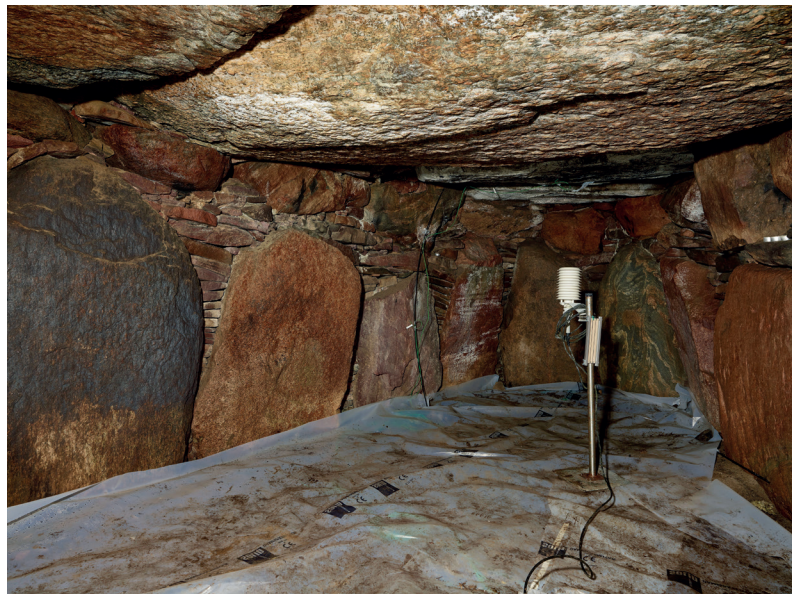
Figure 14. The Maglehøj chamber seen looking north, with a damp-proof membrane on the floor. The internal climate sensors can be seen on the right (Photo: R. Fortuna, Danish National Museum).

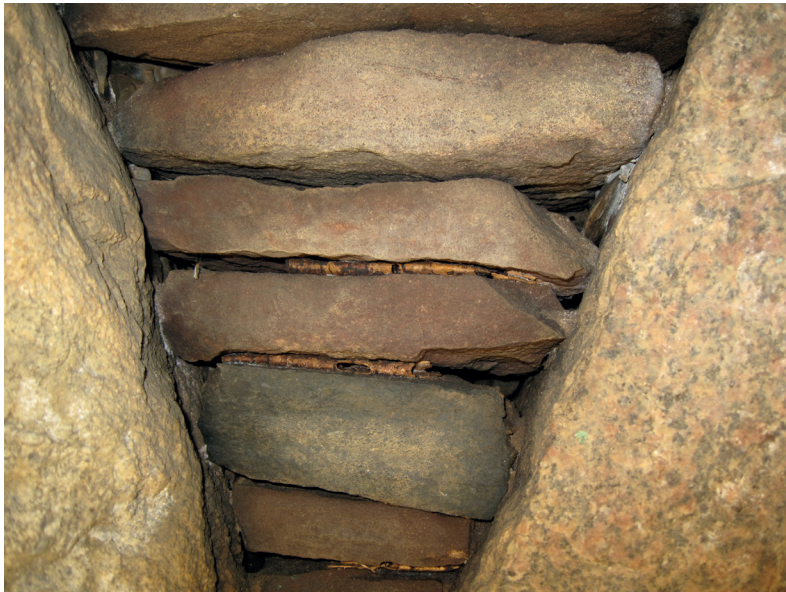
Figure 15. The folded birch bark between the sandstone slabs in the dry-walling in Maglehøj (Photo: L. Aa. Jensen, Danish National Museum).

The influx of ozone into the chamber was then investigated with an open passage. Over the course of two sunny days in June 2016, the ozone level was measured inside and outside the chamber through a period of 48 hours. The ozone level in the middle of the open chamber was 8 ppb (average) but varied between day and night (<1-15 ppb). But the ratio of inside to outside concentration was, however, largely a constant 0.25. Spot measurements undertaken directly in front of the dry-walling showed a slightly lower inside to outside ratio of *c.*0.2. In the open chamber there is, accordingly, free access for ozone, with the birch bark also being exposed. In the two centuries that have elapsed since the Maglehøj chamber was reopened, the birch bark has been influenced by ozone corresponding to a millennium of open air. This has probably contributed to degradation of the bark by oxidation (Figure 15).

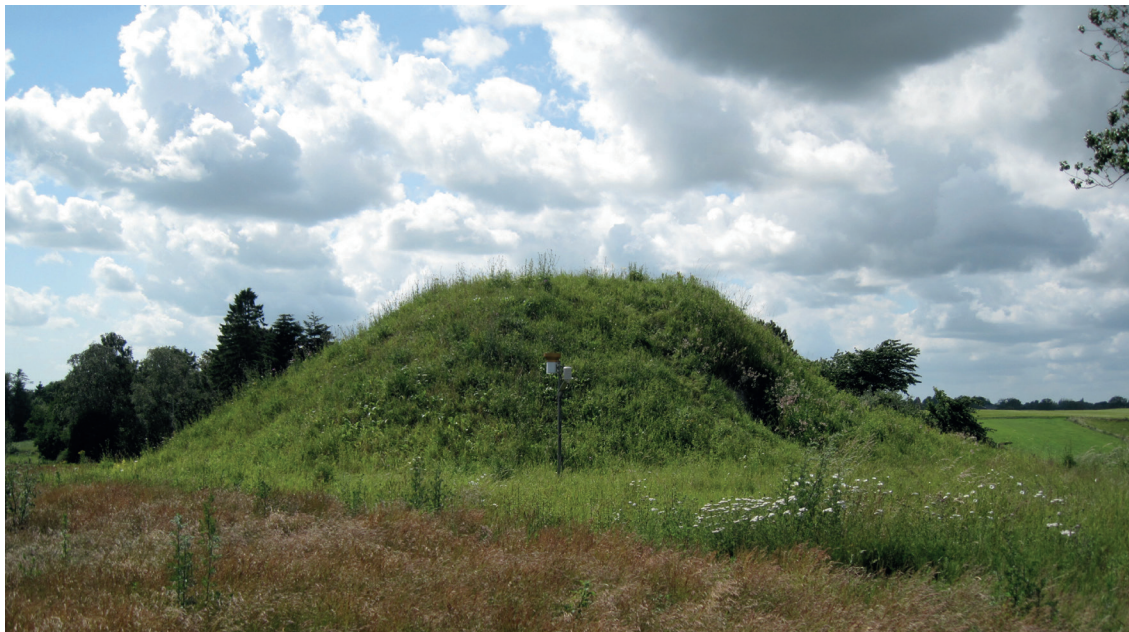
Figure 16. Maglehøj seen from the south with the entrance to the right. The external climate sensors can be seen in the centre (Photo: L. Aa. Jensen, Danish National Museum).

Based on the results of the investigations of the preservation conditions for birch bark, it is recommended that a permanent, air-tight closure of the door is established to stabilise the internal climate and keep the chamber free of ozone. Access for visitors is already hindered by a locked airtight metal door, so accessibility will not be further impeded. There are many other well-preserved burial chambers without birch bark which can better tolerate the wear that people and animals inflict on the remains of the 5000-year-old bark (Figure 16).
