FIELD EXPERIMENTAL STUDY ON EXTERNAL PRESTRESSING REINFORCEMENT OF A 420M PC CONTINUOUS BEAM BRIDGE

Sun Zhonglin, Sun Quansheng, Li Jianfei and Yang Shengqi

Department of Civil Engineering, Northeast Forestry University, Harbin, 150040, China; sunquansheng@nefu.edu.cn

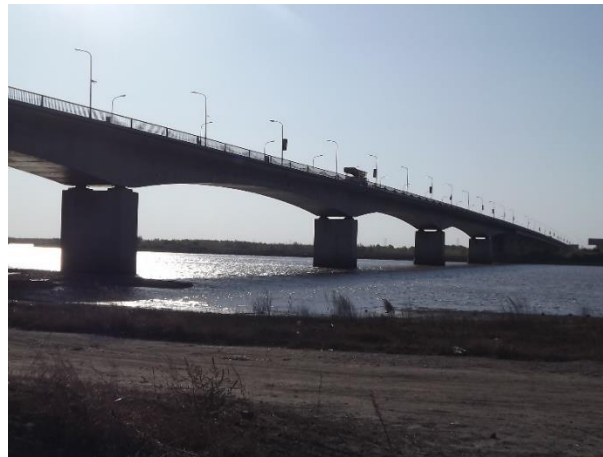
Fig.1 - Bridge type layout (unit: m)

A 420 m PC continuous girder bridge was completed in September 1995. Cracks appeared in the roof, floor, and web of the main girder of the bridge under long-term vehicle load and the surrounding environment. Overall, there were more cracks on the outer surface of the bridge. The majority of the crack width is concentrated in the range of 0.10 mm to 0.40 mm, and the length ranges from 0.3 m to 2.6 m. The width, length, and number of these cracks tend to increase over time. The bridge layout is shown in Figure 1.

(a) Field bridge

(b) Span and number

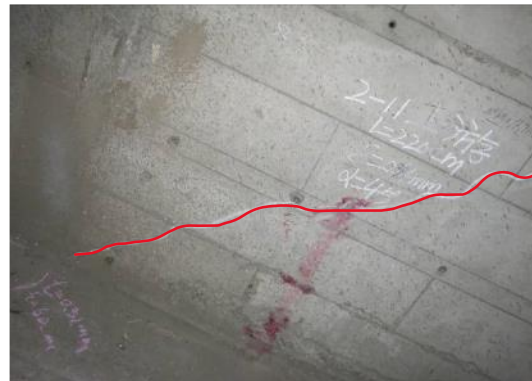
(b) Inclined cracks of the web near the top of No. 11 pier ($L=2.2m$ $\delta=0.18mm$ $\alpha=45^\circ$)

At span 9, 5.49 m from the top of pier 9, inclined cracks began to appear on the web. Two oblique cracks were found. The crack lengths were 1 m and 0.91 m, respectively. The crack widths were 0.06 mm and 0.08 mm, respectively. The inclined cracks of spans 10, 11, and 12 were mostly concentrated between 34 and 39.5 meters from the fulcrum. The crack length was 0.41 m to 1.34 m. The crack width is 0.12 mm to 0.42 mm. They are caused by the principal tensile stress. Bending cracks appeared over a distance of 17.8 to 12.4 m. The crack height was between 0.06 m and 0.23 m. The crack width was between 0.02 mm and 0.14 mm. At span 13, 4.43 m from the top of pier 14, the web began to appear inclined. The crack length was 1.15 m. The crack width was 0.12 mm.

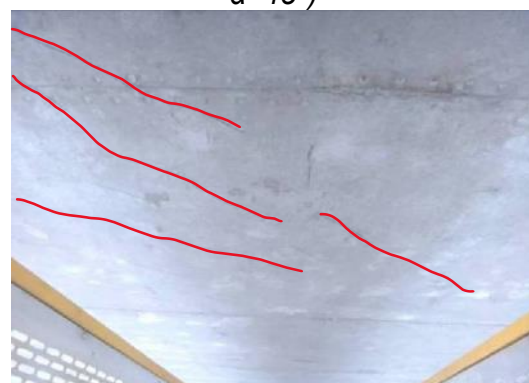
(e) Inclined cracks of the bottom plate in No. 10 hole ($L=4.4m$ $\delta=0.3mm$ $\alpha=45^\circ$)

Secondly, the box girder floor and roof were checked. Some of the floor cracks were inclined cracks on both sides of the web extending to the middle line of the floor, while others were parallel to the bridge direction. The number of cracks increased gradually from each pier to the middle span. The number of floor cracks in span 10, span 11, and span 12 box girders increased gradually from the pier to the midspan direction. The two sides of the middle line of the floor cracks were symmetrical. In the range of 20 m on both sides of each pier, the bottom plate of the box girder had mainly longitudinal cracks. In the L/4 ~ 3L/4 section, a number of inclined cracks appeared in the bottom plate near the edge of the web. The floor crack width was mainly concentrated between 0.1 mm and 0.4 mm. The length of the crack was mostly concentrated in 0.70 m ~ 4.60 m. The roof

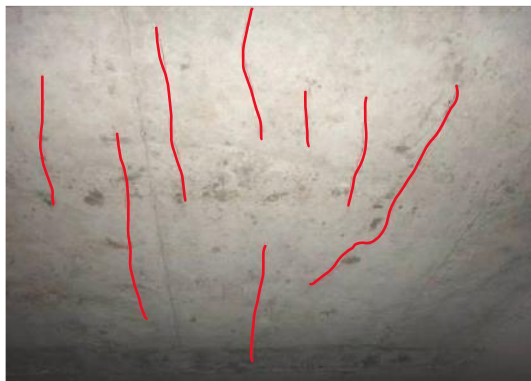
(i) Longitudinal cracks in the roof near of No.10 pier ($L=2.5m$ $\delta=0.2mm$ $\alpha=15^\circ$)

cracks were symmetrically distributed along the bridge deck midline and increased from the pier to the midspan direction. The longest crack was 5.34 m. The maximum crack width was 0.34 mm. In the range of 15.5 m from the piers on both sides (pier 10 and pier 11), dense intermittent longitudinal cracks appeared. The crack length was between 0.30 m and 2.60 m. The crack width was between 0.08 mm and 0.18 mm. The distribution of main cracks in box girders is shown in Figure 2. (Symbol description: crack length is expressed as $L=0.1m$, crack width is expressed as $\delta=0.1mm$, crack tilt angle is expressed as $\alpha=45^\circ$)

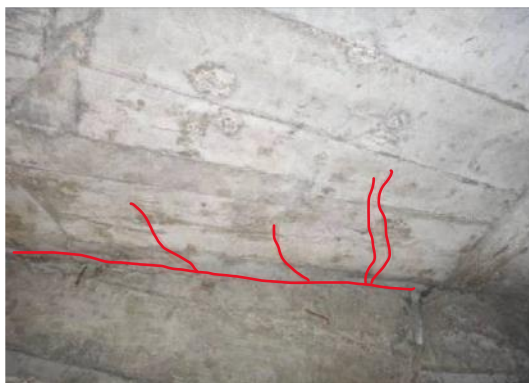
Finally, the crack distribution of the prestressed tooth plate and diaphragm was checked. There were many inclined cracks at the bottom of the roof at the top prestressed tooth plate of pier 9 and the top prestressed tooth plate of pier 14. The crack length was 0.15 m to 0.52 m. The crack width was 0.08 mm to 0.20 mm. The inclination angle was $30^\circ \sim 60^\circ$. There were no stress cracks discovered in the diaphragms of piers 10, 11, 12, and 13. The diaphragm at the middle section of span 9 ~ 13 had vertical cracks on the top of the passing holes. On the one hand, the crack cracked horizontally downward along the direction of hole thickness. On the other hand, it extended vertically upward to the bottom of the roof. The width was between 0.14 mm and 0.30 mm. The length was between 0.35 m and 1.43 m. The distribution of specific cracks is shown in Figure 3.

(a) Inclined cracks of tooth plate of No.11 box ($L=0.52m$ $\delta=0.2mm$)

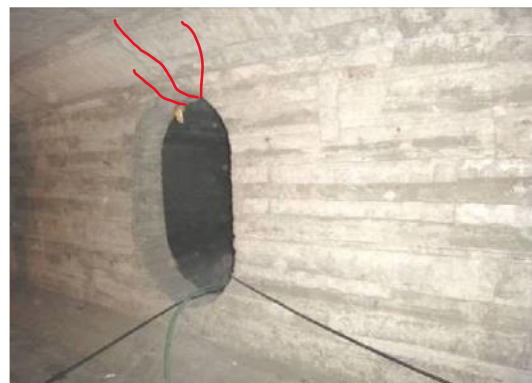
(b) Cracks in diaphragm of No.12 box ($L=1.43m$ $\delta=0.3mm$)

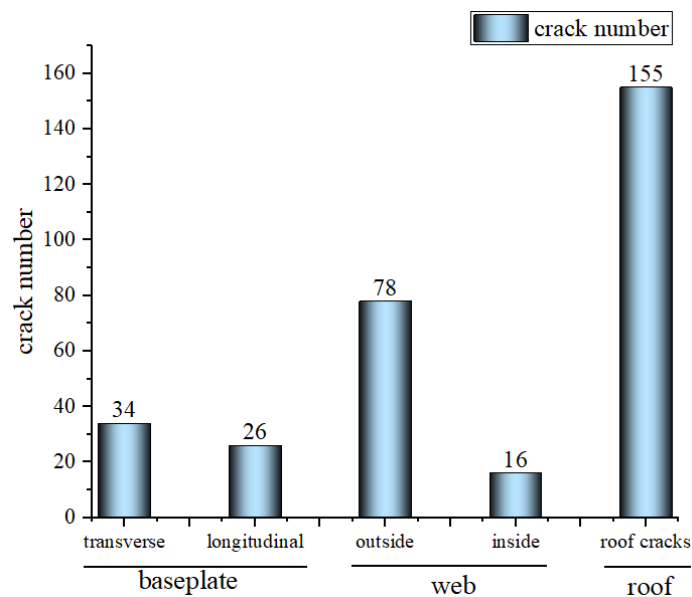
Use a tape measure to determine the size of the crack. The crack tester measures the crack's width, and the cracks are categorized based on their placements. Classify all cracks examined as shown in Figure 4.

Fig.4 - Number of different types of cracks

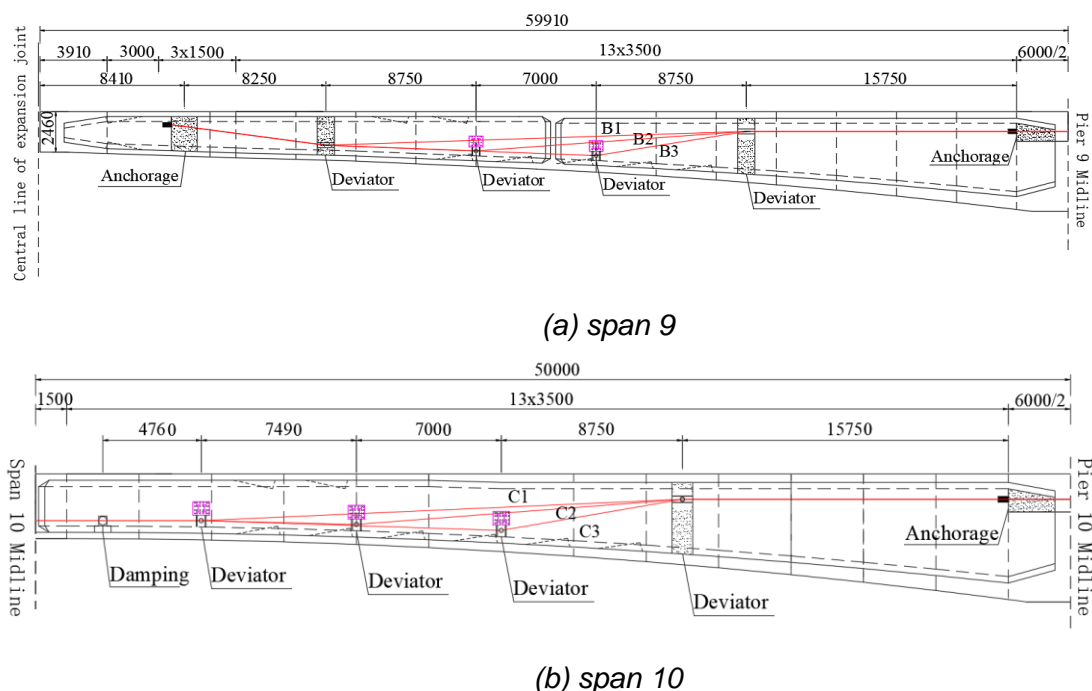
Fig.5 - Detailed layout of steel beam (unit: mm)

The externally prestressed tendons were added to the box girder to improve the cross-sectional strength, control the development of cross-section cracks, and effectively improve the stress of the girder. Six strands for span 9 and 13. Eight strands for span 10, 11 and 12, each consisting of 13 steel wires with a nominal diameter of 15.2 mm [15]. The two ends of the side span external prestressed steel beam were respectively anchored on the beam and the anchorage block. The middle-span external prestressed steel beam was cross-anchored on the anchorage block at the pier top. The detailed arrangement is shown in Figure 5.

The externally prestressed steel beam was tensioned at both ends. The tension control stress was 1209 MPa. The steel bundle was wrapped in a corrosion-resistant casing. Adjustable cable force and a replaceable anchor were used to facilitate future bridge maintenance. The field layout of externally prestressed tendons is shown in Figure 6.

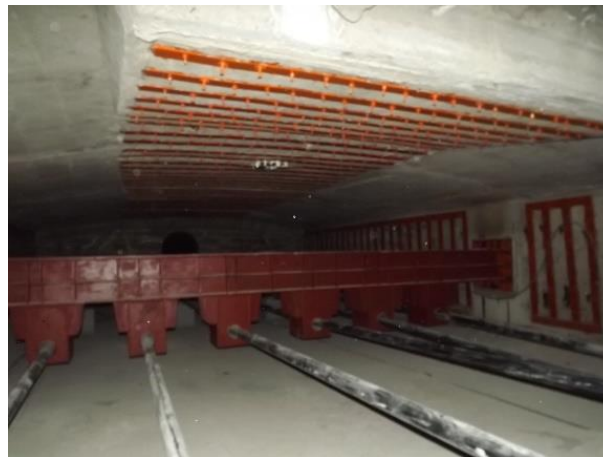
Fig.6 - Field condition of external prestressed bundle

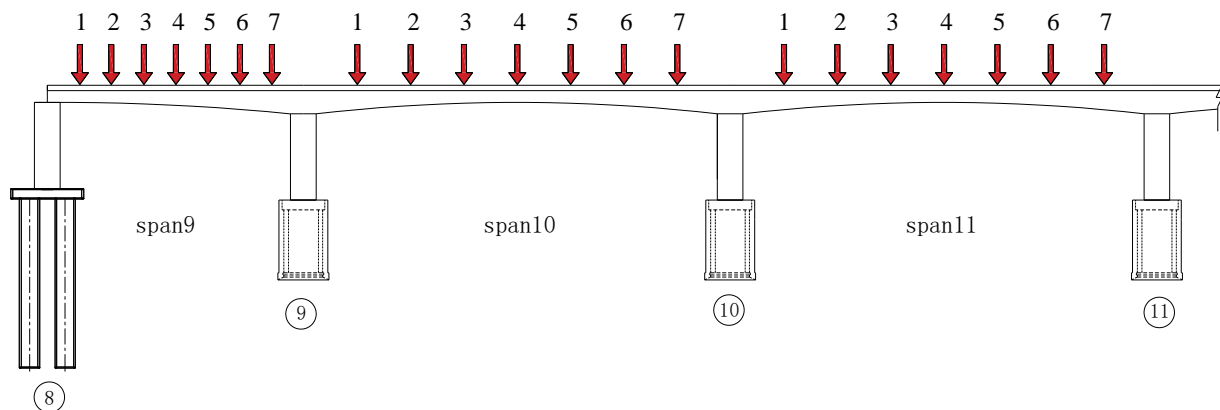
Specific test sections were selected as follows: Seven deflection test sections and one strain test section were arranged for each span. The deflection test sections were located at L/8, 2L/8, 3L/8, 4L/8, 5L/8, 6L/8 and 7L/8. The strain test section was located at 4L/8. The specific layout is shown in Figure 7.

Fig.7 - Deflection and stress test sections

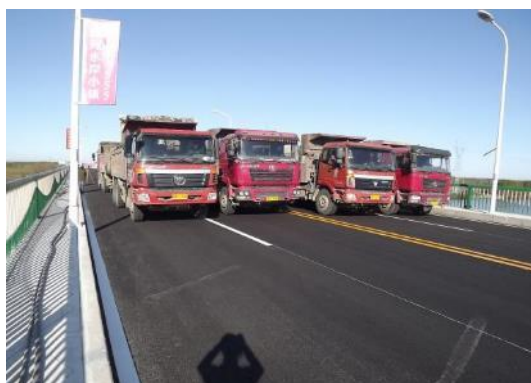
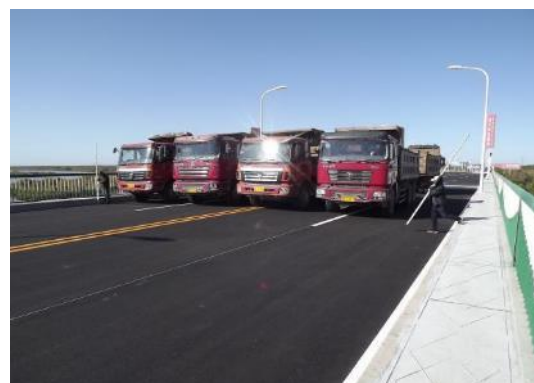
(a) Centric layout

(b) Eccentric layout

Fig.9 - Site loaded vehicle arrangement

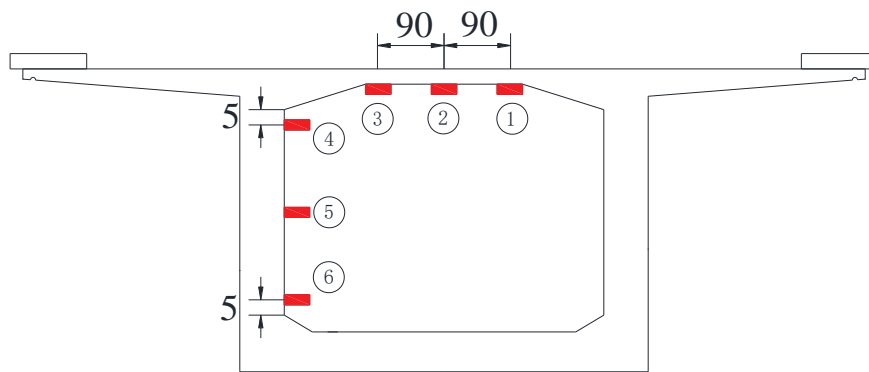
The strain sensors were arranged in the interior of the box girder. The measurement points were arranged on the top, web, and bottom surfaces at the mid-span position and on the top and web surfaces at the abutment position. The deflection was measured with a precision level. In deflection

measurement, the pier top was a fixed point. The tower ruler was placed on the test section. The precision level was placed on the pier top beam. The vertical deflection of the test section relative to the pier top was measured. The arrangement of measurement points is shown in Figure 10.

(a) Mid-span strain layout

(b) Pier top strain layout

(c) Deflection sensors layout

Fig.10 - Deflection and strain sensor locations illustration (unit: cm)

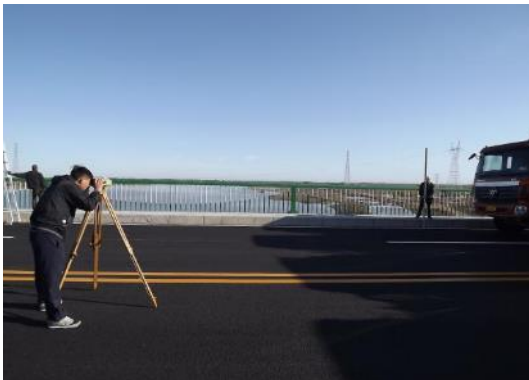
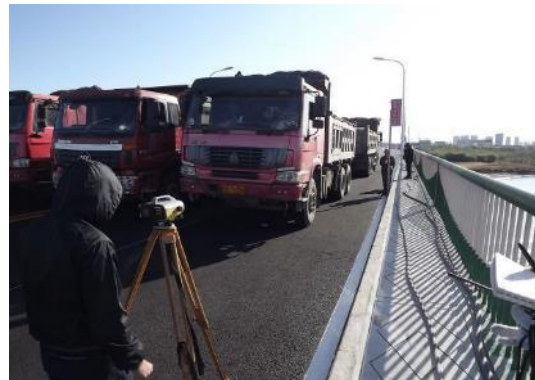
Fig.11 - Field measurement

The picture of the field test is shown in Figure 11.

(a) Field measurement

(b) Field measurement

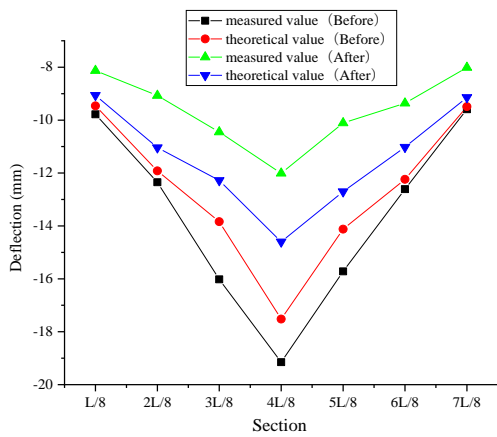
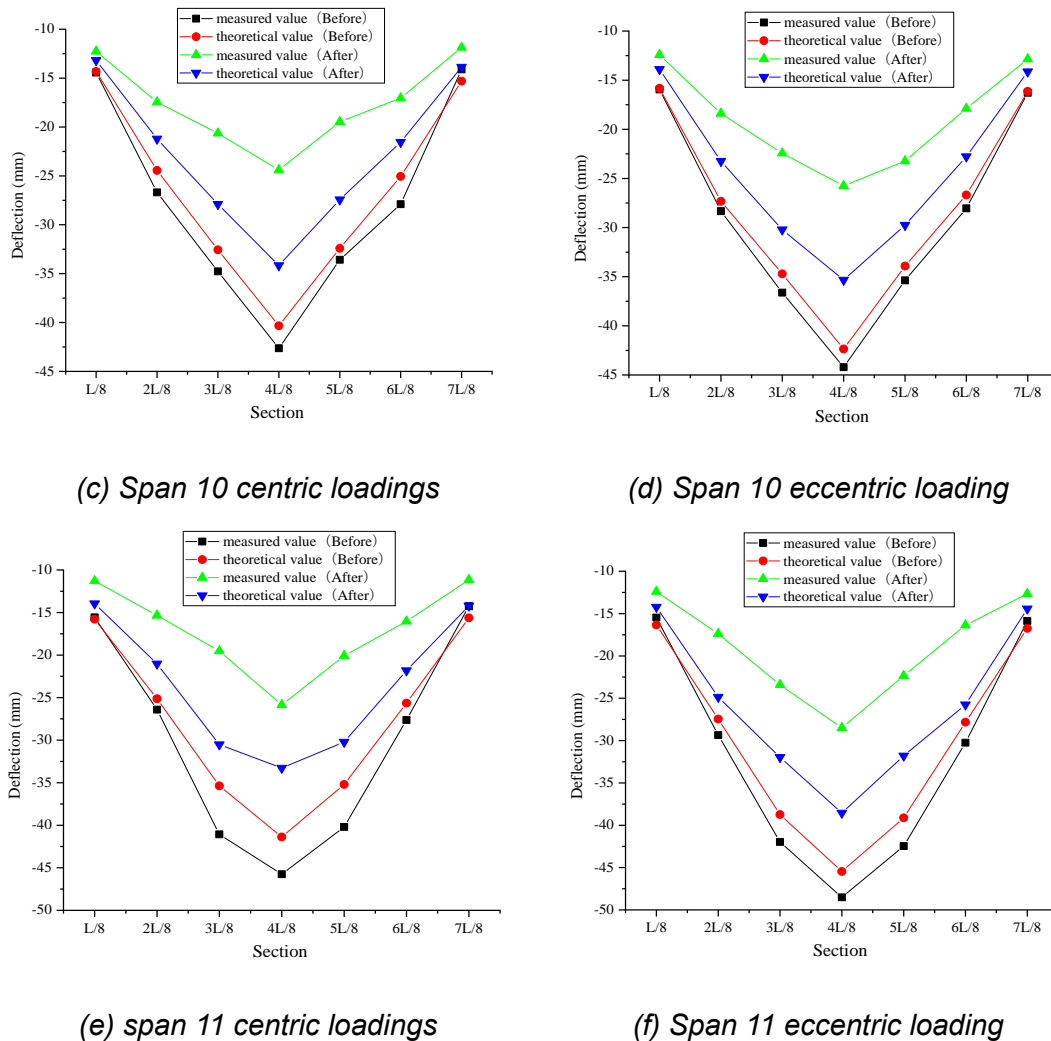
Deflection is an important parameter to characterize the bearing capacity of a bridge. The vertical deflection data and theoretical finite element model data of spans 9, 10 and 11 before and after reinforcement are shown in Figure 12.

(a) Span 9 centric loadings

(b) Span 9 eccentric loading

Fig.12 - Vertical displacement data

According to the above curve, the bearing capacity of the No. 9 span increased by 18 %. The bearing capacity of the No. 10 span increased by 15%. The bearing capacity of No. 11 span increased by 18%. These results demonstrate how external prestress can greatly increase the structure's stiffness.

Comparison of deflection data before and after reinforcement. Most measured deflection data had exceeded theoretical data before reinforcement. After reinforcement, the measured deflection data has decreased to varying degrees. The maximum measured deflection after reinforcement is 28.49 mm, which is 41% lower than that before reinforcement of 48.52 mm.

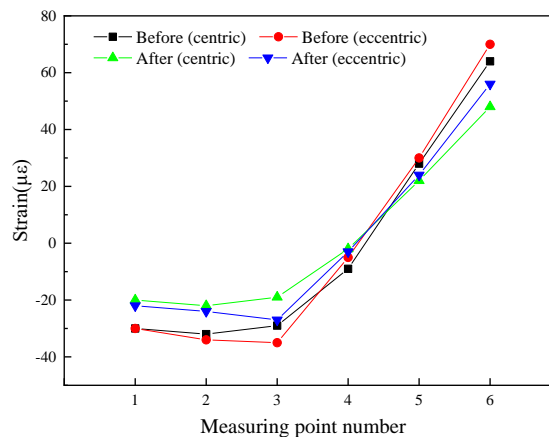
At the top of pier 10, the bearing capacity increased by 14% on average. The calibration coefficient increased by 16% on average. The measured strain data are shown in Figure 14.

Fig.14 - Measured strain data under static loading test
