EXPERIMENTAL STUDY ON THE SEISMIC DAMAGE OF AEOLIAN SAND CONCRETE COLUMNS WITH DIFFERENT REINFORCEMENTS

Yaohong Wang, Xiaoyan Ma, Qing Han, Qi Chu and Zeping Zhang

Inner Mongolia University of Technology, School of Civil Engineering, Hohhot, Inner Mongolia, China; wyh@imut.edu.cn, 20171800217@imut.edu.cn, 19880000016@imut.edu.cn, 20171100260@imut.edu.cn, 20171800225@imut.edu.cn

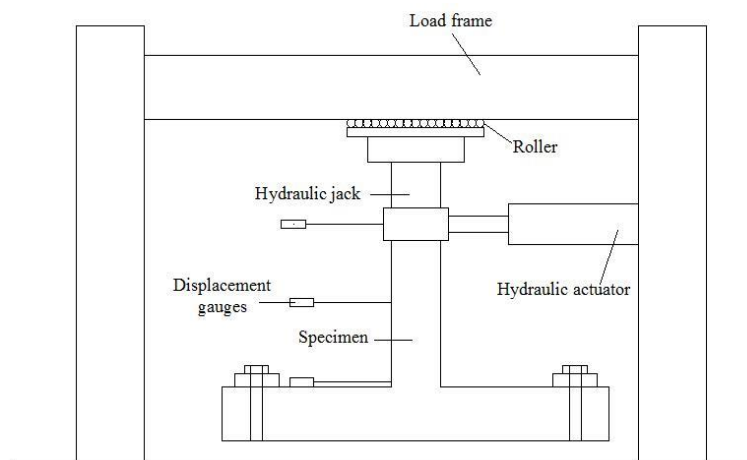
Fig. 2 – Test devices

The cyclic loading tests were conducted at the Key Laboratory of Civil Engineering Structure and Mechanics at the Inner Mongolia University of Technology, China. The test devices are displayed in Figure 2. The height of the horizontal loading center away from the bottom of columns is 875 mm.

After the vertical pressure was applied to the vertical jack, the axial compression ratio was maintained constantly throughout the test. A horizontal low-cycle reciprocating load was applied by manipulating the pushing and stretching of the horizontal jack. In the tests, the load control method was used first. When the skeleton curve shows a significant inflection point, it is considered to enter the yield stage. Then, the displacement control method was used. The displacement of each step was integer multiples of the yield displacement. The loading continued until the bearing capacity of the specimens dropped to 85% of the peak load. In total, there were 3 electronic displacement gauges deployed in the test. They were used to measure the displacement of the specimens.

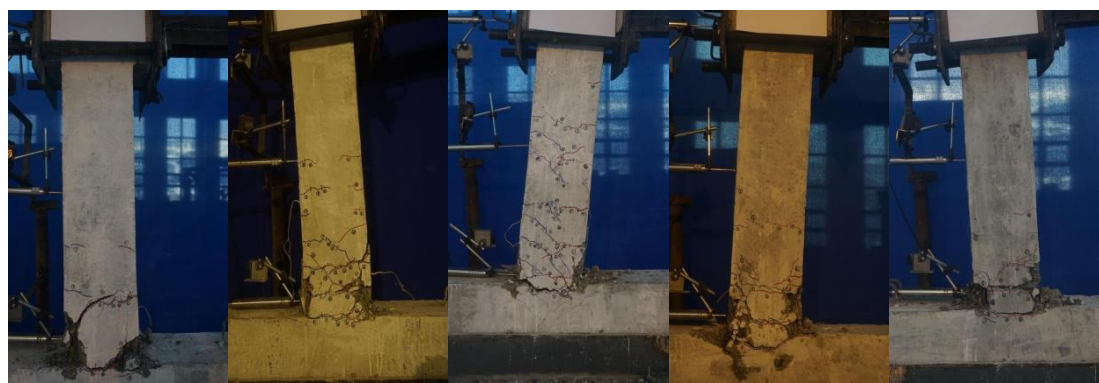
Fig. 3 – The destructive form of the specimens

The destructive forms of the specimens are displayed in Figure 3. The details of damage when the specimens were broken are displayed in Figure 4. During the tests, the failure processes of the specimens were recorded in detail. When the specimens were under the same load, the degree of damage decreased with an increase in the longitudinal reinforcement percentage and in the transverse steel ratio.

As the load reached 21.8kN in the forward direction of the fourth cycle, a few horizontal cracks formed on the bottom of the column. The widths of these cracks were all approximately 1.5 mm. In the negative direction, 2 cracks formed in the middle and lower parts of the specimen. As the load reached 56.8kN, a wider crack with an angle of approximately 45° appeared approximately 300mm from the bottom of the column. The existing cracks were gradually widened. As the force reached 79.5kN, a large crack with an angle of approximately 60° formed at the bottom of the specimen, with slight spalling of the concrete. The width of this crack was approximately 5.6 mm. After this, more cracks quickly developed and intersected each other. When the specimen was broken, the concrete on the bottom of the column was crushed and peeled off over a large area. Concurrently, the stirrup and the longitudinal reinforcements were exposed and seriously buckled.

The first cracks formed in the middle and lower parts of the column. As the positive force reached 32.8kN, a few new cracks with lengths ranging from 56 mm to 93 mm formed at the bottom of the column. When the positive force reached 83.7kN, many oblique cracks formed in the middle and lower parts of the column and were inclined downward by 30°. In the following negative direction, these oblique cracks rapidly developed and intersected each other. As the force reached 124.3kN, the existing cracks continued to expand, accompanied by the sound of cracking concrete. As the loading force was 144kN, the concrete on both sides of the bottom of the column started to peel off. As the column was destroyed, the concrete at the bottom was completely crushed. It can be observed that the stirrup and longitudinal reinforcements were exposed and yielded.

loosening. When the specimen was broken, the concrete of the root segment was completely crushed and peeled off over a large area. The exposed longitudinal steel bar and stirrup were stretched and bent.

As the load reached 43.2kN, the earliest cracks with a maximum length of 68 mm, which located in the lower part of the column. When the force was 95.8kN, there were many cracks in the middle and lower parts and almost extended obliquely down 60°. Some cracks on the right side of the root segment extended to the left with a slight peeling of the concrete. The cracks on the left side of the root segment were inclined downward 30° along the foundation beam. As the load was 147.8kN, the cracks in the middle and lower parts continued to develop. Some cracks showed a lightning shape. Subsequently, more cracks quickly developed and intersected each other. When the specimen was broken, the concrete on both sides of the root segment was crushed and peeled off. The longitudinal bar was exposed on the right side and was clearly bent. Additionally, the stirrup of the root segment was exposed and had yielded.

As the load reached 48.4kN in the negative direction, the 5 earliest cracks formed in the lower parts of the column. The cracks developed rapidly and were distributed horizontally. As the load was 138.5kN, some cracks in the lower part showed a lightning shape and penetrated each other. On the right side, a crack of 56 mm in length extended from the root segment of the specimen to the middle and lower parts of the specimen and followed an angle of approximately 60°. As the peak load was 158.3kN, the largest crack in the root segment of the specimen widened to 4.2 mm. Concurrently, the concrete of the root segment began to partially peel off. When the specimen was broken, the concrete of the root segment was completely crushed and peeled off over large areas. The results indicated that the stirrup and longitudinal reinforcement were exposed and had seriously buckled.
