## SWEPT SOURCE TEST: COUPLING MEASUREMENTS REPORT

**DOC. TYPE:** TECHNICAL NOTE

**PROJECT REF.:** PL-LFI-PST-TN-058

**DATE:** October 2004

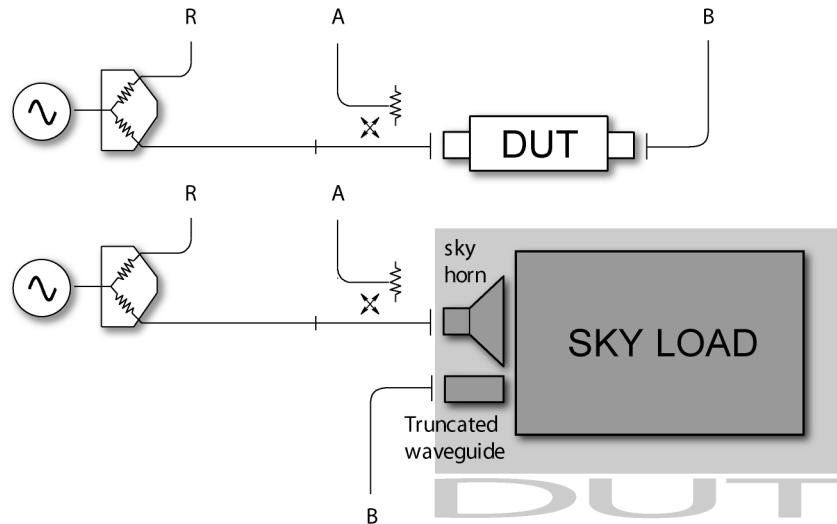
The setup is a standard measurement setup for a 2 port device (see figure upper scheme) measurement performed with a scalar network analyser at IASF – Bologna. The Device Under Test is the composed by the *sky horn – Truncated waveguide* system seeing the *sky load* (Figure 1 lower scheme).

Figure 1: Schematic view of the measurement setup

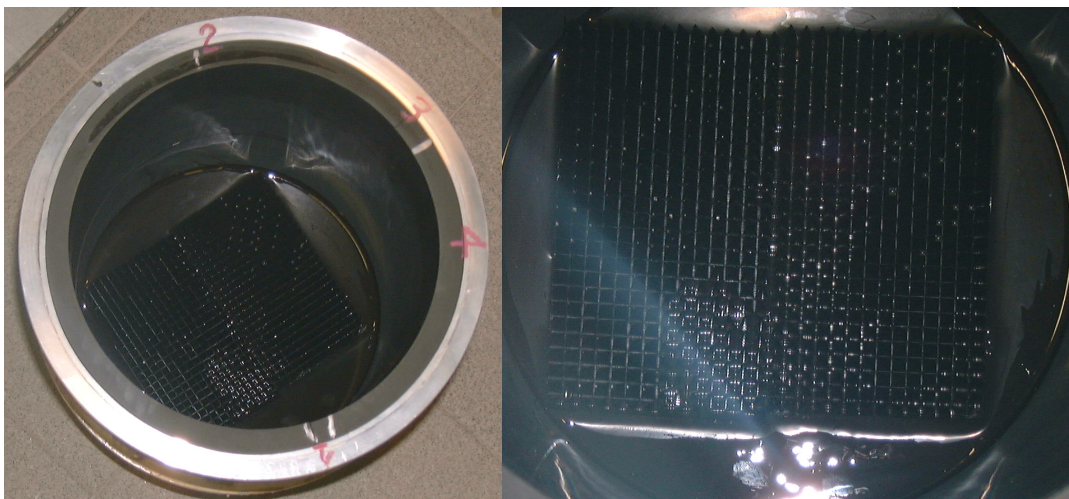
The sky load used here is not the sky load will be integrated in the LFI RCA cryo chamber but is similar. Internal dimensions are the same and on the bottom part two rectangular sheets of pyramids have been inserted to simulate the actual sky load.

Figure 2: Sky load used during this tests.

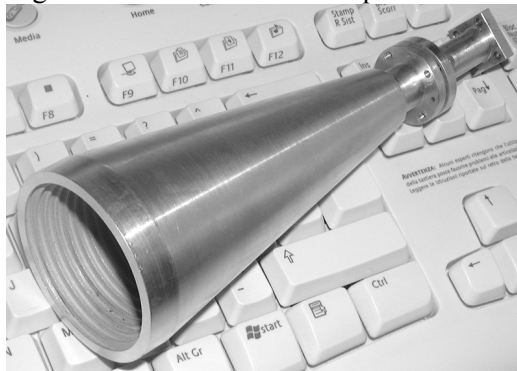
The sky horn is the LFI 30 GHz EBB. Its performances are reported in **Errore. L'origine riferimento non è stata trovata.** and [RD 3]. This horn design is similar to the Flight Model. The corrugation profile is the same. The circular waveguide straight section and the external profile are not.

*Figure 4 Sky horn. This horn is the LFI EBB horn connected to the circular / rectangular waveguide transition.*

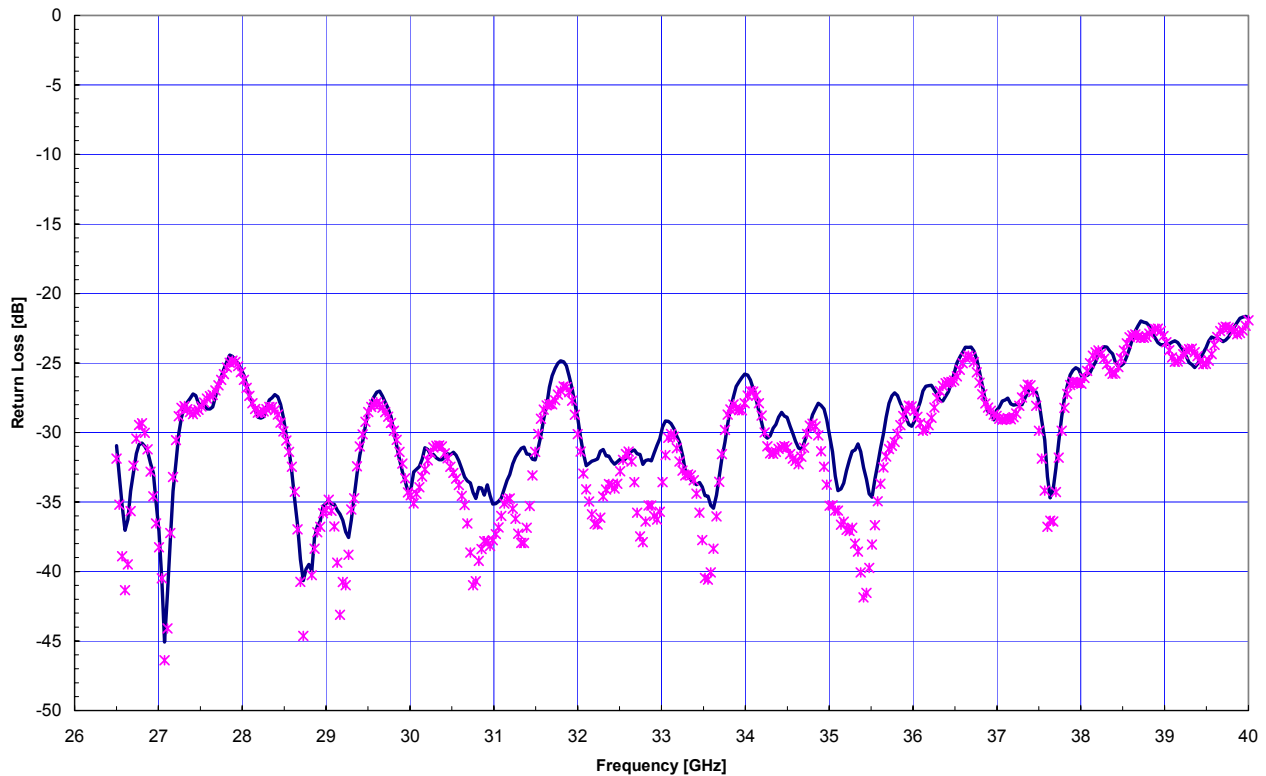
Firstly, the return loss of the horn connected to the circular/rectangular waveguide adapter has been performed both with the horn radiating in the lab and the horn radiating into the *sky load*. Results are reported in Figure 5.

*Figure 5: Return loss of the Sky horn and its adapter radiating on free space (solid line) and on the sky load (asterisks)*

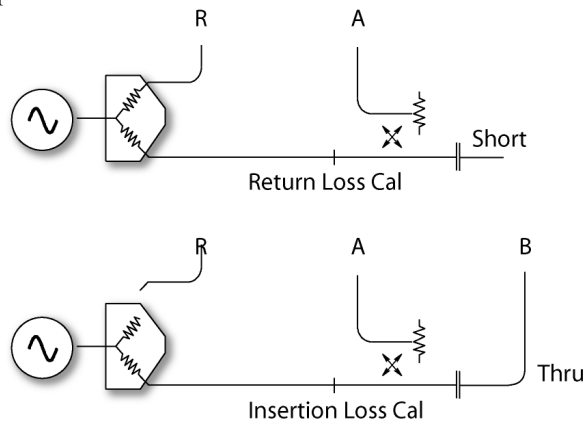
Calibration of the port A ( $S_{11}$ ) has been done with an aluminium foil acting as a short at the Horn (including circular to rectangular adapter) / Directional Coupler interface. What has not calibrated is the effect of the corrugated horn (including the adapter) mismatch and its attenuation. However it's negligible. Calibration of the port B ( $S_{21}$ ) has been done connecting the port B, which is the truncated waveguide, directly at the directional coupler interface.

Figure 7: 2-port scalar standard calibration concept

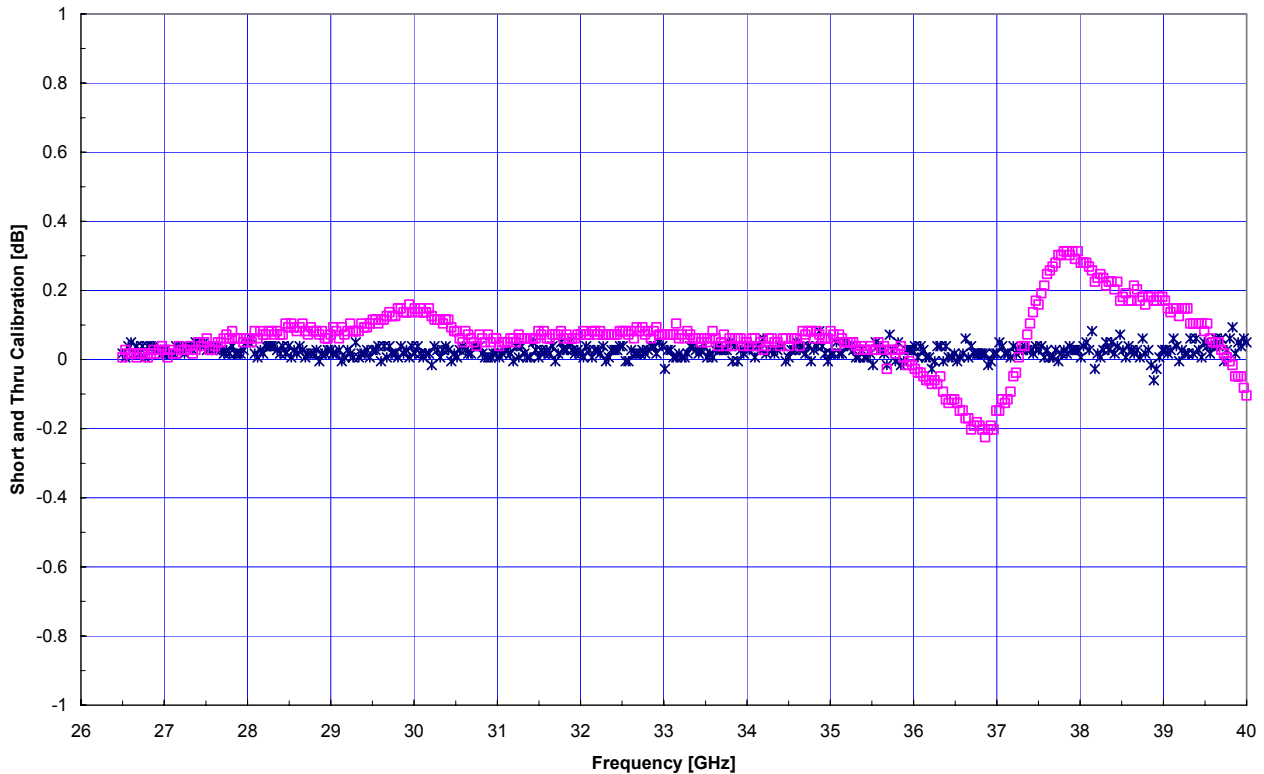
At the end of the tests, calibration has been checked again. The curves are reported in *Figure 13* showing a calibration stability well below  $\pm 0.1$  dB for the S11 parameter (return loss) and better than  $\pm 0.3$  dB for the S21 parameter (coupling).

Figure 13: Calibration check. Asterisks: Calibration of the S11 parameter. Squares: calibration of the S21 parameter.
