Experimental and numerical inspection of cracks in ferrule cracking of BK1 cement crusher

ABSTRACT. This article defines the main actions planned in the procedure of non-destructive testing and analysis of defects in the BK1 industrial mill of the cement plant of the GICA group. One of the subjects attracting the attention of researchers and engineers was the propagation of cracks in the shell of the BK1 mill, which behaves like perforated plates. This inspection technique makes it possible to position and size defects (cracks) in the plates. The objective of this work is the detection of cracks in the shell of the BK1 cement mill. In order to avoid bursting of the crusher, the preventive technique of ultrasonic inspection using a multi-element translator is used, while minimizing downtime and increasing production. Found Results allow us to determine and analyze the different types of defects, which will be repaired. It was concluded that the stress concentration at the assembly holes, the vibration effects and gradient of the temperature due to the effect of welding were the causes great residual stresses at the level of the weld. We note the addition of a mass of weld during th

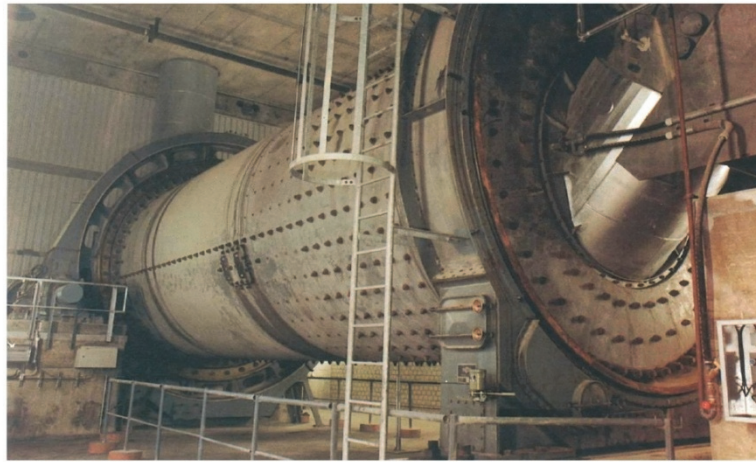
Figure 1: Broyeur Air-Swept [16].

The grinding of cement is ensured by ball mill of beginning of 90 ton / h in closed circuit of 4m diameter and 15 m of length. The mill fan air is purified by an electro-filter. Injection of water into the mill guarantees a favorable purification condition, see Fig. 1.

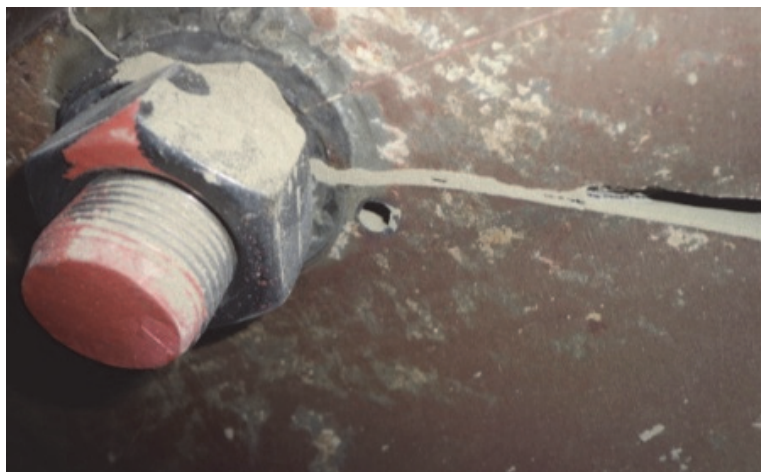
Figure 4: Crack that propagates towards the bolt hole.

Some cracks were triggered from certain locations in the mill grinder shell and propagated to the assembly holes as shown in Fig. 4. For particular cracks, paths propagation was nearly same on both sides of the gear, however there were numerous cases of crack propagation on one side. Given that, the previous appearance of some analogous cracks in some places could be interpreted to faulty design. The measured crack growth rates were compared to those observed over a 4 years age for actual cracks.

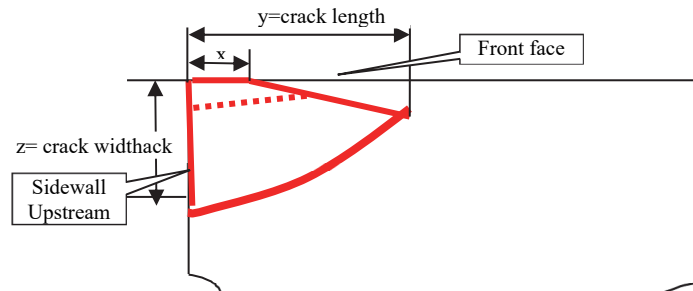
Figure 5: Crack Geometry.

According to Fig. 5, we observe a reference of the geometry of the crack near the bolt's holes, or x and the development of the crack in the attack face, and y is the length of the total crack, thus z and the evolution of the crack in width. We note that the red dotted line in Fig. 5 is the history of the crack, the state of the internal crack before it opens outwards (the surface of the ferrule).

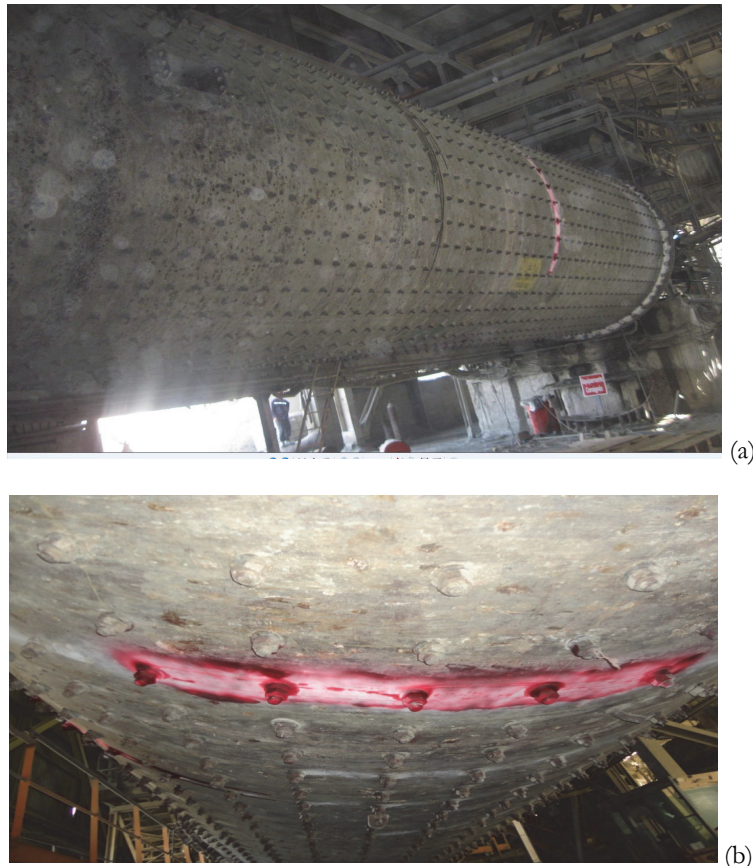
Figure 6: Crack repaired (a) far or perspective view of the crack, and (b) near view of the crack

For this purpose, the crusher is periodically surveyed by preventive maintenance, in order to ensure proper functioning of the installation. Cracks at the level of the crusher shell require us to control and repair the crack if it takes an optimal length that accelerates at break (see Fig. 6).

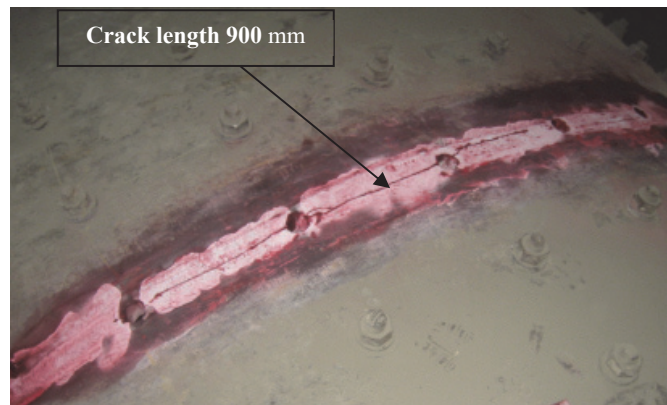
Figure 7: Crack propagates through holes

According to the periodical control of the shredder shell BK1, it was observed in the macroscopic plane that the surface of the crack propagates towards the holes, taking into account the concentration of stresses at the level of these holes which generates plastic zones which weaken and favor this propagation of the holes. These cracks have a different length and depth according to the inspection report at the cement plant (see Fig. 7).

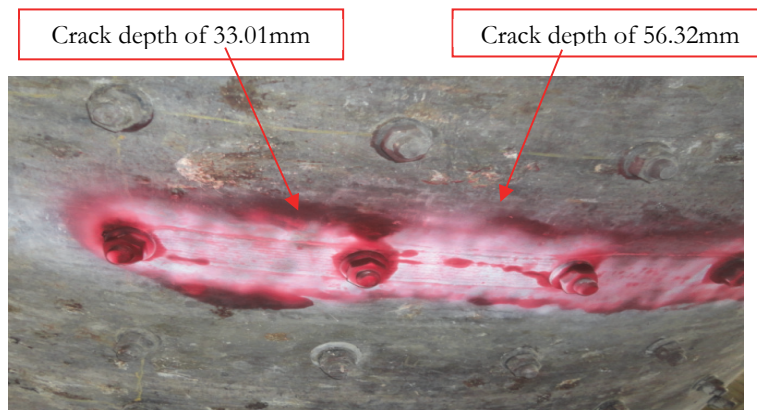
Figure 8: Crack leading to the length of 2400mm

During the shell inspection period, two cracks were observed, primary the measurement of first crack were 280 mm of length and 56.32 mm in depth (between two bolts), and the second crack with 50mm of length and 33mm of depth, see Fig. 8. The depths of these two cracks were measured with the EPOCH 1000i ultrasonic device, see Fig. 9.

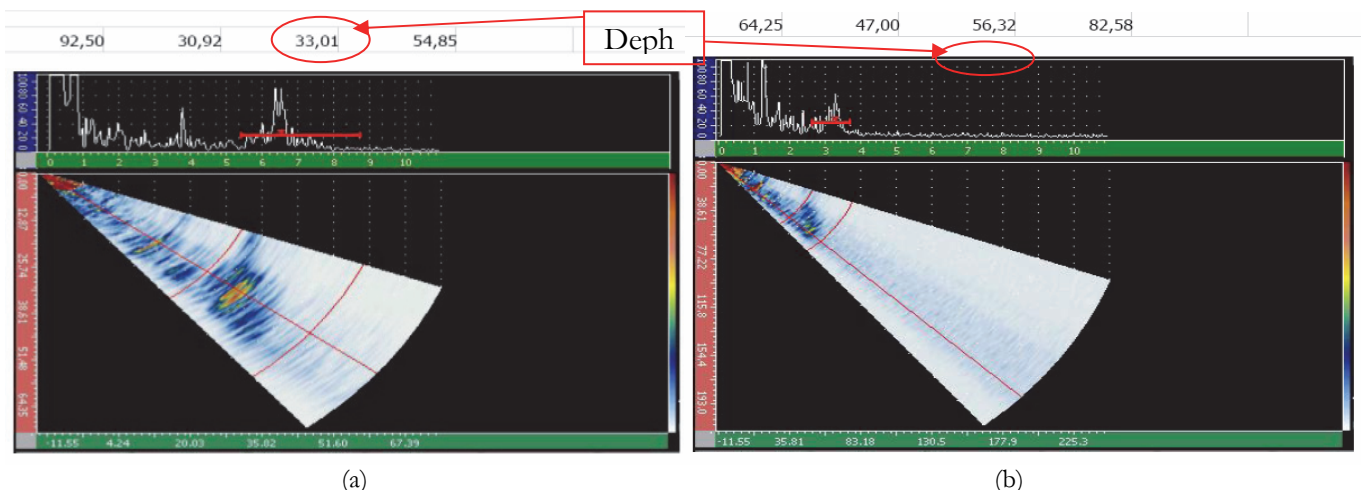
Figure 9: NDC from the depths of the opening crack (a) crack depth is 33.01mm, and (b) crack depth is 50.32mm.

It was observed, that there is proportionality between the crack length and their depth, as well as the tendency of the cracks to propagate towards the holes. We can say that the causes are the concentration of the stresses as well as the presence of residual stresses due to plasticity of the area around the holes.

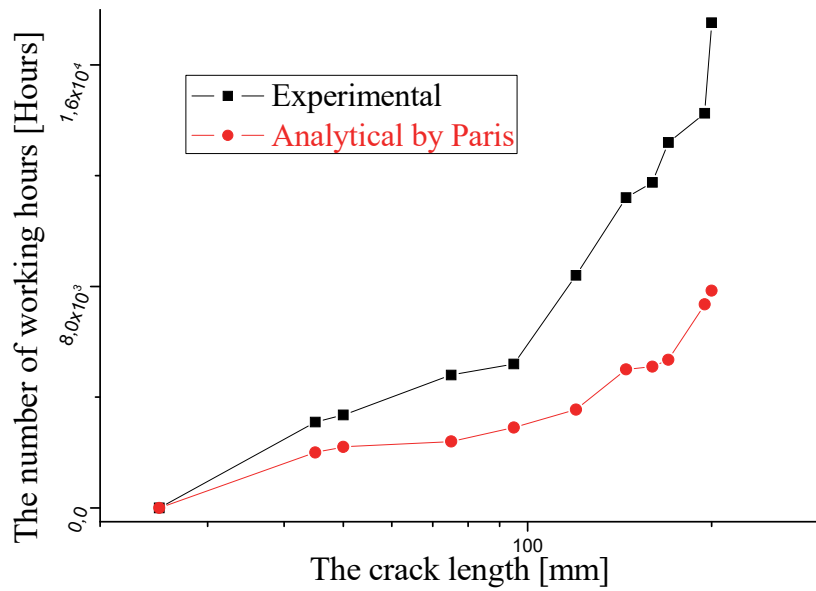
Figure 13: The Crack length measured against the hours of operation of the BK1 crusher.

In this study, we used stress and displacement point matching methods for the ease and consistency with our original model. As shown in Fig. 13 and 14, the estimated life obtained from Paris equation and experimental analysis were compared. The analysis made possible better estimation of the actual life of the BK1 mill shell by experimental fatigue analysis higher than that of the analytical Paris methods.
